Building application and thermal performance of vacuum insulation panels (VIPs) in Canadian subarctic climate

Building Application and Thermal Performance of Vacuum Insulation Panels (VIPs) in Canadian Subarctic Climate

IVIS 2013 – Extended Paper

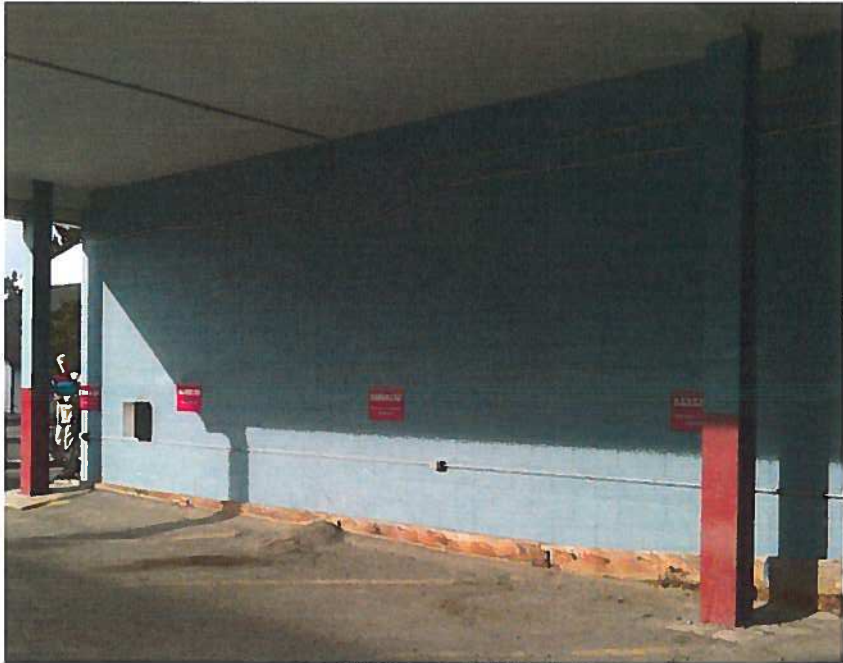
Figure 4. Wall selected for VIP retrofit project.

The existing wall selected for retrofitting with VIP insulation was made of 50 mm x 150 mm (2"x6") stud construction with fiberglass batt insulation and a concrete block exterior with a nominal total insulation value of RSI 3.5 (R20) (RSI: thermal resistance in SI units, $K.m^2/W$; R: thermal resistance as expressed in North America, $ft^2.F.hr/Btu$). The insulation goal for this wall after retrofit was based on previous studies which showed that the economic wall insulation level in northern locations was in the order of RSI 8.8 – 10.5 (R50 to R60) [7], with higher values in attic areas. Thus it was originally proposed to install two layers of VIPs with a total nominal RSI value of 10.5 (R60).

As an initial step, a picture and thermal image of the wall were taken at the site as shown in Figures 4 and 5.

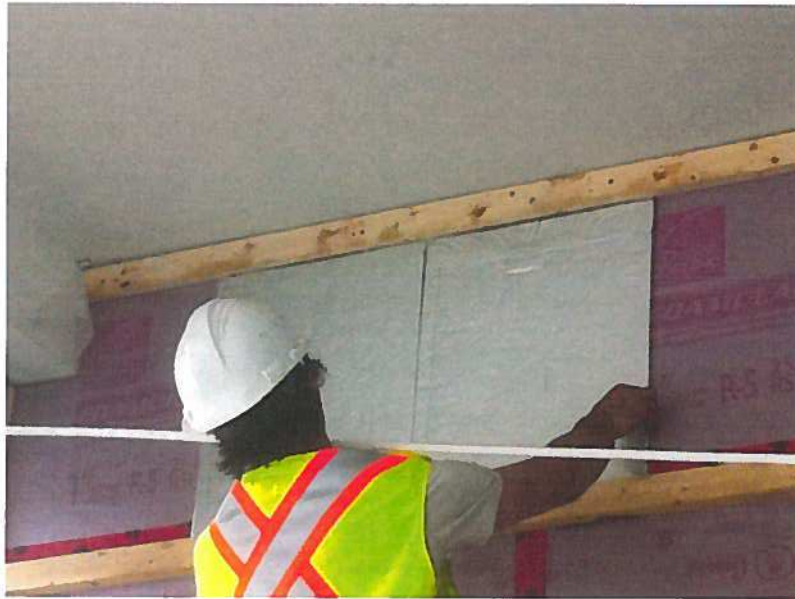
Figure 6. Installation of the vacuum insulation panels (VIPs).

This strategy was effective. None of the supports had to be moved as all the VIPs fit properly. Hence, the installation of the VIPs proceeded quickly (Figure 6).

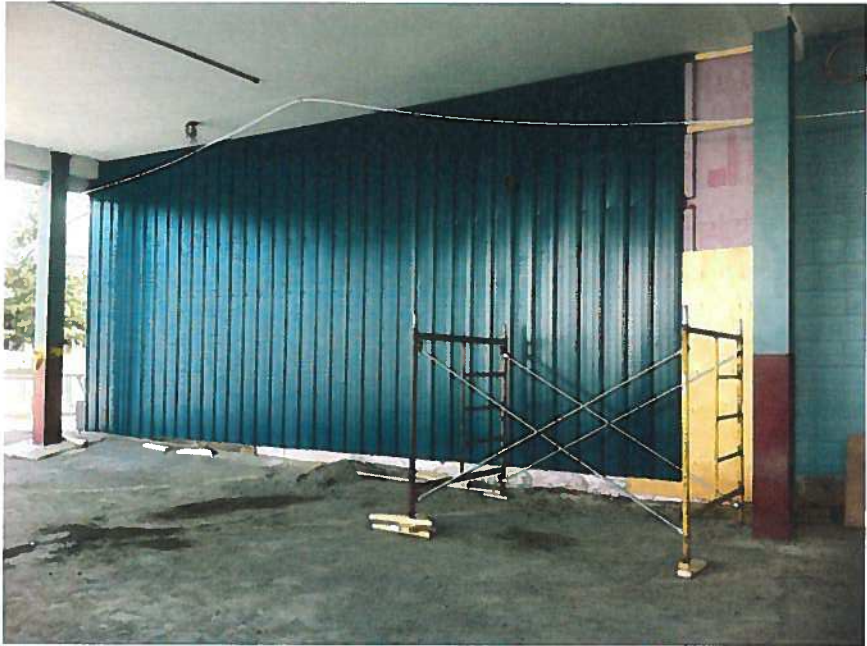
Figure 7. Insulation and siding.

As a final step, electrical and water lines, signs, etc. in the area were reinstalled. The siding, nearly complete is shown in Figure 7. An infrared image of the wall with the vacuum insulation panels installed is shown in Figure 8. Although the ambient temperature is higher than it was when the first infrared image was taken before adding insulation, it is clear that the area with the greatest heat loss is over the 50 mm x 75 mm (2" x 3") support members which are not covered with VIPs.

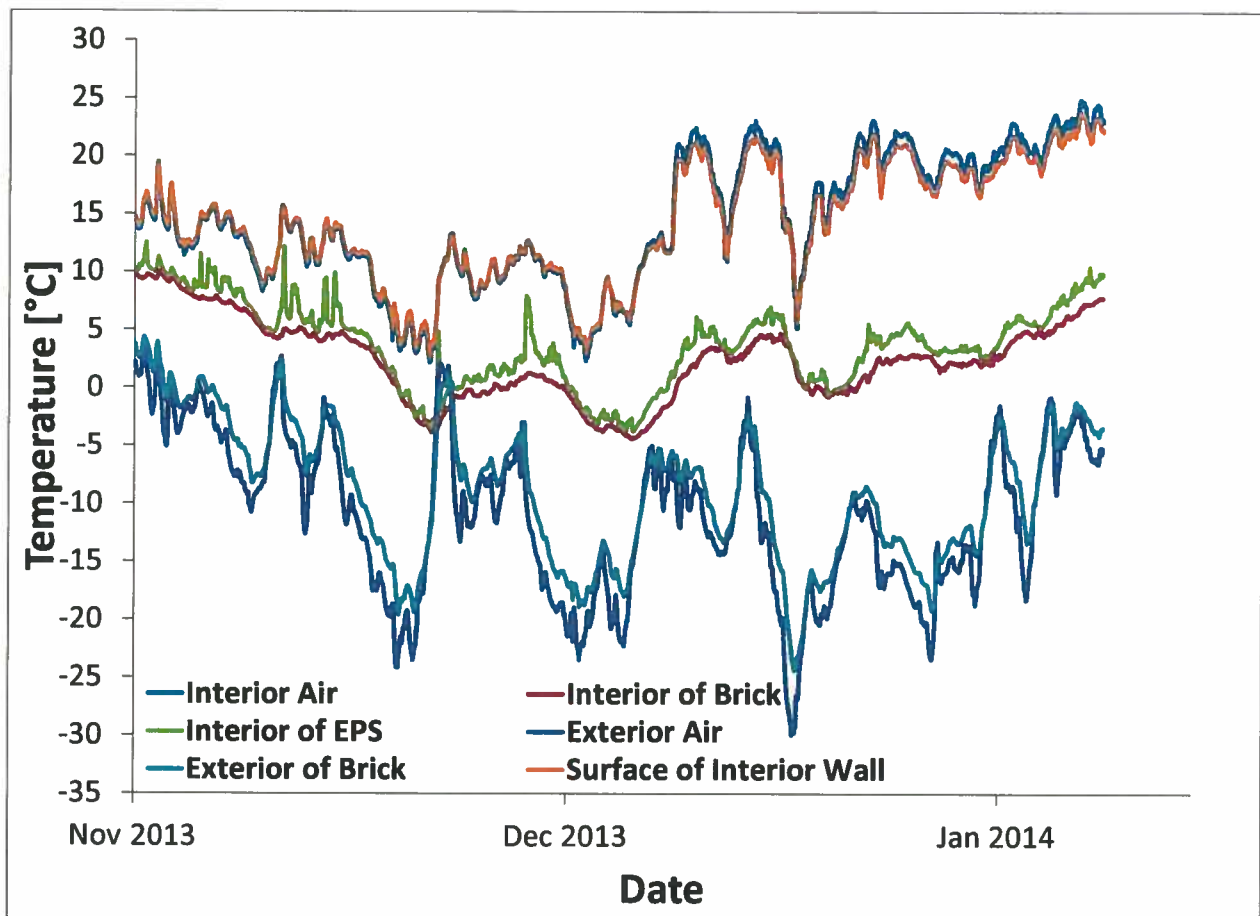
Figure 11. Hourly average temperatures for sensors on interior of wall assembly – November 2013 to January 2014

The temperatures on the interior side of the wall assembly recorded from November, 2013 to January 2014 are shown in Figure 11. These plots show the outdoor air temperature reaching minus (-) 30°C in December 2013.

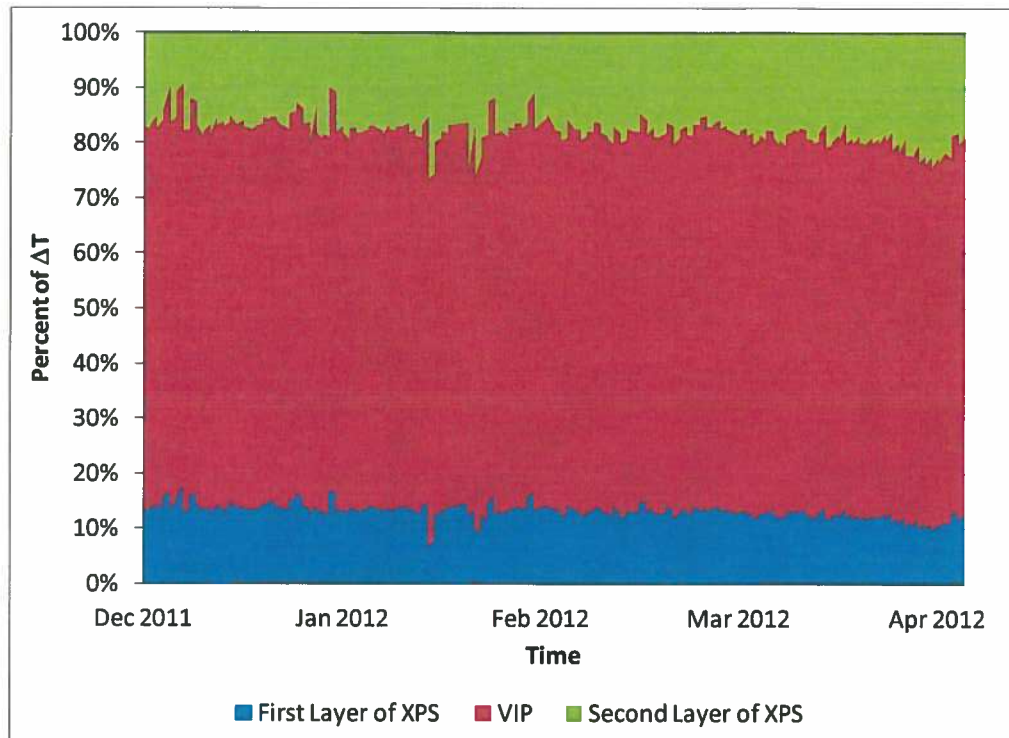
Figure 12. Percentage of Temperature Difference graphs for December 2011 to April 2012

The graphs of the percentage of the temperature difference across each of the three insulation layers for the entire time period (three winters) are shown in Figures 12 to 14. These graphs clearly reconfirms the observations presented above based on the results presented in Table 1.
