Failure Modes and Mechanisms in Gray Cast Iron Pipes

J. M. Makar, R. Desnoyers and S. E. McDonald

Institute for Research in Construction, National Research Council Canada, Ottawa, Ontario, Canada

Presented at Underground Infrastructure Research 2001, Waterloo, Ontario, June 10-13

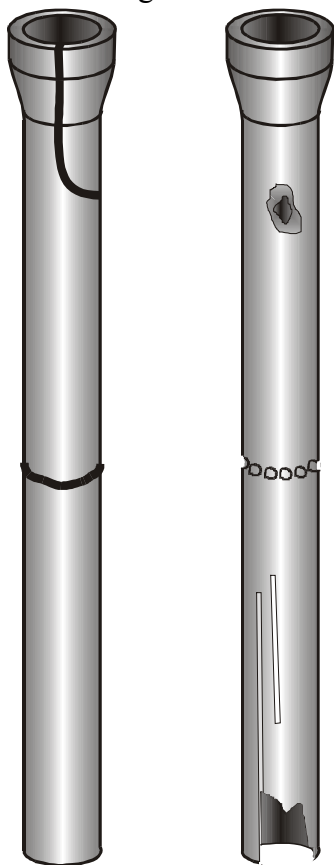
Figure 1. Failure modes for small (<380 mm) diameter pipe. Left pipe: bell splitting at top of pipe, circumferential cracking at middle of pipe. Right pipe: corrosion through-hole at top of pipe, chain created corrosion pitting at middle of pipe, elongated corrosion pitting with blow out hole at bottom of pipe. Generally these failure modes will not be seen on the same pipes.

Circumferential cracking is the most common failure mode for small diameter (<380 mm diameter) gray cast iron pipes (Figure 1). Typically this type of failure is caused by bending forces applied to the pipe. The resulting failure occurs in a manner similar to a twig snapping, with the failure crack propagating across the circumference of the pipe. This type of failure may also be caused by soil movements producing tensile forces on the pipe, producing a simple tensile failure.

Large diameter pipes generally have too high a moment of inertia to produce the circumferential failures shown in Figure 1. However, large diameter gray cast iron pipes do fail by having a section of the bell shear off as shown in Figure 2. A possible cause of this failure mode is compressive forces pushing the spigot of a pipe into the bell of the next pipe in the pipeline. However, bending forces are more likely to be the cause of this type of failure. Simple compressive loading would tend to produce a crack that propagates down the length of the pipe, but a bending force would produce the type of shearing shown in the figure. An example of this mode was seen in a 1998 failure of a 914 mm diameter main in Boston.

the pipe coating, resulting in a series of corrosion pits located around the circumference of the pipe (see Figure 1 for a sketch of this failure).

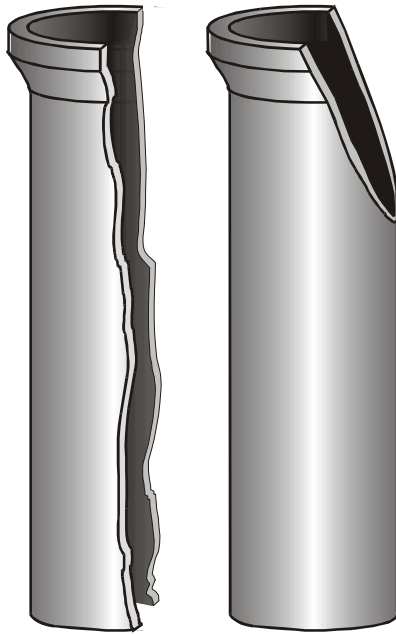
Figure 2. Failure Modes for large (>500 mm) diameter pipe. Left pipe: Longitudinal splitting. Right pipe: Bell shearing. Corrosion pit failure modes are also common on these pipes.

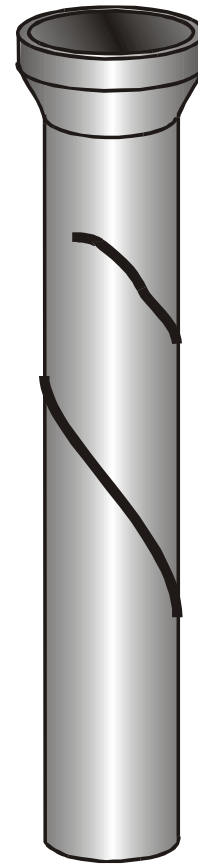
Figure 3. Spiral failure mode in mid-diameter (380 mm –500 mm) pipe. Corrosion pitting failures have also been seen in these pipes.

Some medium (380 mm –500 mm) diameter pipes experience a unique failure mode where the crack in the pipe appears to start in a circumferential fashion and then propagates down the length of the pipe in a spiral fashion. This failure mode has been seen in Des Moines, St. Louis and Ottawa. In the two former cases the failures were associated with pressure surges. The appearance of this failure mode also suggests that the failure is produced by a combination of bending forces and internal pressure.

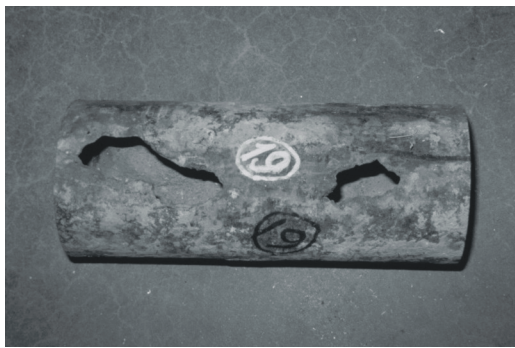
Figure 4. Heavily corroded gray cast iron pipe. (City of Toronto)

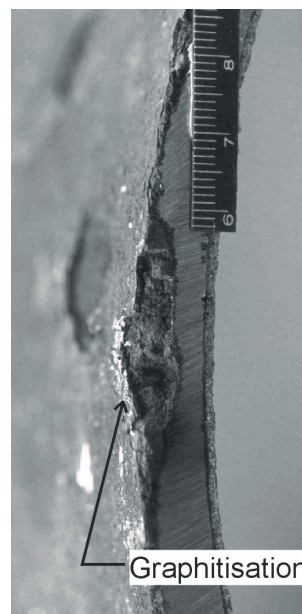
Figure 5. Cross-section of ductile iron pipe showing graphitisation. (City of Ottawa)

However, the Water Research Centre in the United Kingdom has observed examples of graphitisation in ductile iron pipe (De Rose and Parkinson, 1985). NRC has investigated ductile iron pipe failures from the cities of Ottawa and Toronto where graphitisation was also observed (Figure 5). An elemental analysis of the graphitisation from the Ottawa pipe showed high amounts of carbon, iron and oxygen in approximately the same proportions as seen in graphitisation in gray cast iron pipes. Additional trace elements from the surrounding soil were also identified. While graphitisation is less common in ductile iron pipes than in gray iron pipes,

it is clearly still a possibility. Visually undamaged ductile iron pipes should not, therefore, necessarily be assumed to be without corrosion damage.

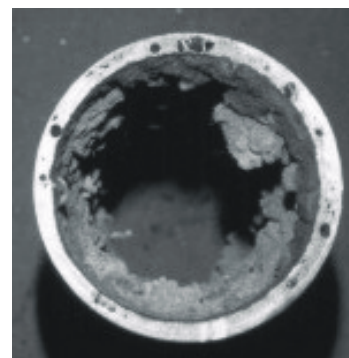
Figure 6. Pit cast pipe showing porosity (black dots on cut metal surface). (City of Toronto)

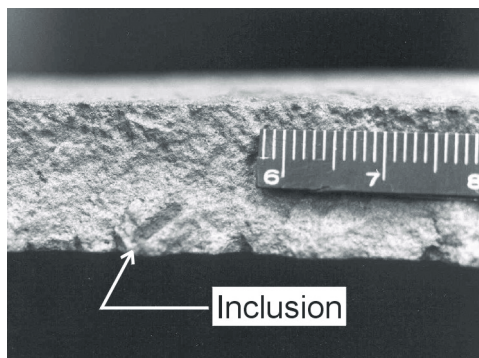
Figure 7. Inclusion along a fracture surface. (City of Ottawa)

Inclusions are unintentional objects created in metals during manufacturing that are not part of the continuous fabric of the material (Figure 7). They weaken the pipe metal by acting as crack formers, reducing the total cross-section of metal in the pipe and producing stress concentrations. The inclusion shown was formed from iron oxide, but a more common inclusion is undissolved ferrosilicon. The latter material was a common means of adding silicon to cast iron, which lowers the melting point of the metal and makes it easier to cast. However, if the metal cools too quickly, the ferrosilicon will not completely dissolve, leaving behind a black, spherical inclusion.

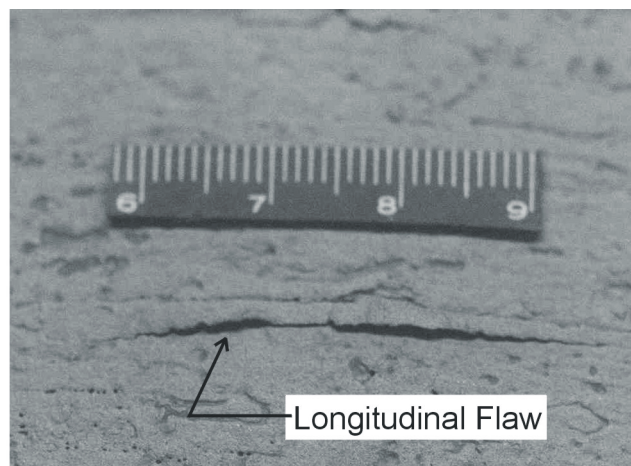
Figure 8. Longitudinal flaw in spun cast pipe. (City of Ottawa)

Spun cast pipes generally appear to have fewer casting defects than pit cast ones. However, they do experience a variety of defects that can only be produced by the spin casting process. Figure 8 shows an example of a longitudinal surface defect. The particular pipe photographed here and in Figures 9 and 10 had numerous examples of this type of defect on its outer surface, which would have been in contact with the pipe mould. In some cases these defects were detached from the pipe surface as shown in Figure 8, while in others they appeared only as parallel lines on the pipe.

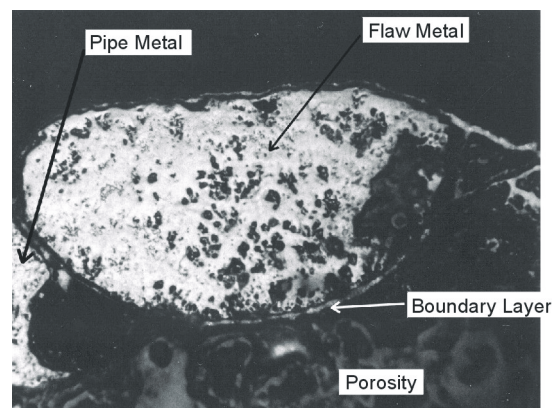
Figure 9. Cross-section of longitudinal flaw. (City of Ottawa)

Figure 9 shows a cross-section of the pipe wall across one of these longitudinal flaws. Both the flaw material and the pipe itself are composed of cast iron. However, a noticeable pore is located di-

rectly below the flaw and an iron oxide boundary layer was identified between the flaw and the pipe wall. The presence of the boundary layer and the semi-circular shape of the flaw cross-section suggests that the flaw material solidified before the bulk of the pipe. The iron oxide layer was produced by contact with the air as the flaw metal cooled, while the elongated shape and the observed cross-section was produced by a combination of surface tension and the centrifugal “forces” produced by the spinning mould.

As shown in Figure 9, the microstructure of the pipe was investigated in order to determine the type of pipe. The presence of graphite flakes in the metal, rather than spheres showed that it was gray cast iron. An elemental analysis confirmed that the pipe metal did not have the small amount of magnesium necessary to produce ductile iron. The microstructural analysis did show that the type and form of the graphite flakes in the pipe changed part way through the pipe wall. This change was responsible for the change in the fracture surface shown in Figure 18.

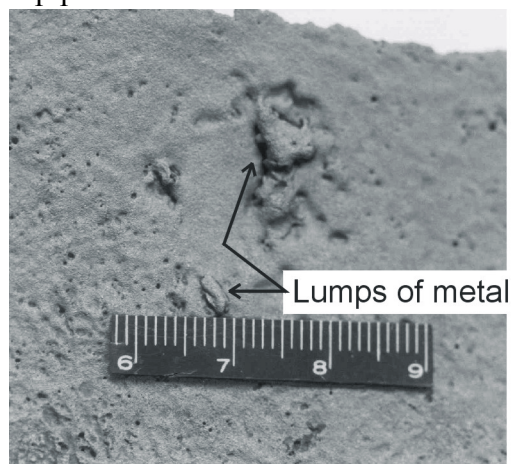
Figure 10. Lumps of metal on pipe surface. (City of Ottawa)

The same pipe also had lumps of metal standing proud of the pipe surface (Figure 10). Normally molten metal would be spread out by the spinning process. The presence of the lumps suggests that the pipe metal was cooler than desirable during the casting process, allowing the lumps to solidify in place.

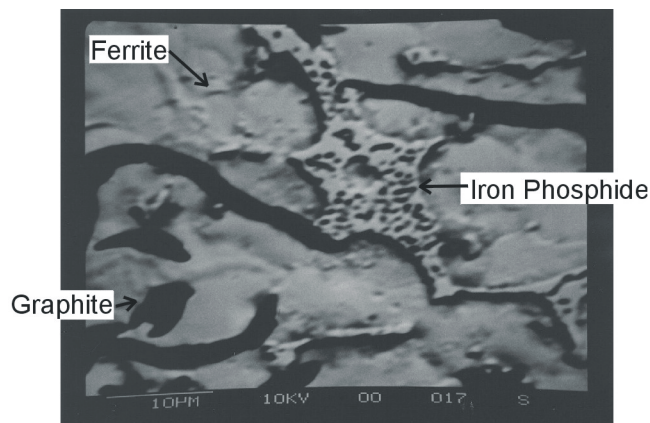
Figure 11. Portion of iron phosphide network within pipe metal. (City of Moncton)

A final type of manufacturing flaw observed in a number of cast iron pipes is the presence of iron phosphide networks throughout the pipe metal (Figure 11). Phosphorus was added to molten cast iron in order to lower the melting point of the metal and its viscosity. This meant that lower casting temperatures could be used, reducing the total cost

of manufacture. However, the presence of phosphorus can also produce the type of network shown in Figure 11. This iron phosphide compound is even more brittle than gray cast iron and its presence weakens the pipe. Most modern steel and cast iron manufacturing attempts to minimise the phosphorus content, with specifications calling for a value that depends on the quality of the steel but is typically

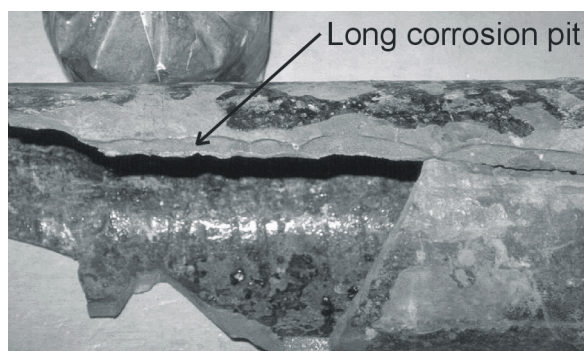
Figure 12. Elongated corrosion pits caused by scratching pipe. (City of Ottawa)

iron and ductile iron pipes have been observed to corrode without noticeable coating damage, but damage to the coating enhances the probability of significant corrosion in the damaged area. In the case shown in the figure, the long thin pits corroded to the point where the metal was paper thin at the bottom of the pit. A pressure surge caused the pipe to fracture along the pit, followed by a full blow out. Similar damage has been observed on ductile iron pipes from the City of Toronto. In this case an unpadded chain was placed around the pipe when it was being moved. Each link of the chain damaged

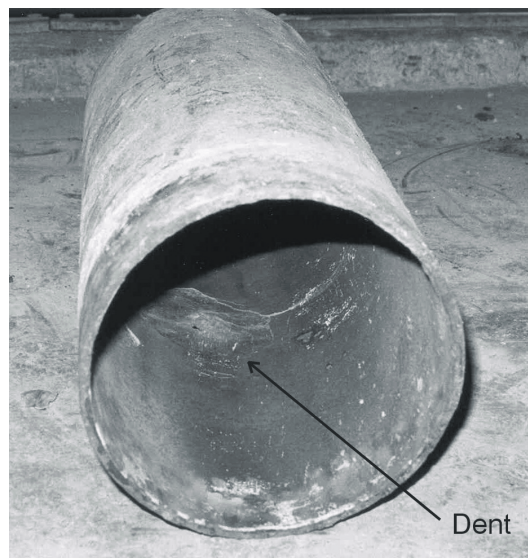
Figure 13. Dent and hole in ductile iron pipe due to third party damage. (City of Toronto)

Another common source of failures due to human error is third party damage. Excavations made on or near pipelines without accurate knowledge of their location frequently causes pipeline damage or failure (Figure 13). This type of failure is common to all buried utilities, including both pipelines and other services such as telephone and television cabling.

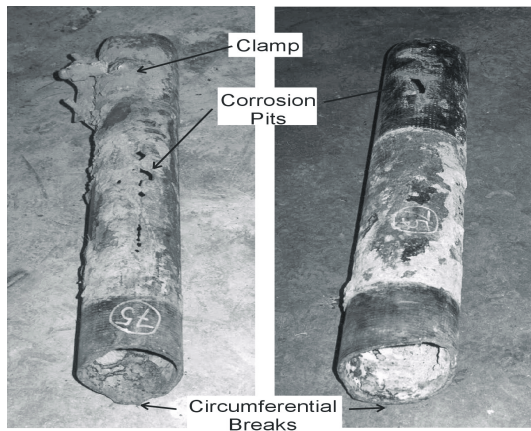
Sometimes problems can be perpetuated through simply following a water utility's standard operating procedures. Figure 14 shows two pieces of a single pipe that experienced four distinct failures in the length shown. The back of the left pipe section was connected to the front of the right one by the clamp that is shown in the picture. Each of the failures was associated with corrosion pitting. These failures appear to have taken place over a significant length of time, with the response to the first three cases being to place a stainless steel clamp over the damaged area. The pipe was not removed until the very long corrosion pit on the left section developed.

An examination of the damage to the pipe makes it clear that it was located in a very corrosive environment. The stainless steel clamps held the pipe together, but did not prevent further corrosion in a nearby location. In fact, a number of pipe failures observed by NRC occurred next to previous failures covered by stainless steel clamps. It is possible that some aspect of the repair procedure itself may be responsible for the subsequent failures. More research is required to investigate this possibility.

Figure 14. Multiple failures on same pipe. (City of Toronto)

This result suggests that alternate approaches to simple clamping for dealing with corrosion related failures may be desirable. One method used by some cities is to add a sacrificial anode to the pipe at the site of each failure. This should protect the pipe for the duration of the anode's life. The anodes can

also be checked and replaced if necessary on a scheduled basis, rather than through emergency repairs.

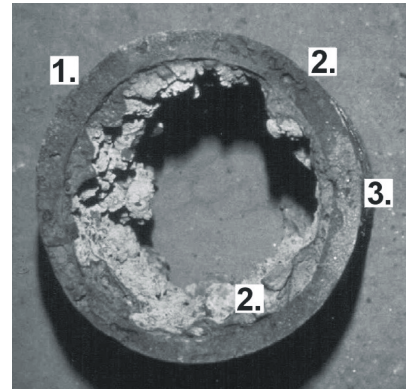
Figure 15. Multi-event circumferential failure. “1” indicates the first cracking event, “2” indicates the second cracking event and “3” indicates the region that was intact until broken in the laboratory. (City of Toronto)

Figures 15 and 16 show two examples of multiple event failures. Their role in a pipe failure can be detected by carefully examining the fracture surface of the pipe. In the case of the pipe shown in Figure 16, only about 80% of the pipe circumference had been cracked through at the time it was removed from service. The intact circumference, labeled as region 3 in the figure, was broken in the laboratory using a stress testing machine. Examination of the entire fracture surface afterwards showed that two cracking episodes had taken place while the pipe was in use. Region 1 was covered with a relatively thick layer of corrosion products that had an orange colour and regions of gray material. The regions labeled 2 in the figure had a much thinner layer of corrosion product with a dark red colour. The gray colour of the graphite flakes that give gray cast iron its name could also be seen below the corrosion products.

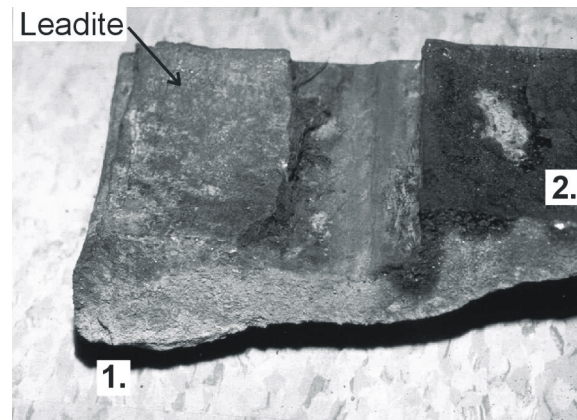
Figure 16. Multi-event bell splitting failure. “1” indicates the start of the first cracking event at a small corrosion pit while “2” indicates the start of the second cracking event. (City of Ottawa)

In the case of Figure 16 the visual examination showed evidence of two cracking episodes, with one region near the bell having thick corrosion products and an orange-gray colour and the other region closer to the end of the crack having thin corrosion products with a dark red colour. An elemental analysis shows the presence of a number of elements on both regions of the fracture surface that are not present in the pipe metal. These elements were therefore acquired from the surrounding soil. However, the region with thicker corrosion products showed the presence of sulphur, aluminum, potassium and a high quantity of calcium, while the region with the thinner layer of corrosion products showed considerably smaller amounts of the last three elements and no sulphur at all. This difference indicates that the fracture surface under the thicker layer had been exposed to the surrounding soil for a longer period of time than that under the thinner layer, providing

further evidence for a multi-event cracking process. Elemental analyses have been done for other fracture surfaces with similar results.

Although the pipe in Figure 16 clearly shows that not all circumferential failures require complete cracking around the pipe, visual identification of different cracking episodes can be very subjective in nature. Further evidence for this phenomena is provided by elemental analysis of the fracture surface.

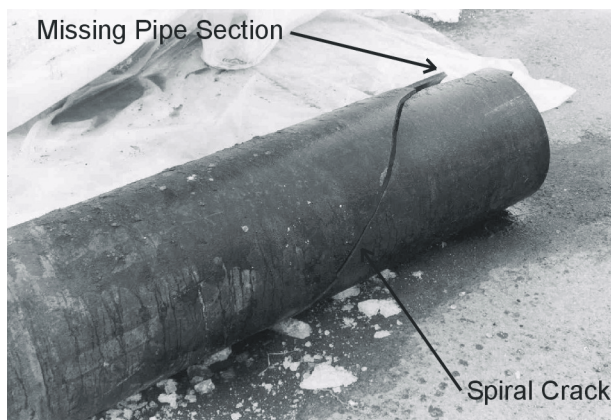
Figure 17. Medium diameter pipe failure. (City of Ottawa)

The sample delivered by the Region to NRC consisted of only half the failed pipe. In addition, a section of the pipe at the point where the crack likely initiated was missing. These missing sections of pipe meant that the exact cause of the failure could not be determined. However, it was possible to examine the rest of the pipe and determine its quality.
