NRCC-50294

A version of this document is published in / Une version de ce document se trouve dans:
Proceedings: The First International Conference on Building Energy and Environment,
Dalian, China, July 13-16, 2008, pp. 2482-2489

AIR INTRUSION AND ITS IMPACT ON ENERGY PERFORMANCE OF ROOFING ASSEMBLIES

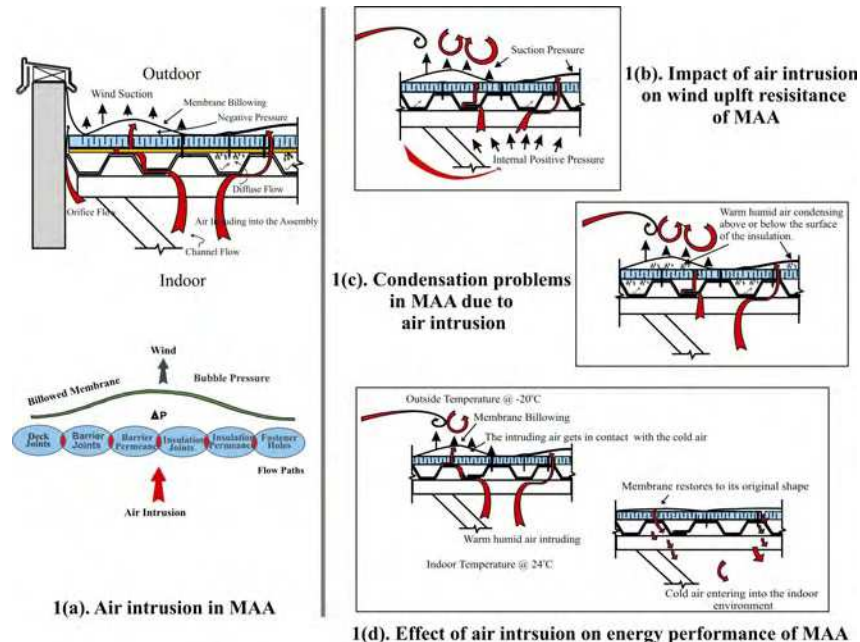
Figure 1: Air Intrusion and its impact on life cycle performance of MAA

Approximately one-fourth of North American low slope/commercial buildings are roofed with MAA (NRCA 2004). Recently, wind uplift performance studies of the MAA (Baskaran, et al. 2003, 2006) identified air intrusion into the roof assembly as one of the major factors that affect its performance. For airflow to occur, there must exist two prerequisites, one is the pressure difference between two locations, and the other is a continuous flow path or opening connecting the locations. MAA meets these two prerequisites during wind uplift conditions. Figure 1(a) illustrates the airflow mechanism through MAA. Wind induced suction lifts the waterproofing membrane and causes membrane billowing and elongation between the attachments. The magnitude of the wind induced suction; the membrane's elastic properties and the fastening

pattern determine the deflection of the membrane billowing. The momentary displacement or billowing of the membrane creates a relative negative pressure below the lifted membrane and this draws indoor air into the roof, thereby satisfying the first prerequisite. The second prerequisite is met by the lack of airflow control at the deck level (i.e. between deck and insulation). Flow paths are created by the component's air permeability and joints/junctions/penetrations in the roofing assembly.

Being able to control air intrusion is critical in roofing design, as this has several effects on the performance of the roof—on wind uplift, condensation and energy. Addressing these performance issues, Figure 1 (b), 1(c), 1(d) illustrates the details. Despite the significance of air intrusion on roofing systems performance, no study exists in the literature (Molleti, 2006) that addresses the air intrusion characteristics of a roofing assembly. Therefore, a research study was initiated at the National Research Council of Canada (IRC/NRC) with the objective of developing a new test procedure for air intrusion quantification of roofing assemblies. This paper presents air intrusion data from five roofing assemblies. It also compares the measured air intrusion rates of the assemblies with the requirements prescribed in the codes.

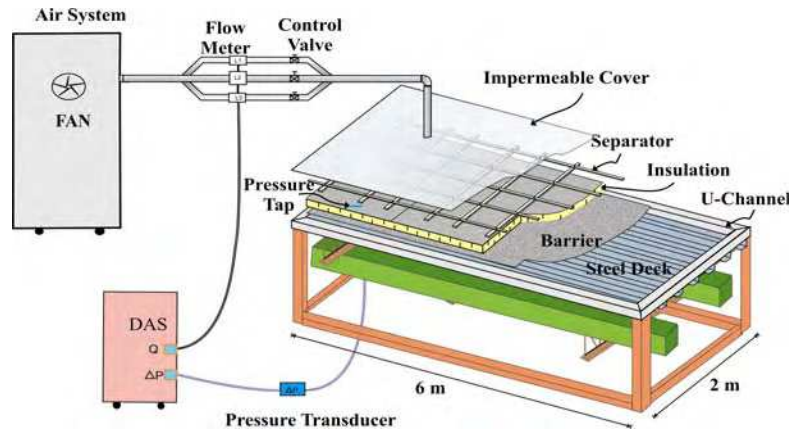
Figure 2: Experimental approach for quantification of air intrusion in roof assemblies

Recently, Molleti and Baskaran (2006) reported the details of the newly developed air intrusion test method for roofing assemblies. Figure 2 illustrates the experimental approach developed for the air intrusion quantification. As shown in Figure 2, the test frame has a dimension of 2 m x 6 m x 0.8 m (79" x 236" x 32"). The test specimen/roof assembly is installed in the frame, which is supported on a lifting mechanism with adjustable jacks. This feature allows for investigating different roofing assembly thicknesses accommodating different roofing components. The parameters measured in the test method are 1) applied test pressure difference across the test assembly and, 2) the corresponding volumetric airflow rate.

Following the above experimental approach (Figure 2) the present study quantified air intrusion rates of five roofing assembly configurations. The five roofing assemblies are:

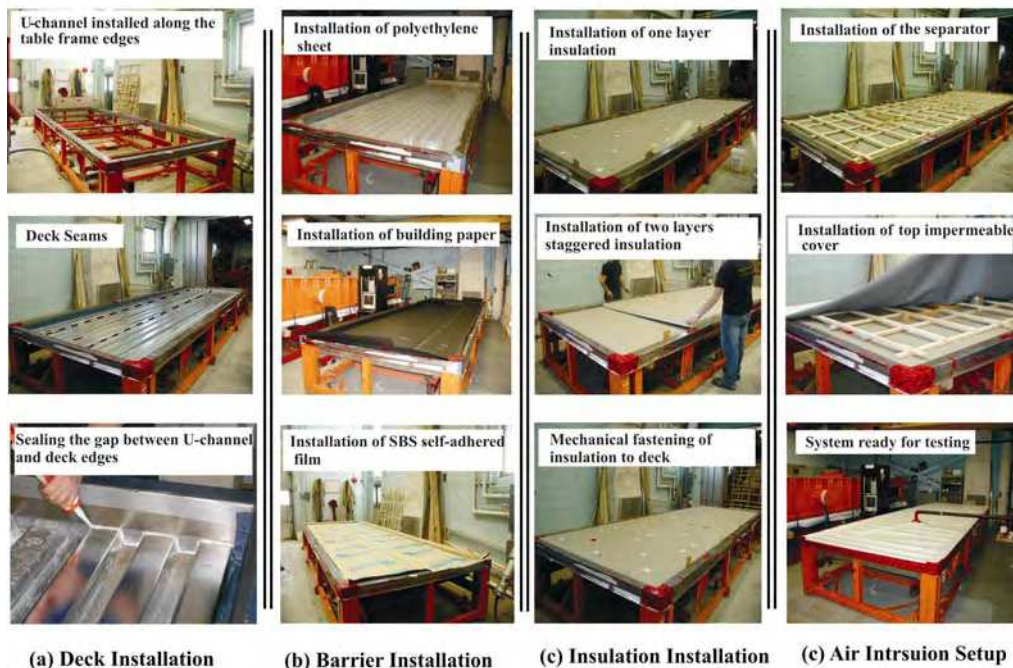
Figure 3: Experimental set up of the test assemblies

The experimental setup assumed that in a roofing assembly the continuous waterproof membrane is airtight and therefore can be excluded from the investigation. Therefore, all the experimental mock-ups were constructed up to the insulation level. As the roof installation is similar for all the tested assemblies, the construction procedure can be classified into four steps as shown in Figure 3. These steps are as follows:

The edge treatment of the test assembly was handled by installing steel U-channels along the test frame edges as shown in Figure 3(a). One full sheet of 914 mm (36 in.) wide and two cut pieces of 610 mm (24 in.) and 483 mm (19 in.) wide steel sheets were installed along the table length. The black dotted lines as shown in Figure 3(a) indicate the deck overlaps/seams. To eliminate the air intrusion along the edges of the deck, the steel deck edges are butted to the U-channel, and the gap between them was sealed using caulking and adhesive membrane.

In the present experimental setup, barrier/retarder means a component installed in the roofing assembly to prevent air intrusion into the system. Figure 3(b) shows the installation of these three barriers/retarders. *A3* had 5 mil thick (0.015”) asphalt-impregnated paper building paper as barrier/retarder. *A4* had 0.8 mm thick (1/32”) SBS (Styrene-Butadiene-Styrene) modified self-adhered film (SAF) as barrier/retarder. Both these barriers/retarders had two seam overlaps. In *A5*, a continuous layer of 6-mil (0.006”) polyethylene sheet was used as a barrier/retarder.

Figure 3 (c) shows the typical layout of insulation attachment. For all five tested assemblies, 51 mm (2”) thick polyisocyanurate boards were used as the insulation. In *A1*, *A3*, *A4*, and *A5* the insulation configuration comprised of a layer of insulation with four full boards of 1219 mm x 2006 mm (48” x 79”) and one partial board. In *A2*, the insulation layout is similar to the former assemblies except that it comprises two layers of insulation in staggered arrangement. The insulation boards were mechanically fastened to the steel deck with 8 fasteners per board.

With the insulation in position and fastened to the deck, a square meshed wooden separator is installed on top of the insulation as shown in Figure 3 (d). This provides the required gap or space between the test specimen and the impermeable cover. Two pressure taps are installed on either ends of the test specimen to measure the applied differential pressure across the test specimen. With the separator installed a continuous sheet of impermeable cover as shown in Figure 3 (d), is laid on top of the separator and the overhang edges are adhered to the frame edges, thus eliminating any extraneous airflow into the test specimen. Provisions are made to install the flow measurement setup on top of the impermeable cover. One end of the flow measurement setup has an air filter, which is inserted into the test specimen, and the other end is connected to the air system. In between them, the flow-measuring device and the adjustable control valve are installed.

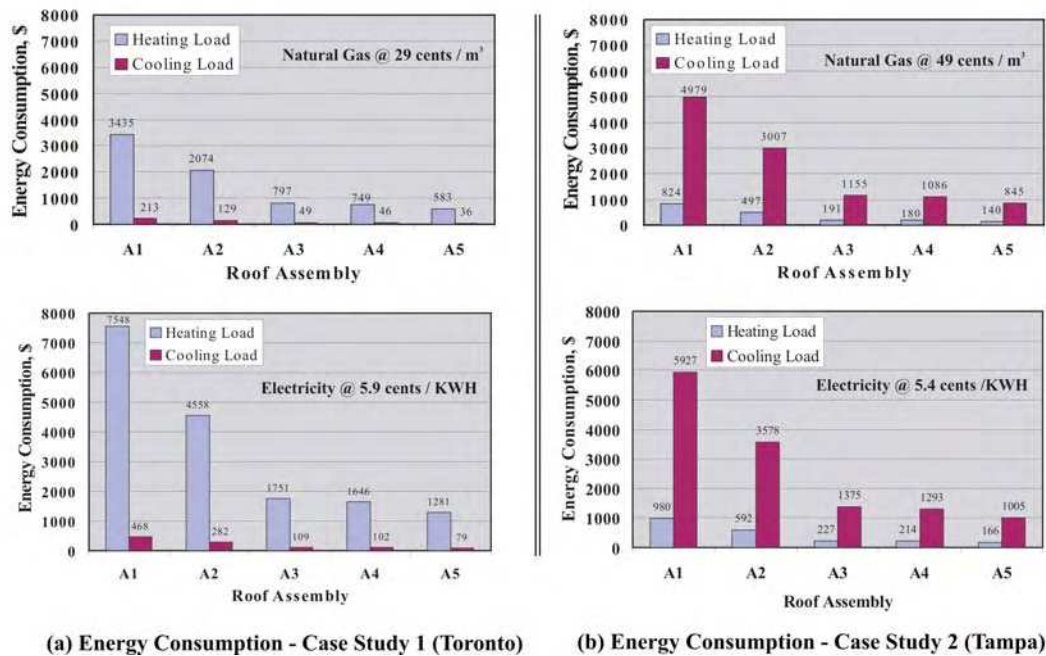
Figure 5: Energy load calculations

Using natural gas (29.92 cents / m^3) and electricity (5.9 cents / KWH) as the source of fuels, the heating and cooling loads were estimated. This calculation represents the energy consumption for a low slope commercial building installed with the roof assembly type Assembly 1 (**A1**). Following this procedure, estimates of energy consumption was determined for the remaining four assemblies (**A2 to A5**). The estimated annual energy consumption in terms of dollars is shown in Figure 5 (a). These comparative numbers clearly indicate that irrespective of the fuel

type, roof assemblies with barriers provide higher energy savings compared to assemblies without barrier.

For the second case study, Tampa (Florida) was selected as the building location. With the exception of the weather data, all other parameters remain similar to Case Study 1. Tampa has 577 HDD and 3488 CDD (*Source: National Oceanic and Atmospheric Administration, NOAA*). Based on this data, Figure 5 (b) presents the heating and loading calculations. Similar to the Case Study 1, roof assemblies with barriers provide higher energy savings compared to assemblies without barrier. However, Florida, being a warm state, the city of Tampa has higher cooling loads compared to heating loads, which was contrary to case study 1.
