### **Assessment of friction stir welds with nondestructive methods**

*COM2008Winnipeg : Conference of Metallurgists, proceedings, 2008*

## ASSESSMENT OF FRICTION STIR WELDS WITH NONDESTRUCTIVE METHODS

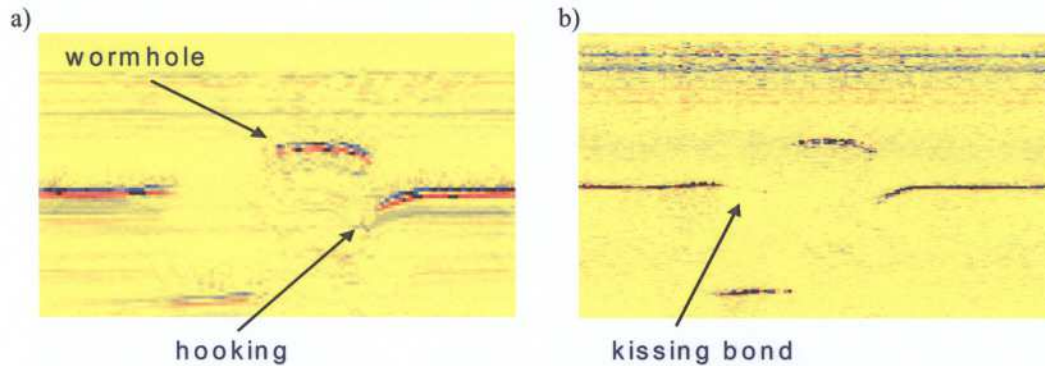
FIGURE 4 - Cross-section of the lap joint in Figure 4, with inspection from the far side of the tool. SAFT image using a) immersion and b) laser-ultrasonics

side using immersion (frequencies up to 50 MHz) and laser-ultrasonic inspection (frequencies up to 220 MHz). The presence of hooking defect oriented downwards on one side as well as a similar wormhole, below the interface when viewed from the weld side, are observed with better resolution when using laser-ultrasonics. More importantly, a kissing bond present in the weld is detected by laser-ultrasonics as a slight reflection along the interface and above that from the weld surface. This capability was confirmed by the detection of another kissing bond defect in a similar sample.

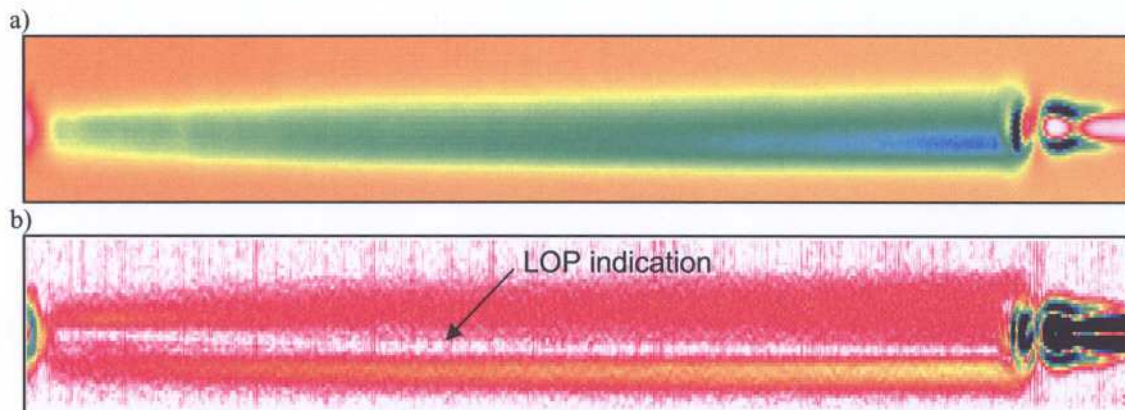
FIGURE 9 - C-scan image from PEC at LOI of the butt-joint sample with a variable pin depth a) before and b) after applying edge identifier and background subtraction operators

With PEC measurement, inspection procedure and signal processing conditions similar to the ones mentioned above were used. In Figure 9a, the scan result using the LOI feature alone identifies the changes in the weld depth by a wider region as the pin depth is increased from left to right, but not the LOP defect. The weld is indicated by the changes in electrical conductivity associated with the extension of the heat-affected zone due to the welding tool shoulder contact with the plate. Figure 9b shows the C-scan image after applying the Sobel magnitude edge identifier filtering, allowing visualization of the LOP defect. It is believed that quantification in terms of defect depth would be possible by manufacturing reference blocks of known LOP depths.
