### Fire performance of engineered floor/ceiling systems and impact on occupant safe escape in residential basement fire scenarios Su, Joseph Z.

## Background

- Multi-phase studies – Fire Performance of Houses
- Phase 1 – basement fires and unprotected floor assemblies over basement
  - To study impact on the ability of occupants on upper storeys to escape from the perspective of tenability and structural integrity of tests assembly as egress routes
  - To determine the sequence of fire events
- Phase 1b – basement fires and protected floor assemblies over basement
  - To study impact of protection measures on the life safety of occupants

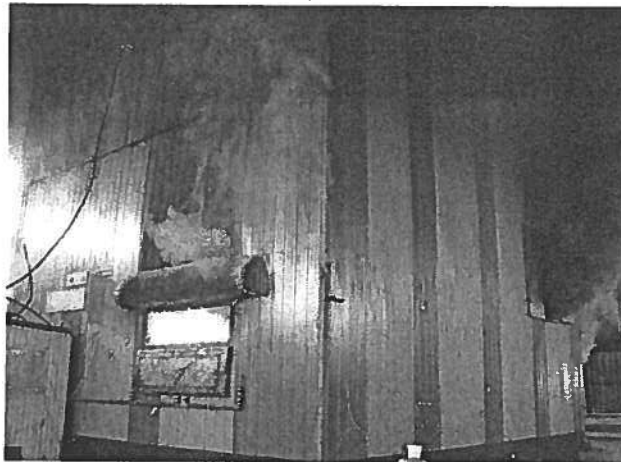
## Test Facility

- A full-scale test house simulating a two-storey detached single-family house with a basement

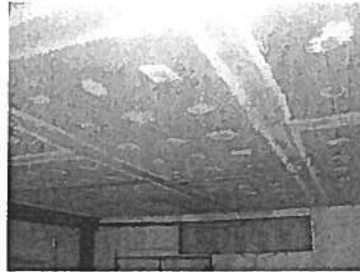
## Basement Ceiling Protection

**Wood I-joists**

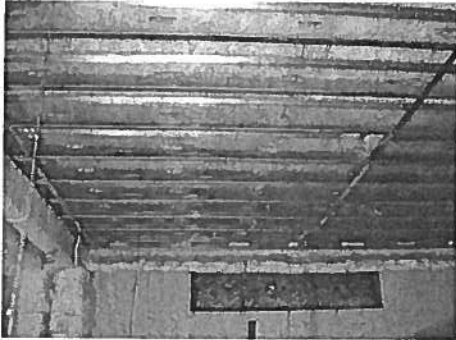
## Basement Ceiling Protection

### Steel C-joists

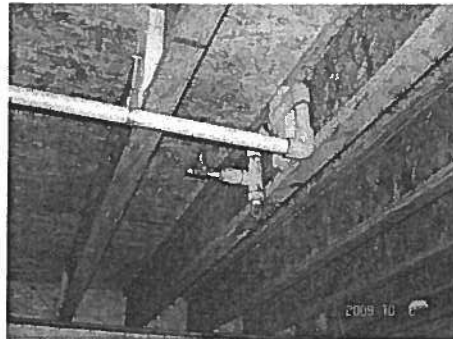
## Sprinkler Design B

- 1" CPVC plastic piping
- Flow test (static water supply pressure: 50 psi)
  - 83.2 Lpm (22 USgpm), 20.2 psi at the head
