Protection of Ductile Iron Water Mains against External Corrosion: Review of Methods and Case Histories

B. Rajani and Y. Kleiner

Abstract: Ductile iron replaced grey cast iron as pipe material in the early 1970s. It has been estimated that almost half of all new water mains in North America are ductile iron. The main cause of the structural deterioration of all metallic mains is external corrosion, which is induced by environmental and operational conditions. Internal corrosion, on the other hand, can cause significant functional (hydraulic, water quality) deterioration within the distribution system. Methods for external corrosion protection include passive (coatings, wraps, etc.), active (cathodic protection) or a combination of both. Successes and failures have been reported on the usage of various methods under different conditions and circumstances. This paper provides the state of the practice in corrosion protection of ductile iron water mains, and describes case histories that have been reported from around the world. Some conclusions are drawn as to the suitability of methods to specific circumstances.

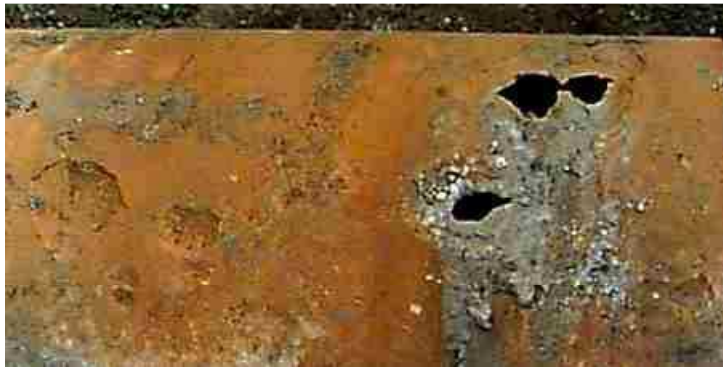
Figure 1. External corrosion of ductile iron pipe (source: PDL).

- Corrosion pitting, whereby localized corrosion creates a pit in the pipe wall. This pit can grow from either the inside or the outside surface until the pipe is fully penetrated, resulting in a water leak (Figure 1). Corrosion pitting is typical mainly in grey cast iron and steel pipes although some anecdotal evidence suggests that it may occur in DI pipes as well (Makar and Kleiner, 1999). Corrosion pits, when large and deep enough, can also cause weakening of the pipe structure by acting as stress risers. The pipe is likely to fail at the corrosion pit if it is subjected to excessive external stresses (e.g., soil pressure, bending moments, thermal induced stress, live loads, etc.) or internal pressure.

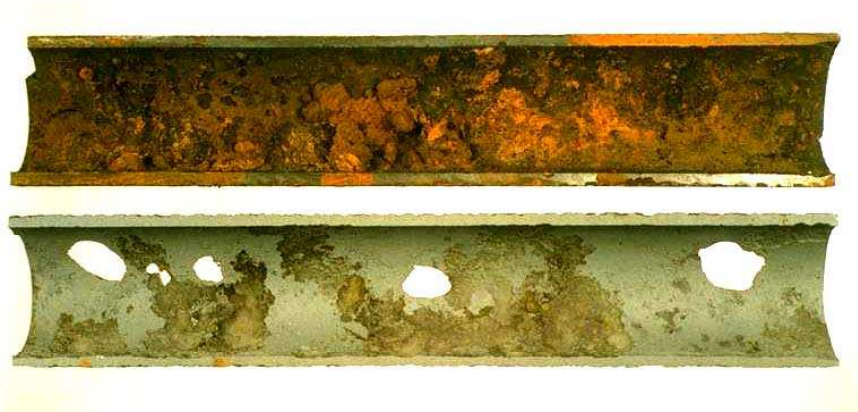
Figure 2. Pipe held water under pressure but found to be totally corroded (source: PDL).

- Graphitisation, whereby the iron content of the pipe is leached away through corrosion, in a region resembling a corrosion pit, leaving behind a carbon flake matrix. This is typical of grey cast iron due to its material properties. Graphitisation is similar to corrosion pits in the way it weakens the pipe structure, however, it differs in the way it creates water leaks. Often, a graphitized water main will not leak even if the ferrous content was completely leached out, because the graphite forms a plug that can prevent water from leaking (Figure 2). However, any disturbance, such as water hammer, soil movement, etc., can dislodge this “plug” to create an instant leak.

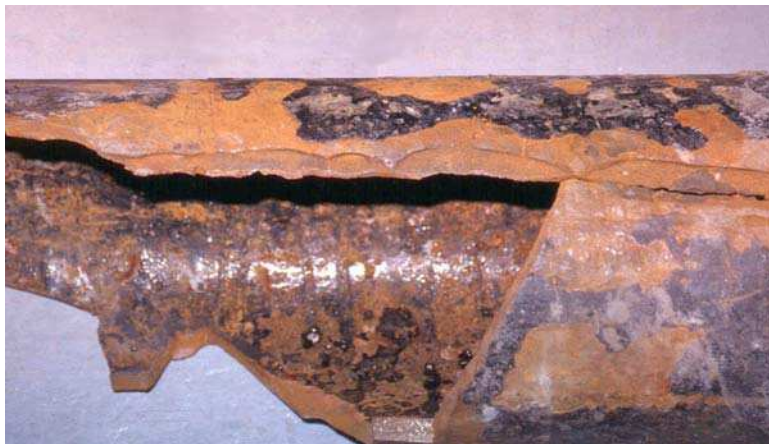
Figure 3. Longitudinal split following corrosion initiated by scratch in coating (Ottawa, 1998).

Corrosion can start as a result of mishandling during transportation or installation. It can manifest itself in various shapes and forms that subsequently affect pipe strength. For instance, Makar (2000) reported on a cast iron main that received a long and deep scratch in its bituminous coating during installation. Corrosion developed along this scratch, and when it became deep enough, the pipe burst in a longitudinal failure that occurred along the corrosion line (Figure 3).

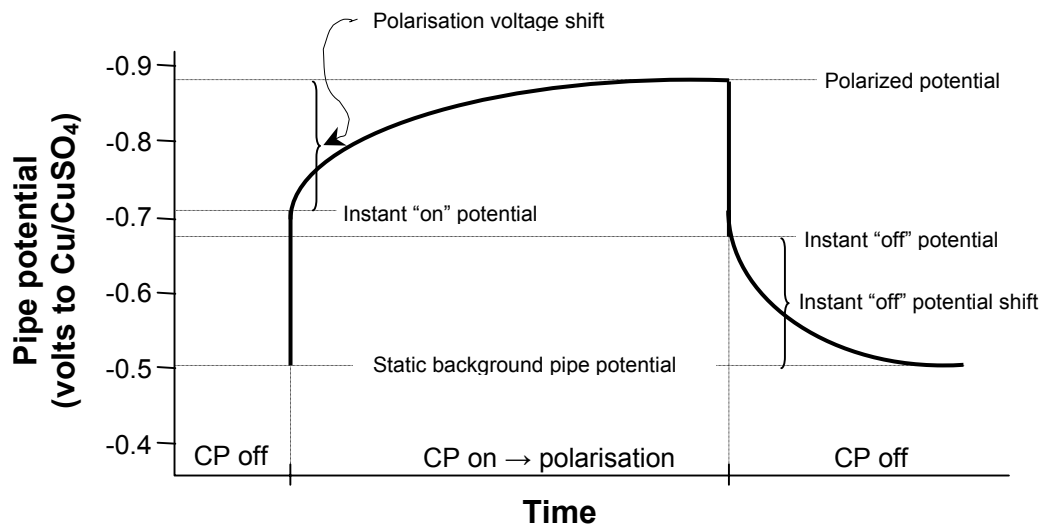
Figure 4. Polarization potential over time when cathodic protection is applied (after Wendorf, 1988).

All chemical reactions typically start at a relatively high rate, and then, if conditions do not change, the reaction rate will slow down and tend to reach some equilibrium rate, which is lower than the initial rate. In corrosion, this phenomenon is called *polarization*. Polarization in buried pipes is typically predominant near the cathode, where hydrogen ions receive electrons and become hydrogen gas. The increasing presence of hydrogen gas interferes with the delivery of electrons from the cathode to the hydrogen ions. The net effect is that the cathode becomes increasingly more negative until its potential is almost as negative as the anode. This acts to retard the corrosion reaction because the difference in potential between the anode and the cathode is what drives the corrosion cell.

copper/copper sulphate (Cu/CuSO₄) reference electrode (CSE) (NACE, 1984). The reason for that value is that the most anodic steel found in practical situations has a potential of -800 mV. An additional -50 mV is a safety factor to allow for inaccuracies and extreme cases. Full polarization can typically take weeks or even months.

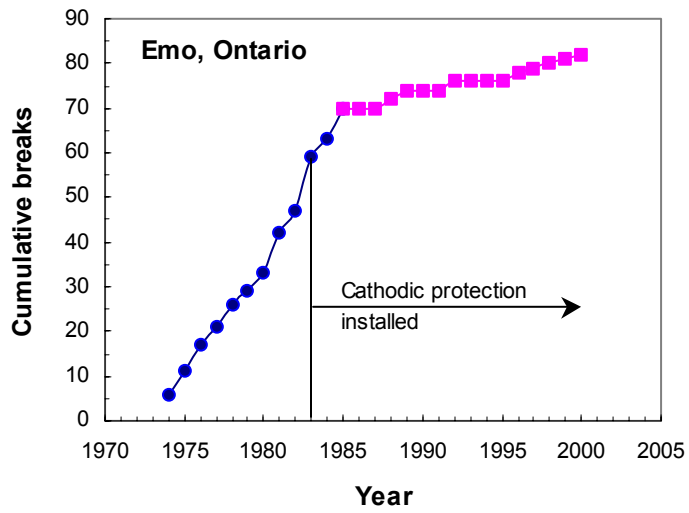
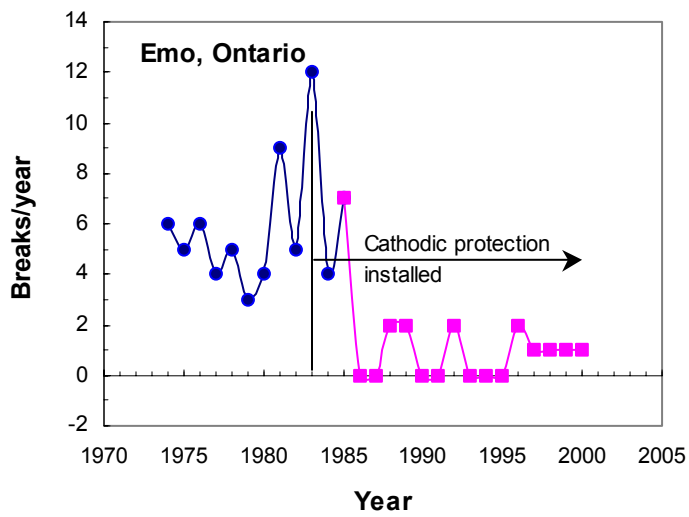
Figure 5. Ductile iron water main breakage history for Emo, Ontario.
