International Journal of Pipeline Systems Engineering and Practice, 1, 4, pp. 156-172, 2010-11-01

AC Pipe in North America: Inventory, Breakage and Working Environments

Abstract: Asbestos cement (AC) pipe constitutes a significant portion of the water distribution pipes still in service in many North American cities. To understand the state of the AC pipe inventory in North America, a survey was conducted of utilities with a large percentage of AC pipes in their water distribution systems. The survey included questions about pipe inventory, breakage, working environments, rehabilitation/replacement practices, and safety- and health-related management practices. This paper summarizes data from the inventory, breakage and working environment portions of the survey. The survey obtained relatively complete inventory information for pipe length, size, years of service, breakage condition, and water quality. Information about the nature of the soils surrounding AC pipes was limited. The survey indicated that utility managers' perceptions of water and soil environments were not always consistent with water and soil test results. Survey data analysis identified pipe age, water quality, a

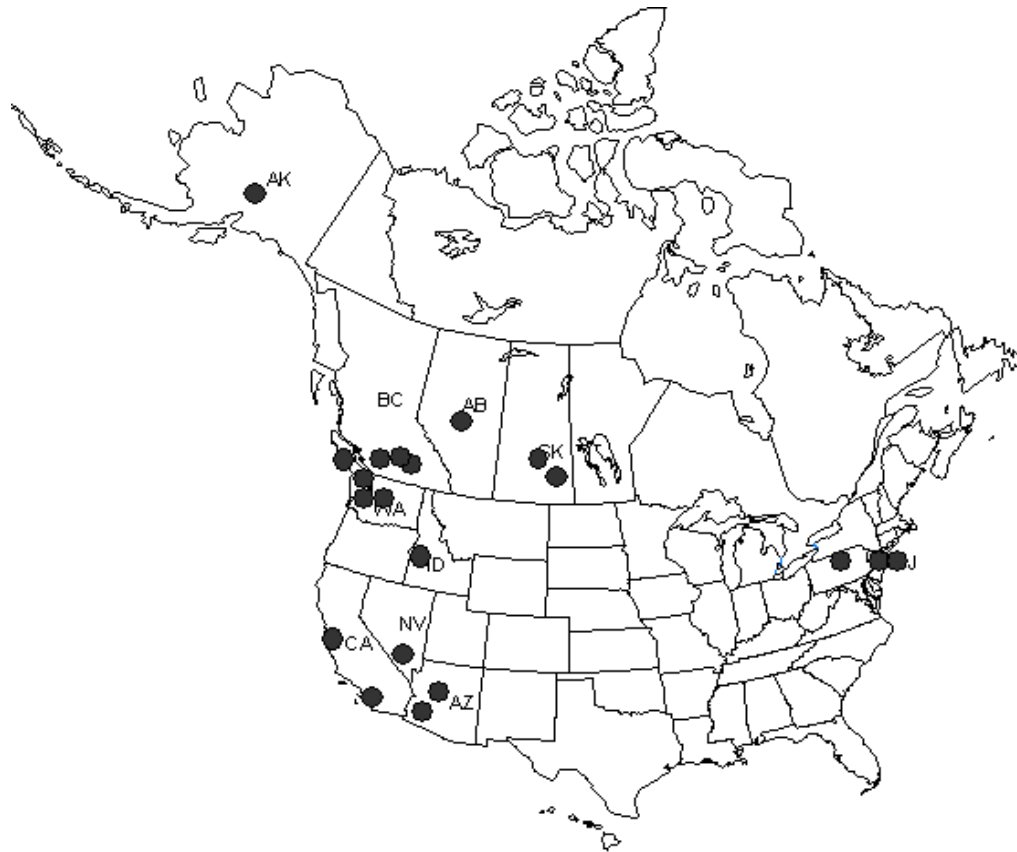
Hu, Wang, Cossitt, and Chowdhury – Figure 1

Figure 1. Geographic location of participating utilities

The survey was sent to 20 utilities that had expressed interest in participating. The participating utilities generally have relatively large inventories of AC pipes in their water distribution systems. Figure 1 shows the geographic location of the utilities that completed the survey. In the United States, most of the survey respondents are located in the western and Pacific states, and two are in New Jersey and Pennsylvania. There are no respondents in other eastern states, or the central and southern states. In Canada, all the participating utilities are located in western Canada, as most of the AC pipes still in use by utilities are found in the west.

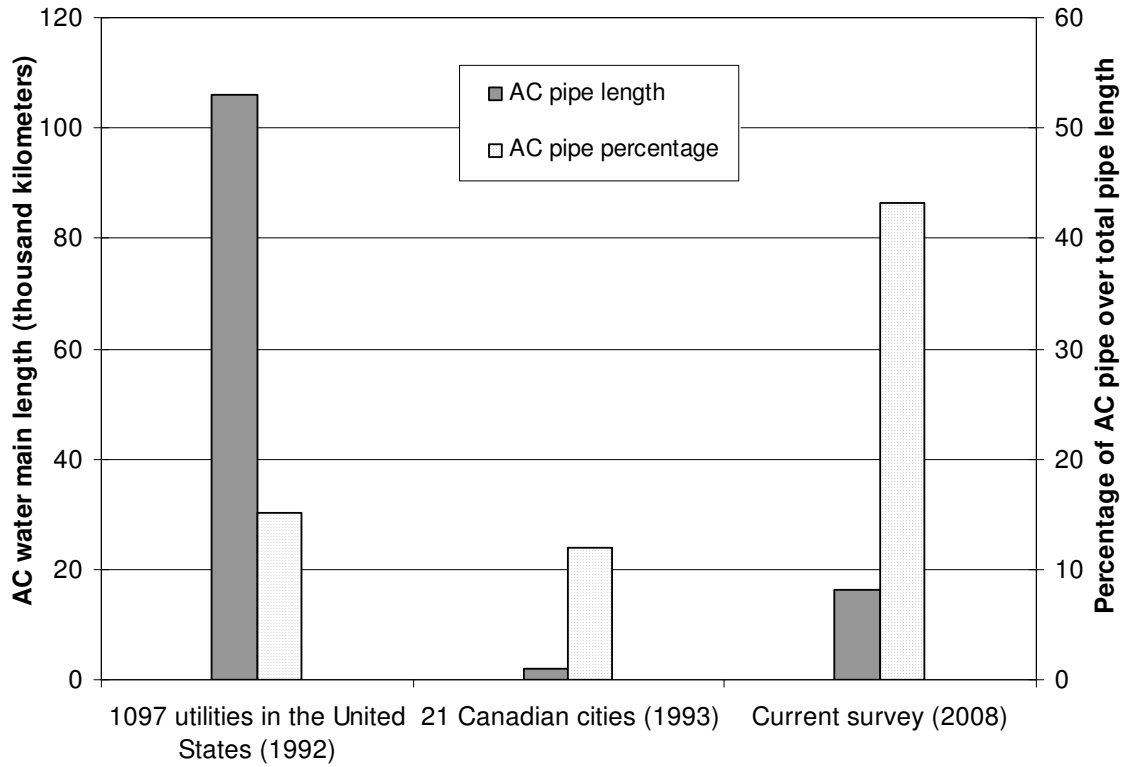
Hu, Wang, Cossitt, and Chowdhury – Figure 2

Figure 2 compares the results of the survey with two previous surveys in terms of AC pipe length and AC pipe length as a percentage of total water distribution system length.

A 1992 survey of 1097 utilities in the United States indicated that AC pipes accounted for 15.1% of the total water distribution systems surveyed. The survey was conducted by the American Water Works Association (AWWA) Water Industry Data Base (WIDB) and the American Water Works Association Research Foundation (AwwaRF) (Krimeryer *et al.* 1994). A later survey of 338 utilities by AWWA confirmed this percentage (AWWA 2004). A similar survey conducted in 1993 for 21 Canadian cities found that AC pipes accounted for 12% of water distribution systems (Rajani and McDonald 1995). The current survey determined that, of the 37,626 km of water distribution pipe operated by the utilities that completed the survey, 43.2% (or 16,238 km) is AC pipe. This high percentage is due to the fact that this survey targeted utilities with high percentages of AC pipes. Thus, the participating utilities have a significant interest in the management of AC water distribution pipes.

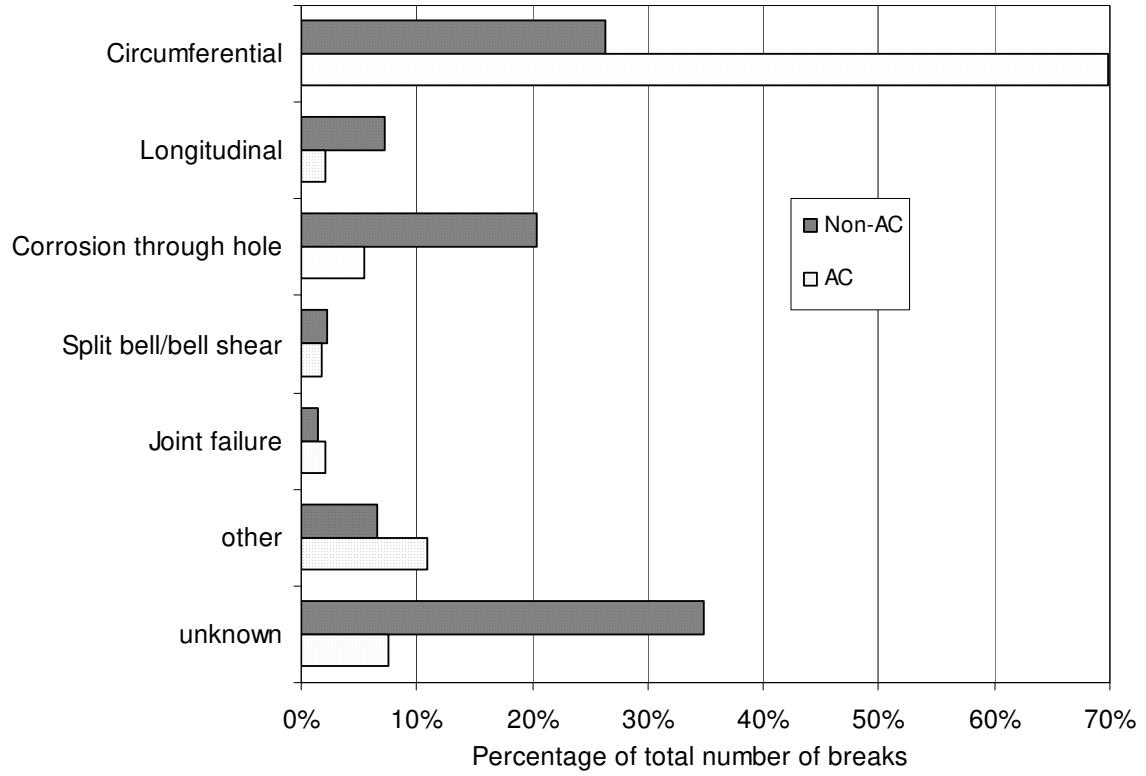
Hu, Wang, Cossitt, and Chowdhury – Figure 9

Figure 9 compares the failure mode of AC water mains to those of all other water pipe materials. The predominant failure mode for AC pipe was circumferential failure, while the predominant failure modes for all other water pipe materials were corrosion and circumferential failure. Some of the surveyed utilities also experienced failures due to improper installation, damage from other construction activities, pull-out of corporation stops (fittings used to connect the service lines to a water main), and other types of cracks.

Figure 9 Failure modes reported for AC and non-AC water pipes

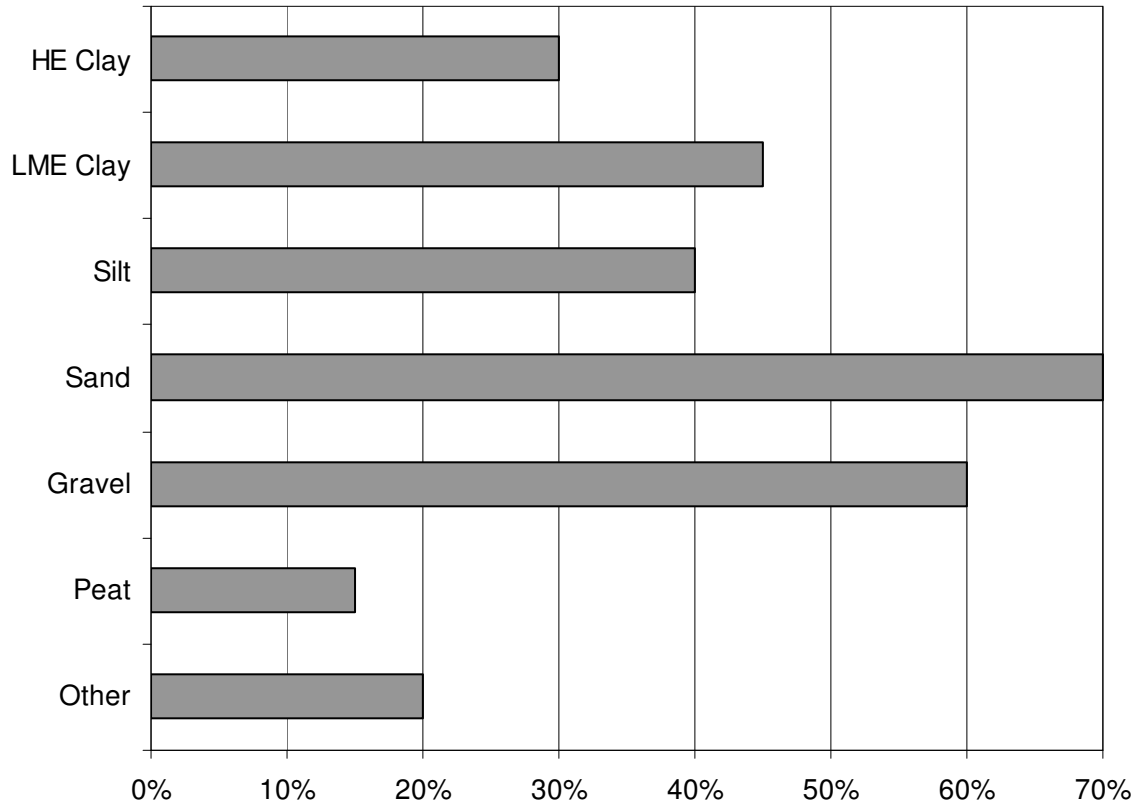
Hu, Wang, Cossitt, and Chowdhury – Figure 12

Figure 12 shows the predominant soil types in which AC pipes were installed by the 20 utilities. The AC pipes in some utilities were exposed to more than one type of soil. Thirty percent of the utilities had pipe buried in high expansive (HE) clays and 45% in low to medium expansive (LME) soils. Expansive clays may affect the performance of AC pipes when soil moisture changes (Hu and Hubble 2007). Sixty percent of utilities had AC pipe buried in gravel, which may be problematic for AC pipe due to possible soil movement and resulting point loading. 15% of the utilities had AC pipe buried in peat. Peat soil may attack AC pipe because it tends to have high sulphate content (Little 2006). Responses for the “Other” category included “glacial tills” and “modified bedrocks”.

Small diameter pipes with smaller moments of inertia will have larger bending stresses and therefore, will have a higher likelihood of pipe failure. Figure 21 is a plot of the average breakage rates against the percentage of AC pipes with diameter of 150 mm and less for 18 utilities. A general increase in average breakage rate can be observed with the increase in percentage of small diameter AC pipes (from 30 to 60 percent). This indicates that soil movement is a contributing factor to the failure of AC pipes. The good correlation is also consistent with the high percentage of utilities with medium to high expansive soils (Figure 12).

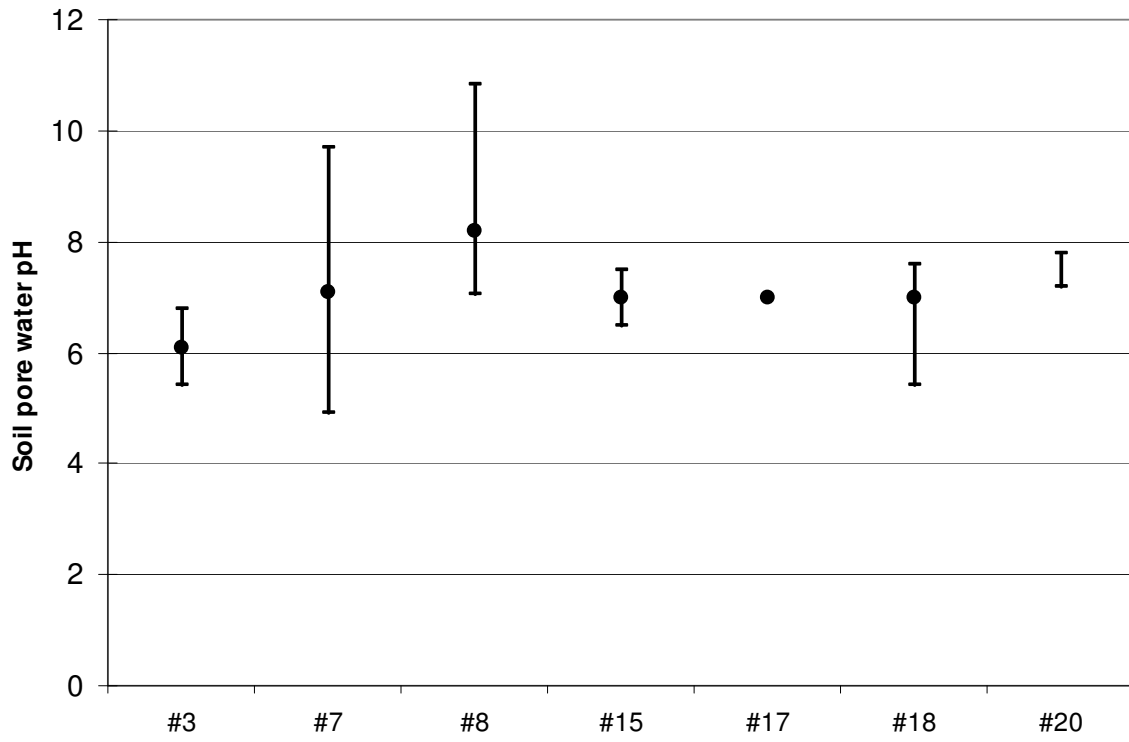
Hu, Wang, Cossitt, and Chowdhury – Figure 14

Only seven utilities provided soil pore water pH data (Figure 14) and each of the averages were in a range between 6.1 and 8.2. When the pore water pH value was above 6, the soils were not considered to be corrosive. Therefore, there was no need to plot the soil pore water pH against the pipe breakage rates. There were insufficient data to assess the effect of soil sulphate content on the average pipe breakage rates as only two utilities' soil sulphate content values were mildly or moderately aggressive to AC pipes (Figure 15).

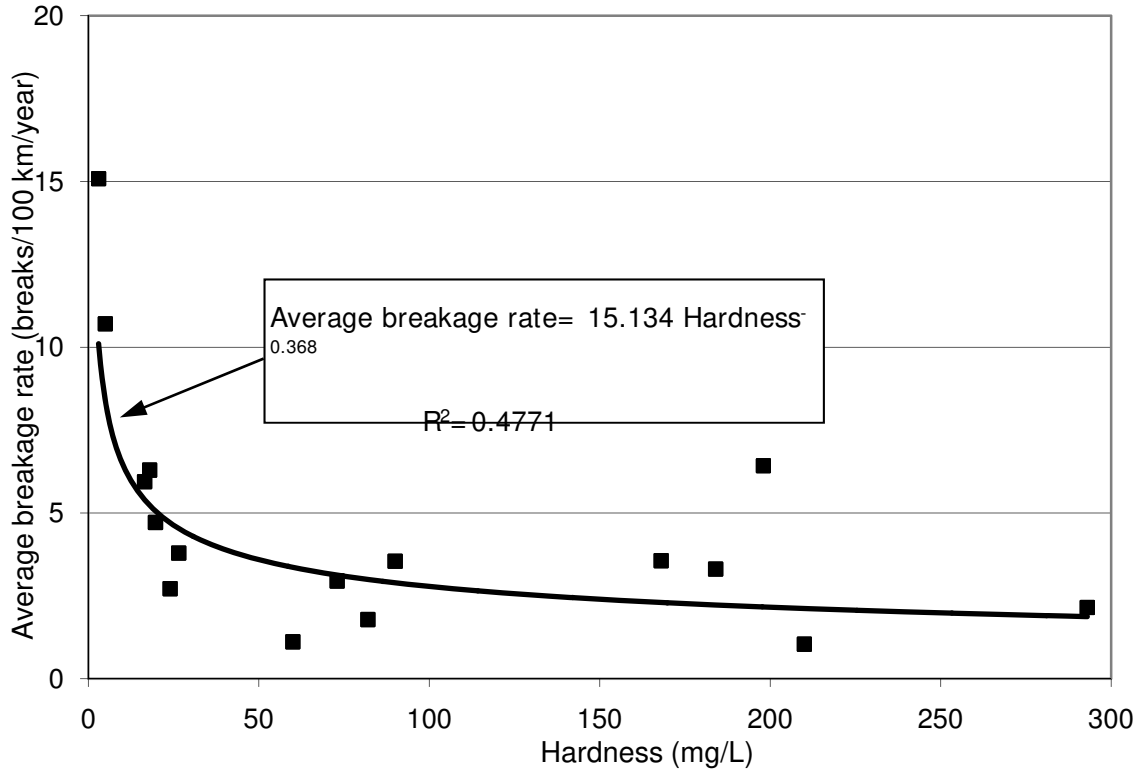
Hu, Wang, Cossitt, and Chowdhury – Figure 18

The effect of the hardness of conveyed water was analyzed to determine whether the trend is similar to the effect of AI on average breakage rate. Figure 18 suggests that a general trend of higher breakage rate with lower hardness (soft) water can be observed with very soft water (below 100 mg/L) being detrimental to the pipes, but that there is not a consistent effect above that level (the data are scattered).

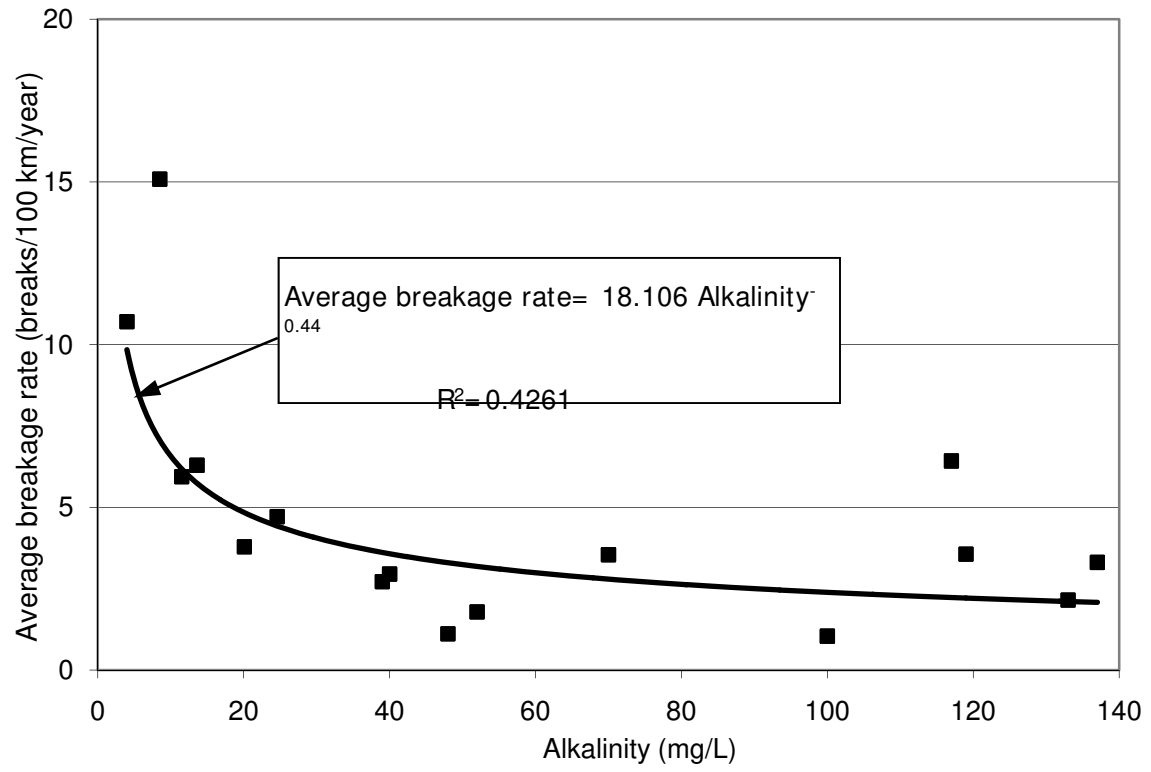
Hu, Wang, Cossitt, and Chowdhury – Figure 19

The effect of the alkalinity of conveyed water on the average breakage rate of AC pipes was also assessed as shown in Figure 19. It suggests that a lower alkalinity causes an

increase in the pipe breakage rate, with very low alkalinity water (below 60 mg/L) being detrimental to the pipes. The effect is not consistent above 60 mg/L. A similar trend was observed by Conroy et al. (2005) with 55 mg/L bicarbonate alkalinity being suggested as a possible threshold in terms of lime leaching. According to their observation, pipes deteriorated much faster in water with alkalinity below the threshold than in water above the threshold.

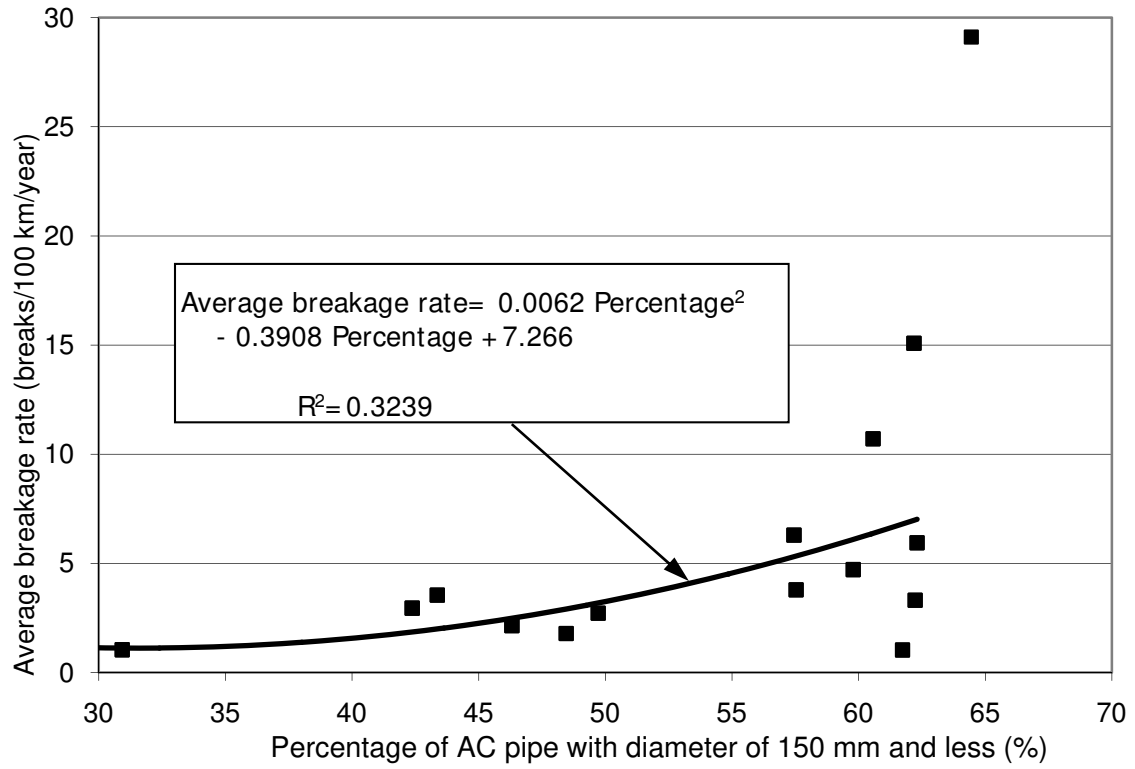
Hu, Wang, Cossitt, and Chowdhury – Figure 21

Figure 21. Comparison of percentage of small diameter pipe versus average breakage rate
