Construction Technology Update, 2011-04-01

Window Sill Details for Effective Drainage of Water

By M.A. Lacasse and M.M. Armstrong

Satisfactory window performance demands a good product and proper installation. This Update presents results from a recent study of sill installation details for the effective drainage of inadvertent water entry at the wall-window interface.

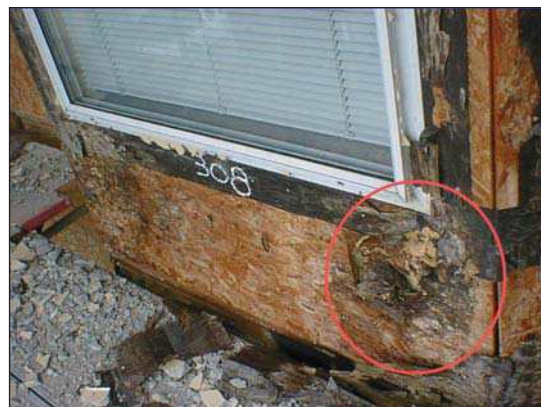
Figure 1. Damage caused by water entry

Inadequate detailing practices and improper installation of windows have led to numerous premature and costly building envelope failures caused by water entry. Because the watertightness of the window itself cannot always be assured over its life, measures should be taken to avert the damaging effects of inadvertent water entry. Water entry can cause damage to interior finishes and in the case of wood-frame construction, may lead to wood rot or the formation of mould in the wall assembly (Figure 1).

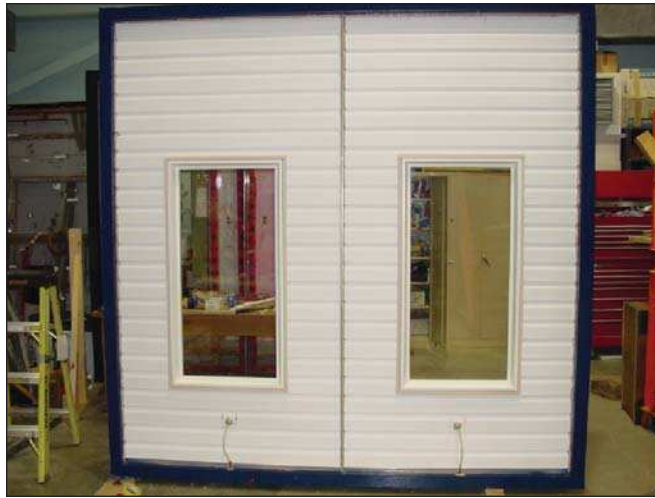
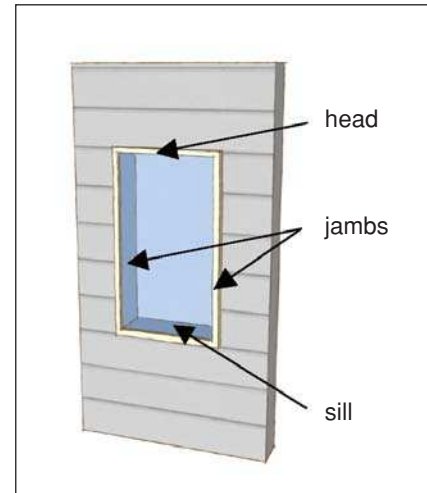
Figure 2. (a) Sample wall-window test assembly; (b) Diagram of wall-window assembly showing locations of wall-window interface details

The laboratory testing was designed to represent residential window installation practice. Testing was conducted on wall-window interface details incorporating vinyl windows with mounting flanges and variations in approaches to their installation. The wall-window assemblies (see Figure 2) were subjected to watertightness performance tests that mimic significant wind-driven rain loads. These test loads match those of significant rainfall events of 5, 15 or 30 minutes duration that might occur every 10 to 30 years.

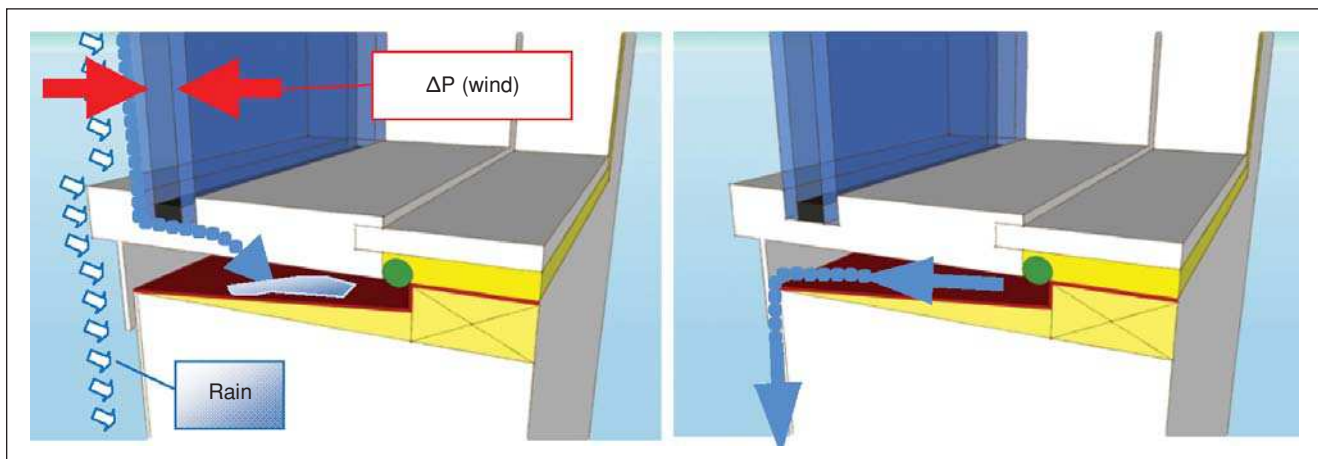
Figure 3. (a) Vertical section of a window with mounting flanges illustrating water entry at the base of the window and collection at sill; (b) Water accumulating at the sill must be drained

Water may enter at the window because of deficiencies in the window components, either inherent or after the window has “aged.” It may also enter because of incorrect window installation. When rain water is driven to the window, the risk of water entry at any deficiency increases, given that water may enter small openings due to the actions of gravity, capillary forces, or wind. Water entering a defective window or along the perimeter interface between the window and cladding may find its way into the wall assembly, but ultimately some water drains downwards and collects at the sill (Figure 3).

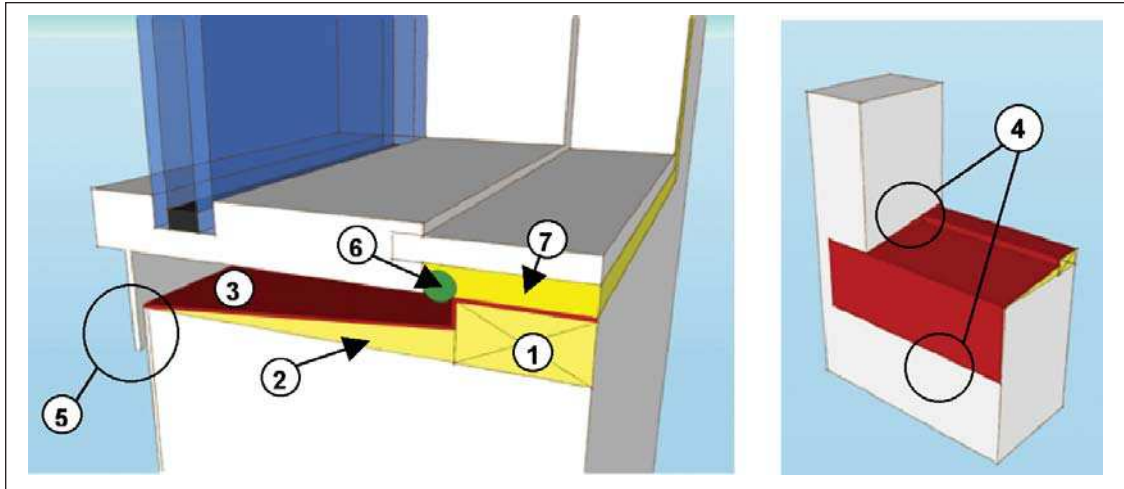
Figure 4. Vertical section of window showing key elements for adequate management of inadvertent water entry at the window sill

Results derived from the laboratory testing of different window installation designs showed that the window should be installed with a sill flashing “system.” Key elements of a sill flashing system for a window with a mounting flange that provides adequate protection to inadvertent water entry are provided in Figure 4 and include:

- Back dam (1)
- Sloped sill (2)
- Sill flashing membrane wrapping up the jambs and over the sheathing membrane at the sill (3)
- Proper lapping of flashing layers and the sheathing membrane (4)
- Drainage gap behind the window flange (5)
- Backer rod and sealant to provide continuity of the air barrier (6)
- Insulation to the interior side of the sill, leaving the drainage path unobstructed (7)

The final element in the installation is insulation. Insulation should be placed at the head and jambs and, as shown in Figure 4, at the sill as well. Note that the sloped sill should remain unobstructed so as to allow for proper drainage.

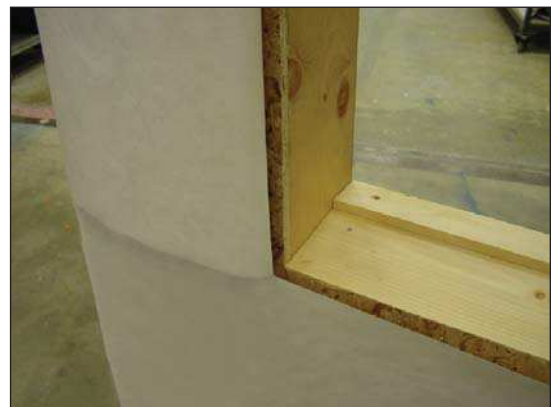
Figure 5. Sloped sill and back dam

The back dam, as the name suggests, provides a stop to water being driven into the wall assembly at the innermost part of the window opening; the sloped sill (the unprotected sloped sill and back dam are also shown in Figure 5) ensures that any water entry at the window sill is simply directed to a gap between the window frame and the edge of the sill where it drains to the exterior simply by the action of gravity. To promote adequate drainage, the slope at the sill should be at least 1/15 the depth of the window sill (i.e. ¼-in. rise over 3¾ in. depth).

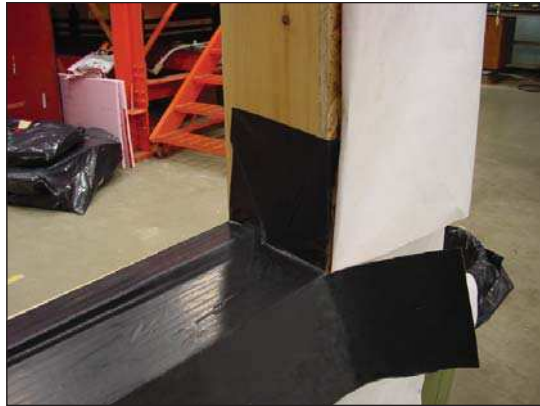
Figure 6. Pan flashing (black, self-adhered membrane) extends up the jambs

A sill flashing membrane is installed to protect the sloped sill; this same protection is extended up the jambs (Figure 6). Proper lapping of the flashing layers over the sheathing membrane at the sill, but beneath the sheathing at the jambs, helps ensure proper drainage and averts water entry behind the sheathing membrane (Figure 7).

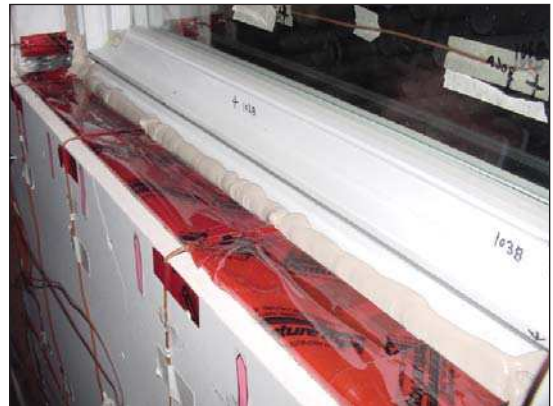
Figure 8. Sealing the window frame to the air barrier at the interior side

Ensuring continuity of the air barrier is a crucial element in the installation of the window. This is achieved by incorporating a sealant and backer rod at the interior perimeter seal of the window assembly (Figure 8). The seal must be made to the interior air barrier element (e.g., a polyethylene vapour barrier) to ensure continuity.

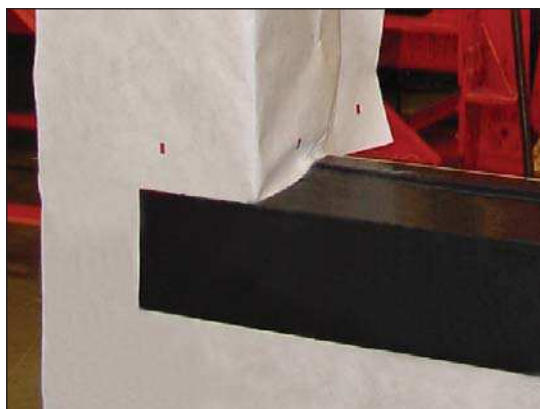
Figure 7. Proper lapping of sheathing membrane and self-adhered flashing (shingle fashion)

Of particular importance to ensuring a successful sill pan flashing is the sequence of installation of the different components. This cannot be overemphasized as without it, it is unlikely that sheathing membranes and flashing will be properly lapped to ensure positive drainage. This proper lapping (shingle fashion) is shown in Figure 7.
