Evaluation of pilot whole-body vibration exposure levels on a CH-147F Chinook military helicopter

Chen, Yong; Ghinet, Sebastian; Price, Andrew; Wickramasinghe, Viresh;
Grewal, Anant

The 50th UK Conference on Human Responses to Vibration [Proceedings], 2015

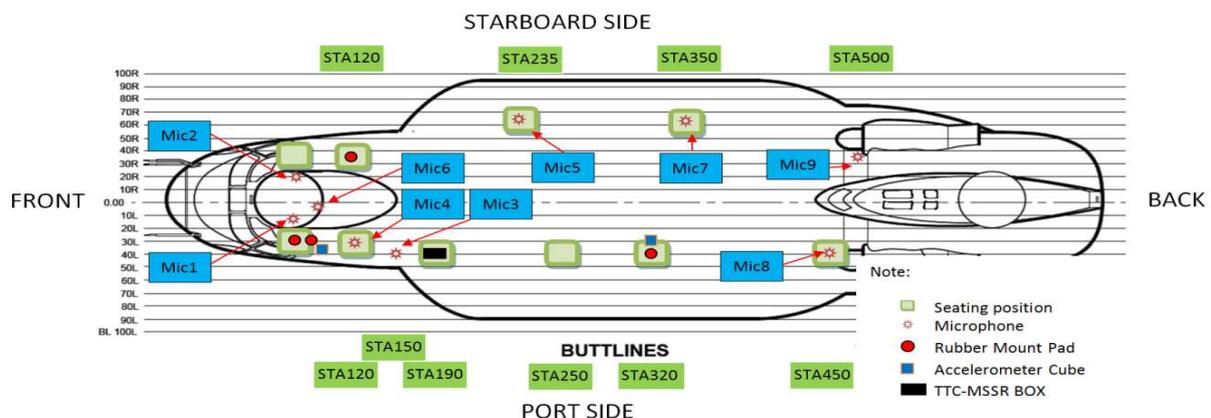
Figure 1: Sensor and aircrew locations in the CH-147F helicopter cabin

The aircrew whole-body vibration measurement was performed in accordance with ISO2631-1:1997 entitled "Mechanical Vibration and Shock - Evaluation of Human Exposure to Whole-body Vibration - Part 1: General Requirements". Measured aircrew member positions included a portside pilot seat, a starboard side flight engineer seat at STA120 and an occupant seat located at STA320 portside, as schematically shown in Figure 1.

The maximum flight speed condition during the flight test was 150 knots. Flight conditions for each flight or manoeuvre were maintained for a minimum of 60 seconds to provide a steady operational environment suitable for stationary data recording. The test aircraft layout and instrumentation suite locations are also shown in Figure 1.

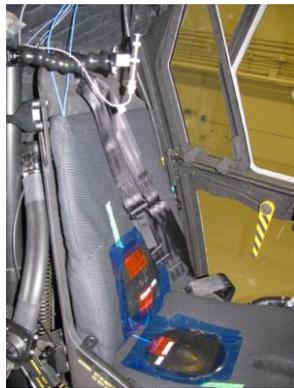
2a) pilot seat

Figure 2: Rubber mounts on the pilot and flight engineer seat cushions

On the CH-147F portside pilot seat frame, a standard thin layer of seat cushion was provided to the seat bottom and backrest pads. Two formed rubber mounts were used for vibration measurement at the seat cushion interfaces: one at the pilot-cushion interface of the bottom cushion and the other at the pilot-cushion interface of the backrest cushion. Both formed mount pads were firmly taped to the seat cushion surfaces to avoid sensor movement due to the pilot operations during the flight operations. This configuration is shown in Figure 2a.

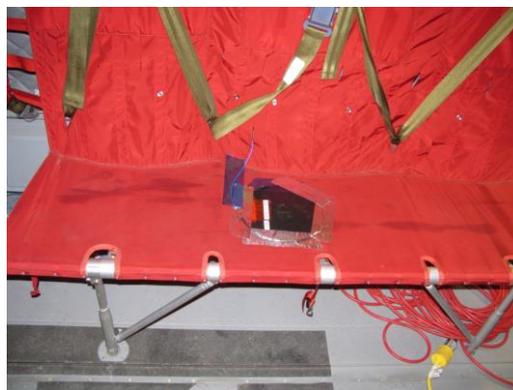
Figure 3: STA320 rubber mount on the passenger cabin seat

One formed rubber mount was installed at the interface of the cabin seat bench located at STA320 portside. Compared to the pilot and flight engineer seats, the seat pad and the backrest of the cabin seat bench were made of canvas fabric only. The rubber mount was also taped to the canvas fabric to avoid movement due to the passenger operations, as shown in Figure 3. In the flight test, the occupant sitting at this location was also chosen to operate the TTC-MSSR vibration data recording device manufactured by the TTC Corp. as shown in Figure 5.

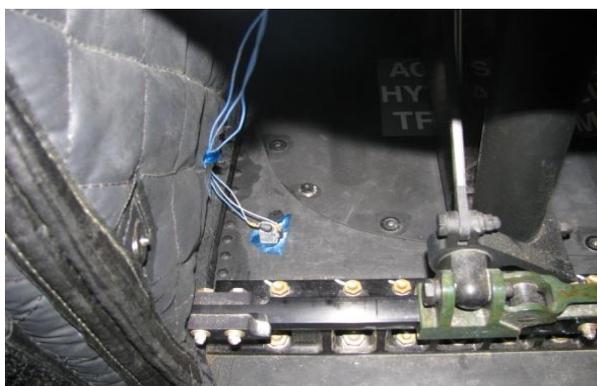
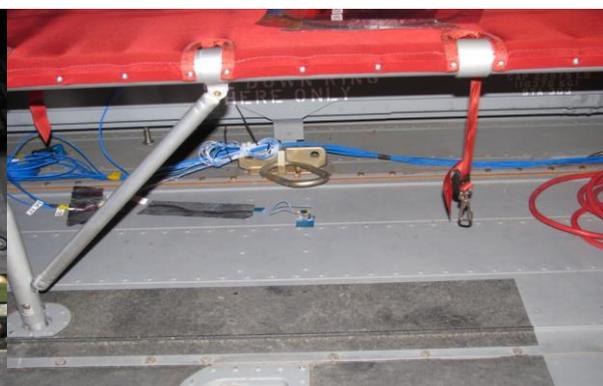
Figure 4: Accelerometer configurations on the CH-147F helicopter floor

To evaluate the vibration transmission path, helicopter floor vibration levels were also recorded at two floor locations: one underneath the portside pilot seat frame and the other underneath the cabin passenger seat at STA320 portside, as shown in Figure 4. For each location, three ICP type uniaxial accelerometers were attached to a plexiglass® cube using Superglue. The plexiglass® cube was then glued to blue flash tape on the floor to ensure the accelerometers were aligned with the orthogonal X, Y and Z directions of the CH-147F helicopter. This arrangement avoided any damage of, or glue residue on, the helicopter floor.

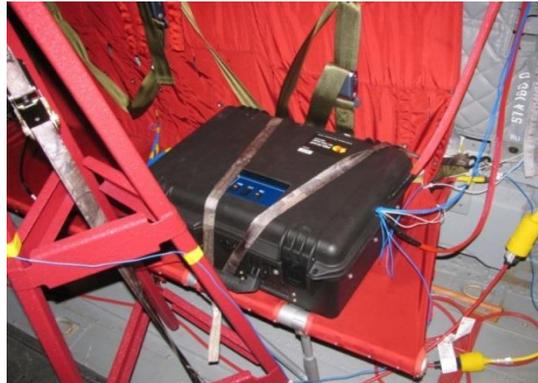
Figure 5: STA190 portable data recording instrumentation box (TTC-MSSR)

A TTC MSSR-100C series miniature data acquisition system was installed on the CH-147F Chinook helicopter as a non-essential item for normal flight operations. This device was configured as a self-powered, standalone unit operating on batteries, and strapped to the passenger bench seat at STA190 portside location, as shown in Figure 5. It is important to note that each functional module of the acquisition system was certified by the manufacturer according to applicable military standards (MIL) and other non-government standards for aircraft flight test purposes. As integrated, the system was not part of the CH-147F helicopter critical flight instrumentation and did not interfere with aircraft operations. This arrangement was approved by the Department of National Defence (DND) authorities to meet the airworthiness requirements for on-board instrumentation in a military aircraft.

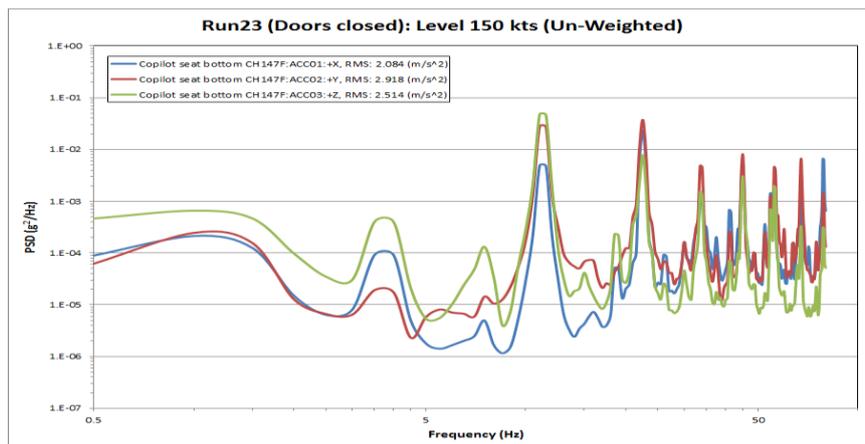
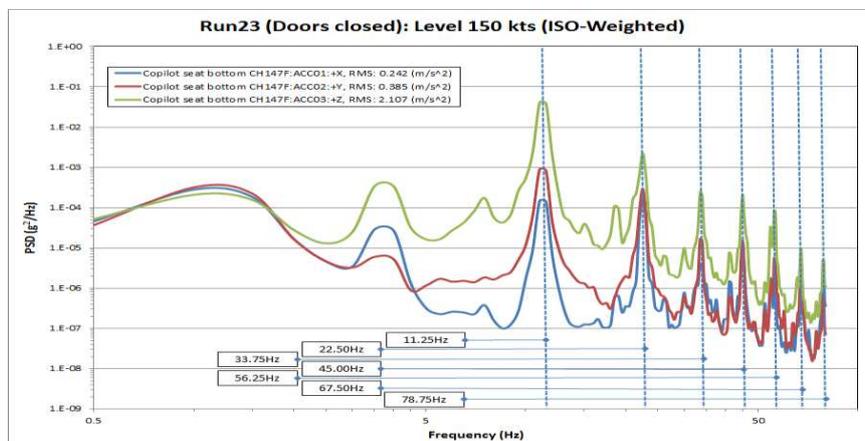
Figure 6: Pilot seat bottom vibration at 150 knots level flight condition

The whole-body vibration level of the 50th percentile pilot during the 150 kts forward flight condition is shown in Figure 6a) and Figure 6b where the blue, red and green lines represent the X, Y and Z directions respectively and the vertical dotted lines indicate the harmonic frequencies of the rotor speed. It was clearly shown that the pilot whole-body vibration was introduced by the N/rev harmonics of the tandem rotor speed. The dominant vibration peaks included the 3/rev at 11.25 Hz and 6/rev at 22.50 Hz, generated by the three-bladed tandem main rotor configuration of the CH-147F helicopter (N=3). Comparing the un-weighted vibration spectra measured in the three orthogonal directions of the pilot bottom seat cushion interface, the vibration levels were found quantitatively close, with 2.1, 2.9 and 2.5 m/s² in the X, Y and Z directions, respectively. After applying ISO weighting, the vibration in the Z direction became dominantly high at 2.1 m/s² while the weighted vibration level was 0.24 and 0.39 m/s² in the X and Y directions respectively.

With reference to the “Comfort and Perception Ratings” presented in ISO2631-1:1997, the pilot whole-body vibration level during the 150 kts forward flight condition was qualitatively rated as “Extremely Uncomfortable”. Consequently, according to the “Vibration Health Guideline Caution Zone”, the suggested maximum exposure time for the pilot was estimated to be between 16.5 and 66 minutes.

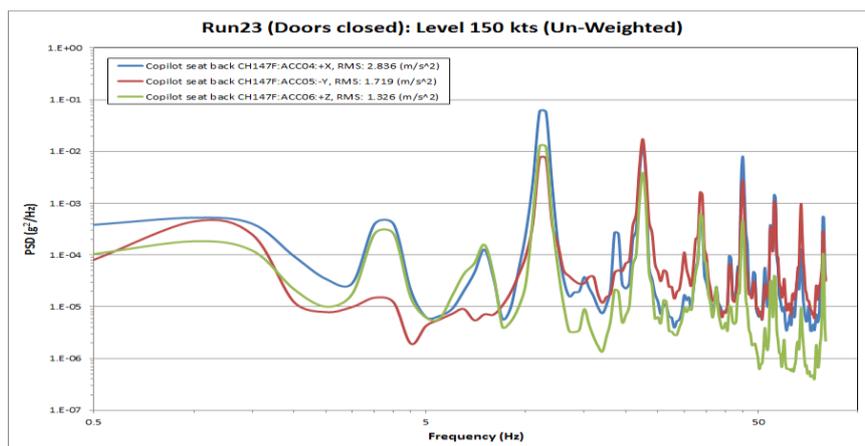
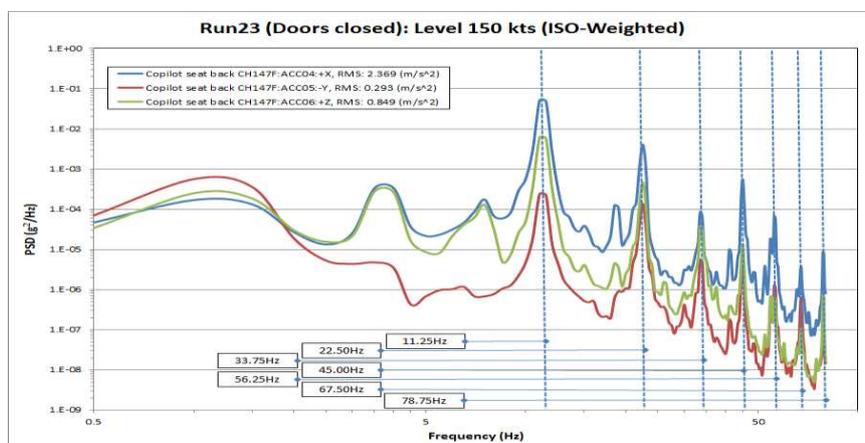
Figure 7: Pilot seat backrest vibration for closed doors configuration at 150 knots level flight

At the pilot seat backrest cushion interface, the dominant vibration peaks also came from the 3/rev and 6/rev harmonics of the tandem main rotor, as shown in Figure 7 where the blue, red and green lines represent the X, Y and Z directions respectively and the vertical dotted lines indicate the harmonic frequencies of the rotor speed. The X direction showed marginally higher vibration level than the Y and Z directions before weighting was applied. However, after applying the appropriate ISO weighting curves, the derived weighted rms vibration level in the X (fore/aft) direction was 2.87 m/s², which was dominantly higher than the 0.29 and 0.85 m/s² weighted levels in the Y and Z directions. Quantitatively, this weighted vibration value in the X direction of the pilot seat backrest was also 33% higher than the weighted vibration level in the Z direction of the pilot seat bottom interface. It is important to note that the X direction of the seat backrest is the normal direction of the backrest cushion interface and the Z direction is the normal direction of the seat bottom cushion interface.

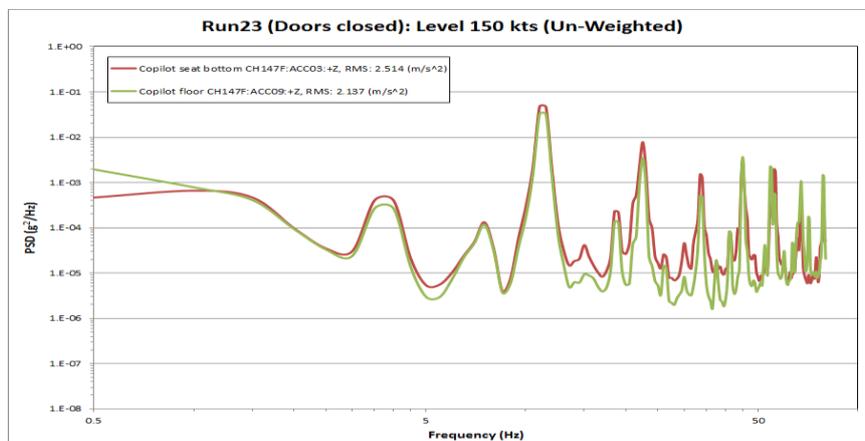
Figure 8: Vibration transmission at the pilot seat location at 150 knots level flight segment

The vibration transmission from the helicopter floor to pilot seat bottom cushion interface was also analysed and the results are shown in Figure 8. Vibration amplitude reduction was observed for frequency components beyond 12/rev harmonics, or 45 Hz, due to the effective damping provided by the seat bottom cushion materials. However, the vibration amplitudes at the lower harmonic peaks such as 1/rev, 3/rev, 6/rev and 9/rev were not reduced but rather amplified. As a result, the vibration level at the seat bottom cushion interface reached 2.5 m/s² which was higher than the 2.1 m/s² measured on the floor. This amplification effect may have been caused by the coupled dynamics of the seat frame, seat cushion and seat floor as well as the occupant body dynamics during the flight. As a short term solution, improvement to the seat bottom cushion design may be able to provide vibration reduction to the pilot whole-body vibration levels.

3. Comparing the vibration spectra at the helicopter floor and the seat bottom interface for the pilot, vibration levels were found to be amplified through the seat in the low frequency range up to 12/rev (45 Hz).

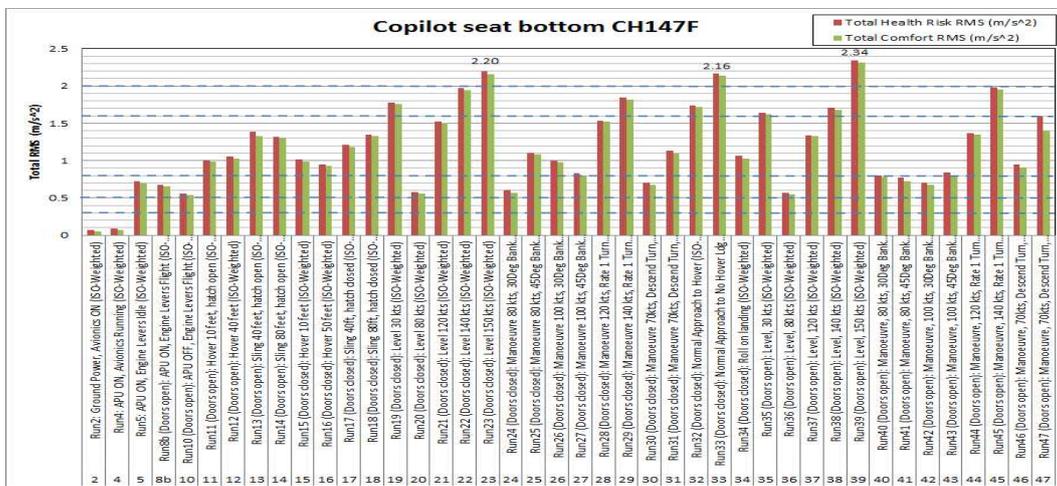
Figure 9: Pilot whole-body vibration levels at seat bottom cushion interface

The pilot whole-body vibration levels in the tested flight conditions are shown in Figure 9 where the horizontal dashed blue lines corresponded to the “Extremely Uncomfortable”, “Very Uncomfortable”, “Uncomfortable”, “Little Uncomfortable” and “No Discomfort” levels as suggested in the ISO2631-1:1997. The weighted whole-body vibration level was observed to exceed 1.6 m/s² in 9 flight conditions which were qualitatively rated as “Very Uncomfortable”. These flight conditions included level flights, manoeuvres above 120 kts, sling load flights and approaches to hover. Specifically, in three flight conditions, namely the 150 kts level flight with doors closed, open and the normal approach to hover, the weighted whole-body vibration level exceeded 2.0 m/s² which were qualitatively rated as “Extremely Uncomfortable”. However, results from the doors open and doors closed flight configuration were found to have no appreciable statistical difference in the pilot whole-body vibration levels.

It is interesting and important to note that the subjective ratings from the pilot seem to be somewhat less severe than analytically measured results. Specifically, as shown in Figure 9, the data for the pilot correlated to conditions of “uncomfortable” in 30 of 42 flight profiles, “very uncomfortable” in 9 of the 42 flight profiles and “extremely uncomfortable” in 3 of 42 flight conditions, although the qualitative

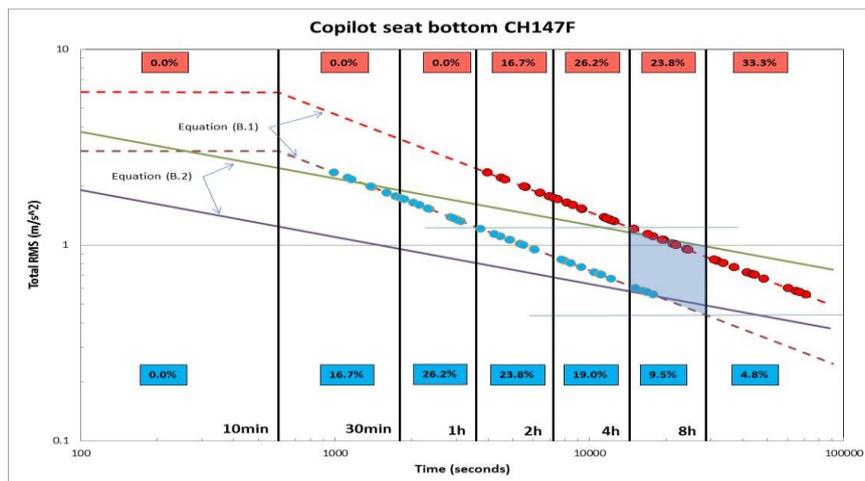
Figure 10: Estimated exposure time limit for each flight condition

Based on the weighted rms vibration levels and referencing to the “Vibration Health Risk Guideline Caution Zone” recommended by ISO2631-1:1997, the maximum continuous daily exposure time has been calculated for each flight condition using the vibration equivalent equation listed in Appendix B of the standard, and the results are shown in Figure 10. Since there is no standard mission profile available for a military helicopter, the measured aircrew weighted whole-body vibration levels in representative flight conditions can be used as reference indexes to determine the helicopter aircrew whole-body vibration exposure in real flight missions using the following equation (ISO2631-1, B.1)

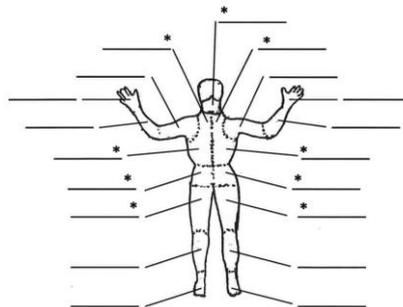
Figure 11: Localized postural discomfort survey form used in CH-147F flight test

In each questionnaire form, the aircrew were requested to rate their subjective perception on the discomfort at various locations on a voluntary basis. The rating was suggested between 0 and 10, where 0 indicated “no discomfort at all” and 10 indicated “extreme discomfort”. An example of the form is shown in Figure 11. The locations of greatest interest included the occupant neck, shoulder, lumbar back, bottom and thigh.
