### **Field performance of concrete repair systems on a highway bridge structure**

*ACI Materials Journal*, 103, 5, pp. 366-373, 2006

# **FIELD PERFORMANCE OF CONCRETE REPAIR SYSTEMS ON A HIGHWAY BRIDGE**

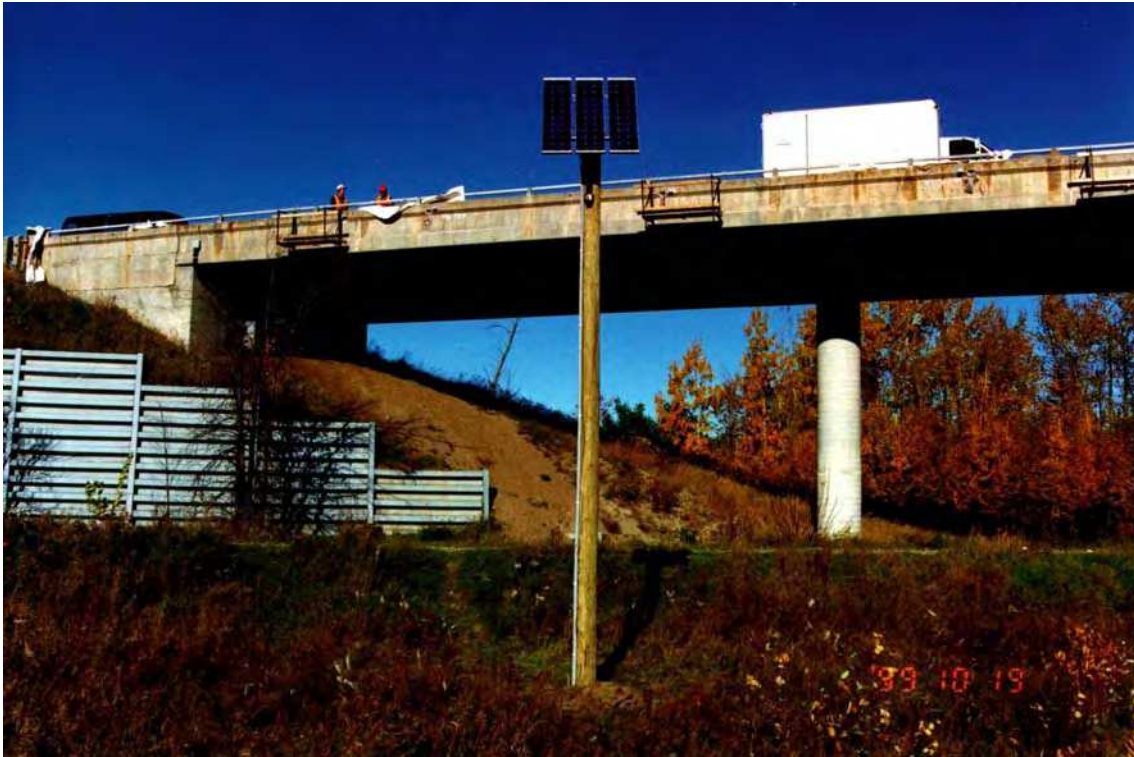
Fig. 1 – Test bridge during repair and instrumentation

simultaneous effects of de-icing salt contamination, freeze-thaw cycles, and wet-dry cycles. The fieldwork consisted of repairing the 24-year old corrosion-damaged reinforced concrete barrier walls of a highway bridge near Renfrew (Ontario), using six different concrete repair systems, and installing embedded instrumentation in seven test sections for continuous monitoring. Key parameters such as temperature, relative humidity, corrosion potential, electrical resistance and mechanical strain were recorded twice daily at selected locations in the barrier wall. Laboratory tests were also conducted to characterize the concretes of the repair systems used in the field. This paper presents the performance evaluation results of different concrete repair systems installed on a bridge barrier wall monitored with embedded sensors over a three-year period.

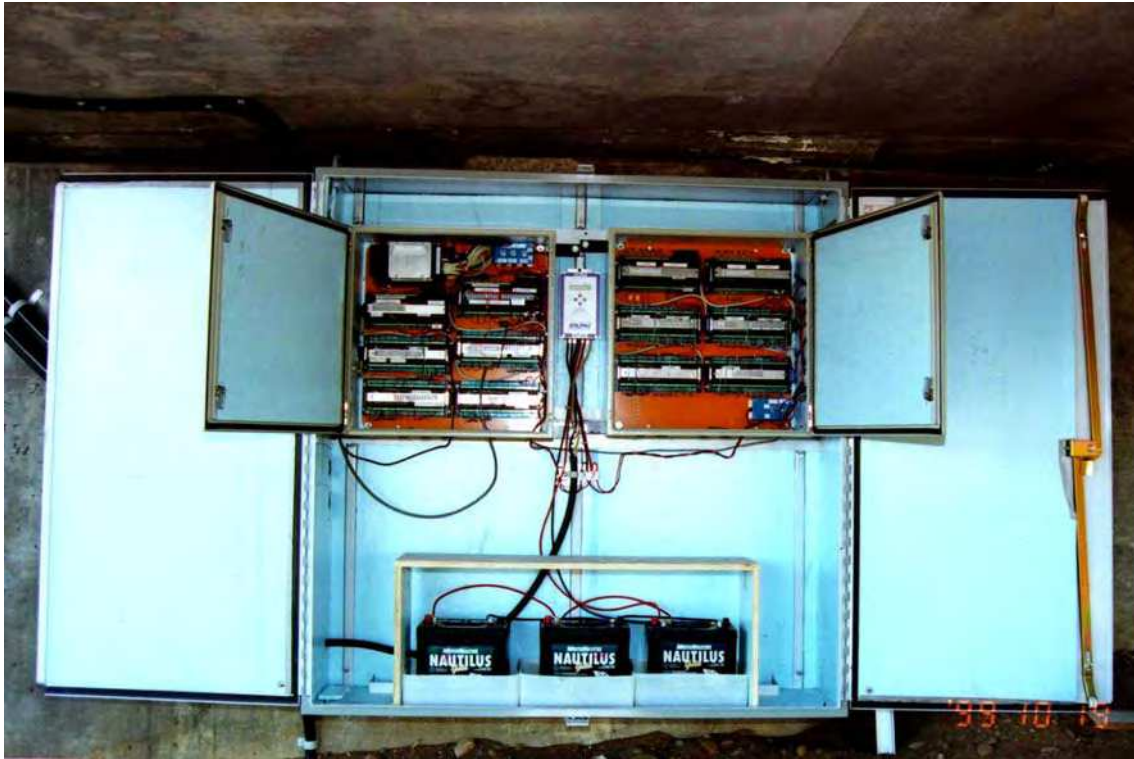
**Fig. 3 – Data logging system installed underneath bridge deck**

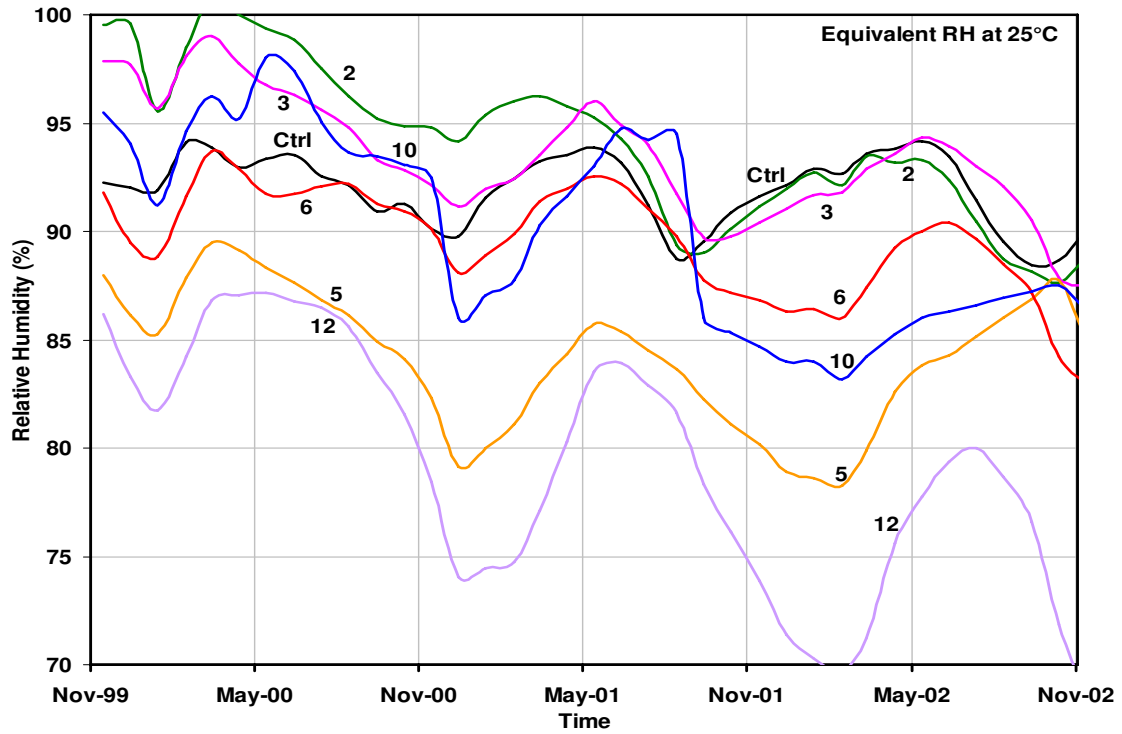
**Fig. 5** presents the monthly average of RH measured in the concrete patches, in which each curve corresponds to one repair system (see Table 1 for the system codes). The concrete RH decreased in all test sections from Nov. 1999 to Nov. 2002 due to gradual drying, combined with a typical seasonal fluctuation, as expected. Two trends were observed: (i) Sections 2, 3, 6, 10 and the control section displayed RH values decreasing from 90-100% to 85-90% three years later; and (ii) Sections 5 and 12 displayed lower RH values overall, decreasing from 85-90% to 75-80% during the same period. These trends were confirmed by the measurements of electrical resistivity, which will be discussed later. The low RH in the patches of Sections 5 and 12 may be the result of self-dessication in the concrete.

**Fig. 5 – Monthly average relative humidity in concrete patches**

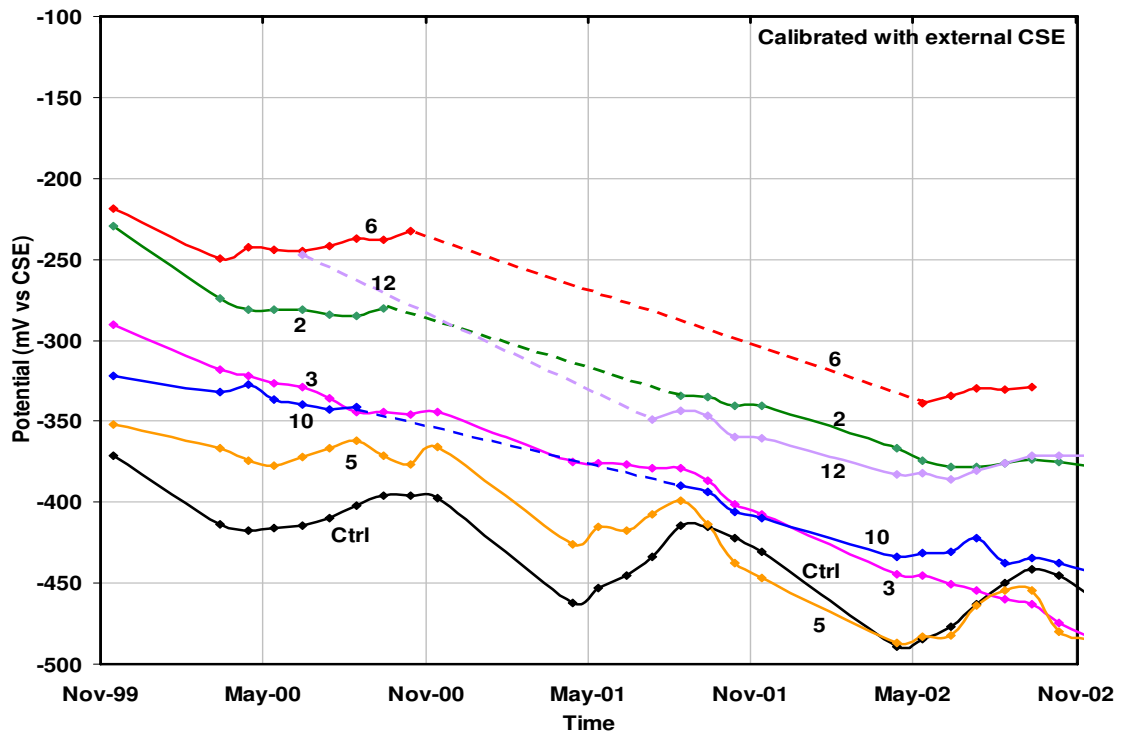
**Fig. 8** presents the monthly average of the corrosion potential of the reinforcing steel vs. CSE measured in the old concrete on electrode RE1 (located 400 mm [16 in.] away from the patch). The curves show that the corrosion potential of the old concrete in all test sections shifted towards more negative values by more than 100 mV during the three-year period. This is an indication that the risk of corrosion in the substrate was still increasing after the rehabilitation.

Fig. 8 – Monthly average corrosion potential in old concrete (RE1)

as macro-cell corrosion in the old concrete near the patch (as shown in **Figs. 7-8** and **Table 3**). However, it was also demonstrated (in **Fig. 8** and **Table 3**) that all the repair systems investigated in this study had little influence on the micro-cell corrosion developing in the old concrete. Moreover, all repair systems failed to prevent shrinkage cracking in the patches, which may accelerate chloride ingress through the cracks and initiate localized corrosion in the near future.

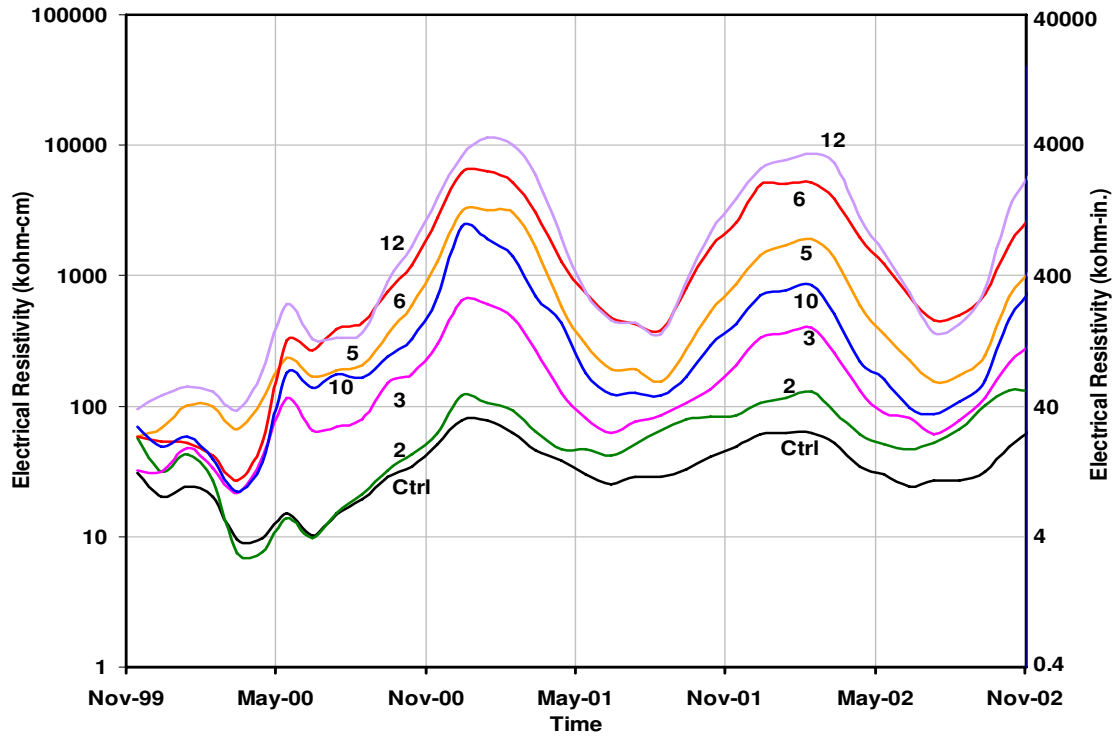
In general, the larger the electrical resistivity of the concrete, the smaller the corrosion rate of the reinforcement. **Fig. 9** presents the monthly average of electrical resistivity in the concrete patches. The values of electrical resistivity ranged from 10 k $\Omega$ -cm [4 k $\Omega$ -in.] to 10,000 k $\Omega$ -cm [4,000 k $\Omega$ -in.] depending on the environmental conditions and the test sections monitored. Considering that dry conventional concrete has a known electrical resistivity close to 1,000 k $\Omega$ -cm [400 k $\Omega$ -in.], values as high as 10,000 k $\Omega$ -cm [4,000 k $\Omega$ -in.] seem reasonable for high-density, low permeability concrete in dry conditions. The trends observed for the electrical resistivity are in agreement with the trends for the measured RH values (but inversely proportional). Due to continuous drying, an overall increase in electrical resistivity by almost an order of magnitude is observed from Nov. 1999 to Nov. 2002, corresponding to an overall decrease of approximately 10% in RH for the same period. The concrete patches in Section 2 and the control section had the lowest resistivity values overall (and highest RH values), while the patches of Sections 5 and 12 had the highest resistivity values overall (and lowest RH values). A wide seasonal variation of resistivity is also observed, with high resistivity corresponding to low RH and low temperature measured in the winter. This wide variation of resistivity is explained by the significant effect of temperature and RH on the electrical resistivity of concrete, especially during winter when the electrolyte in the concrete pores is frozen leading to very high values of

**Fig. 9 – Monthly average electrical resistivity in concrete patches**

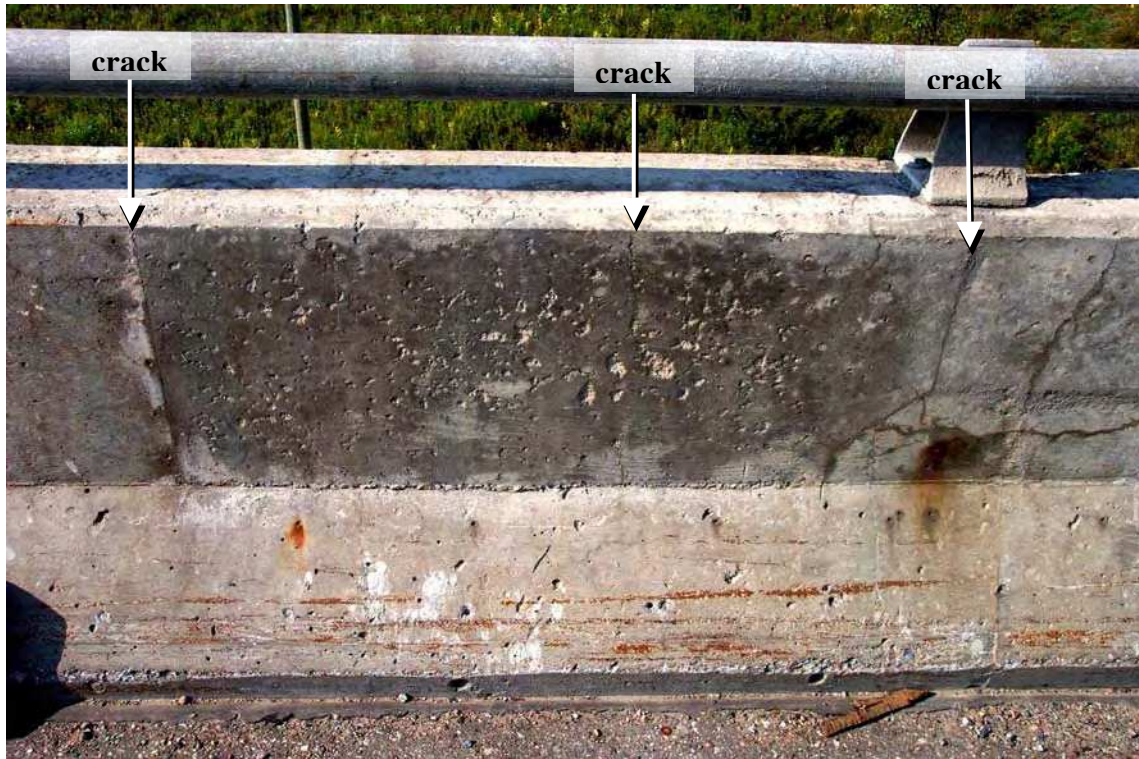
**Fig. 13 – Photograph of repaired Section 2 after four years (Oct. 2003)**

5. Vertical shrinkage cracks were observed in the concrete patches of the repair systems tested in this study. As a result, reinforcement corrosion, due to chloride ingress in the concrete patches, may initiate in the near future.
