### Moisture investigations in connection with paints on external renderings

Technical Translation 1374

Title: Moisture investigations in connection with paints on external renderings  
(Feuchtigkeitstechnische Untersuchungen im Zusammenhang mit Anstrichen auf Aussenputzen)

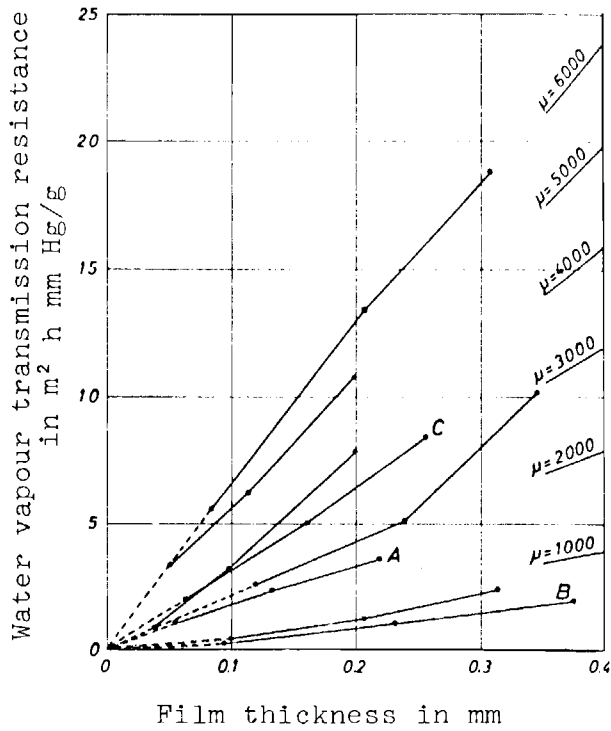
Fig. 1

Relationship between water vapour transmission resistance and film thickness of various emulsion paints

The paints marked A, B and C were also used in the later investigations

The diffusion resistance factors of the commercial emulsion paints tested are found within a comparatively broad range between  $\mu = 500$  and  $\mu = 6,000$ . On the basis of the relationship between paint consumption and mean thickness of coating represented in Figure 2, for a paint consumption of  $0.5 \text{ kg/m}^2$ , which is common in practice, a water vapour transmission resistance between 1 and  $10 \text{ m}^2 \text{ h mm Hg/g}$  may be expected for coats of paint 0.15 mm thick of different manufacture. The values of the transmission resistance of the customary 2 cm thicknesses of external rendering lie in a range between 2.5 and  $5 \text{ m}^2 \text{ h mm Hg/g}^{(3)}$ . The water vapour transmissibility of an emulsion paint thus corresponds in order of magnitude to the transmission of a layer of rendering 2 cm thick.

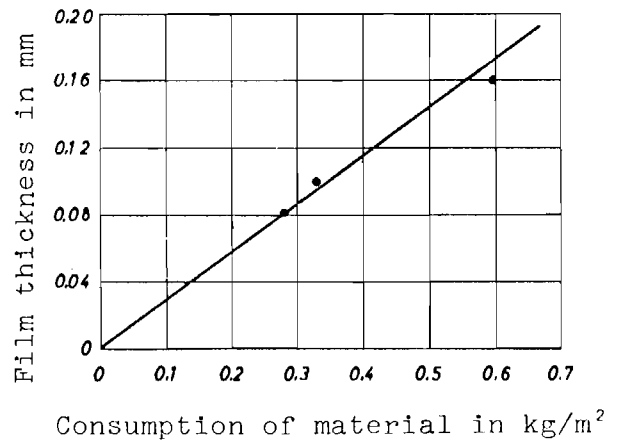
Fig. 2

Relationship between film thickness of paint and amount of paint applied

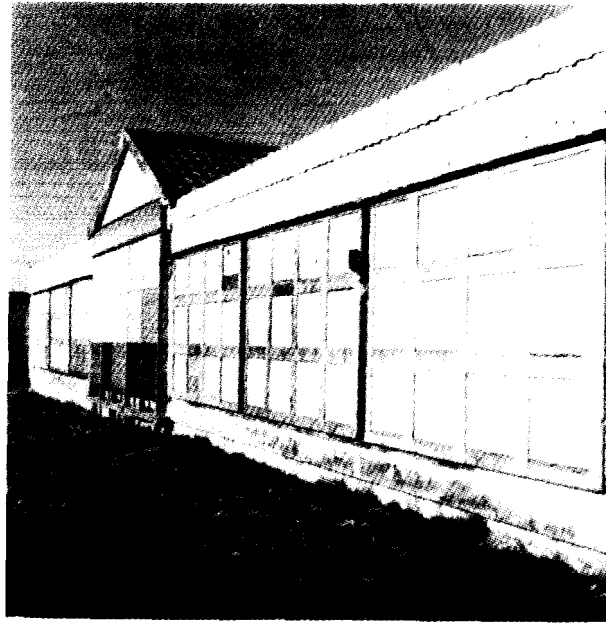
Fig. 3

View of the west side of the test stand for wall specimens on the Holzkirchen test site

Between the 4th and 5th vertical row from right: receptacle for measurement of driving rain

On the Holzkirchen test site a test stand was erected, the west and east sides of which comprised a lattice structure capable of receiving wall specimens 27.5 cm thick (24 cm masonry, 2 cm external rendering, 1.5 cm internal plaster) and 50 cm x 50 cm in area (Fig. 3). The wall specimens were built in wooden frames, which were prevented from absorbing moisture by the application of two coats of bituminous paint. The joints between the wooden frames and the external rendering were sealed with a plastic filler, so that rain could only penetrate the masonry through the rendering. Two specimens were produced of each wall design, which differed with respect to structural material, rendering and paint. One of the two specimens was exposed to the west, the other to the east, in the test stand. The westerly exposed specimens (the windward side) were fully exposed to the weather. The quantities of driving rain striking them were measured. The easterly exposed specimens were protected by an overhang; the drying conditions uninfluenced by sun and rain could thus be determined on these specimens.

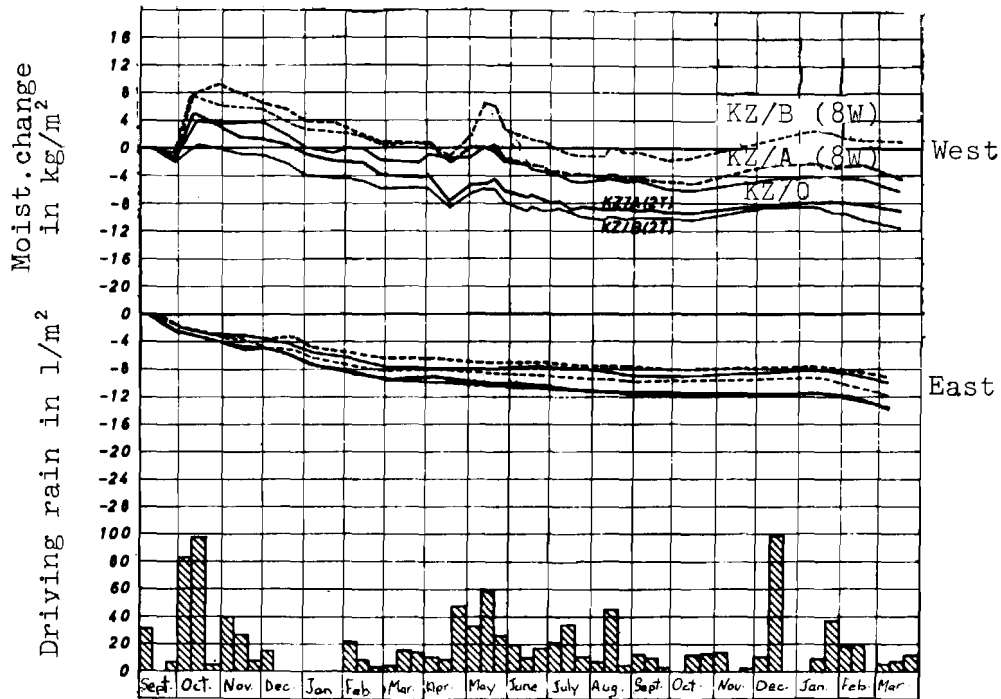
Fig. 4

Changes of moisture content in the westerly and easterly exposed wall specimens of "dry" perforated brick masonry with lime-cement rendering (KZ) without (o) and with paints A and B applied two days (2 T) and eight weeks (8 W) after completion of rendering

The gravimetrically determined moisture changes in the course of a year and a half of outdoor exposure of the wall specimens are presented graphically in Figures 4 to 7 along with details of the amounts of driving rain striking the west specimens. They show that the rendered specimens without paint as a rule show greater increases of moisture when exposed to rain than the corresponding painted specimens in which some increase of moisture also occurs. Accordingly the paints can be considered water-repellent in the strict sense of the term.

The difference in moisture content changes between west and east specimens, obtained from the measured results shown in Figures 4 to 7, are given in Figure 8. For this the moisture-time curves of the wall specimens with lime external rendering in each case were plotted only for the periods of time during which the emulsion paints showed no perceptible frost damage. The representation in Figure 8 is thus suitable for a comparative appraisal of the effect of paint applied to the different types of masonry or rendering, as the case may be. For greater clarity in the examination of two paints (A and B) the areas between the two moisture curves have been hatched. From these results (Fig. 8) the following conclusions are drawn:

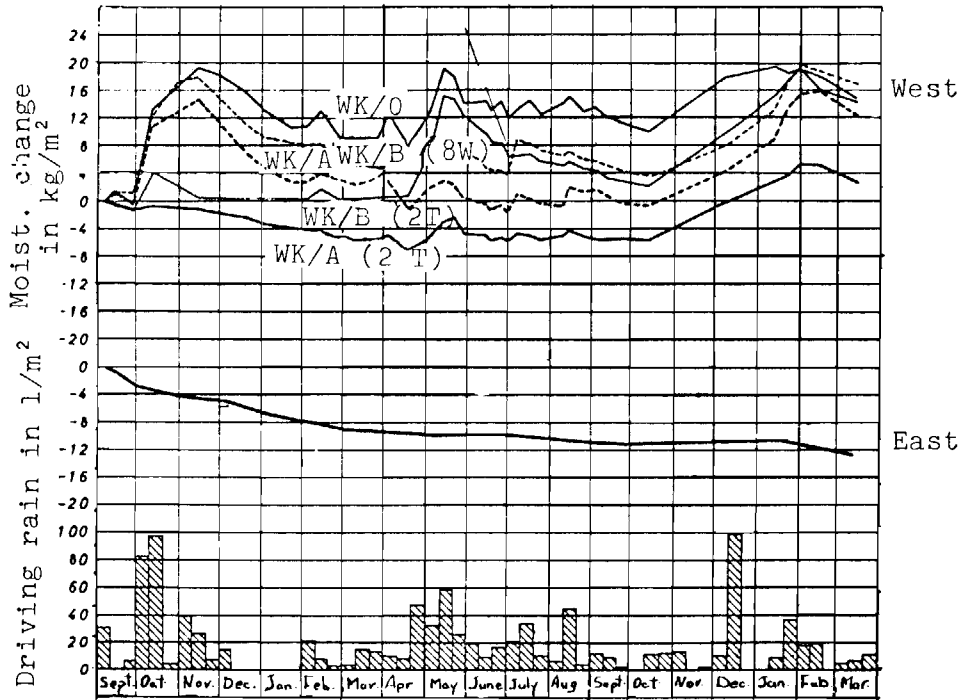
Fig. 5

Changes in the moisture content of the westerly and easterly exposed wall specimens of "dry" perforated brick masonry with lime rendering (WK) without (o) and with paints A and B, applied two days (2 T) and eight weeks (8 W) after completion of rendering

In the moisture curves of the easterly exposed specimens no appreciable differences are found and therefore a mean moisture curve is plotted

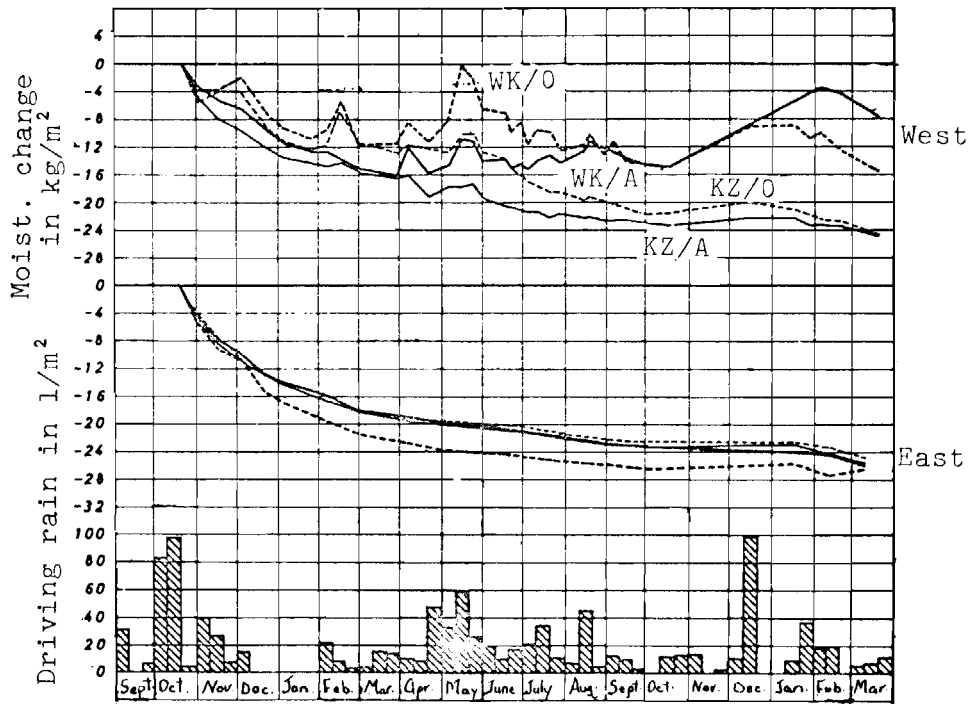
Fig. 6

Changes in the moisture content of the westerly and easterly exposed wall specimens of "wet" perforated brick masonry with lime-cement rendering (KZ) and lime rendering (WK) without (o) and with paint A, applied 17 days after completion of rendering

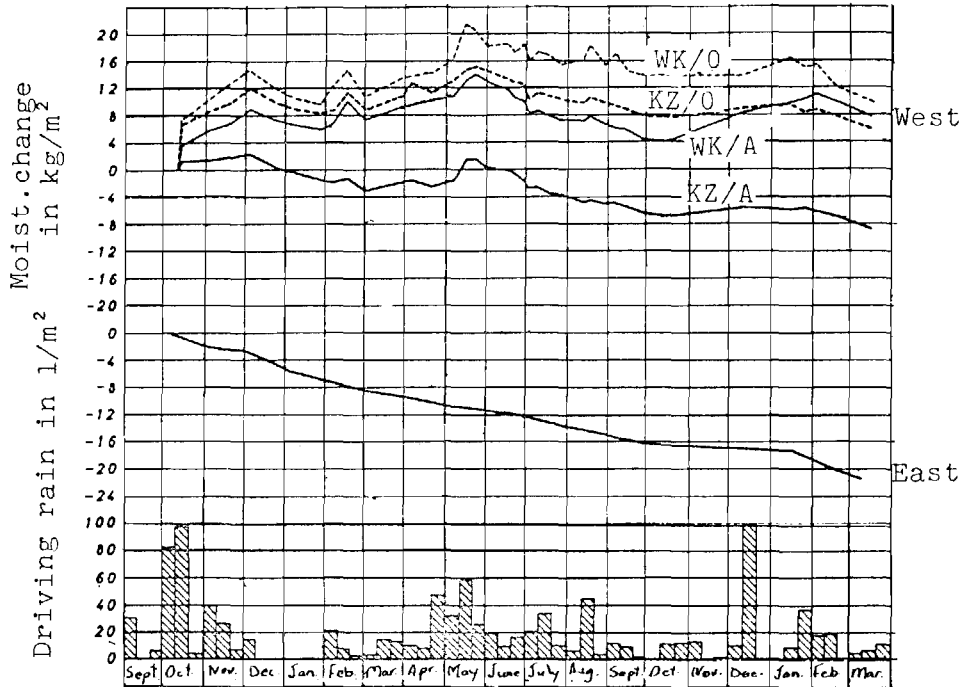
Fig. 7

Changes in moisture content of westerly and easterly exposed wall specimens of aerated concrete masonry with lime-cement rendering (KZ) and lime rendering (WK) without (o) and with paint A, applied 7 days after completion of rendering

In the moisture curves of the easterly exposed specimens no appreciable differences are found and therefore a mean moisture curve is plotted

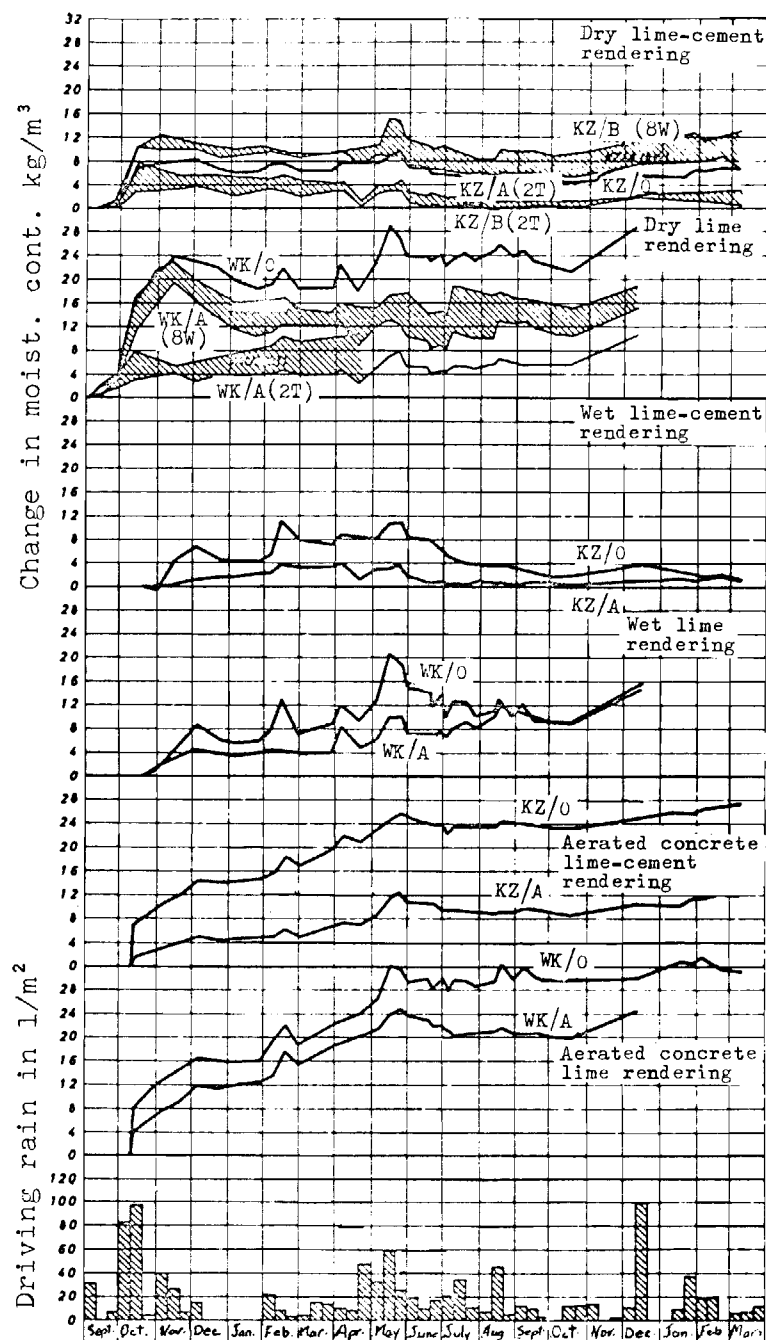
Fig. 8

Changes in moisture content of wall specimens of different building materials with lime-cement and with lime external renderings without (o) and with emulsion paints (A and B), brought about by the effect of weathering (west side)

The figures in brackets give the time between completion of the rendering and application of the paint (in days (T) or weeks (W))

The different water-related properties of the wall material (brick with high capillary absorptivity and aerated concrete with low capillary absorptivity) and the different initial moisture conditions (dry and wet masonry) strongly affect the moisture content of the unpainted wall specimens; the maximum moisture increases during a year occur in aerated concrete masonry, followed by "dry" and "wet" brick masonry in that order. On the same type of masonry, moreover, greater moisture increases are obtained with a straight lime rendering than with a lime-cement rendering (without paint in both instances). These results confirm earlier findings that the moisture conditions in external walls frequently exposed to rain depend on the capillary properties of the masonry material and the conditions of moisture content of the rendering after its application<sup>(4,5)</sup>. The moisture increases during rain are of course reduced by the emulsion paints applied, but the basic differences due to the properties of the wall masonry material remain. This is especially clear in Figure 9, where the moisture curves (west-east differences) of the wall specimens with lime-cement rendering without paint, as well as those with paint A, are compared.

This frost damage occurred mainly during the second test winter of 1961-62, in which frost set in immediately after rather heavy rainfalls in December (see Fig. 8). The damage manifested itself first of all in the lifting of paint and sections of the rendering at isolated, locally restricted places on the wall. These initial places were probably flaws in the paint at which particularly large amounts of moisture had been able to penetrate during the rainfalls. As the winter progressed the frost damage spread out from these points (Fig. 15a and b), sometimes to the point of complete scaling of the lime rendering, which, subjectively judged, was very brittle. In lime-cement renderings coated with emulsion paints no frost damage occurred (Fig. 16).

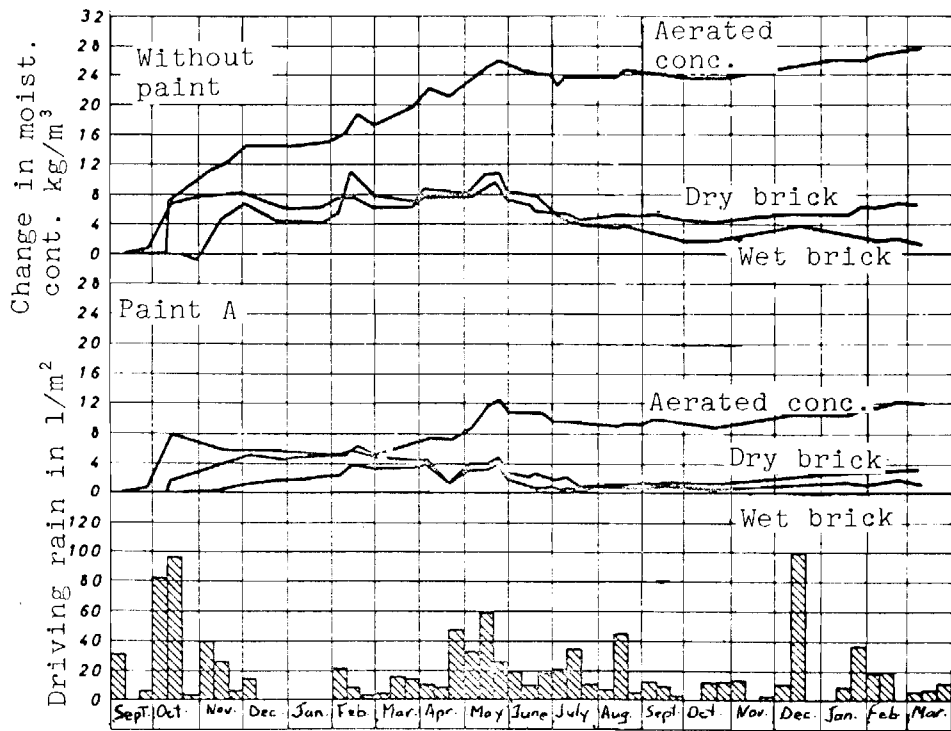
Fig. 9

Changes in moisture content of wall specimens  
of different building materials with  
lime-cement external renderings without and  
with emulsion paint A

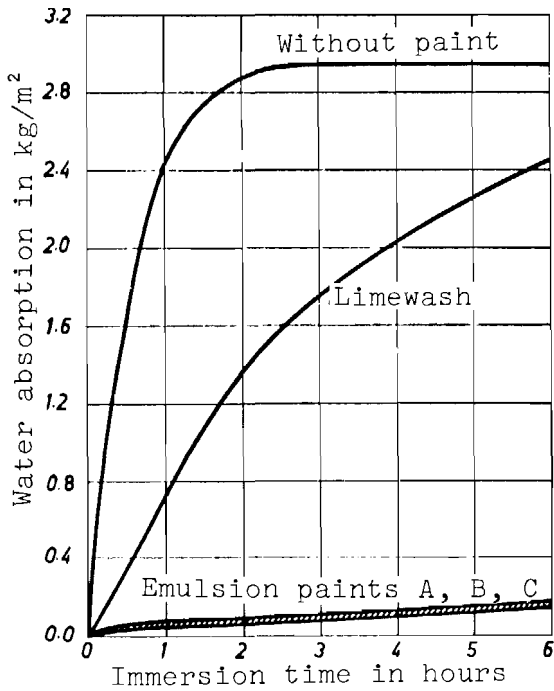
Fig. 10

Capillary water absorption as a function of the time determined from specimens of lime-cement rendering without paint and with coats of whitewash and emulsion paints

Mean values from measurements on three individual specimens in each case

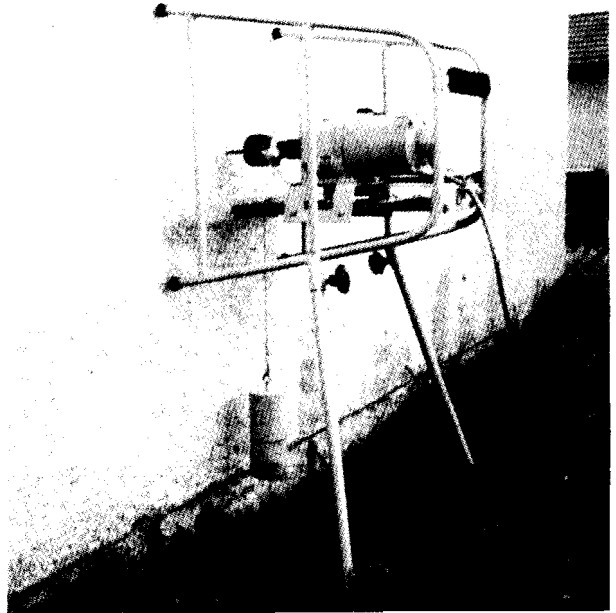
Fig. 11

Instrument for determining the hardness of a rendering

Using a masonry drill (10 mm in diameter) applied with constant force to the surface of the rendering, a hole was drilled in the latter, and the depth of penetration and rpm of the drill are measured continuously. For this purpose a framework was constructed (Fig. 11) in which a slow-speed drill (16 rpm) was made freely movable in the horizontal direction on rollers. With the aid of a pulley, a perpendicular weight (9.4 kg) causes the drill to be pressed with a constant force against the surface of the rendering. A tachometer mounted on the apparatus and a dial gauge make it possible to read the rpm of the drill and the depth of penetration continuously. The number of revolutions per mm of penetration can be regarded as the characteristic value for the hardness of the rendering. Since the area of measurement is small, the result may be greatly influenced by local irregularities in the rendering. It is advisable, therefore, to take several measurements on any given rendering surface and to average the results.

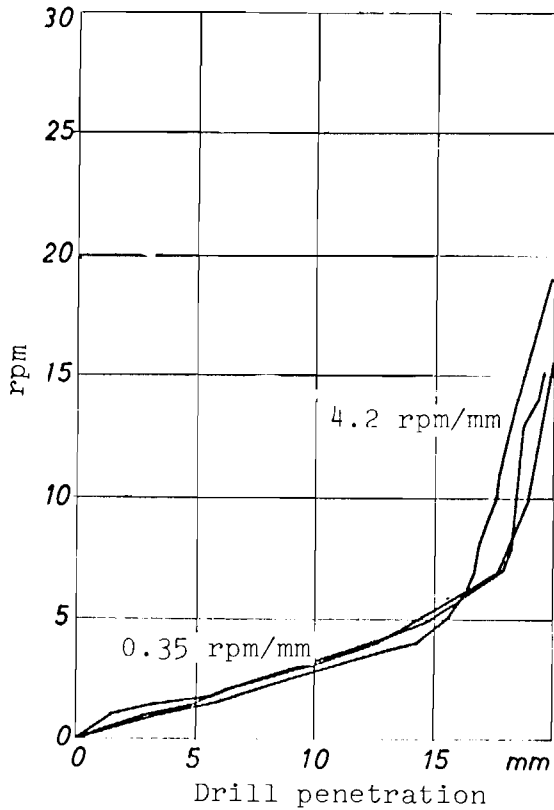
Fig. 12

Relationship between rpm and drill penetration into a soft lime rendering (with surface painting)

The slope of the curves after the drill penetration of 16 to 18 mm is due to the cement-spray plaster (rough coat) at the base of the rendering. The results at 3 different measuring points agree well

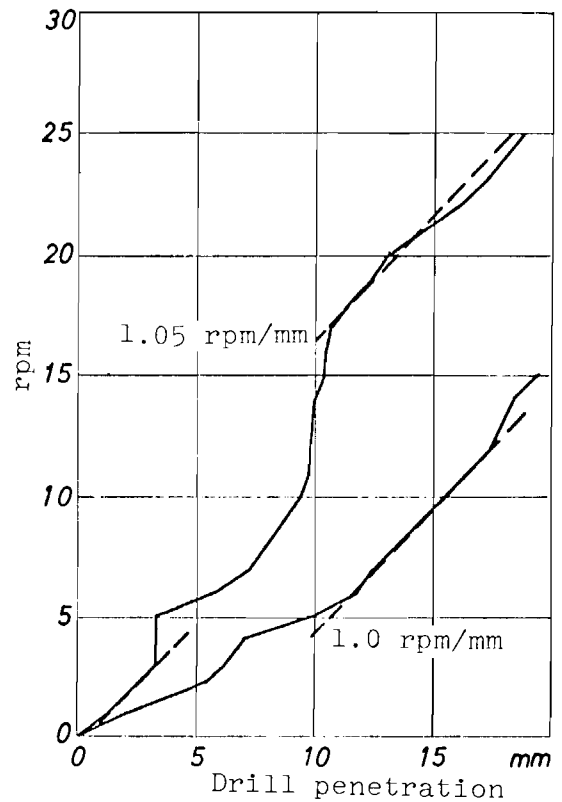
Fig. 13

Relation between rpm and drill penetration for a harder lime rendering (without surface painting).

The irregularity in the shapes of the curves (steeper slopes) are due to the fact that the drill has encountered a comparatively large grain of sand. For evaluation purposes slopes indicated with the broken lines are used (1.05 and 1.0 rpm/mm)

In harder renderings, deviations in the shape of curve are found from time to time owing to the drill striking a comparatively large grain of sand. In such a case the smallest or "most frequent" slope is to be chosen as representative of the hardness of the rendering (Fig. 13).

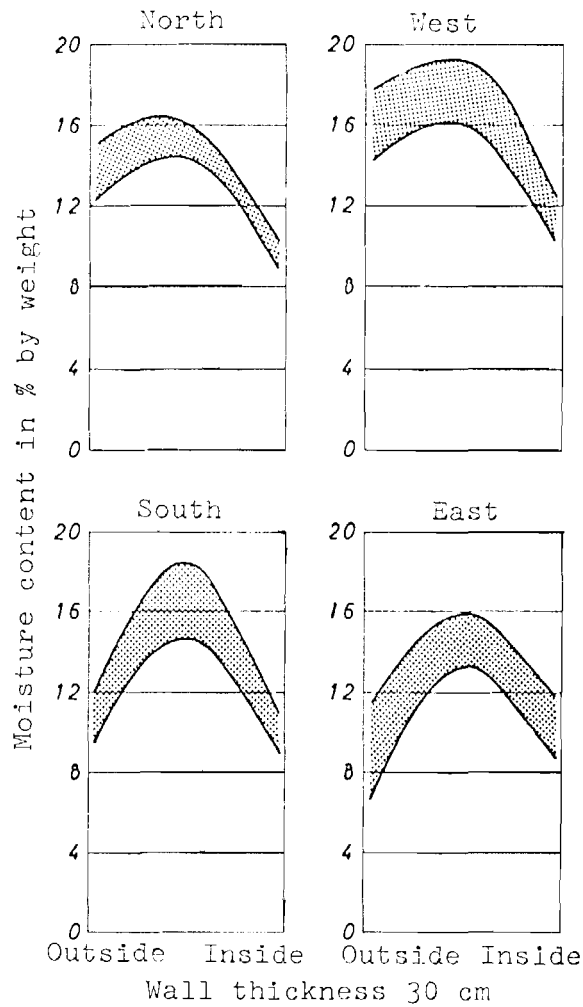
Fig. 14

Moisture distribution in outside walls of experimental houses constructed with 30 cm thick hollow pumice concrete blocks

Average ranges of measurement over the testing time

From the results of moisture measurements made on the outside walls it was concluded that the direction in which the wall faces has a greater effect on the moisture condition than the kind of paint employed. The moisture distribution values measured on walls facing the same way with different paints at different places at the beginning and at the end of the tests in all cases lay within comparatively narrow limits which were characteristic of the direction in question (Fig. 14). On the north and west walls against which the rain beats frequently the moisture content in the outside layer of the wall was higher than that of the inner layer towards the inside of the building, while in the south and east walls this situation was just reversed. Generally speaking the mean moisture content was above the practical moisture content that is accepted for pumice concrete (about 3% by weight), since in the previous winters the experimental houses had not been continuously heated.

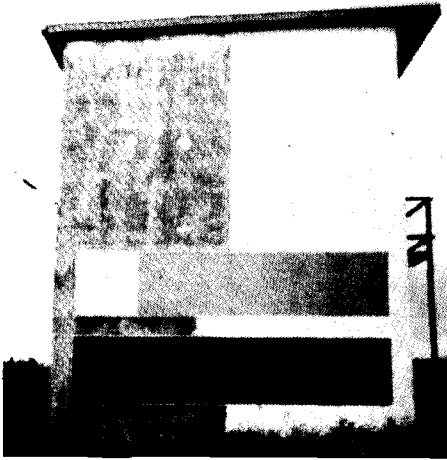
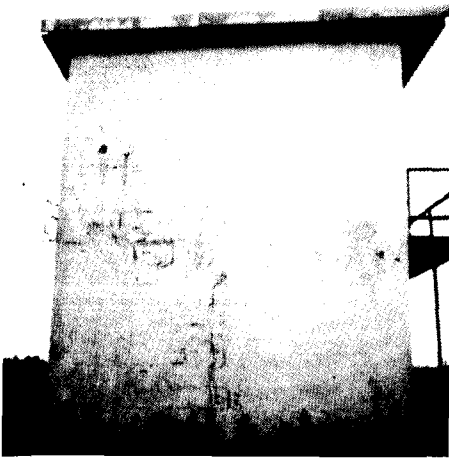
Figs. 17a and b

The west sides of the experimental houses with different paints 1 3/4 years after application

a: Left limewash, right emulsion paint A (on the lower half of the west wall, paints of different colours were used in order to measure the resulting surface temperatures)

b: Left emulsion paint C, right emulsion paint B

Figures 17a and b show the west walls of the experimental houses as they appeared in June, 1962, 1 3/4 years after application of the paint. It will be seen that the whitewash has been almost completely removed by weathering under the extreme conditions of this period, principally as a result of driving rain. The emulsion paints, by contrast, have proved much more durable. Cracks which had existed before painting, mainly along the mortar joints between the hollow pumice concrete blocks, were transferred to the paint and showed up more clearly than before, partly because dirt was deposited in these cracks and partly as a result of the lifting of the paint along the joints owing to frost action. The individual paints tested behaved differently in this respect. The cracks and frost damage appeared most marked in paint C (Fig. 18).

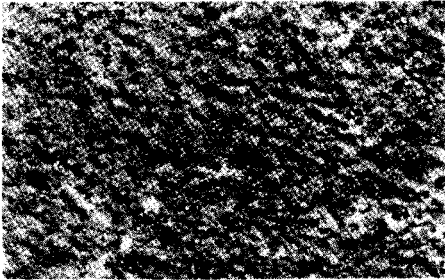
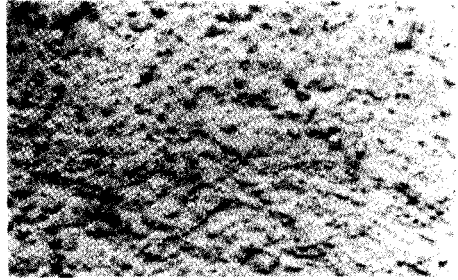
Figs. 19a and b

External rendering with limewash, 5 years after application (June, 1965) on the east side (a) and on the west side (b) of the experimental house

On the less severely exposed north, east and south sides of the experimental houses there were no characteristic differences in the appearance of the paint. Even the limewash here exhibited high stability and covering capacity; after weathering for 5 years the limewash on the east side was worn off only over the coarser sand grains in the rendering (Fig. 19a and b).

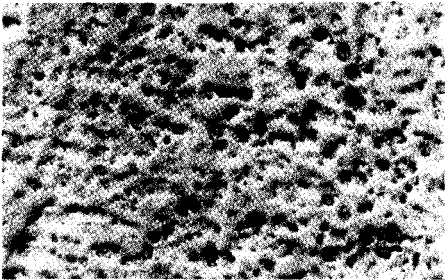
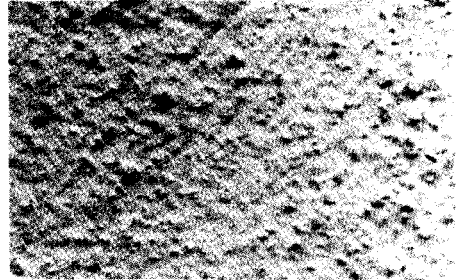
External rendering with emulsion paint A, 5 years after application (June, 1965) on the east side (a) and on the west side (b) of the experimental house

On the west side the film of paint became more porous during weathering (flaws in the paint)

The appearance of the emulsion paint on the east and west walls after 5 years exposure to the weather is shown in Figures 20 to 22a and b. The effects of differences in weather exposure are clearly recognizable. While practically no changes have appeared in the paints on the east side, those on the west side show more or less pronounced weathering phenomena. The smallest changes are found in emulsion paint A (Fig. 20a and b) and the most pronounced changes in emulsion paint C (Fig. 22a and b). It is readily understood that the cracks and flaws in the paints formed as a result of weathering, and paint peeling, starting from cracks in the rendering, largely eliminates the water-repellent action of the paint (cf. section 2.22).

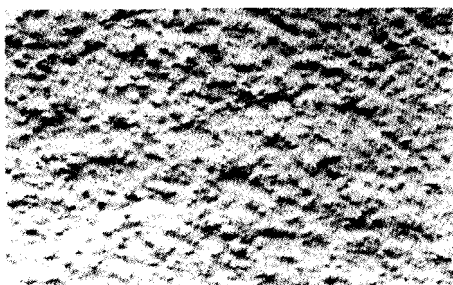
Figs. 21a and b

External rendering with emulsion paint B, 5 years after application (June 1965), on the east side (a) and west side (b) of the experimental house

On the west side fine cracks appeared in the paint in the course of weathering and scaling of paint occurred starting from cracks in the rendering

This result shows that basically the application of emulsion paint to outside walls reduces to a certain extent the moisture migration caused by vapour diffusion from inside outwards, and this can result in a concentration of moisture in the outer wall layer. Under normal conditions in common types of masonry, this concentration of moisture is not great enough to cause damage (frost damage in the external rendering, blistering and lifting of the paint). This generalization takes into account the fact that in the investigations described, the moisture gradient was greater than normal and that a local concentration of moisture due to diffusion is particularly marked in hollow pumice concrete block walls owing to the comparatively small capillary absorptivity of such material\*. The damage mentioned in connection with emulsion paints is probably entirely traceable to the effect of moisture which has penetrated from outside through the film of paint at places where the damage shows (see also Fig. 21 and 22).
