4th Hull Performance & Insight Conference, pp. 272-291, 2019-05-08

Effects of Hull and Propeller Cleaning on Propulsion Efficiency of an Offshore Patrol Vessel

Kevin Murrant, Allison Kennedy, Rob Pallard, Marcel Montrose,
National Research Council Canada, St. John's/Canada, Kevin.Murrant@nrc-cnrc.gc.ca

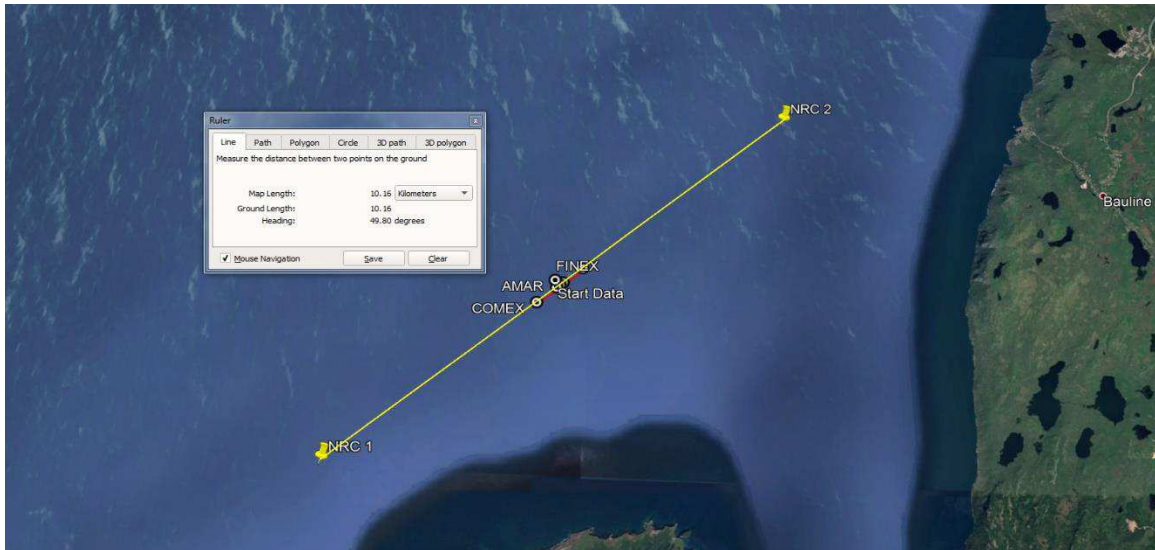
Fig.3: Trials location and direction in Conception Bay, NL

Fig.3 shows the location of the sea trials. The direction of all trials was along the yellow line, between the points NRC 1 and NRC 2. This track has a total length of ~10 km to provide space for the high-speed runs. Each test required 10 minutes of constant rpm, pitch, and speed settings. As such, some tests were shorter in distance than others. All tests were centered near the subsea acoustic probe (Autonomous Multichannel Acoustic Recorder – AMAR) point in Fig.3. The AMAR point is located at 47°41.757' latitude and -52°56.509' longitude. The direction of the yellow line relates to in and out of the Bay, which corresponds with the prevailing wind direction. Once a test was completed in one direction, the vessel would turn around and complete the same test in the opposite direction.

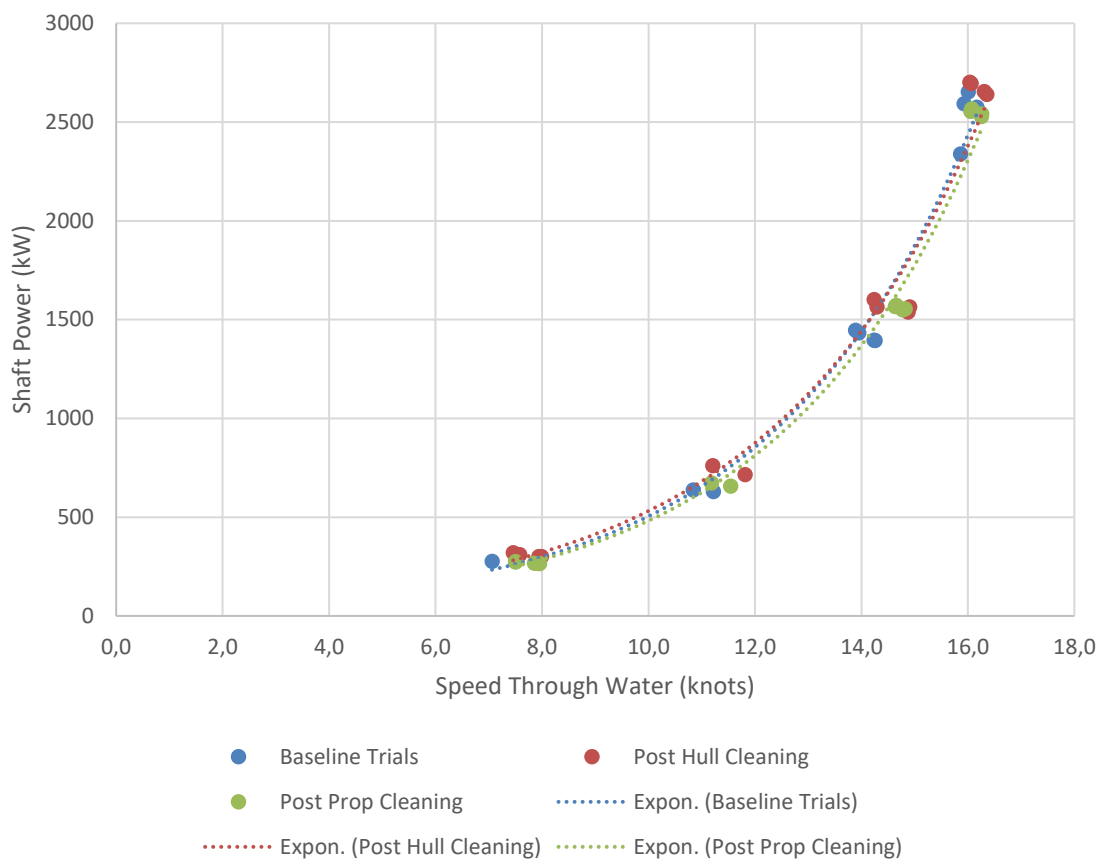
Fig.5: Uncorrected power versus speed data from each test run during each trial. An exponential curve fit is shown to illustrate the trends between trials. The uncorrected data does not show a significant difference between trials in the speed curve.

The measured shaft power versus speed through water for each test during each trial are plotted on the same axes in Fig.5. All collected data points follow a similar relationship that can be fit with an

exponential curve. There is less variation in the post propeller trials data when compared to the other trials results for a given engine setting. This is expected due to the calm wind and sea conditions during the post propeller polishing trials which were lighter than those for the other two trials.

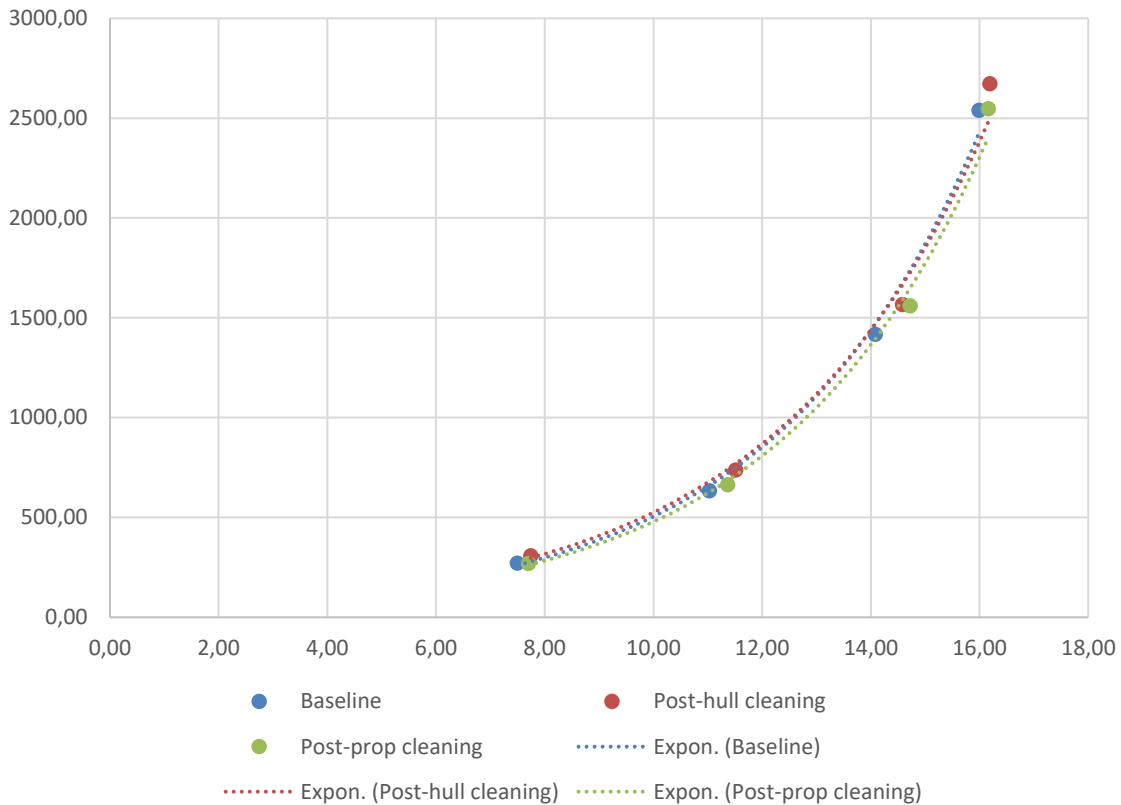
Fig.6: Means of means for each trial. Each data point is the mean of 2-4 runs at that speed in reciprocal runs.

The measured data was analyzed first using the mean of means method to provide further insight towards data trends between trials. The mean of means method involves taking the mean of consecutive double runs at a given engine setting and then taking the mean of those means to represent the speed and power values at that engine setting. The intent of this method is to eliminate the unidirectional effects of wind and current under the assumption that these effects will average to zero. The mean of means for all trials completed at a given engine setting, within each sea trial, were calculated. The results of shaft power and vessel speed through water for each sea trial were plotted (Fig.6). Trend lines were fitted through the data for each sea trial.

The differences in the relationships between power and speed for the three sea trials is clearer here. The trend line relationships between trials change across the speed range. The post-hull cleaning trials trend line requires approximately 4% less power to attain speeds between 12.5 and 16 knots. In this same speed range, the post-propeller cleaning trials trend line indicates that approximately 5% less power is required to attain a given speed when compared to the post hull cleaning trials. These results indicate that a total of approximately 9% less power is required to attain a given speed (in speed range between 12.5-16 knots) as a result of cleaning both the hull and propeller. For speeds less than approximately 12 knots, more power is required to attain a given speed for the post hull cleaning trials when compared to the baseline trials. This result is unexpected and may be influenced by the higher level of uncertainty involved in the lower engine setting trials.

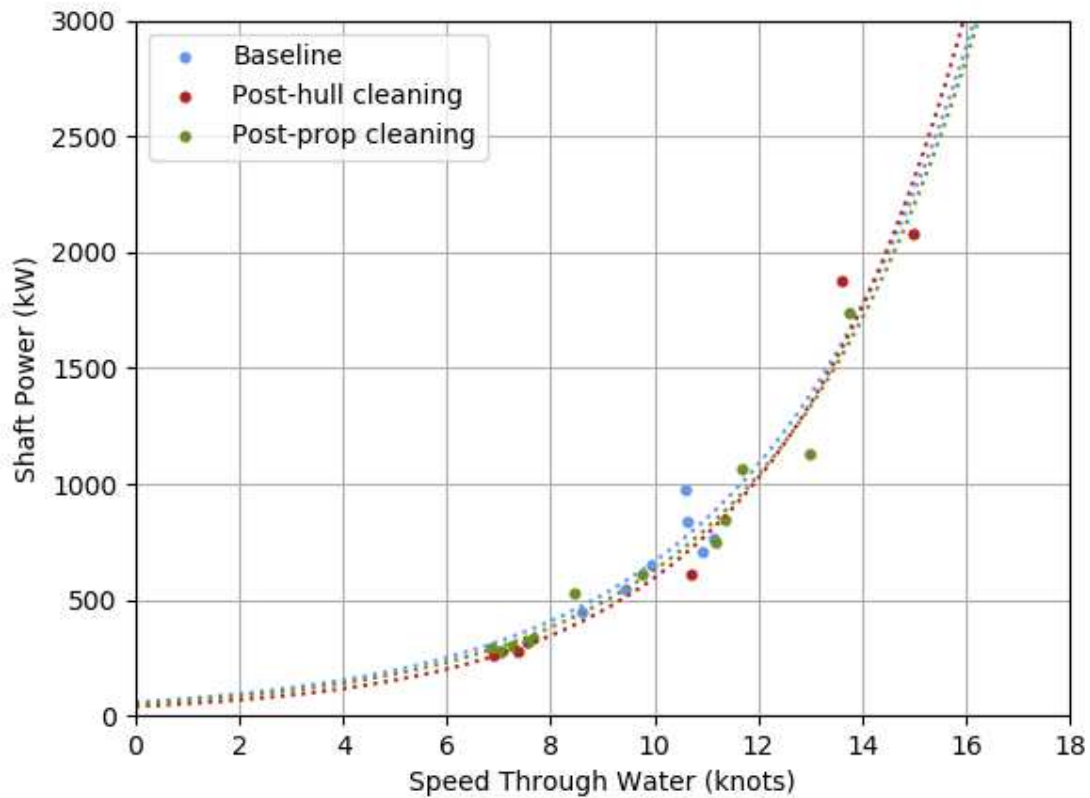
Fig.8: Mean data points extracted from operational data segments greater than 7 knots in speed and 2 hours in duration. Data points are color coded according to the period between cleaning events they correspond with.

In addition to the sea trials conducted under somewhat controlled conditions, operational data was collected on an ongoing basis throughout the time period of the sea trials. From this data, the data was segmented based on speeds greater than 7 knots, and durations of at least 2 hours. Each segment meeting these criteria was averaged to provide a mean data point. These data points, color coded by period between cleaning events, are illustrated in Fig.8.

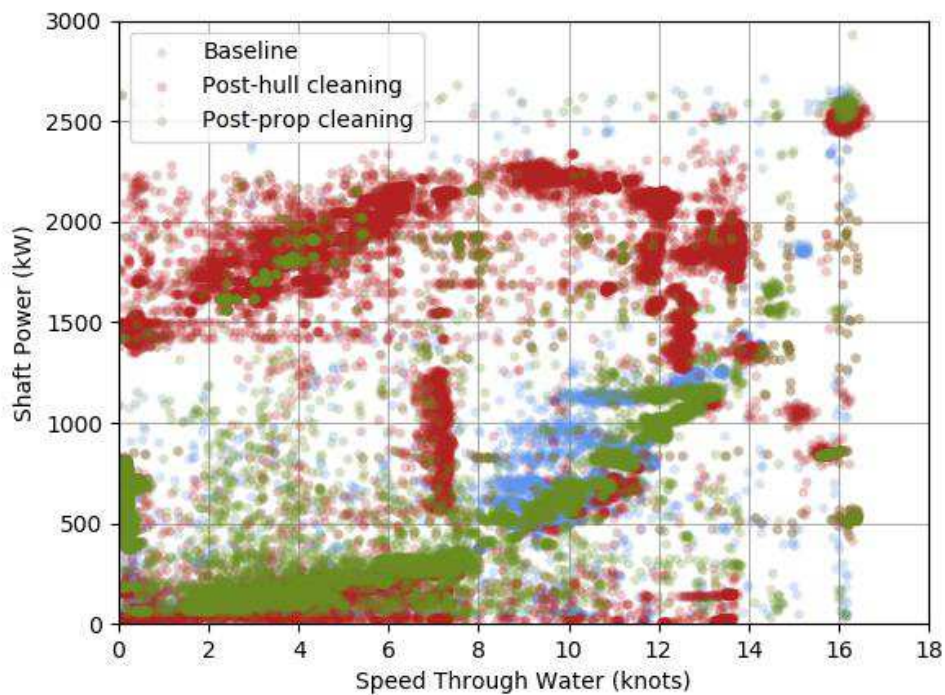
Fig.9: All operational data points throughout time period covering the cleaning trials. Scatter points occur due to operational activities, equipment and instrumentation fluctuation, and environmental condition.

The complete operational dataset is illustrated in Fig.9. This data covers all recorded data points throughout the operational period covering the cleaning trials (May-Aug, 2018). The data points are scattered due to operational activities, such as towing, equipment or instrumentation fluctuations, such as shaft power, and environmental conditions, such as large wind and waves. The open water power to speed relationship is visible, but not easily characterized.

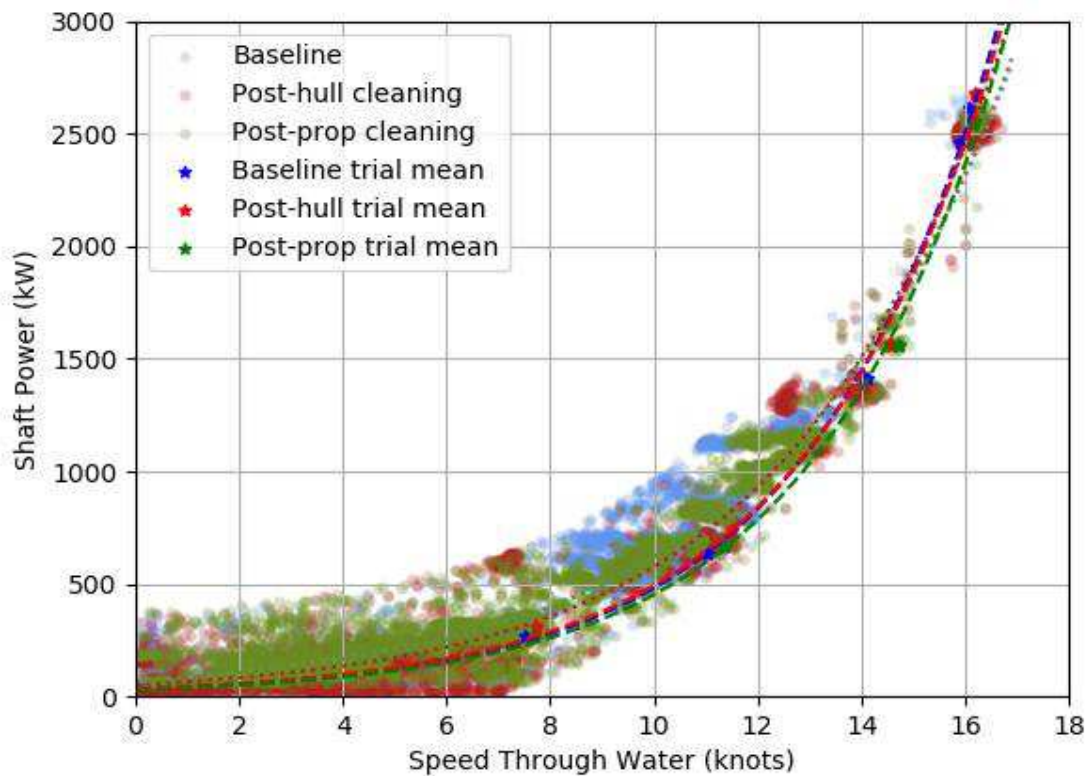
Fig.10: Reduced operational dataset covering trials period. Curve fits are applied for comparison. The mean trial data is shown for comparison with the operational data result.

To reduce the extraneous data points, the data set was clipped by a threshold of 300 kW about the approximate power to speed relationship. Fig.10 illustrates the data set with curve fits and comparison to the mean trial data. From this figure, it can be seen that the relationships are apparent, but the trial conditions capture the minimum power to speed curve from the operational data scatter. This is due to the relatively calm conditions under which the trials were conducted versus the typically rougher conditions encountered by the vessel under normal operation.

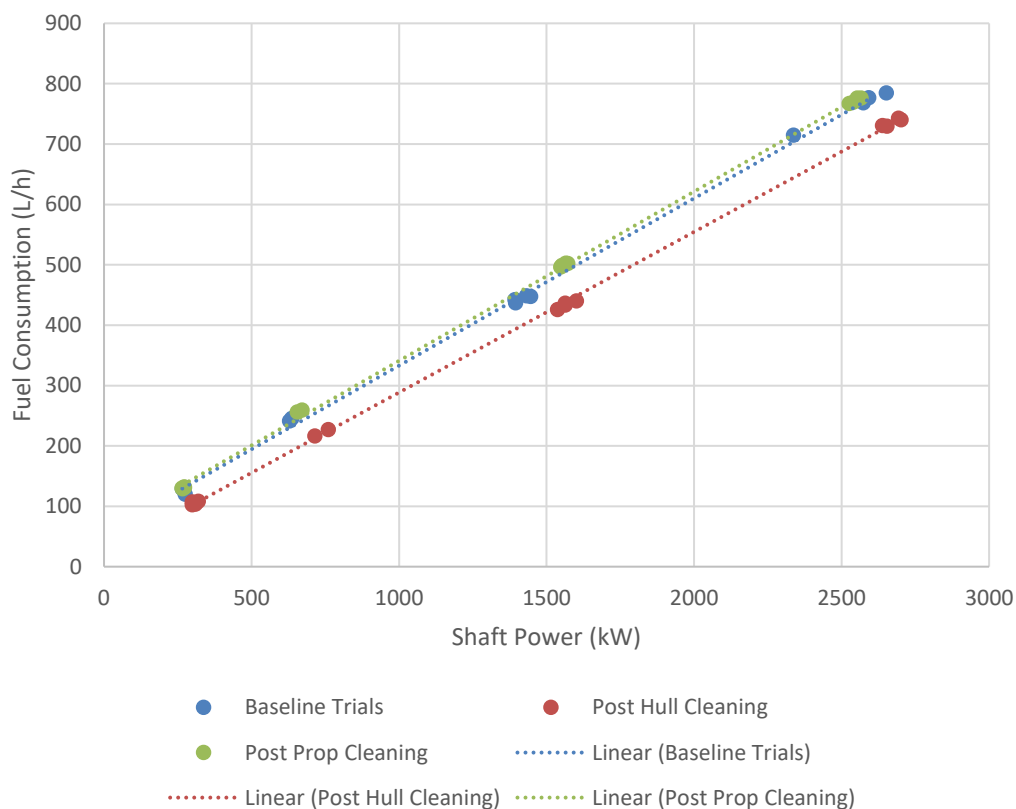
Fig.11: Uncorrected total main engine fuel consumption rate versus shaft power

To identify the fuel curve for the vessel, total main engine fuel consumption versus shaft power was plotted for each trial. The fuel consumption versus power curve should be consistent for all trials since both fuel consumption and shaft power are not affected by external parameters such as environmental condition or hull and propeller condition. The speed attained however, does change as a result of variation in these external parameters. The measured total main engine fuel consumption versus power curve for all trials is shown in Fig.11. For each engine setting tested during trials, the baseline trials and post propeller cleaning trials data aligns well. However, there is an offset when it comes to the post hull cleaning trials data. For these trials there is less fuel required for a given power setting, particularly at higher power values. It is expected that there was some mechanical difference in the fuel measurement system that led to the discrepancy in the post hull cleaning fuel versus power data. A possibility is that one (or more) of the fuel flow meters surrounding one of the main engines was bypassed or partially bypassed or blocked during the post hull cleaning trials. However, the OpDAQ system bypass indicator did not highlight a complete bypass during this, or any of the trials.

The baseline and post propeller trials data for fuel consumption versus power are used to define the general fuel versus power curve for the Cygnus main engines. The post hull cleaning trials data was not used for this purpose due to the discrepancy from the other trials data. The general fuel versus power regression equation (regression equation corresponding to Fig.11) was used to calculate the “corrected” fuel consumption by adding the corrected power values at each engine setting for each trial. The power values corrected using the NavCad wind correction were used in this analysis. There is no quantifiable difference between the fuel consumption rate and speed through water for the different sea trials. This is due to the level of variation in data at single test condition within a given trial and how data from different trials fall within this variability range. For example, at a throttle setting of 8.0, the baseline trials speed through water ranges from 13.9-14.3 knots and the corrected fuel consumption ranges from 373-475 L/h. At this same throttle setting, the post hull cleaning trials speed through water ranges from 14.2-14.9 knots and the corrected fuel consumption ranges from 393-526 L/h. There is overlap in the speed and fuel consumption variability ranges between trials for each engine setting.

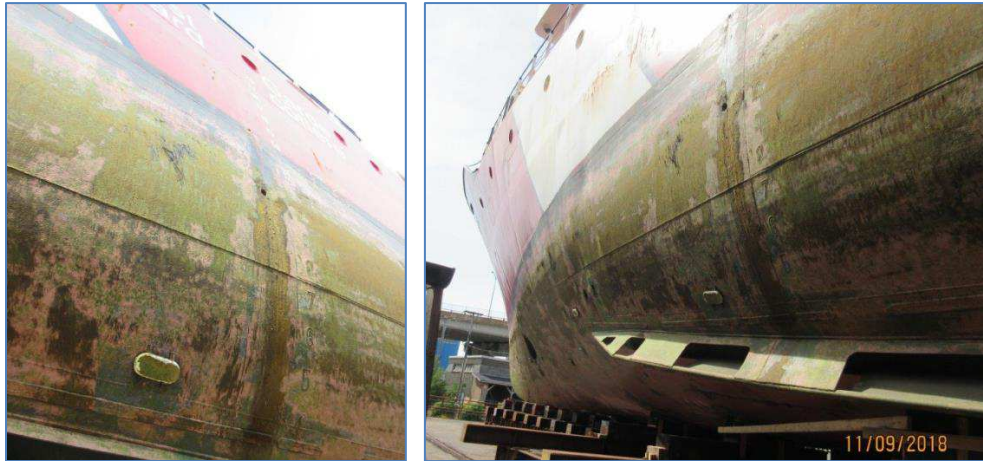
Fig.12: Images of port side of hull during September, 2018 dry dock. The level of fouling is similar to that encountered in May, 2018.

The CCGS Cygnus was taken into dry dock on September 11, 2018 to perform vessel maintenance. When in dry dock, the hull was observed to have a relatively high level of fouling on one side in particular (port). The level of fouling present on the port side was similar to the amount that was present during the underwater survey conducted in May, 2018, prior to cleaning the hull. Specifically, there was slime and sea grass covering a large portion of the underwater hull (Fig.12). These observations were unexpected for two reasons. The first relates to the speed of fouling taking place on the Cygnus hull. Prior to the May hull cleaning, the Cygnus hull had not been cleaned in two years. It was anticipated that the level of fouling present in September, just 3.5 months post hull cleaning, would be much less than that observed during the May survey. Some reasons that could have led to rapid fouling growth during this short period include the relatively warm temperatures during summer 2018 in the region and a depletion in anti-fouling coating.

It is observed that the September hull condition level of fouling differs on the port and starboard sides of the vessel with the starboard side having a higher level of fouling. The May survey results indicated that the starboard side of the hull had a slightly worse level of fouling. It was anticipated that if one side was more fouled than the other in September, it would have been the starboard side to be consistent with earlier results. Increased fouling on one side of the vessel could result from frequent docking on one side (fouling occurs more on side subject to sunlight) or lower quality of anti-fouling coating on one side of vessel. Cygnus Captains were consulted and it was confirmed that the docking side varies. The anti-fouling paint was noted to be highly depleted in September, on both sides of the vessel (see Fig.13). This likely played a role in the high fouling accumulation rate during the summer period.
