**CONCRETE DETERIORATION AND FLOOR HEAVE DUE TO
BIOGEOCHEMICAL WEATHERING OF UNDERLYING SHALE**

P.E. GRATTAN-BELLEW AND W.J. EDEN

Reprinted from
CANADIAN GEOTECHNICAL JOURNAL
Vol. 12, No. 3, August 1975
p. 372

Research Paper No. 646
OF THE
DIVISION OF BUILDING RESEARCH

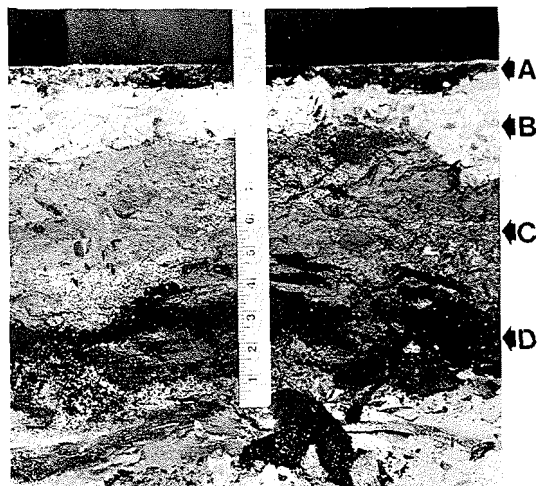
The church was constructed in 1913, but after 15 to 20 years the basement floor had to be repaired and it was covered with a new layer of concrete at that time. Figure 1 shows a section through the floor into the underlying shale. At the top is a 3/4-in. (1.9-cm) layer of bitumen applied about 20 years ago; below this is a layer of good concrete from 1.5 to 4 in. (3.8 to 10 cm) thick; this in turn is underlain by about 5 in. (12.7 cm) of the original con-

FIG. 1. Section through floor into underlying shale (scale in inches, 1 in. = 2.5 cm). (A) Tiles and bitumen; (B) toplayer of concrete; (C) mushy concrete; (D) weathered shale.

The top part of the shale was badly weathered (Fig. 1), but below about 1.5 ft (3.8 cm) it was competent. Numerous narrow veinlets of calcite 0.5 to 2 mm wide transect the shale. The occurrence of calcite veinlets is significant because they provide an additional source of calcium for the formation of gypsum by reaction with the sulfuric acid generated by the oxidation of pyrite (Penner *et al.* 1973). In contrast with the weathered shale found under the floor of the Bell Canada building, in which yellow jarosite ($\text{KFe}_3(\text{SO}_4)_2(\text{OH})_6$) was plentiful, only small patches of jarosite were observed under the floor of the church. Gypsum

The basement floor of the church was placed in two layers, the second after an interval of about 15 years. Although the original concrete has disintegrated to a mushy consistency, the second layer is in satisfactory condition (Fig. 1). Examination with a binocular microscope of the old concrete, which lies directly on the weathered shale, showed that the cement has been largely removed, leaving large voids between the aggregate particles. When subjected to acid attack, it is usual for the soluble phases of cement, calcium hydroxide and calcium silicate hydrate to be removed, leaving a weak porous material such as that observed in this concrete.
