FLAT SLAB TEST HUT PROJECT
WINNIPEG, MANITOBA

A report on the construction and test operation of
an experimental radiant-heated flat slab test hut
conducted by the National Research Council of Canada
Division of Building Research in conjunction with the
University of Manitoba Civil Engineering Department.

Report No. 94
of the
Division of Building Research

Ottawa
July 1956

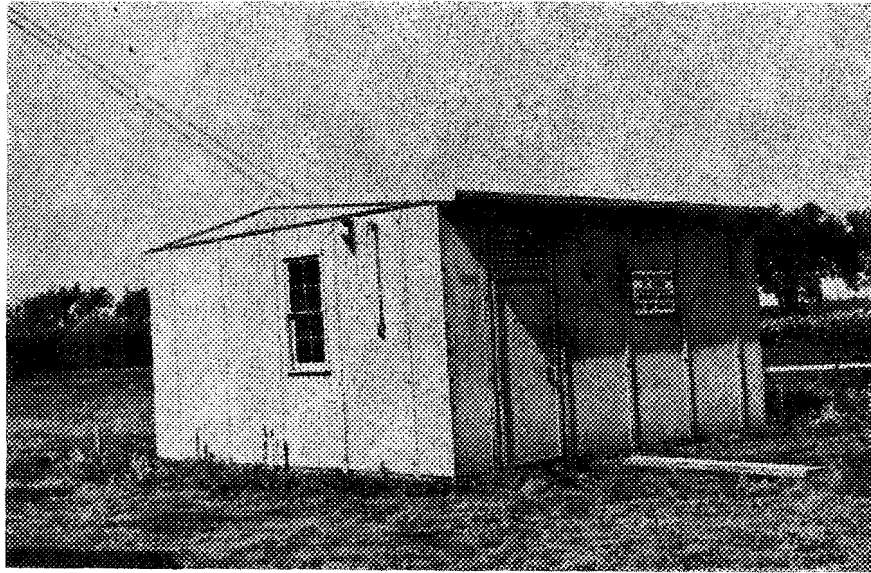
Fig. 1 Completed flat slab test hut.

Figure 1 shows the test hut used in Winnipeg and which is similar to the two Ottawa test huts. It is constructed of prefabricated insulated plywood panels supported on a slab 20 feet square. These dimensions correspond to what may be considered a minimum practical width in actual house construction. Heat was provided by approximately 2000 feet of electrical heating cable installed in three parallel circuits located at the slab mid-thickness. The cable was rated at 6.6 kw. on 220 volts.

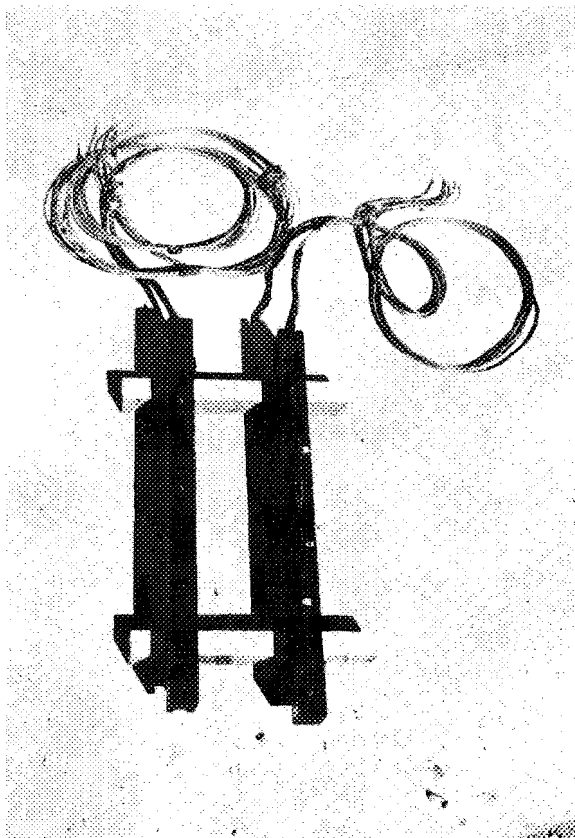
Fig. 2 Mounted thermocouples for soil temperature measurement.

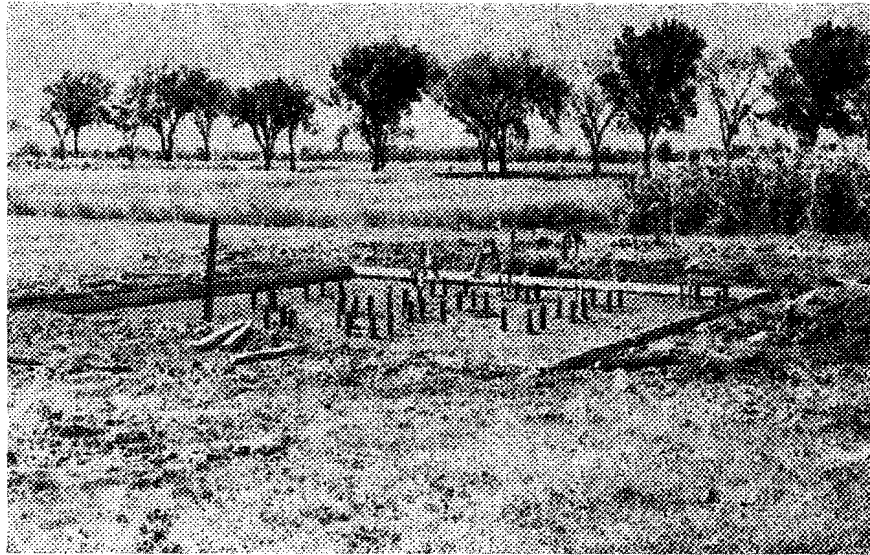
Fig. 3 Flat slab forms prior to placing perimeter insulation. Note bakelite tubes for forming soil test holes in concrete slab.

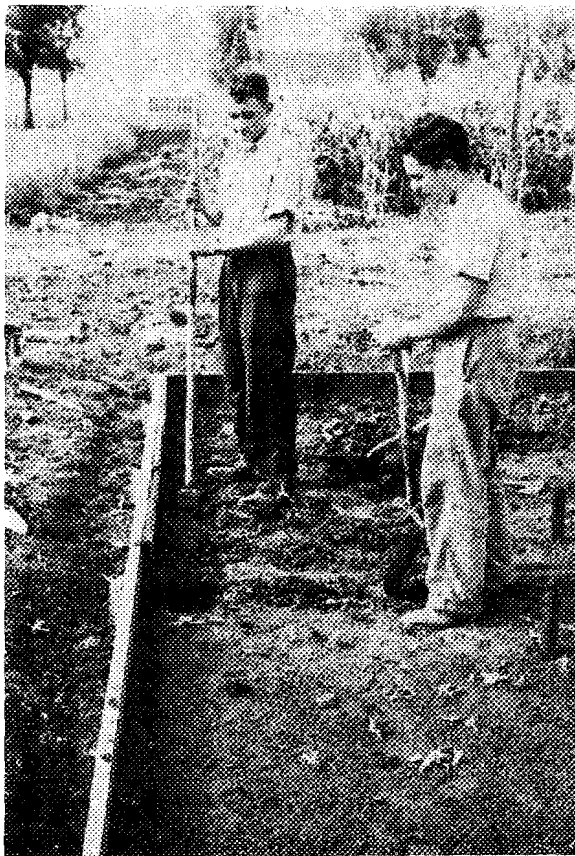
Fig. 4 Placing of perimeter insulation.

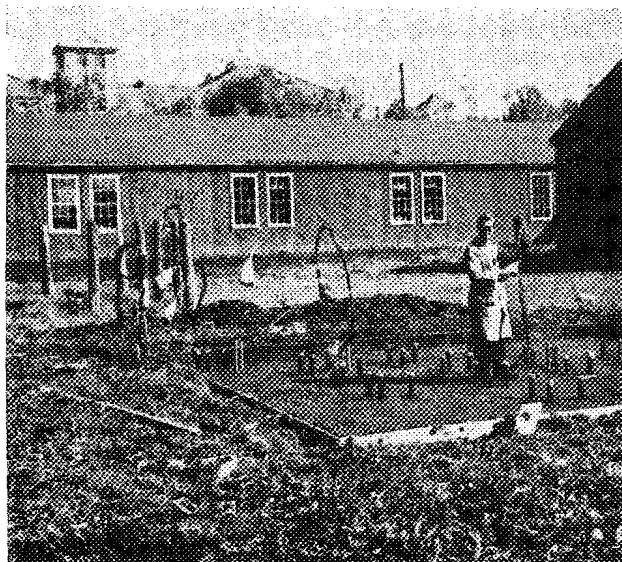
Fig. 5 Forms ready
for placing bottom lift
of concrete.

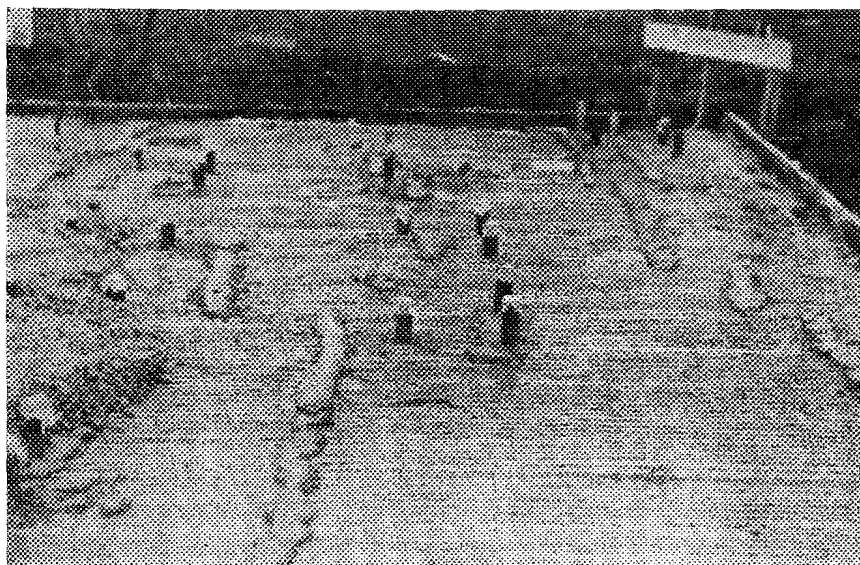
Fig. 6 Heating cable installed.
Note mortar strips holding cable in
place.

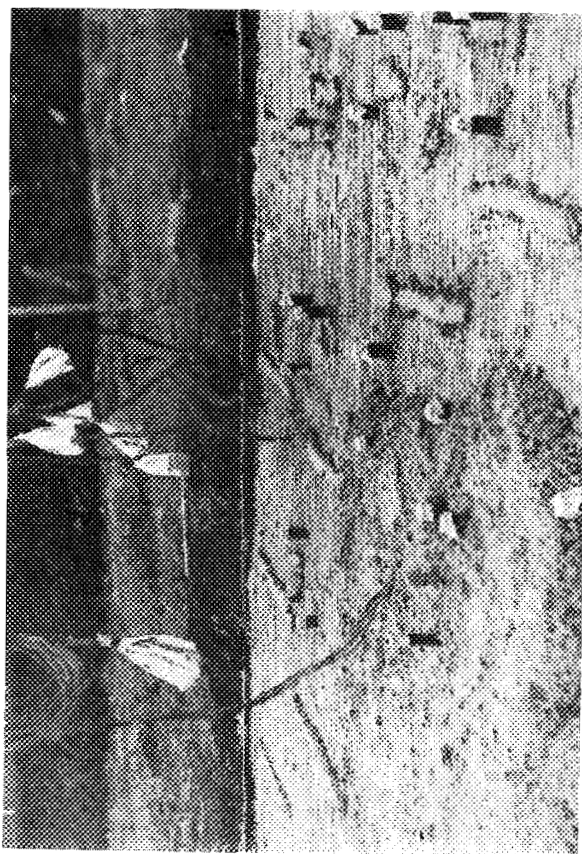
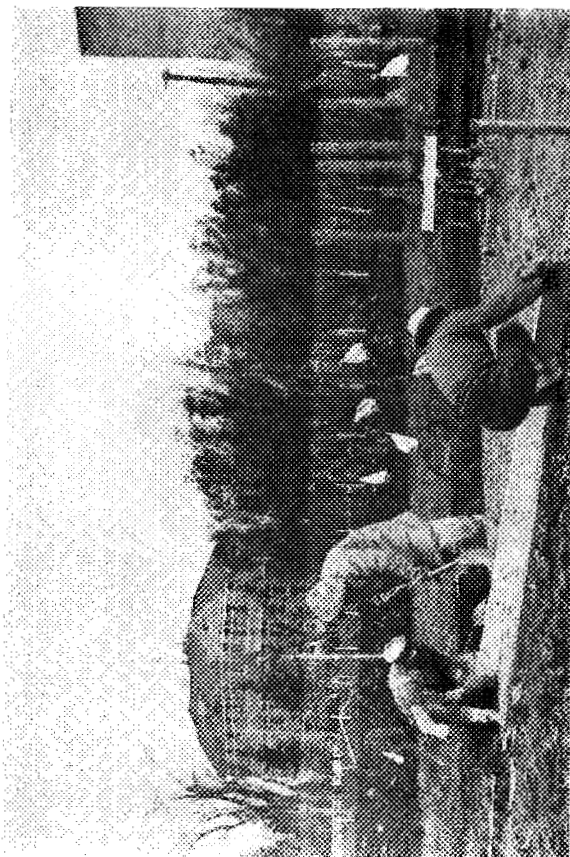
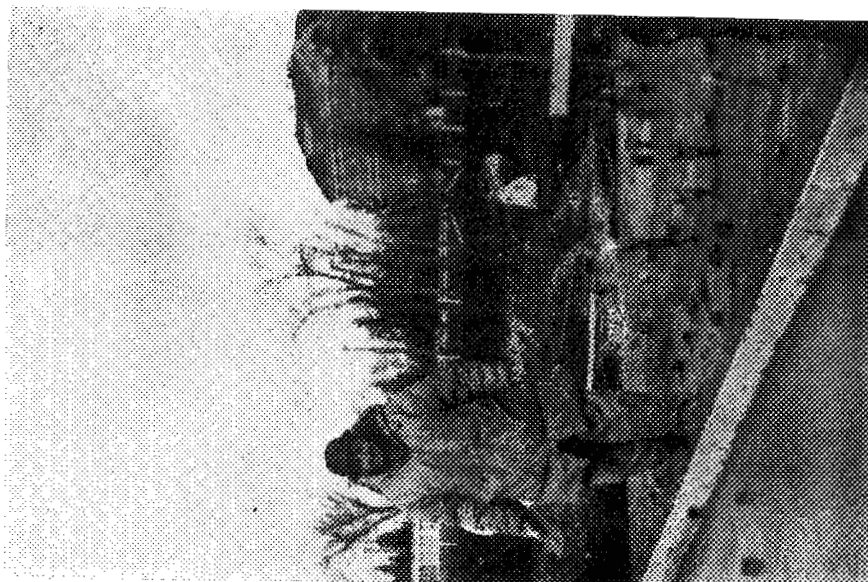
Placing and finishing of
top lift of concrete.

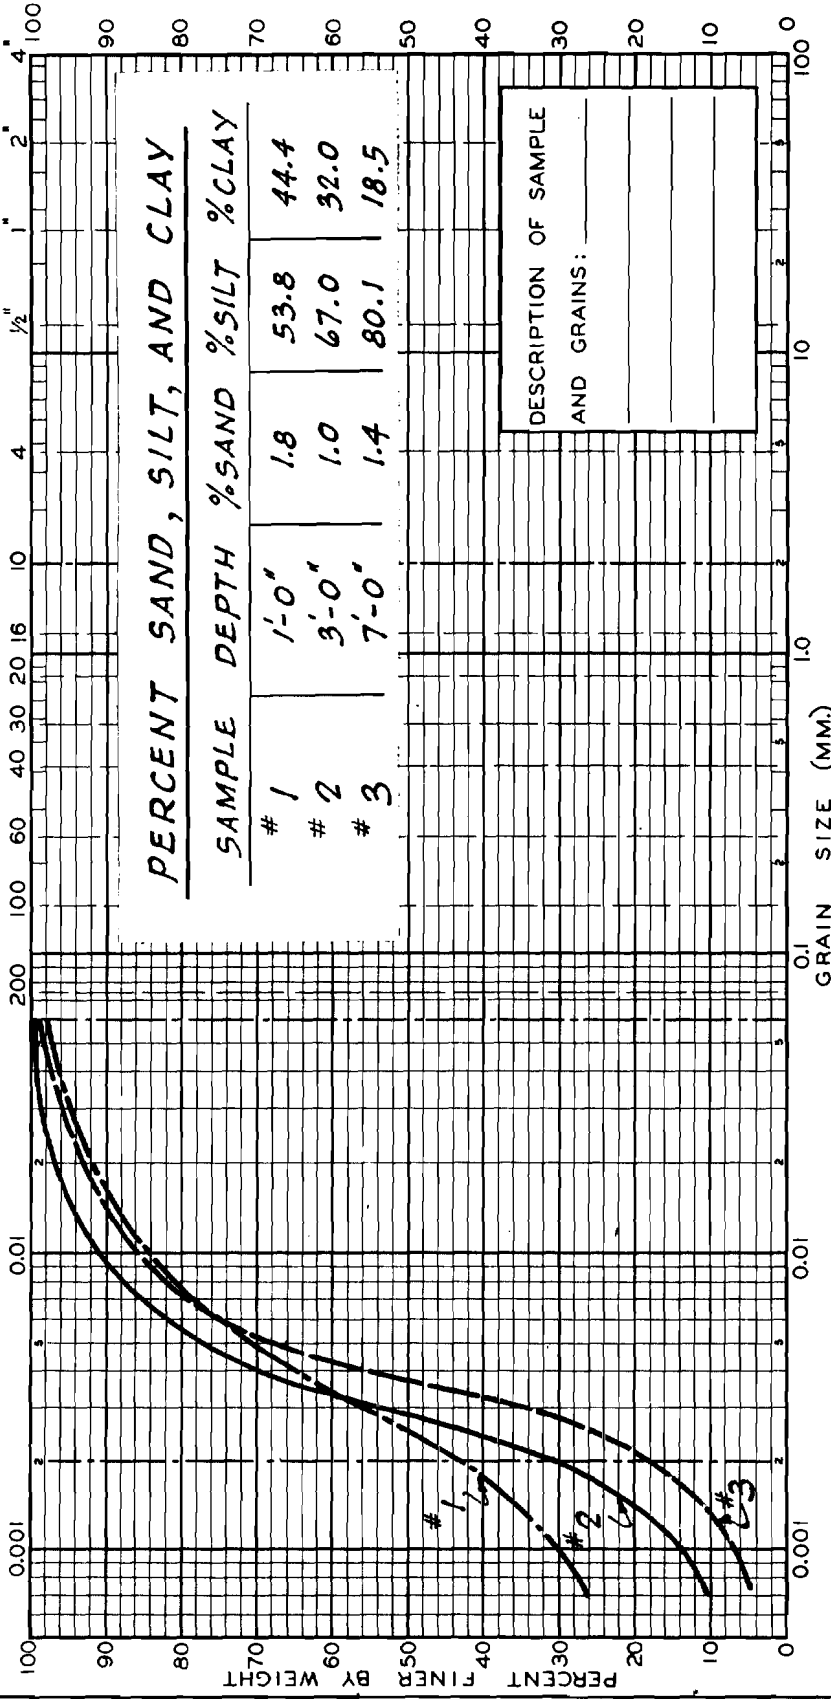
FIGURE 10

MECHANICAL ANALYSIS OF SOILS

PROJECT: N.R.C. FLAT SLAB, WINNIPEG SAMPLE NO. 1, 2 & 3

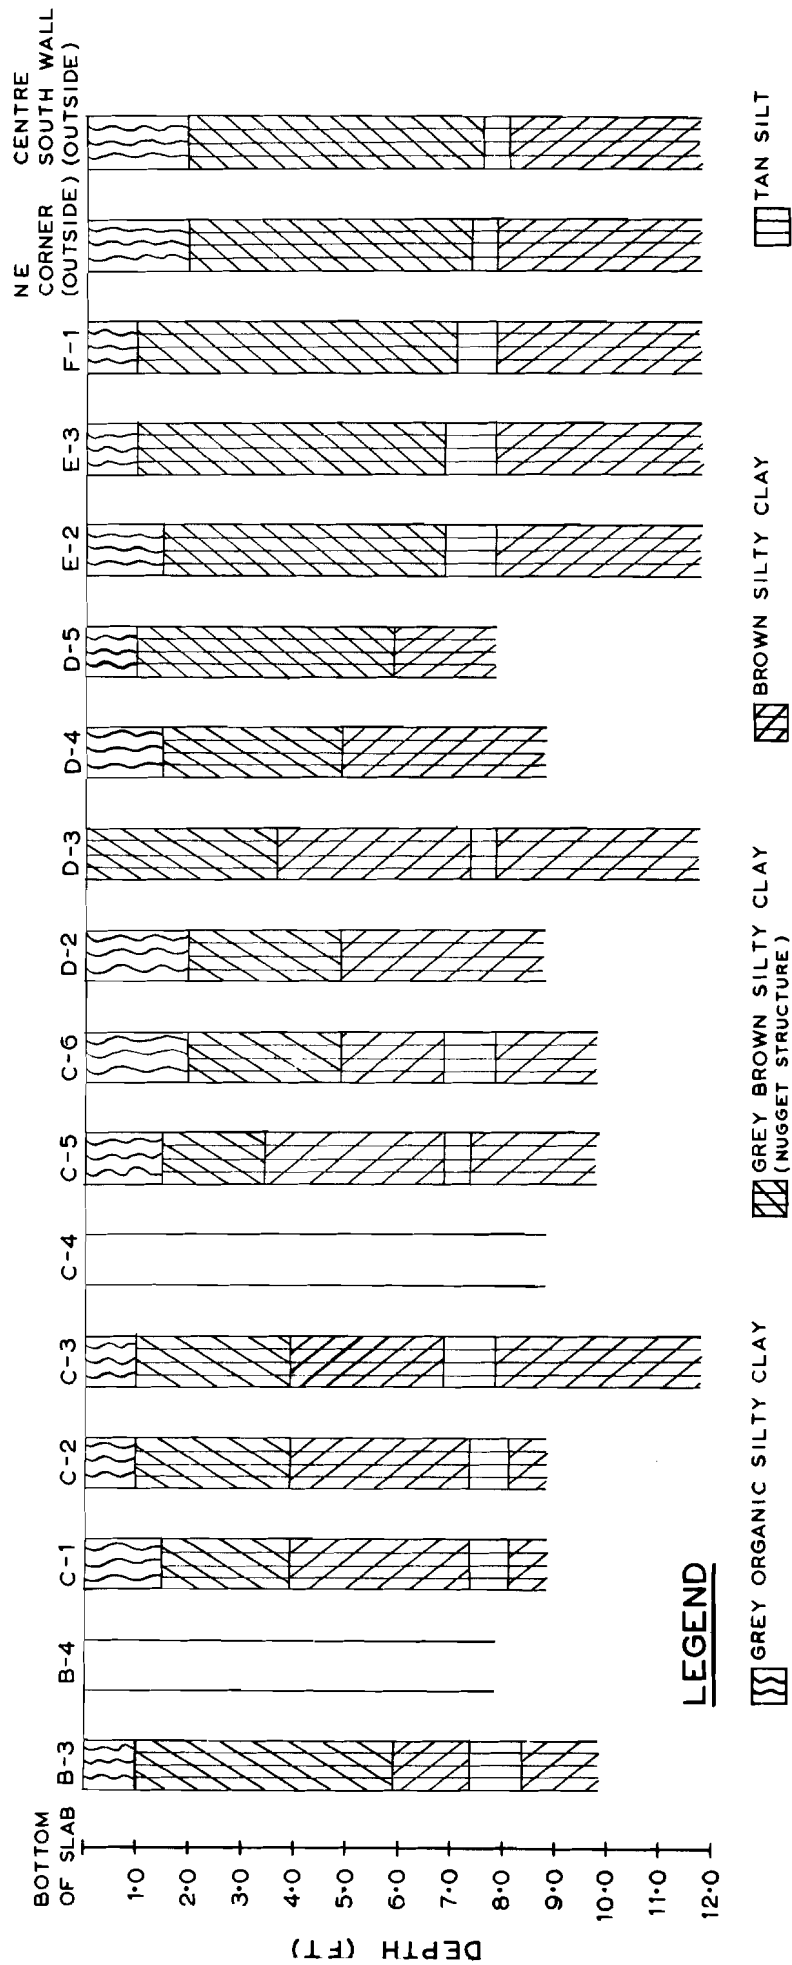
FIGURE 12
SOIL PROFILE BENEATH FLAT SLAB.

The sod was underlain by a black organic silty clay ranging from negligible to about 2 feet thick. Immediately under the black organic clay and extending to the 4- to 6-foot depth a grey-brown silty clay was encountered. Below this material a brown silty clay was found. Between the 7- to 8-foot depth the brown silty clay contained a layer of tan-coloured silt. Free water under considerable hydrostatic head was encountered in the silt layer. Once this layer was penetrated water rose in the test holes. After prolonged wet weather or shortly after the spring thaw, the water rose almost to the ground surface.

The brown silty clay extended to at least the 15-foot depth. It was highly stratified horizontally by fractional-inch-thick layers of silt which are found in local clays of glacial lake origin.

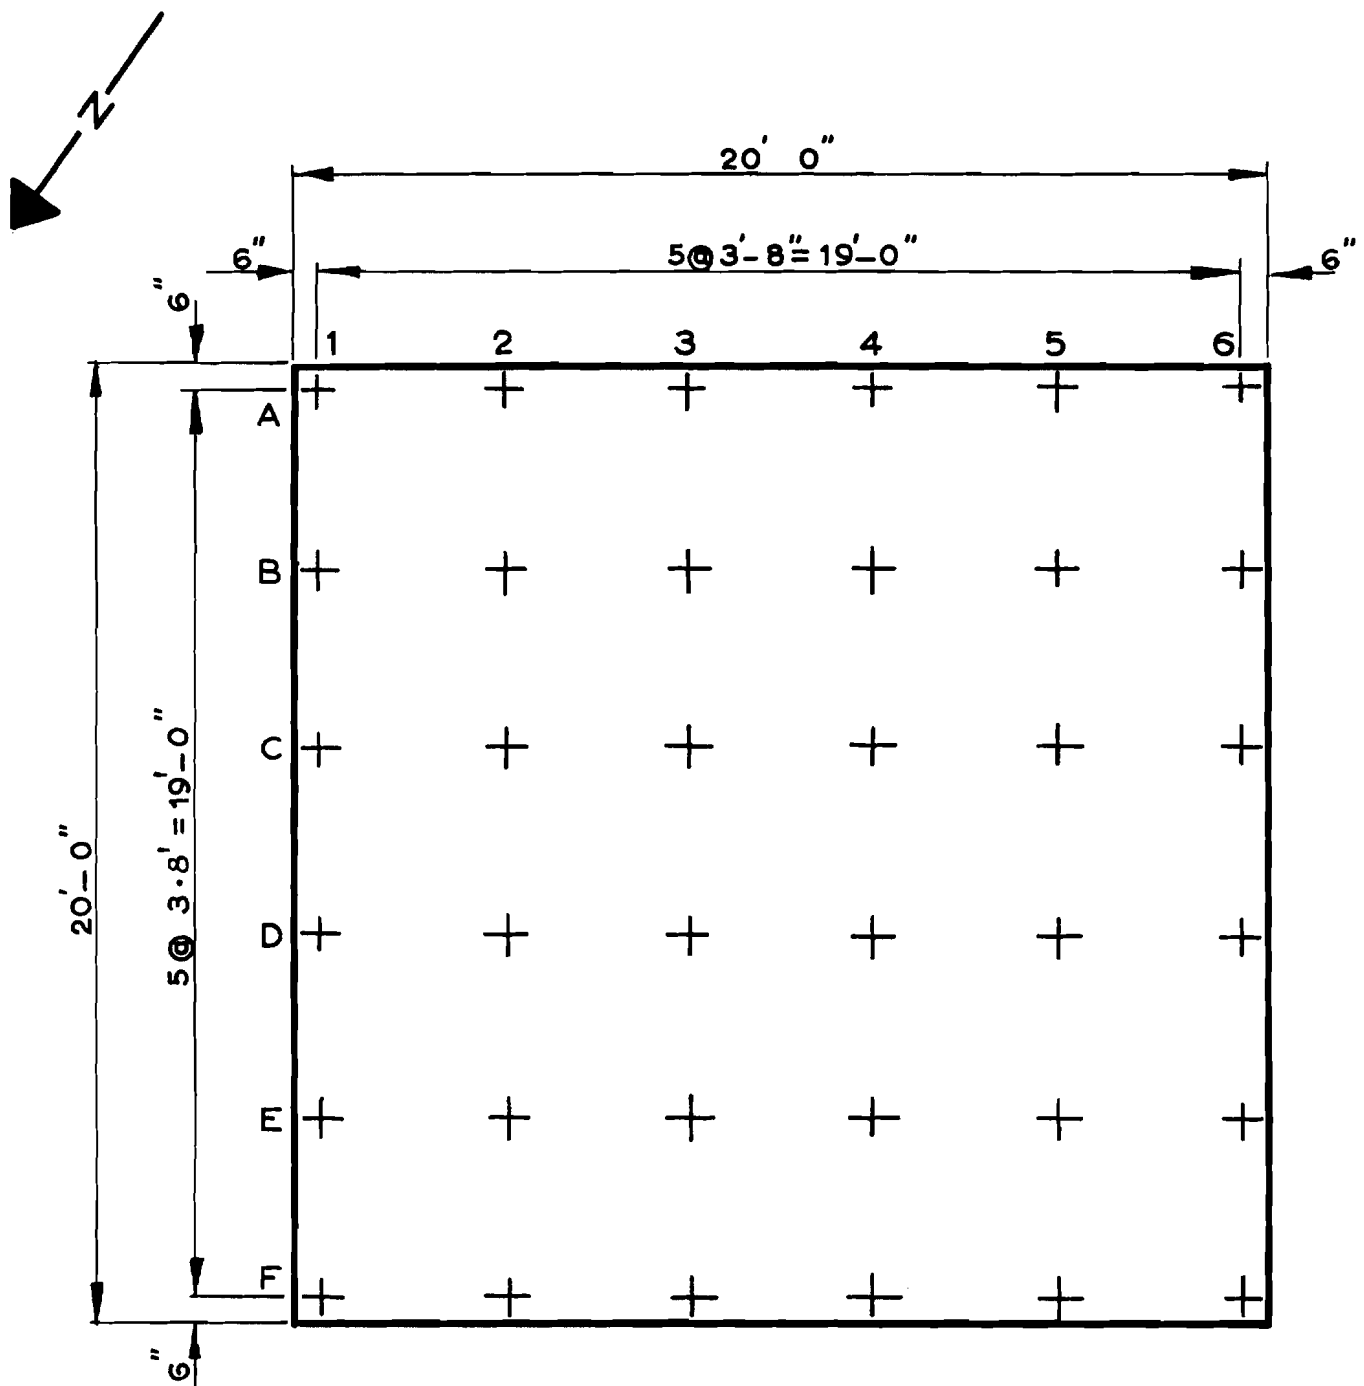
FIGURE 13

SLAB GRID SYSTEM

Accurate measurements were taken of the slab total and differential settlements by running precise levels on 36 points located on the reference grid shown in Fig. 13. The level readings were taken at regular intervals of about 2 weeks initially and approximately once monthly after the first year of operation. The bench mark used was on a building supported on deep end-bearing piles approximately 40 feet long. The piles were known to be supported on a gravel silt and sand mixture locally known as "hardpan" and which approximates a weak concrete.

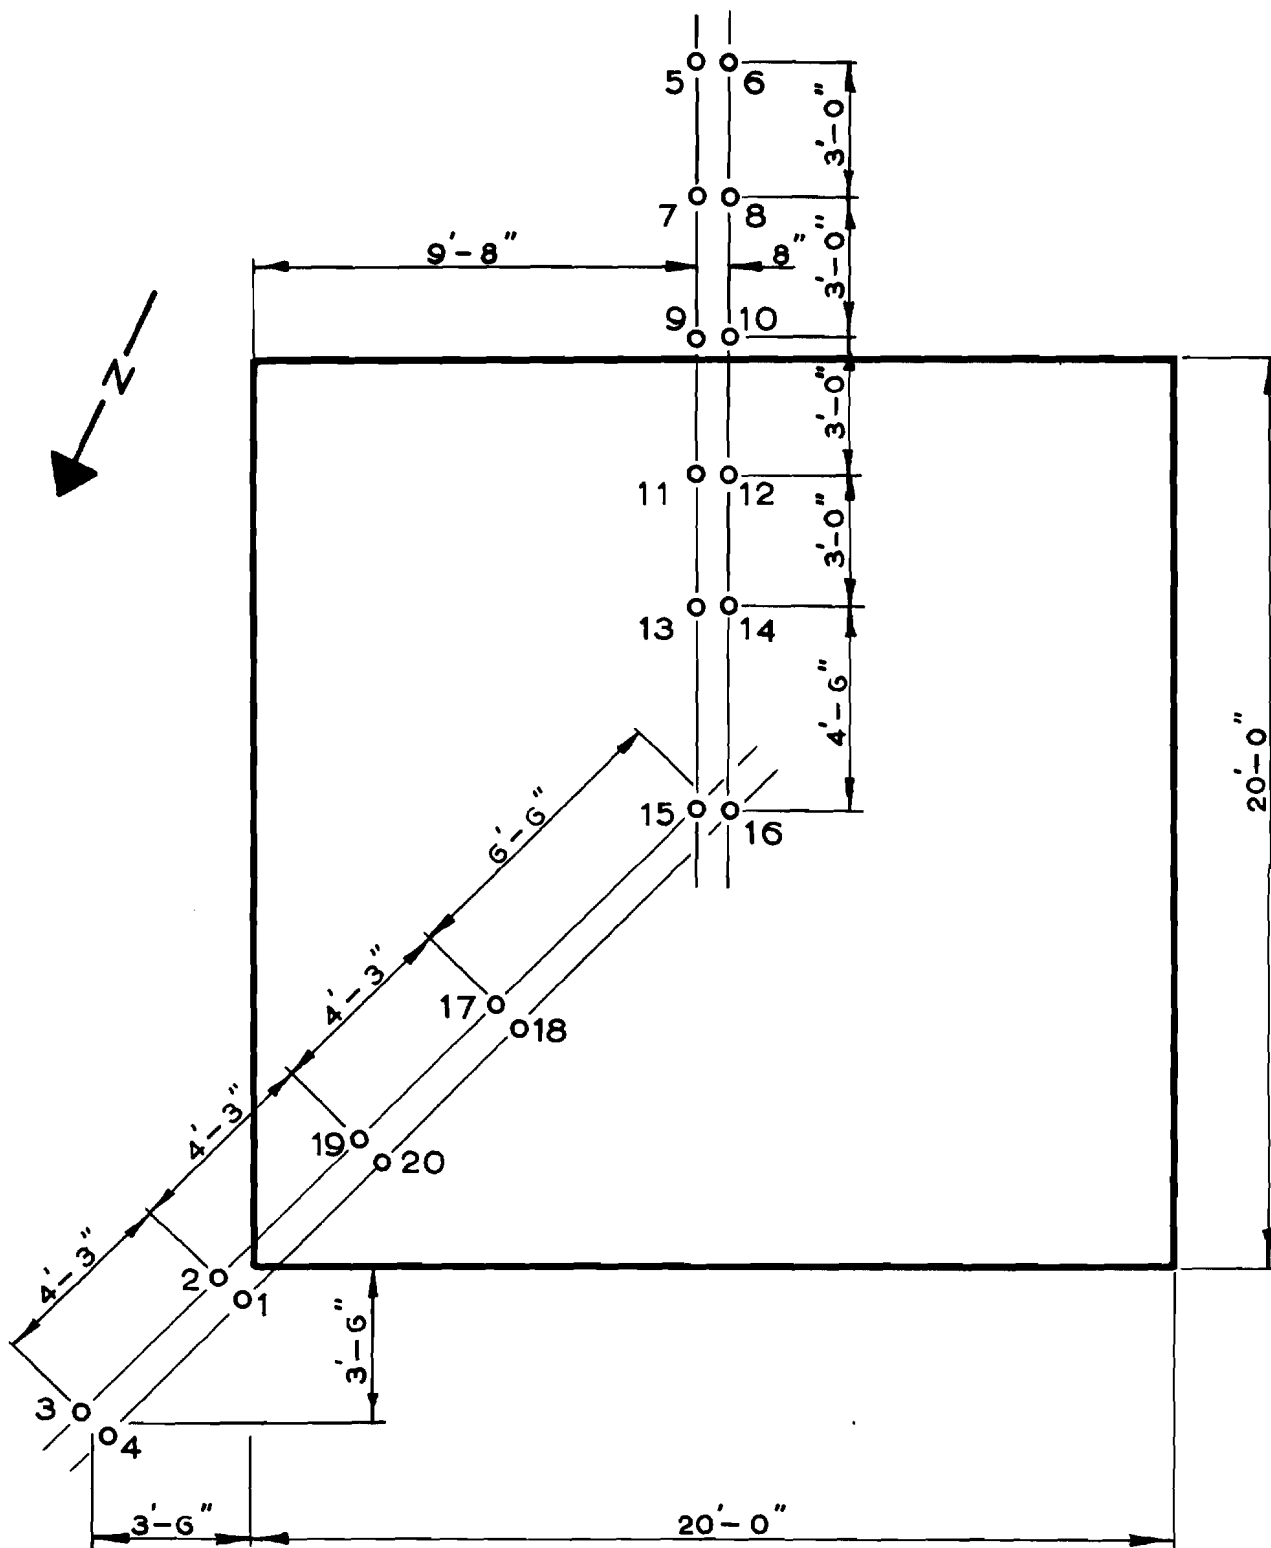
FIGURE 14
LOCATION OF GAUGES

Ten pairs of vertical ground movement gauges, measuring movement at depths of 2 and 5 feet, were placed as shown in Fig. 14. The gauges consist of rods extending to the required depth in the soil through a pipe sleeve which permits free vertical movement of the rod. The rod is supported by a base plate in the soil and extends to the ground surface. The elevation of the top of the rod is obtained using an engineer's level. When the soil shrinks or swells under the base plate, a corresponding vertical movement occurs at the top of the rod. Differences in the elevations of the top of the rod occurring over a period of time represent soil vertical movements. The Winnipeg

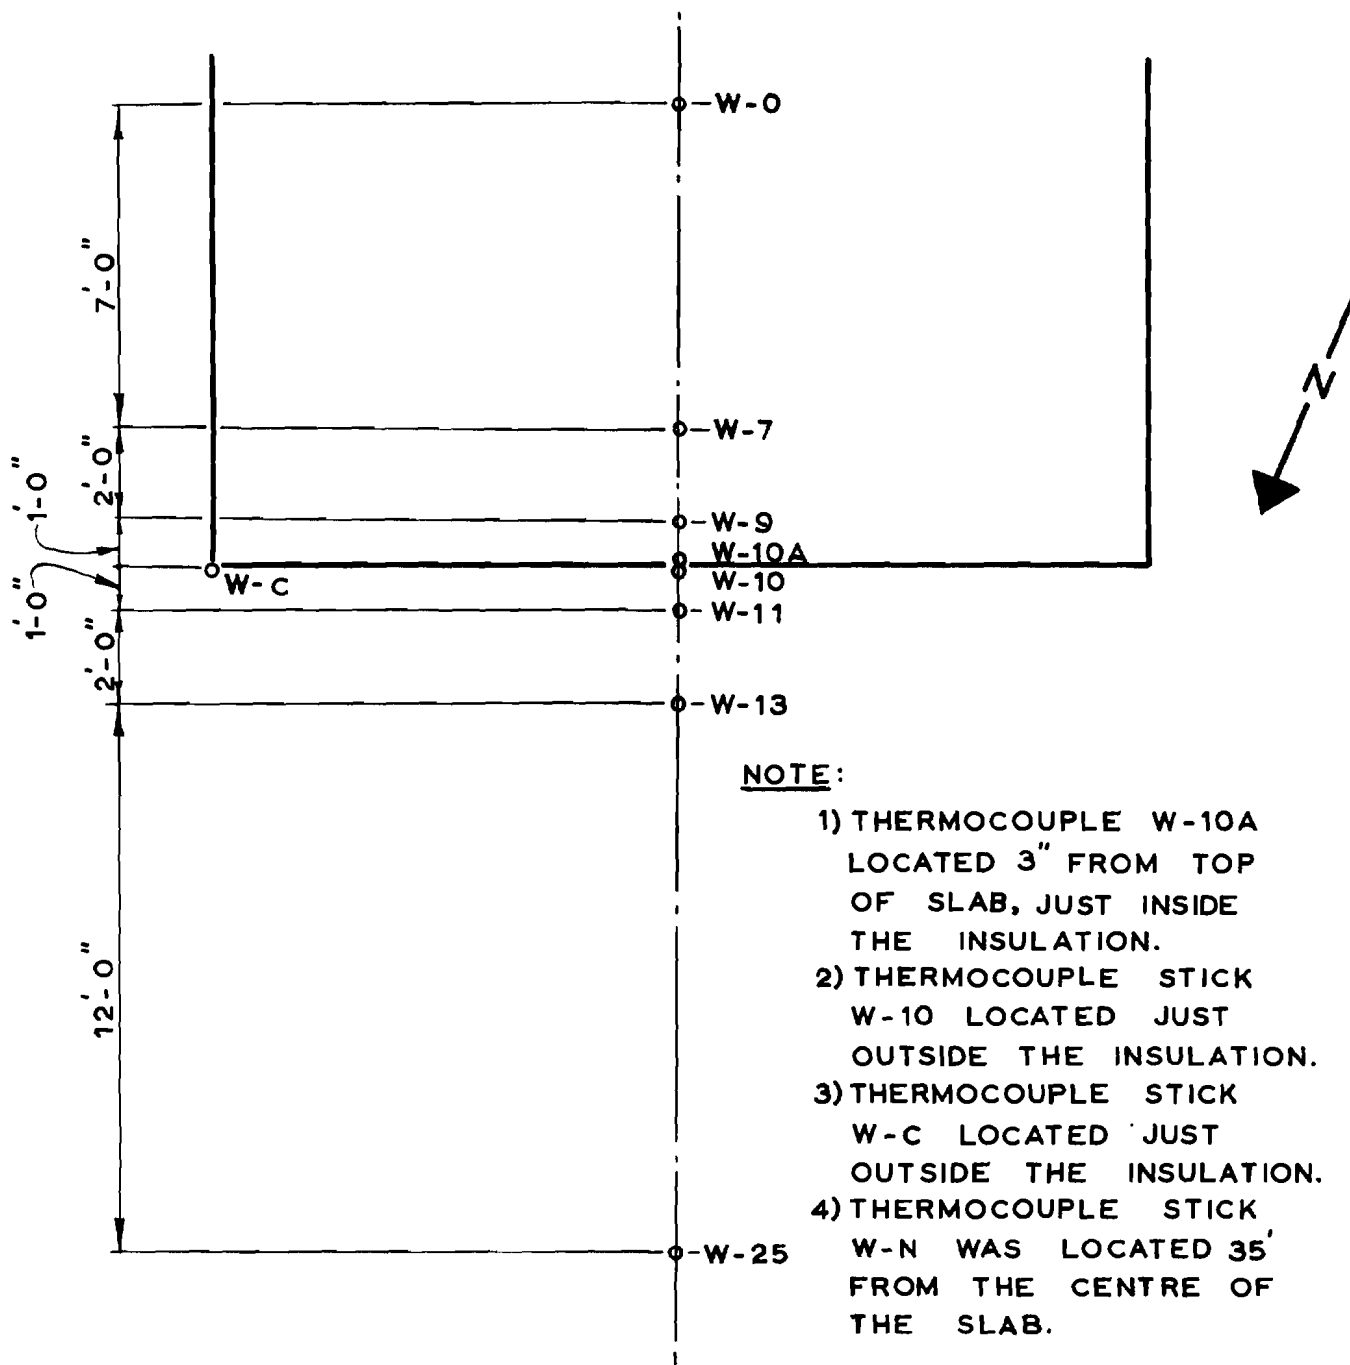
FIGURE 15

PLAN VIEW OF THERMOCOUPLE STICKS

Eighty-two copper-constantan thermocouples were placed in locations as shown in Fig. 15. These permitted temperature measurements at depths ranging from the ground surface to 15 feet, both below the slab and at various distances outside the slab. Thermocouple readings were taken once a week initially and after the first year's operation approximately twice a month.

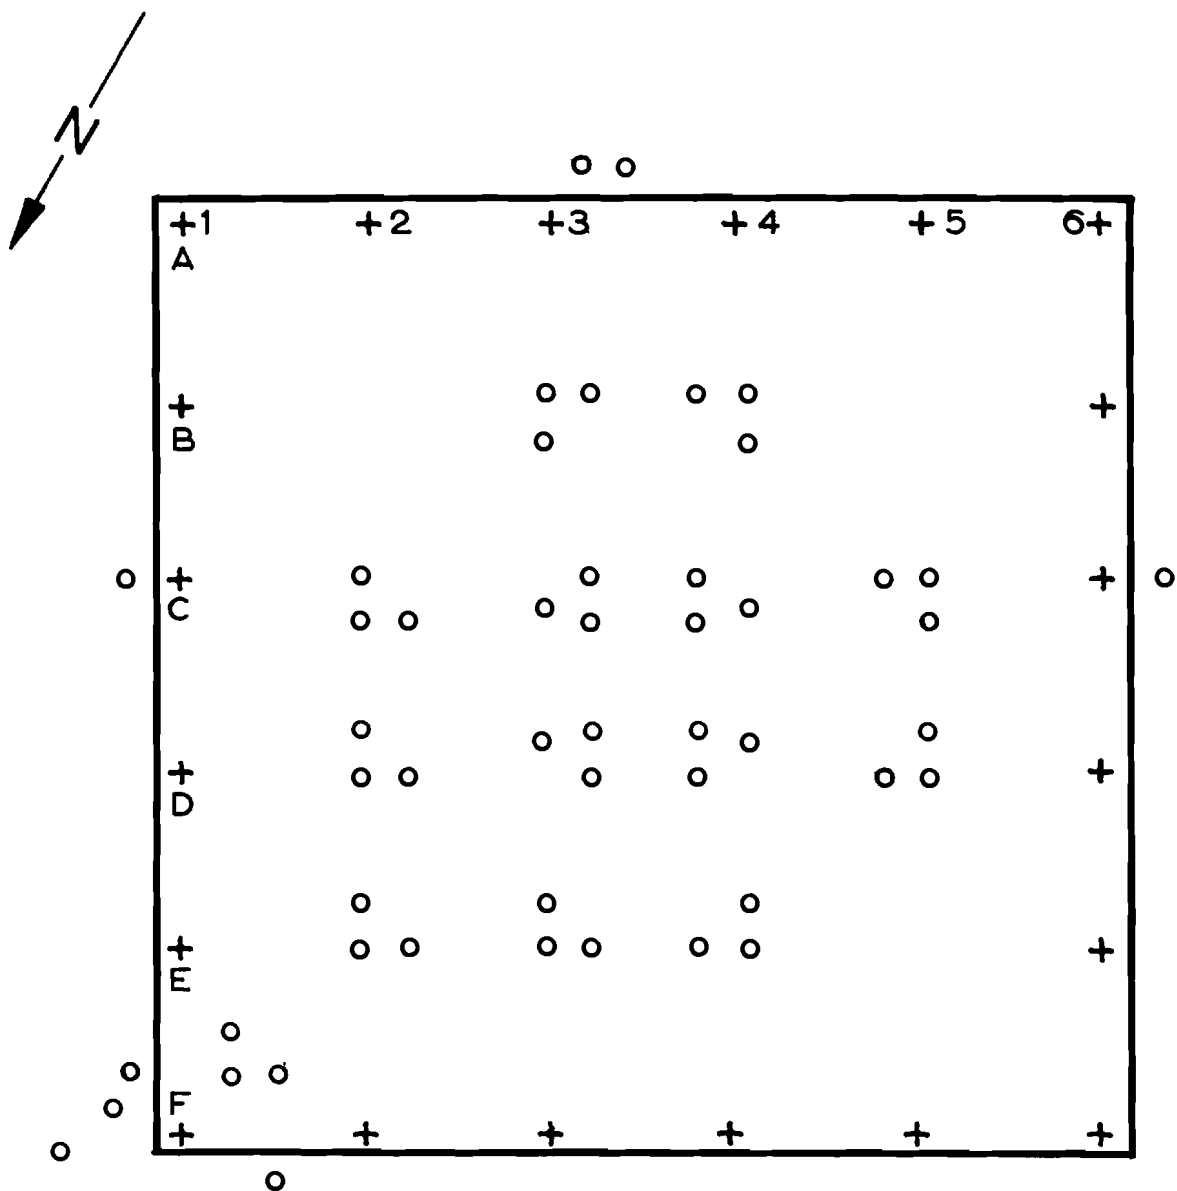
FIGURE 16

LOCATION OF SOIL SAMPLING TUBES.

Figure 16 shows the location of forty-two openings in the floor slab formed by bakelite tubes. Soil samples from under the slab were obtained by augering through the tubes.

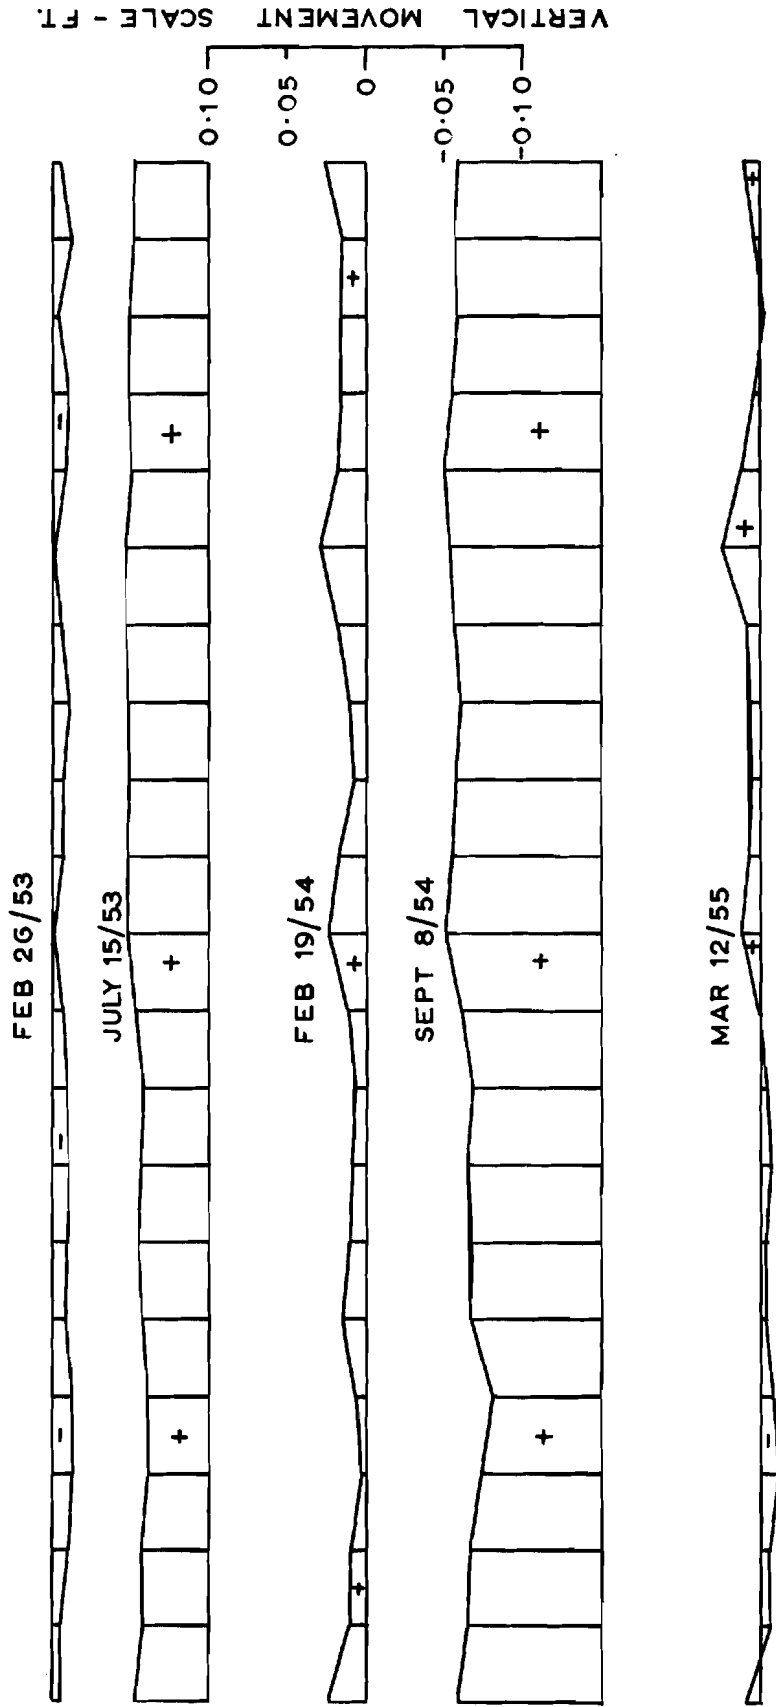
FIGURE 18
N.R.C. U. OF M., FLAT SLAB, WINNIPEG
PLOTS OF TYPICAL VERTICAL SLAB MOVEMENT.
 (POINTS ON PERIMETER OF SLAB)

The elevations of the slab were reduced to vertical movements with respect to the initial readings taken on November 22, 1952. Vertical movements of the slab diagonals and perimeter were found to best represent the movement of the slab. Typical vertical movements are shown in Figs. 17 and 18.

With reference to the top surface of the slab, concave warping caused as much as $\frac{1}{2}$ inch differential movement. The perimeter of the slab, particularly at the corners, moved upwards more than the centre after an increase in soil moisture contents. Convex deformation of the slab did not occur. The concave warping is attributed to the dry condition of the soil at the time the slab was placed. Soil moisture contents would first tend to increase near the perimeter of the slab where the ground is exposed to surface water following wet weather or the spring thaw. Swelling would occur under the perimeter and cause the slab edges to lift.

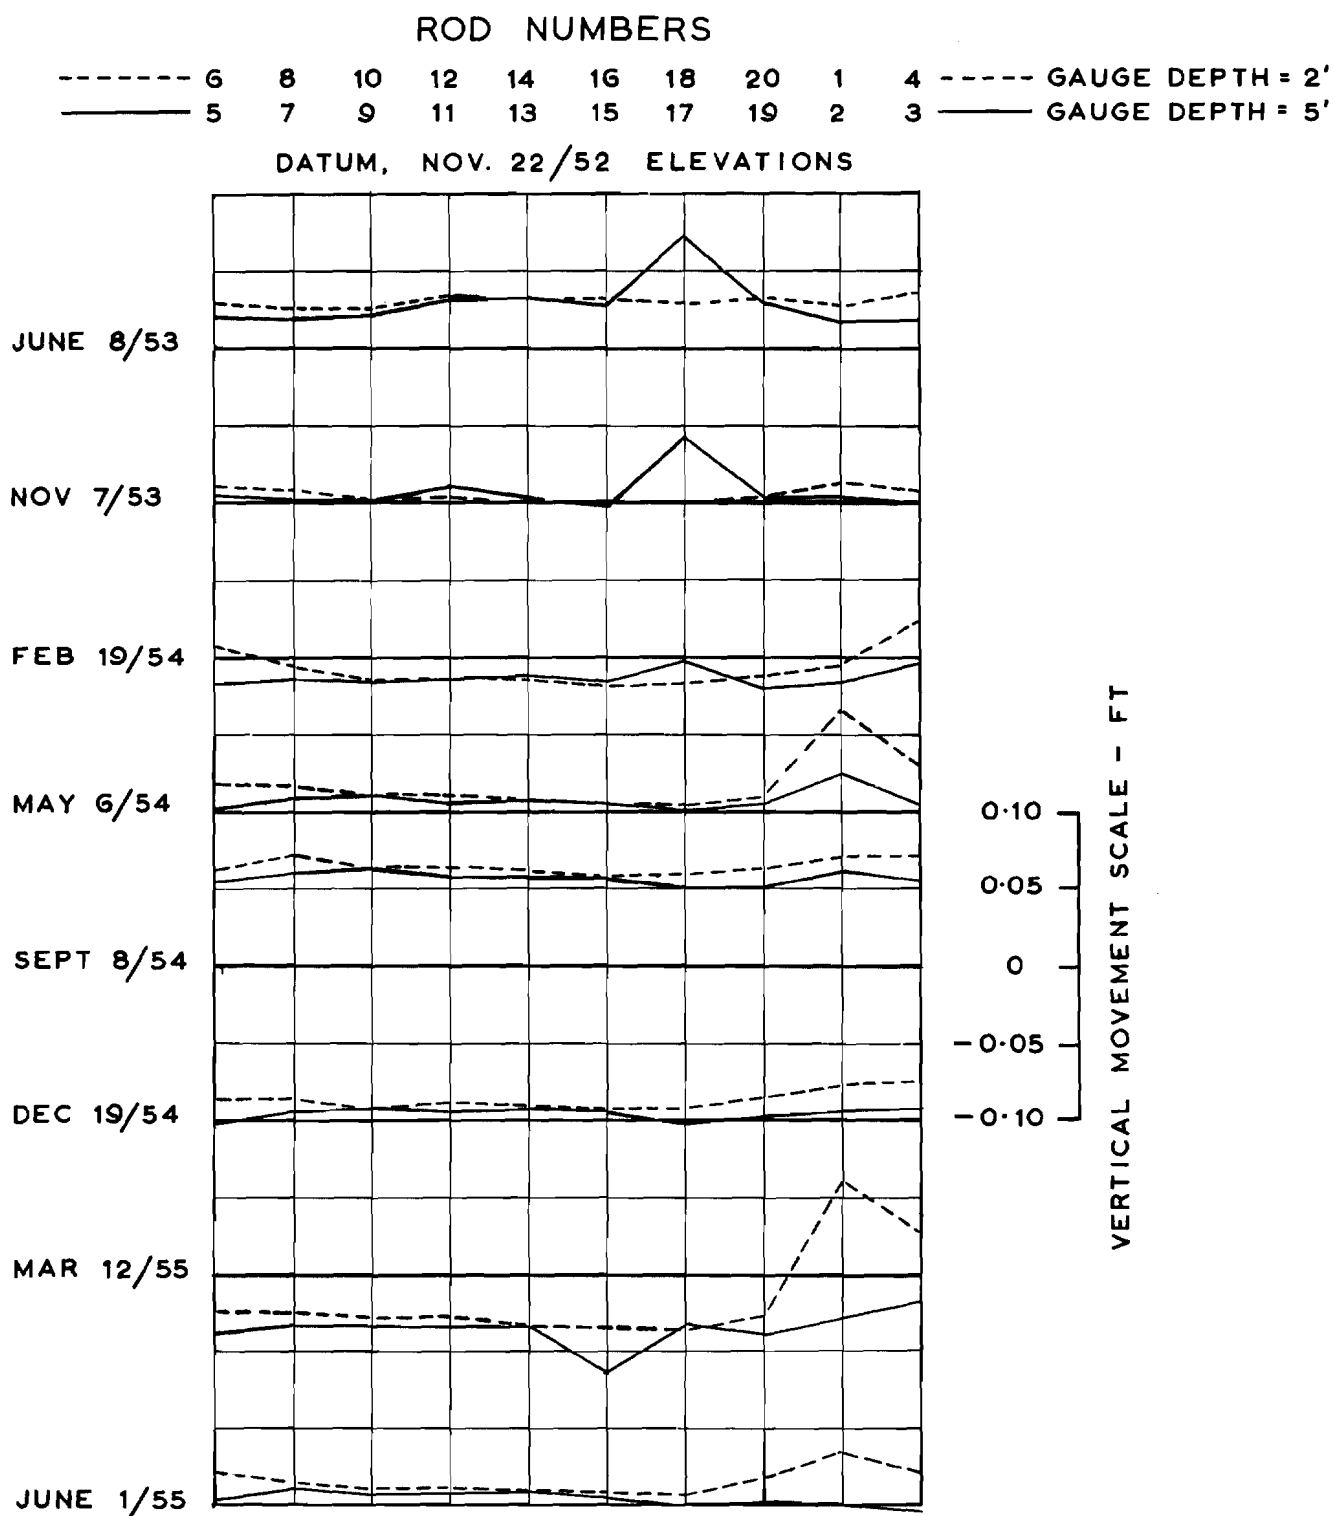
FIGURE 19
SOIL VERTICAL MOVEMENT GAUGE
 PLOTS OF TYPICAL VERTICAL MOVEMENT

The ground movement gauges indicated that shrinking and swelling of the soils at depths up to 5 feet were responsible for the movement of the slab. The shrinking and swelling of the upper 2 feet were greater than for the underlying 3 feet of soil. Typical ground movements are shown in Fig. 19. The ground movement gauges located outside the test hut showed greater movement than those located on the inside.

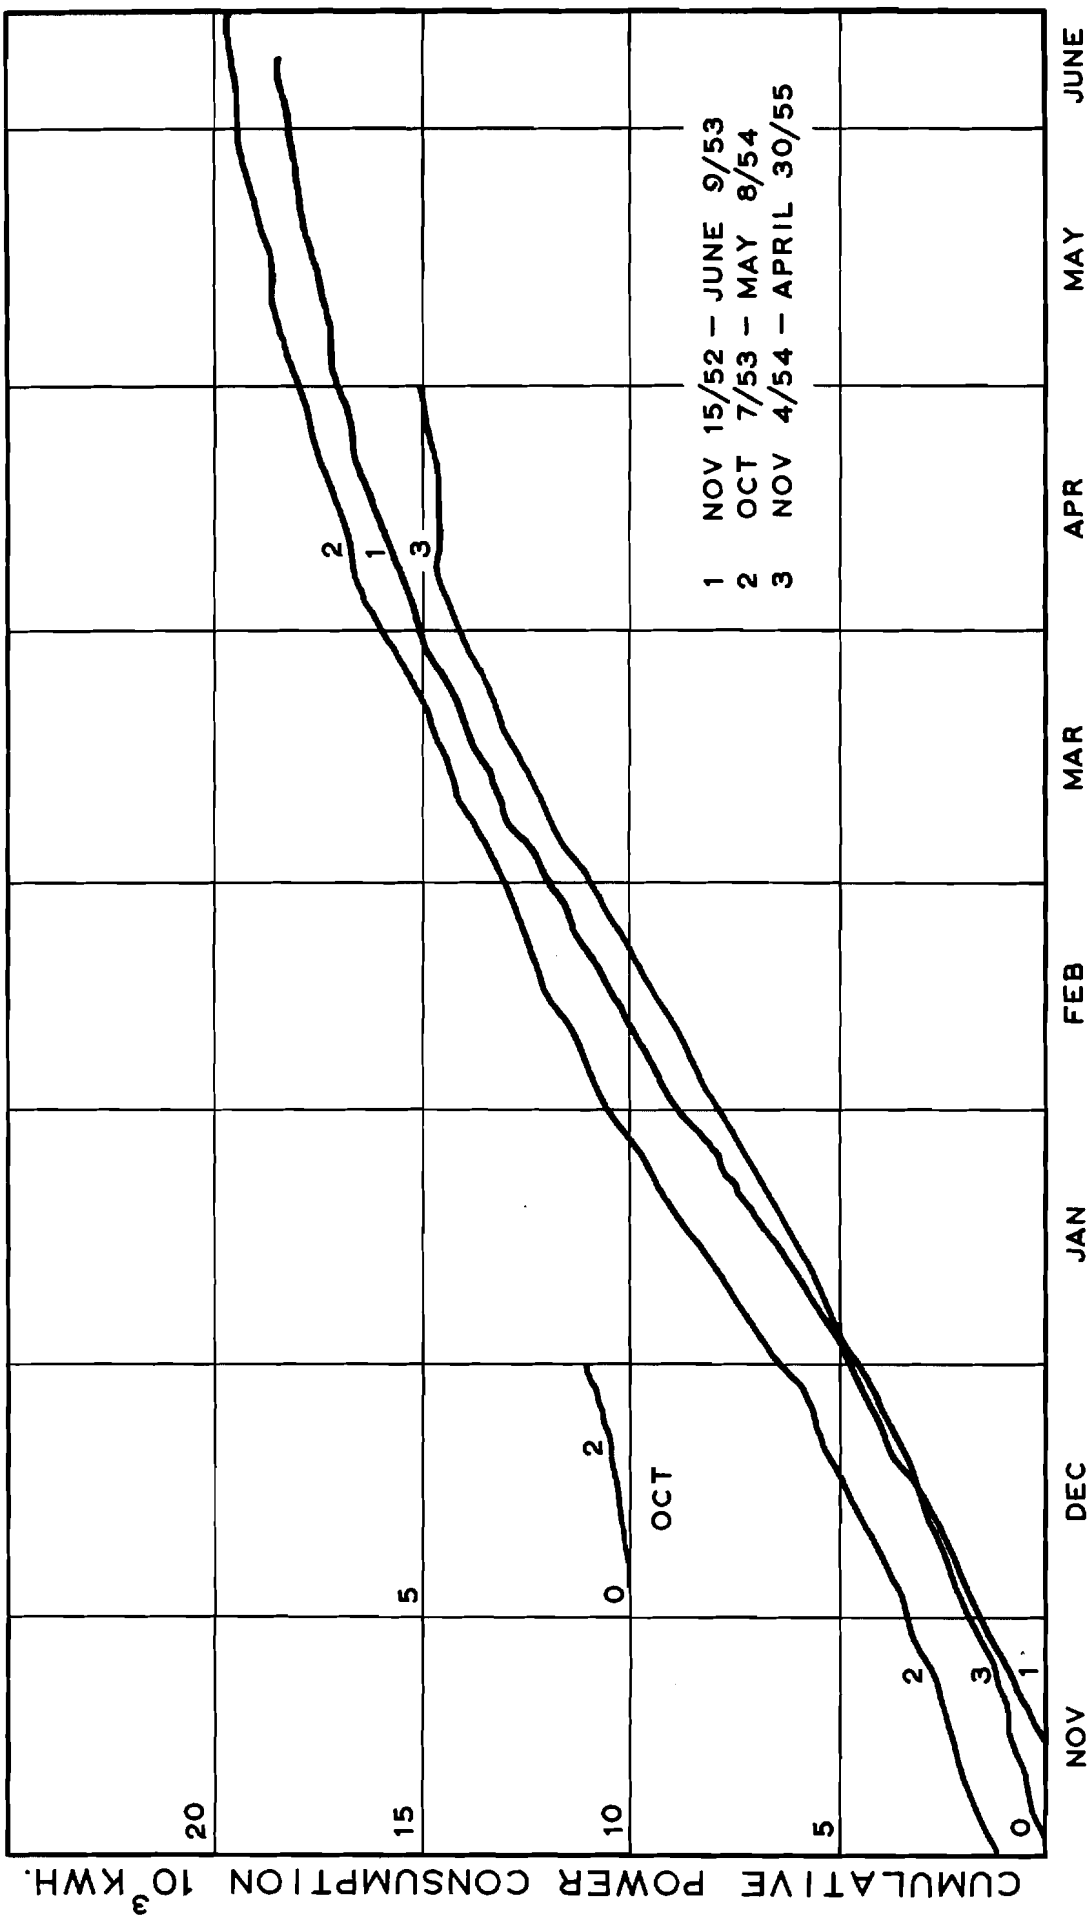
FIGURE 20

TEST HUT CUMULATIVE POWER CONSUMPTION CURVES

Cumulative power consumption curves are shown for each heating season in Fig. 20. During the first year's operation, initial power consumption rates were higher than in the following years. This is attributed to the initial heating of the soil under the slab. At the beginning of the following heating season, there was sufficient heat remaining from the previous heating season that less power was required.
