FLAT SLAB TEST HUT PROJECT
WINNIPEG, MANITOBA

A report on the construction and test operation of
an experimental radiant-heated flat slab test hut
conducted by the National Research Council of Canada
Division of Building Research in conjunction with the
University of Manitoba Civil Engineering Department.

Report No. 94
of the
Division of Building Research

Ottawa
July 1956

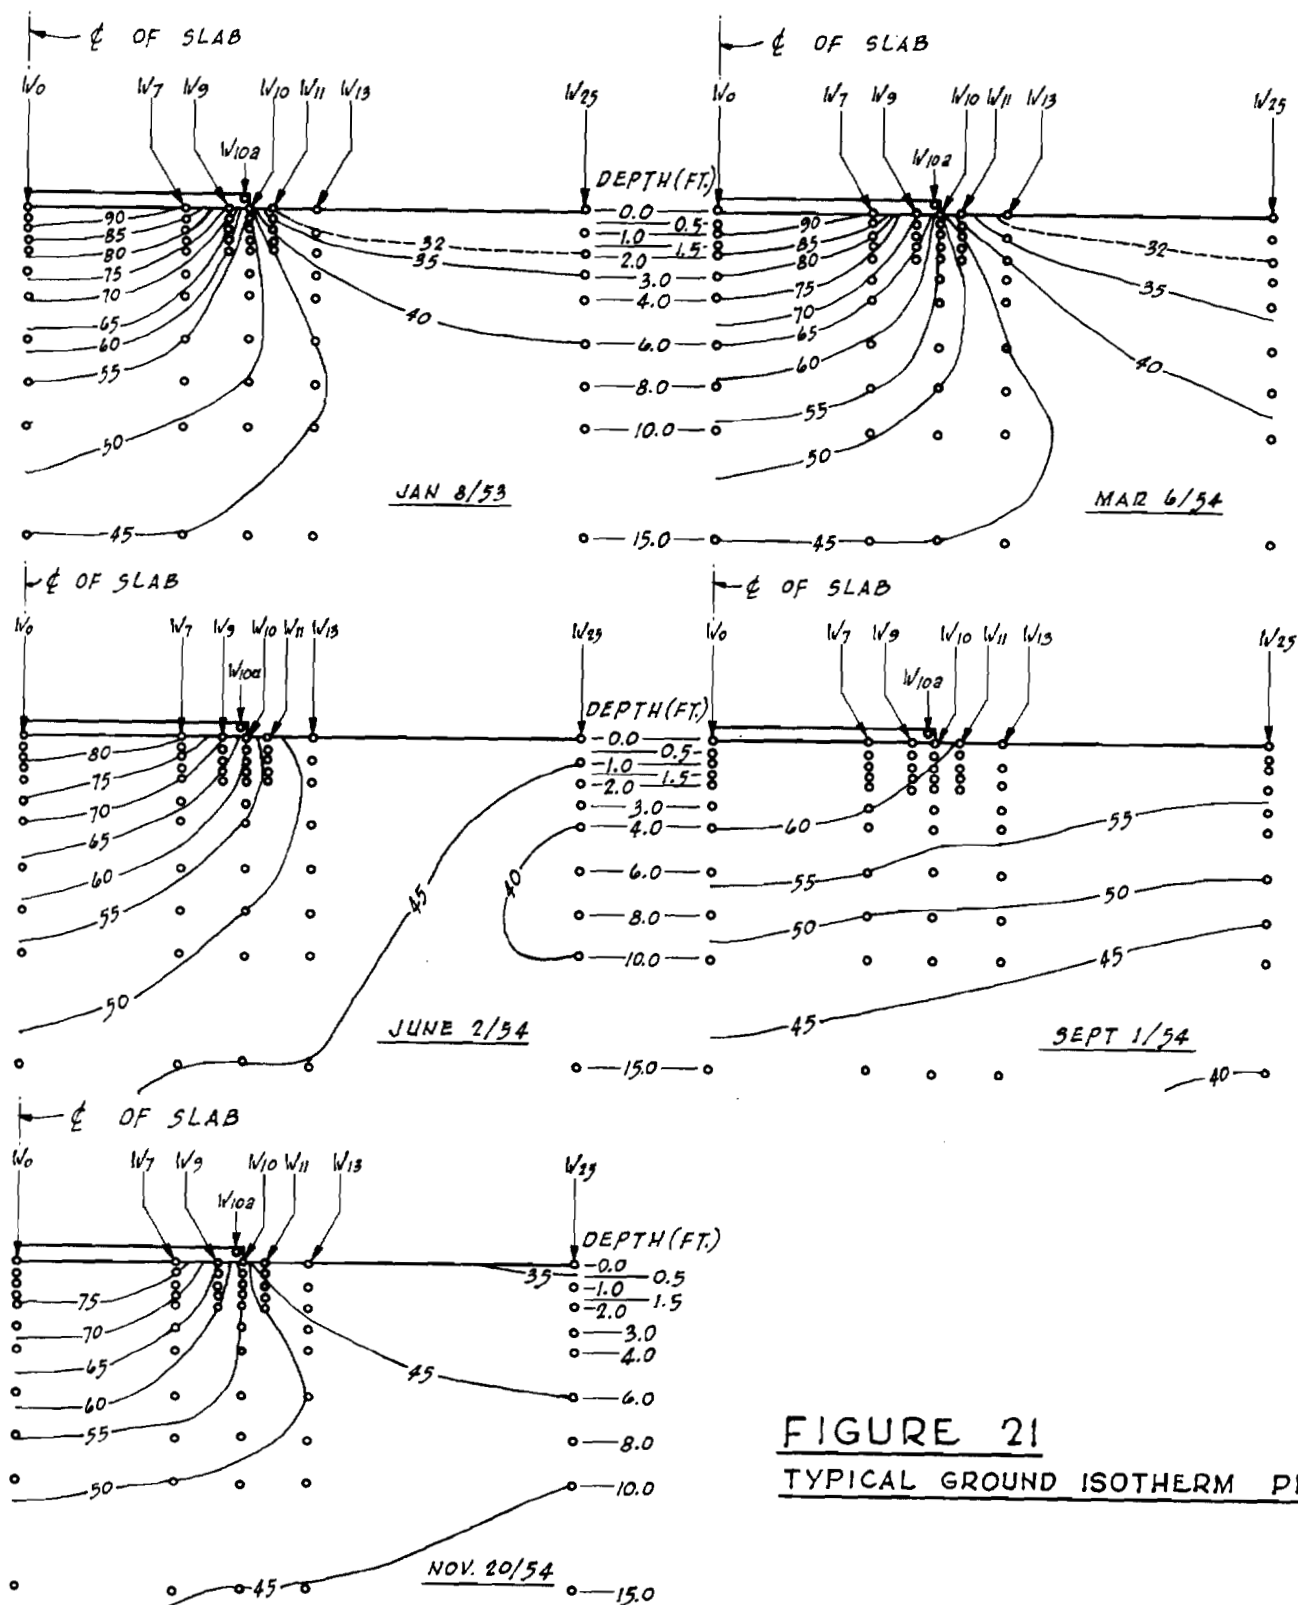
FIGURE 21
TYPICAL GROUND ISOOTHERM PLOTS

The thermocouple readings were reduced to soil temperature. Typical isotherm plots for the soil are shown through a longitudinal section of the test hut in Fig. 21. At no time did frost penetrate under the floor slab. The isotherms showed that a high thermal gradient and high heat losses occurred near the perimeter of the slab. From heat flow theory it is apparent that heat was transferred from the slab downwards and then in approximately a circular path outward and upwards. In winter this heat loss was sufficient to melt the snow for a distance

of about one foot or more beyond the perimeter of the slab. The ground around the slab rarely showed more than a thin surface crust of frozen soil. Deep frost penetration into the soil was prevented as far as 3 feet beyond the edge of the slab. During the cold weather soil temperatures near the perimeter of the slab were as much as 40 to 50°F lower than under the centre of the slab.

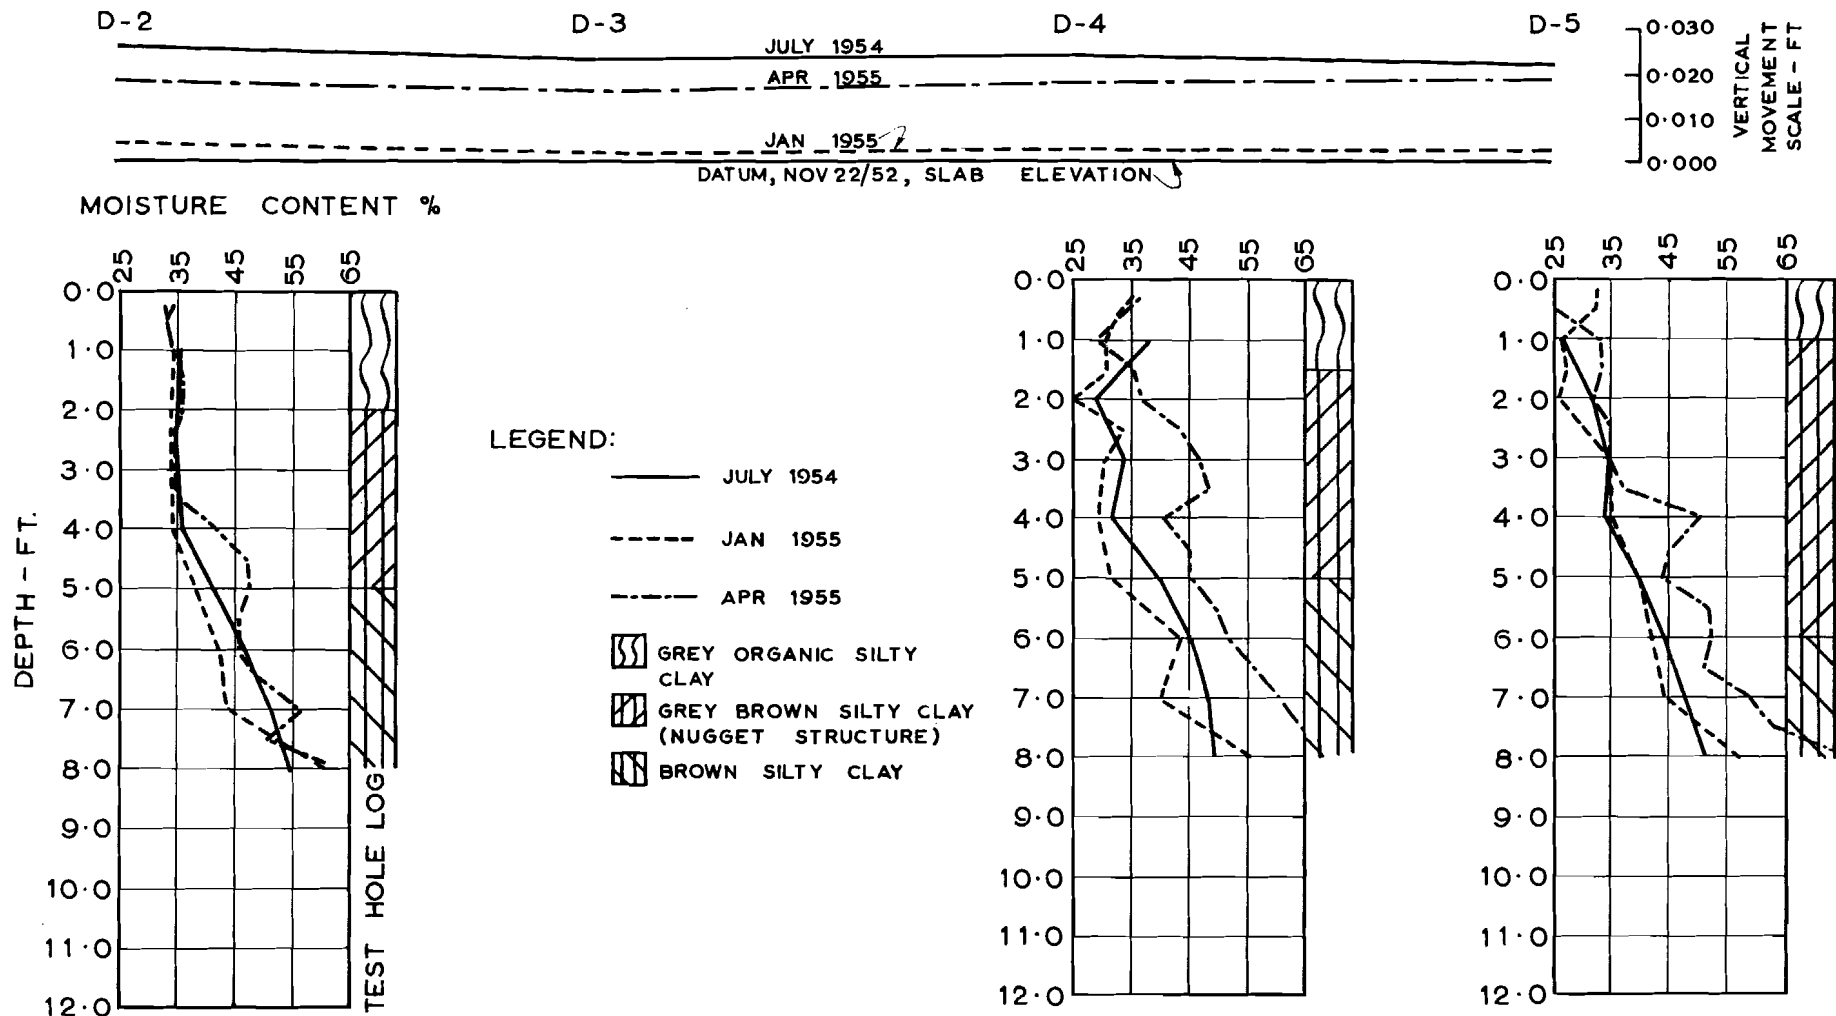
FIGURE 22

CORRELATION OF VERTICAL SLAB MOVEMENTS AND SOIL MOISTURE CONTENT CHANGES

Soil moisture contents both under and outside the test hut were primarily influenced by climatic conditions. Following rains or the spring thaw, soil moisture contents increased generally. The increased moisture content under the centre portions of the slab apparently occurred after a time lag. Soil swelling occurred with increased soil moisture contents and drying resulted in shrinking. The relationship between soil volume changes and soil moisture contents does not seem to be a direct one. Figures 22 and 23 show the vertical movements of the slab and the soil moisture contents. The greatest upward movement of the slab did not occur when maximum moisture contents were observed. It is thought that the capillary rise of water in the soil above the water table may be substantially reduced by a raised water table following heavy rains or the spring thaw. Conceivably, this action could reduce soil intergranular stresses and cause an increase in soil volume without causing an appreciable increase in soil moisture content above the water table.

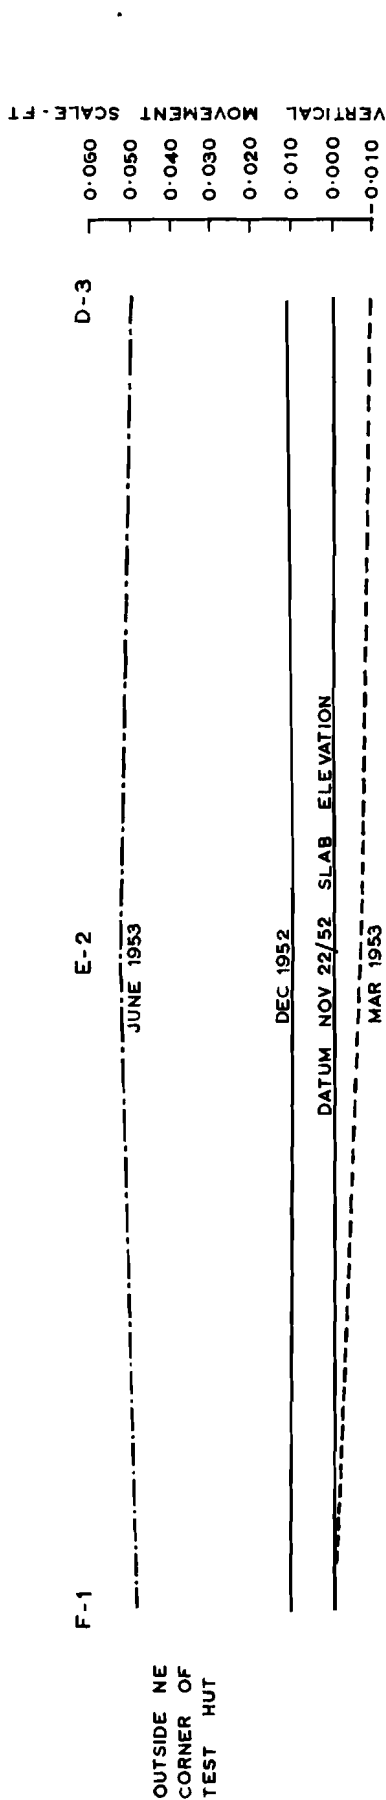
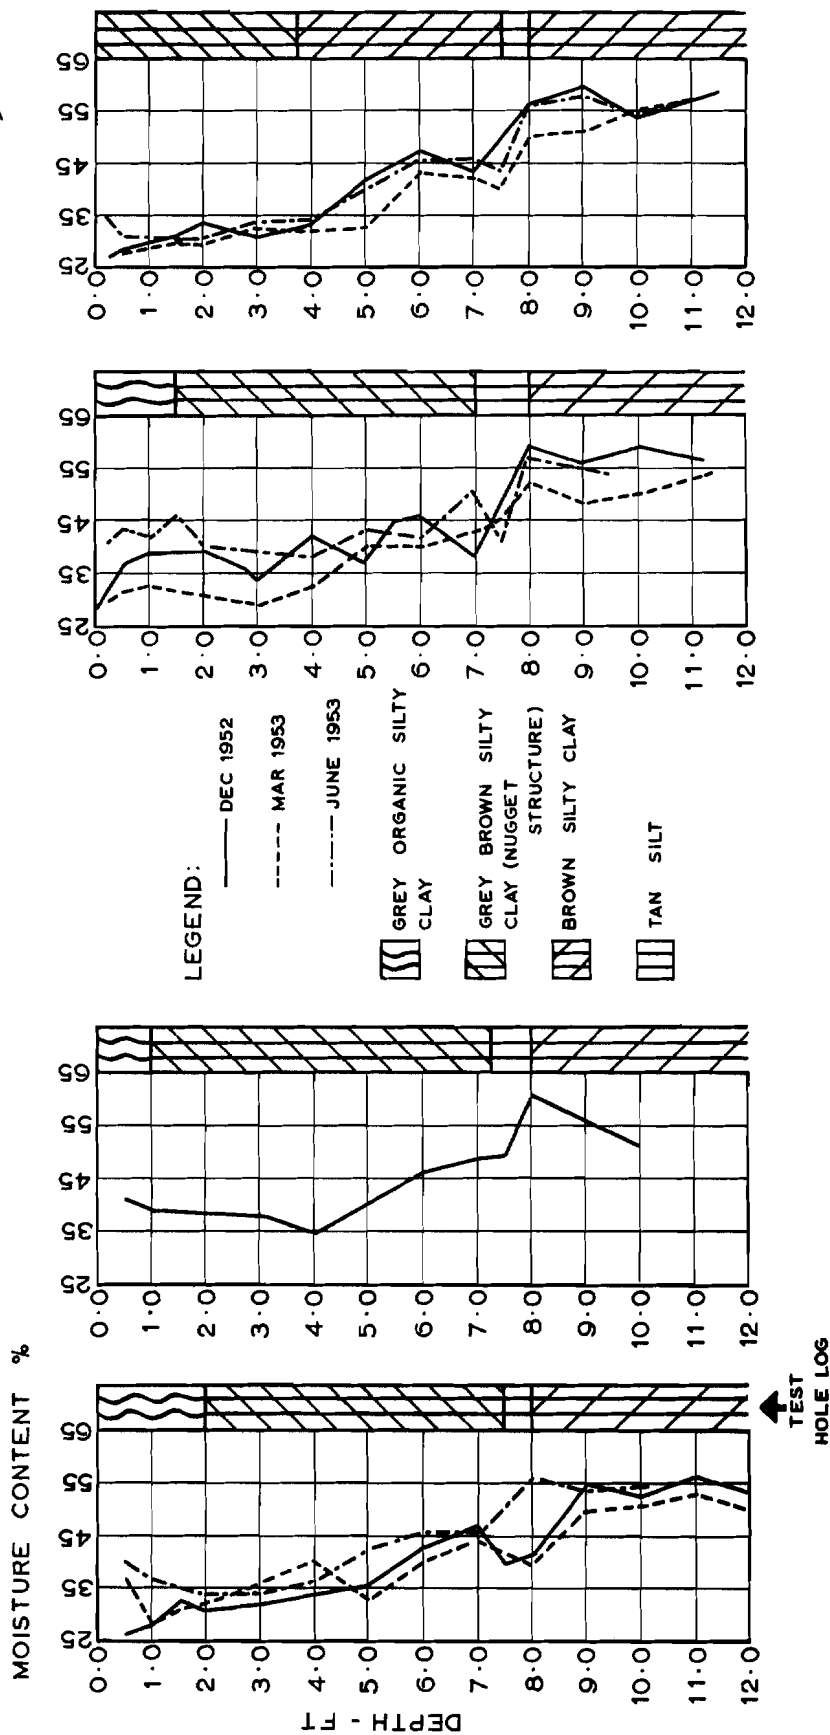
FIGURE 23

CORRELATION OF VERTICAL SLAB MOVEMENTS AND SOIL MOISTURE CONTENT CHANGES
(ALONG SLAB DIAGONAL)

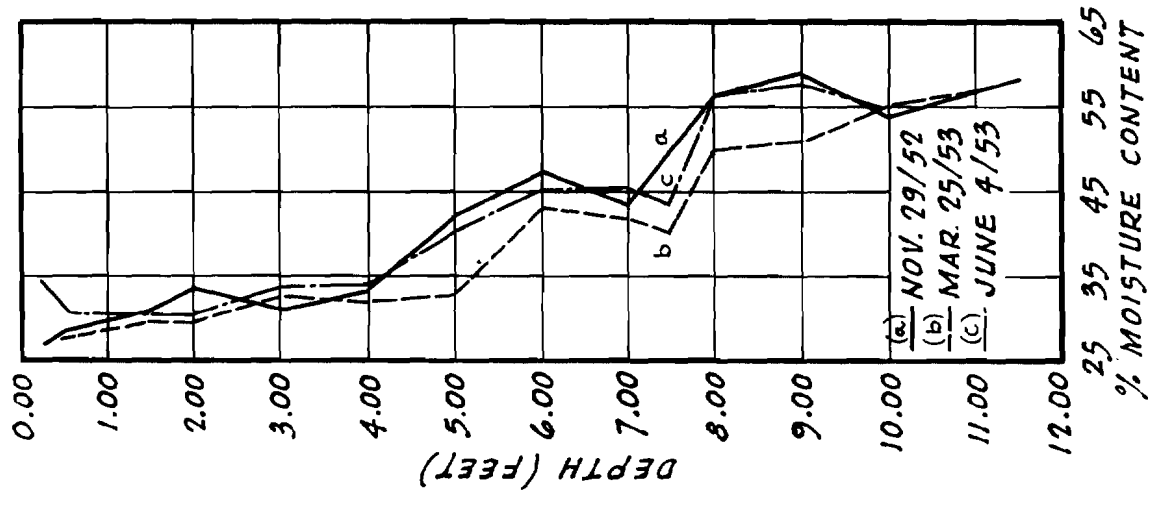
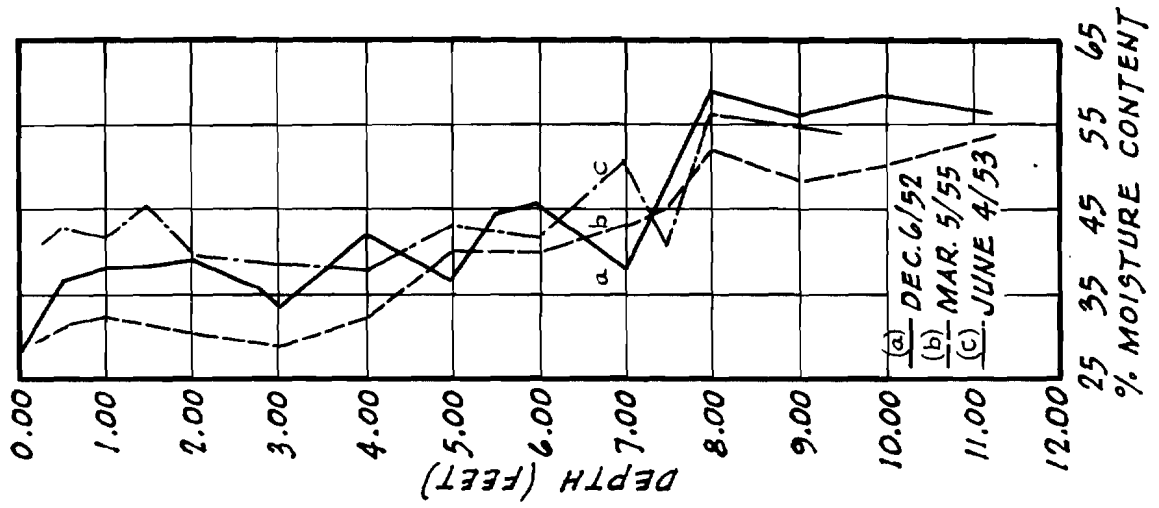
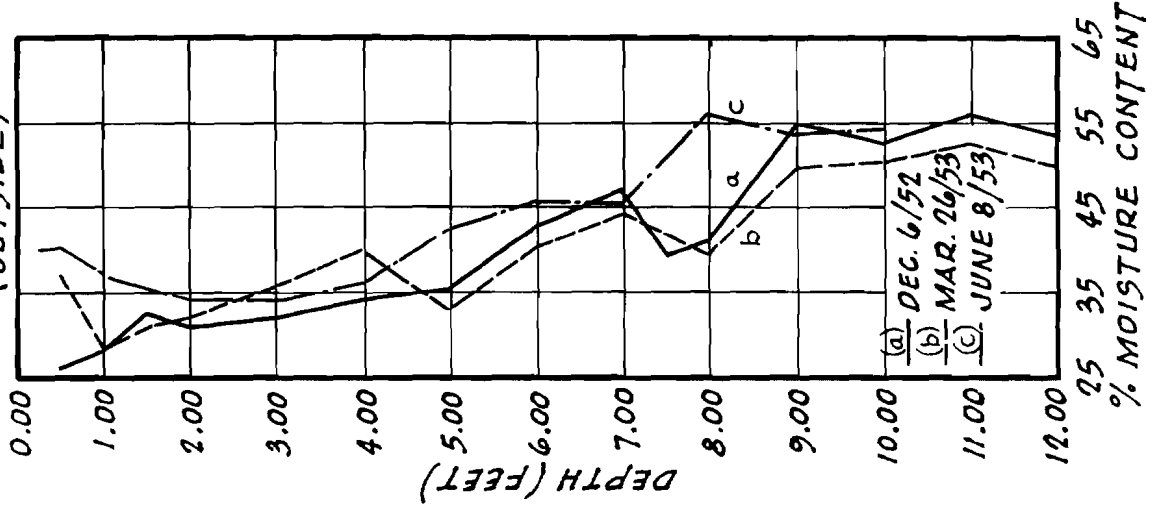
FIGURE 24

MOISTURE CONTENTS - N.R.C. FLAT SLAB, WINNIPEG

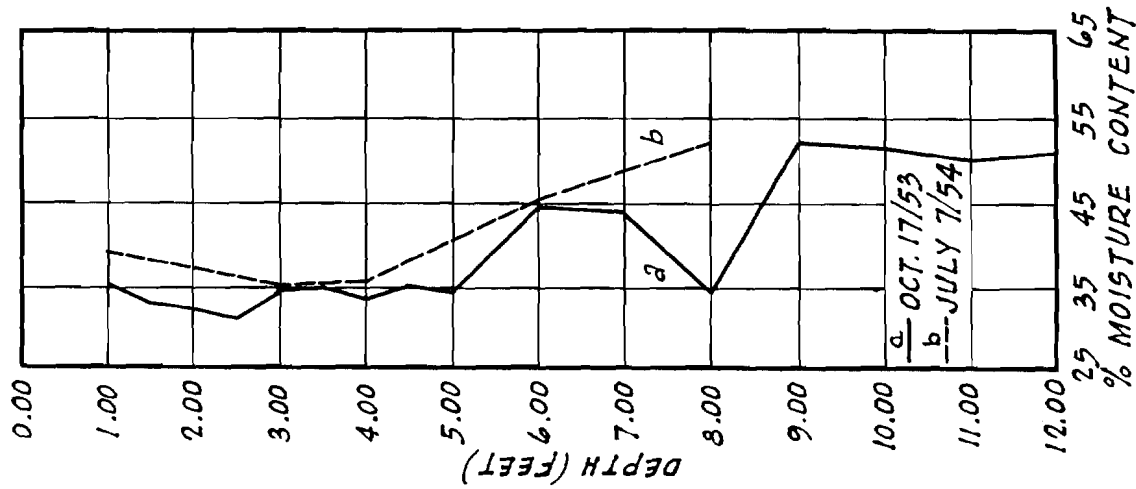
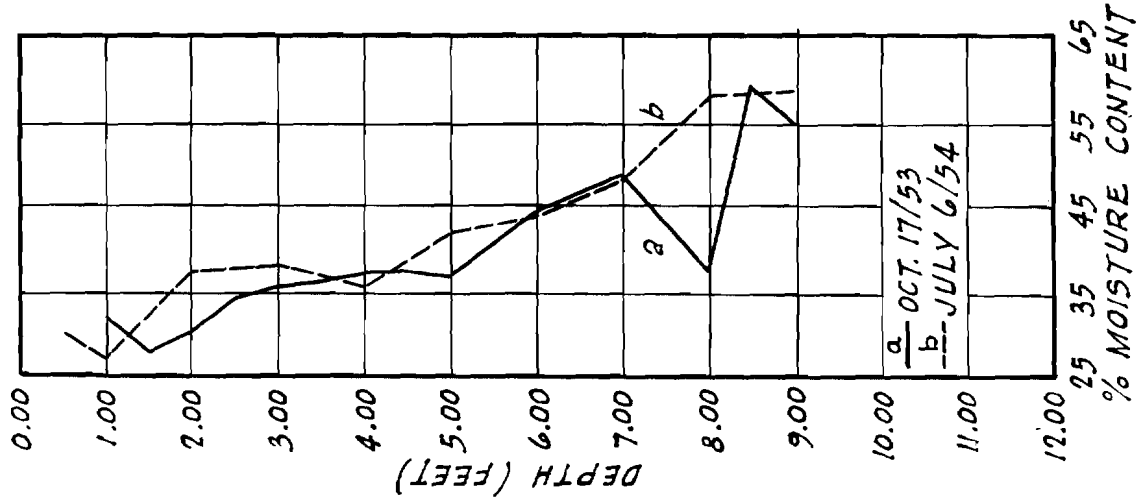
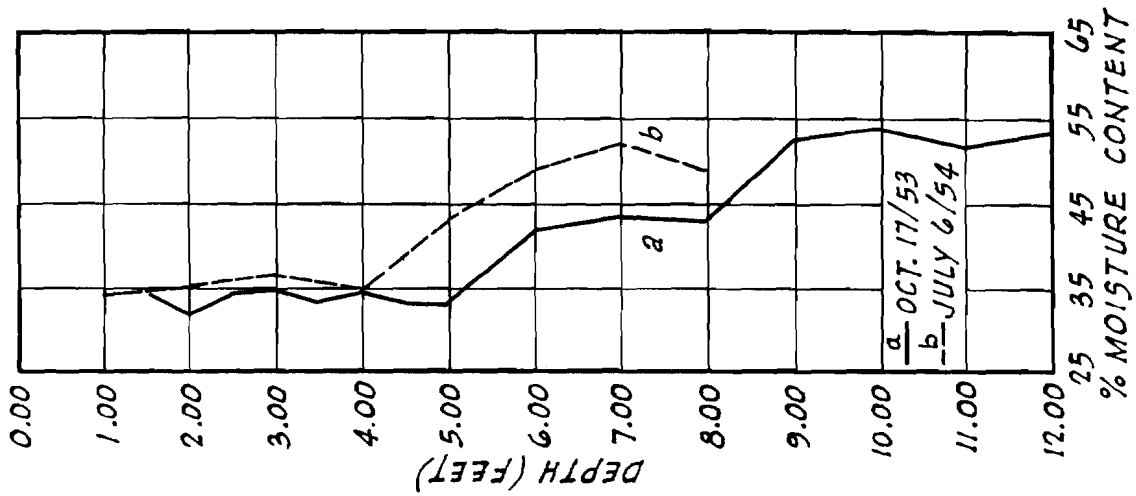
FIGURE 25
MOISTURE CONTENTS - N.R.C. FLAT SLAB, WINNIPEG

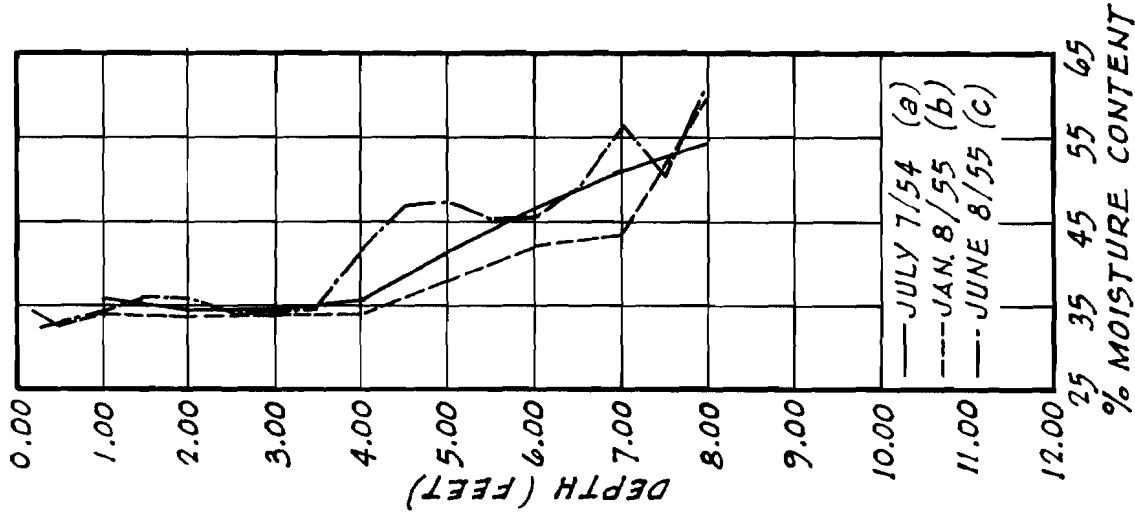
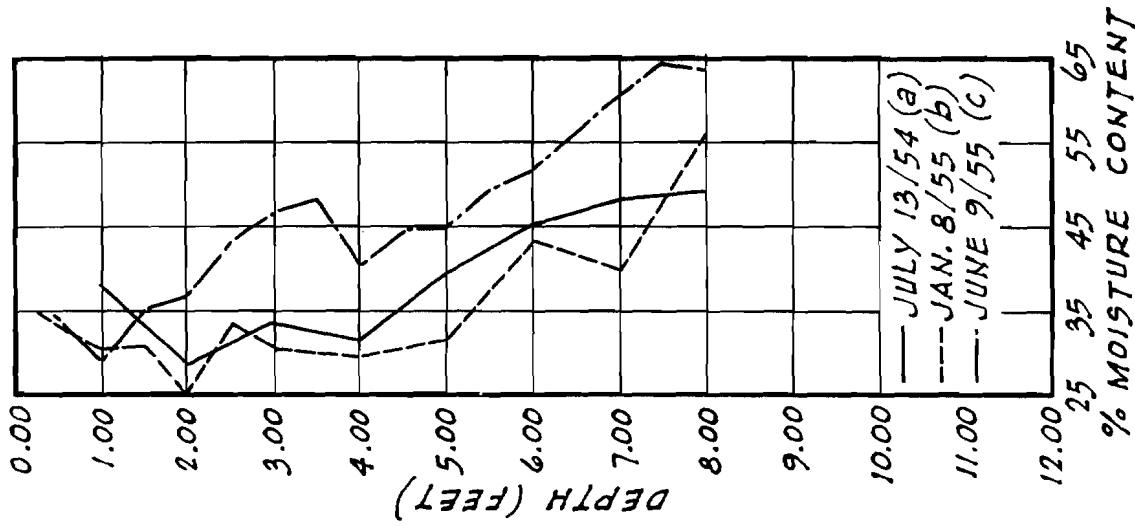
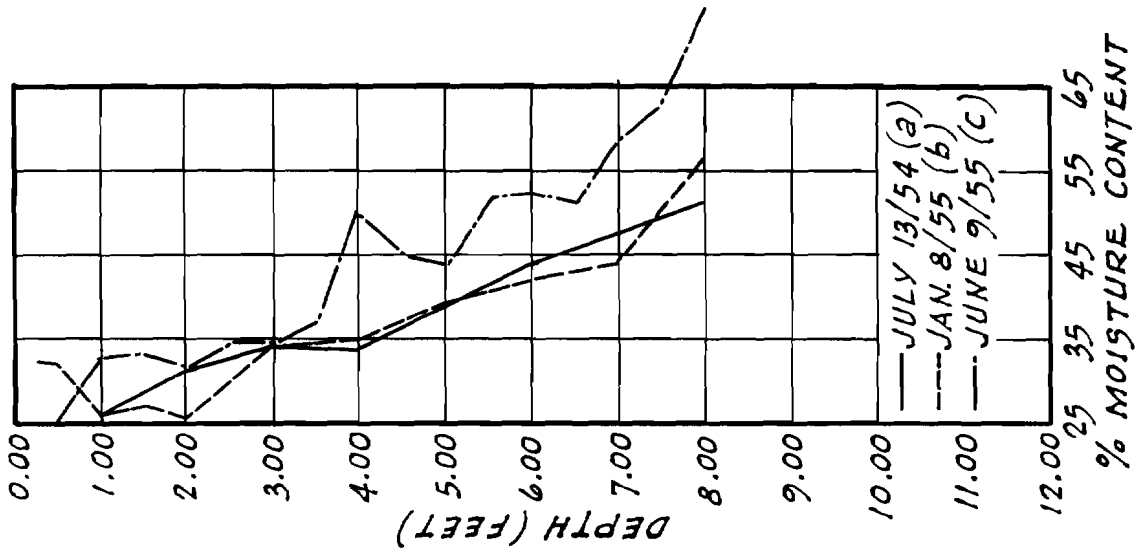
FIGURE 26

MOISTURE CONTENTS - N.R.C. FLAT SLAB, WINNIPEG

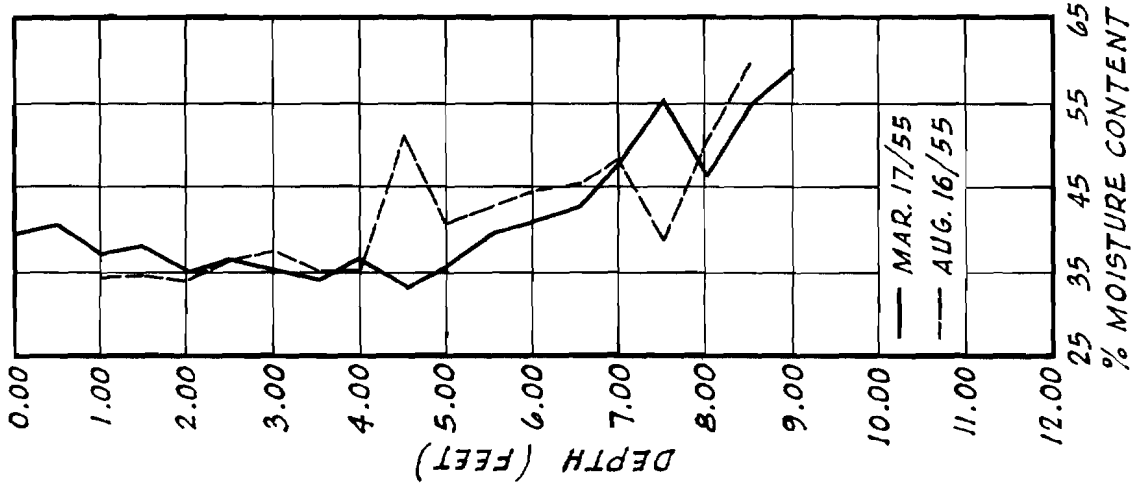
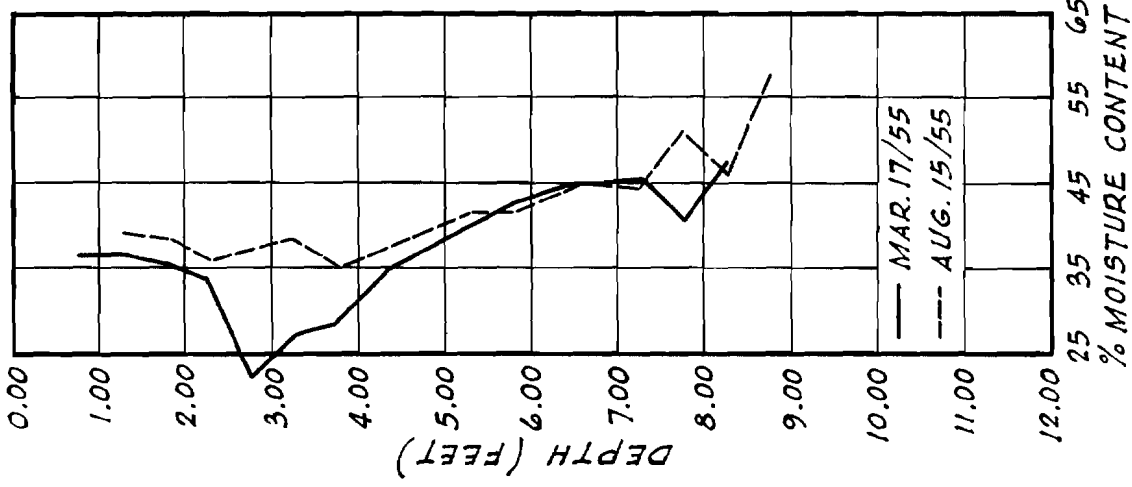
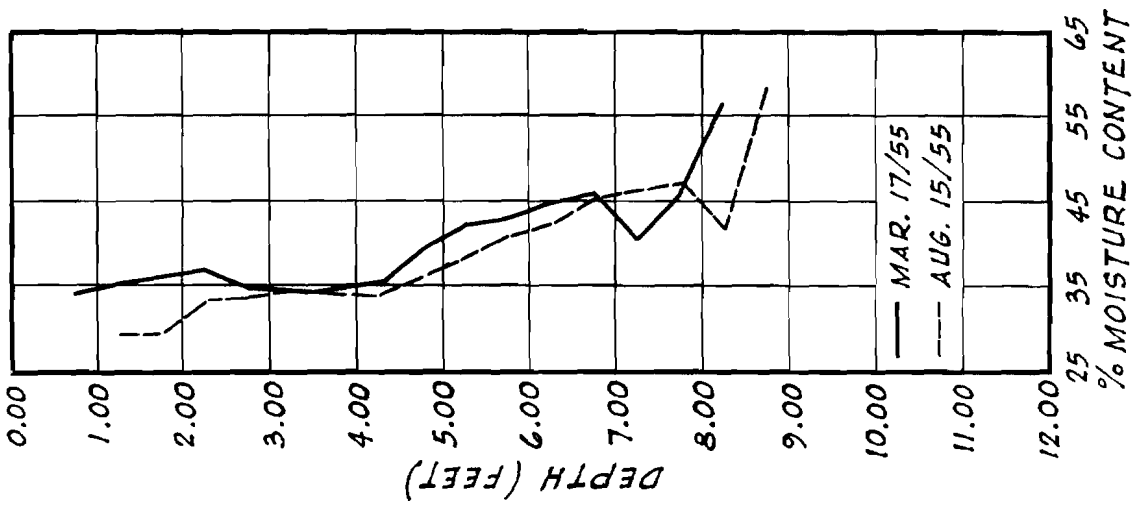
FIGURE 27

MOISTURE CONTENTS - N.R.C. FLAT SLAB, WINNIPEG

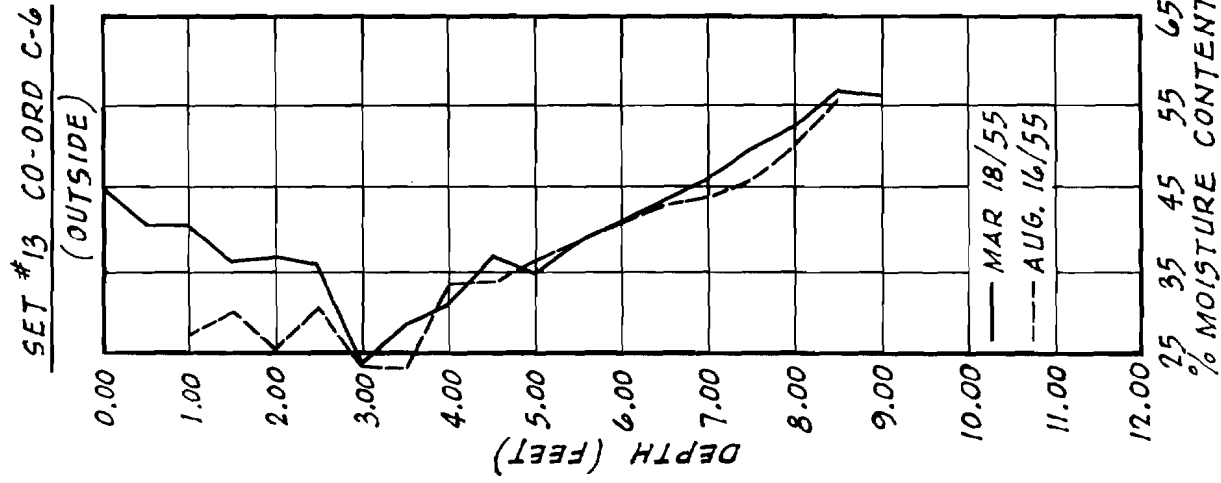
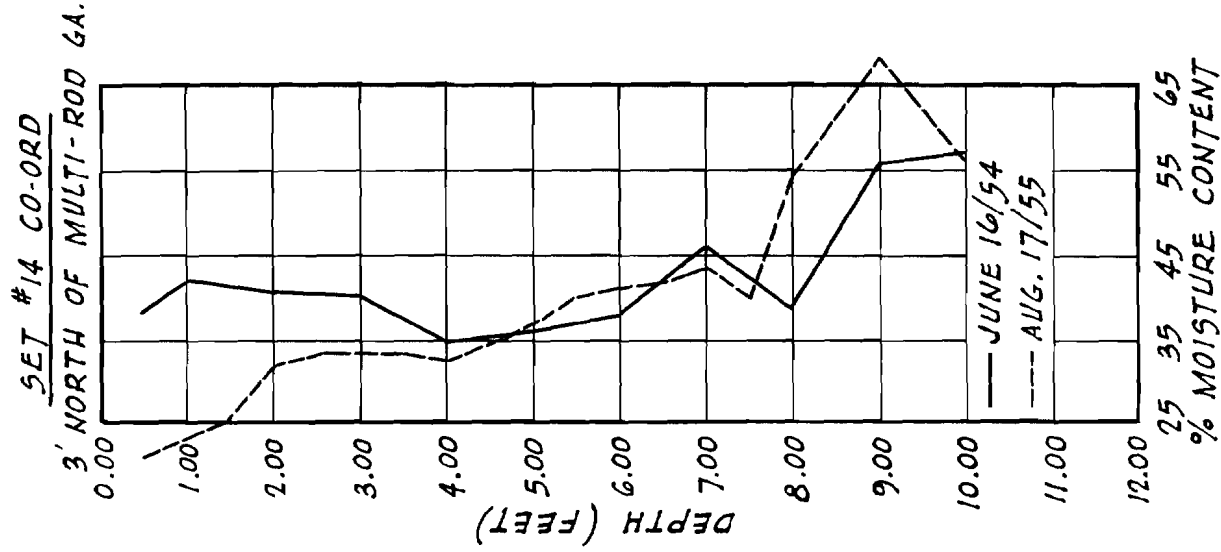
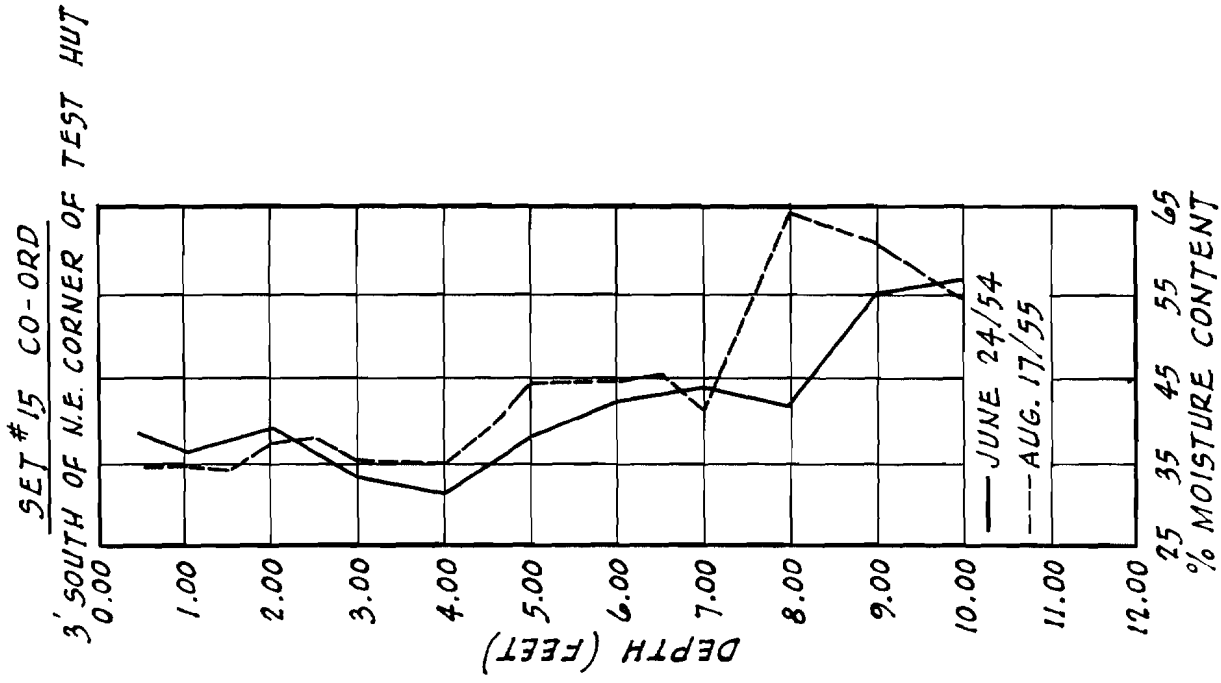
FIGURE 28

MOISTURE CONTENTS - N.R.C. FLAT SLAB, WINNIPEG

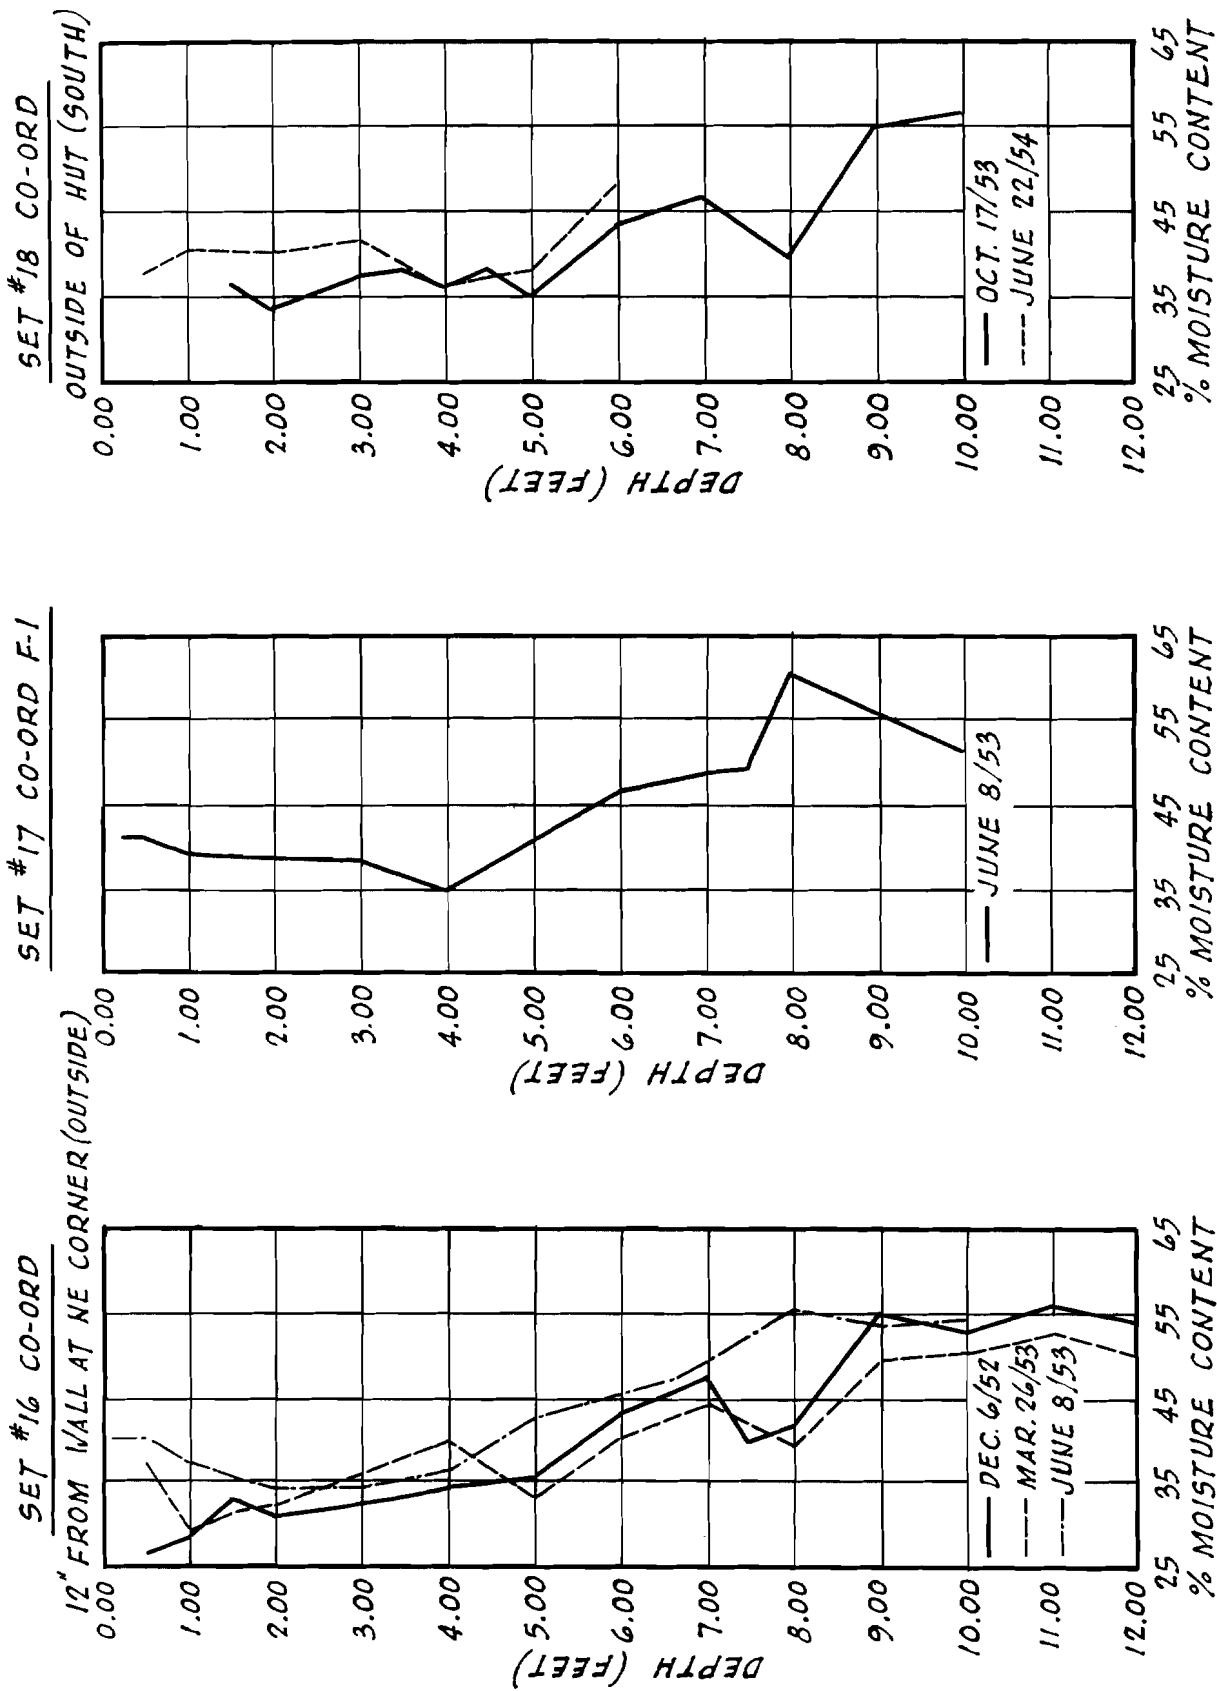
FIGURE 29
MOISTURE CONTENTS - N.R.C. FLAT SLAB, WINNIPEG
