COLUMN COVERS: A PRACTICAL APPLICATION
OF SHEET STEEL AS A PROTECTIVE MEMBRANE

Fire Study No. 27
of the
Division of Building Research

OTTAWA
February 1972

Two fire tests on structural steel columns protected by standard gypsum wallboard held in place with sheet steel column covers are described. The tests showed that sheet steel column covers are able to retain the gypsum board for much longer periods of fire exposure than other mechanical fastening methods. The fire endurance classifications developed were $1\frac{1}{2}$ hr and 2 hr, for two layers of $\frac{1}{2}$ -in. and two layers of $5/8$ -in. standard wallboard, respectively.

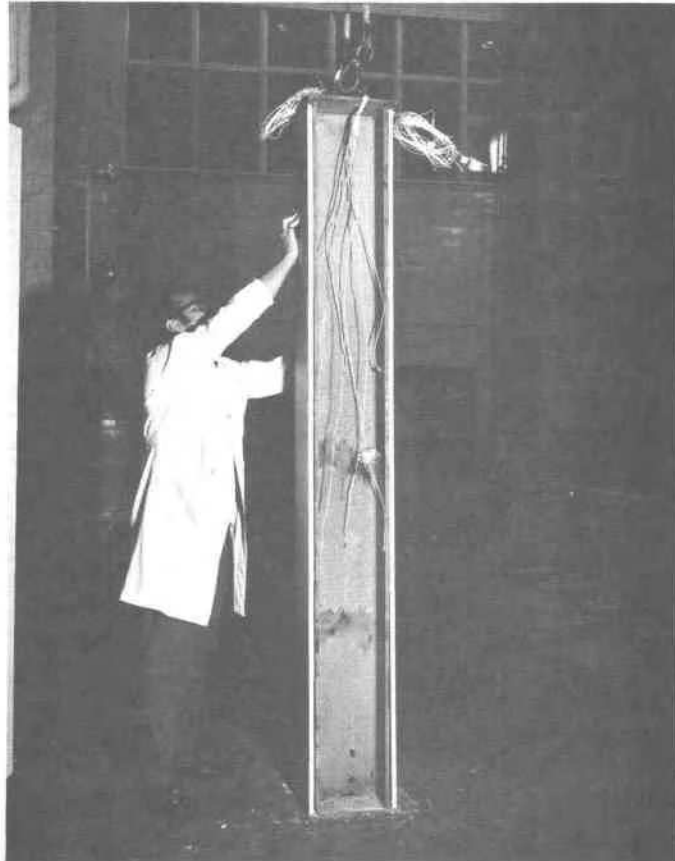
Figure 3: Attachment of First Protective Layer

Gypsum wallboard, supplied in 4 ft by 8 ft sheets was pre-cut to size with a standard cutting knife. Two pieces, sized to fit over the flanges, were placed and each was temporarily held with two strips of masking tape (Figure 3). Figure 4 shows completion of the first layer, with two pieces of masking tape holding each board temporarily in position. The second layer was applied in a similar manner and the sheet steel column cover was positioned (Figure 5), closed, 1/8-in. holes punched with a Whitney punch, and the seams fastened with sheet metal screws, approximately 2 ft o.c., with one screw being about 1 ft on either side of the mid-height of the column. The self-nailing wood strip was centre-grooved to a depth of about $\frac{1}{2}$ in. and pressed onto the seam. The completed specimen is shown in Figure 6.

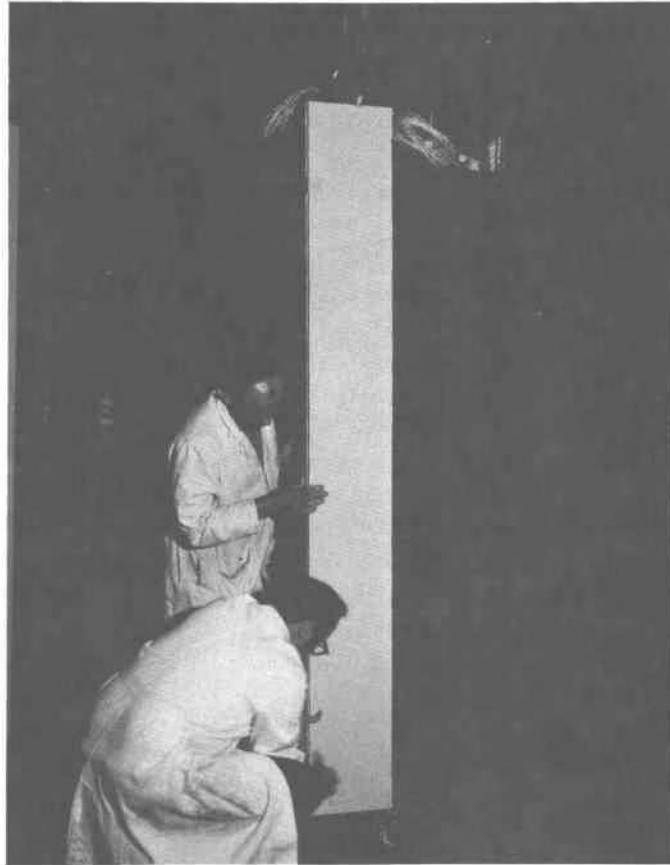
Figure 4: Completion of First Layer

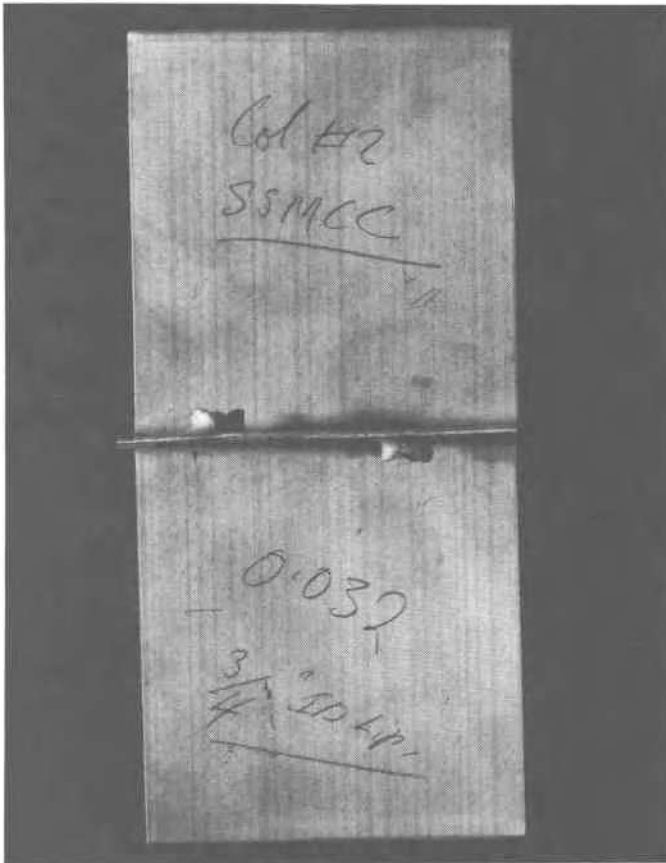
Figure 7: Close-Up of Crimped Seam Joint (Specimen No. 2)

For specimen 2, the procedure was identical up to the stage illustrated by Figure 5. Then the seam was crimped at approximately 1 ft o.c. with a mechanical crimping tool commonly employed in the drywall trade for fastening steel studs to floor and ceiling runners. Figure 7 shows a close-up of the type of joint produced. The wood finish was omitted as it is merely decorative and does not contribute to the fire performance of the specimen.

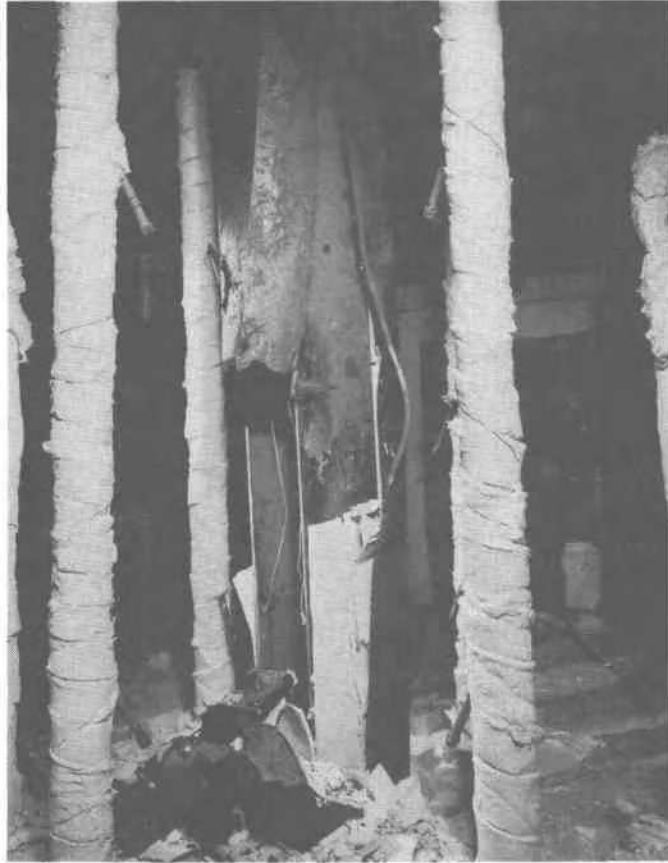
Figure 11: Column No. 1 in Furnace After Test

Figure 11 shows the condition of the specimen in the furnace after it had cooled. Note the bulging on the right side of the seam; it is similar to the appearance of the left side, just before the cover split.

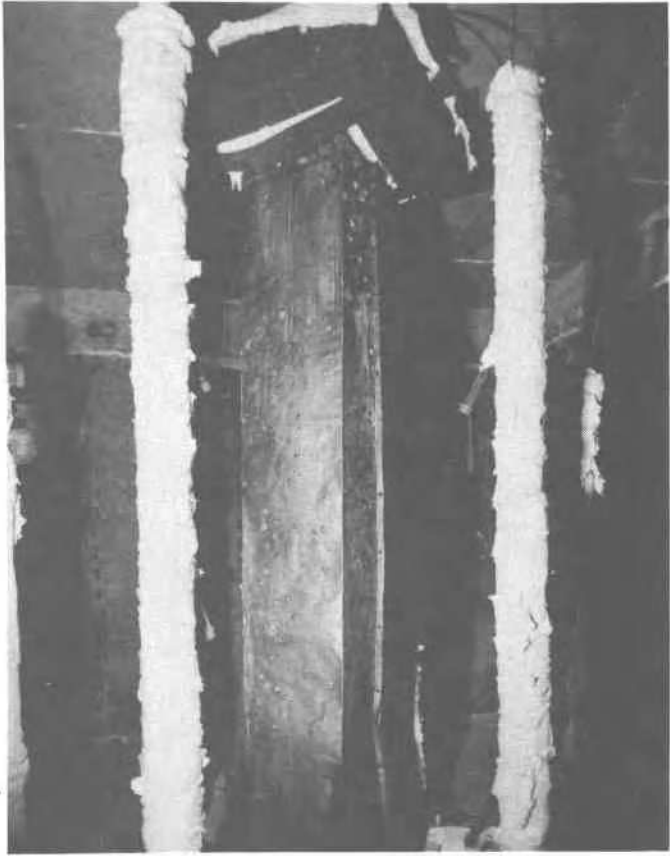
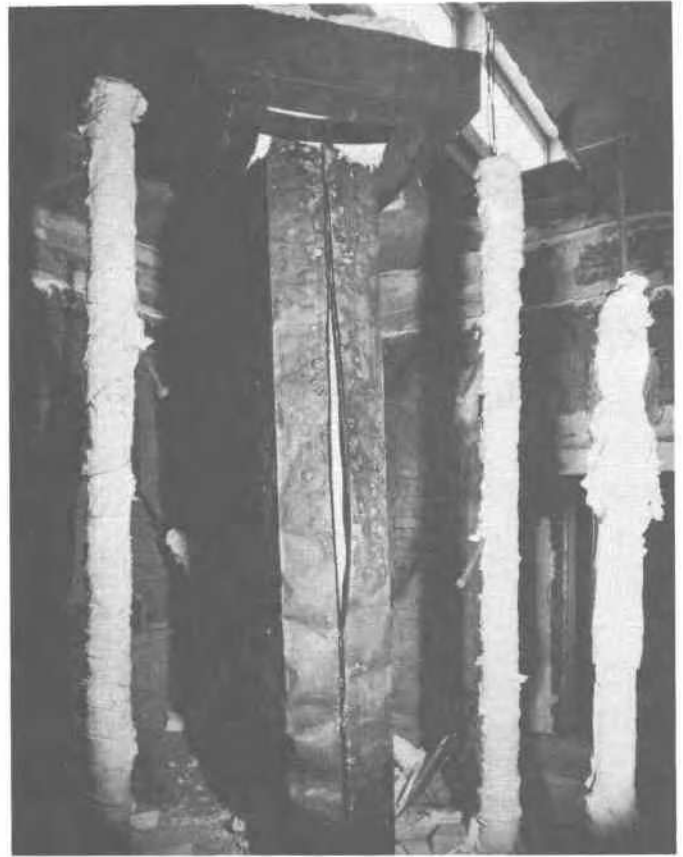
Figure 12: Column No. 2 in Furnace after Test

Figure 12, showing the specimen in the furnace after cooling, indicates the condition of the seam joints and the cover. The opening on one of the joints shown in the photograph was not observed during the fire test. It should be noted that the wallboard behind is still in place.

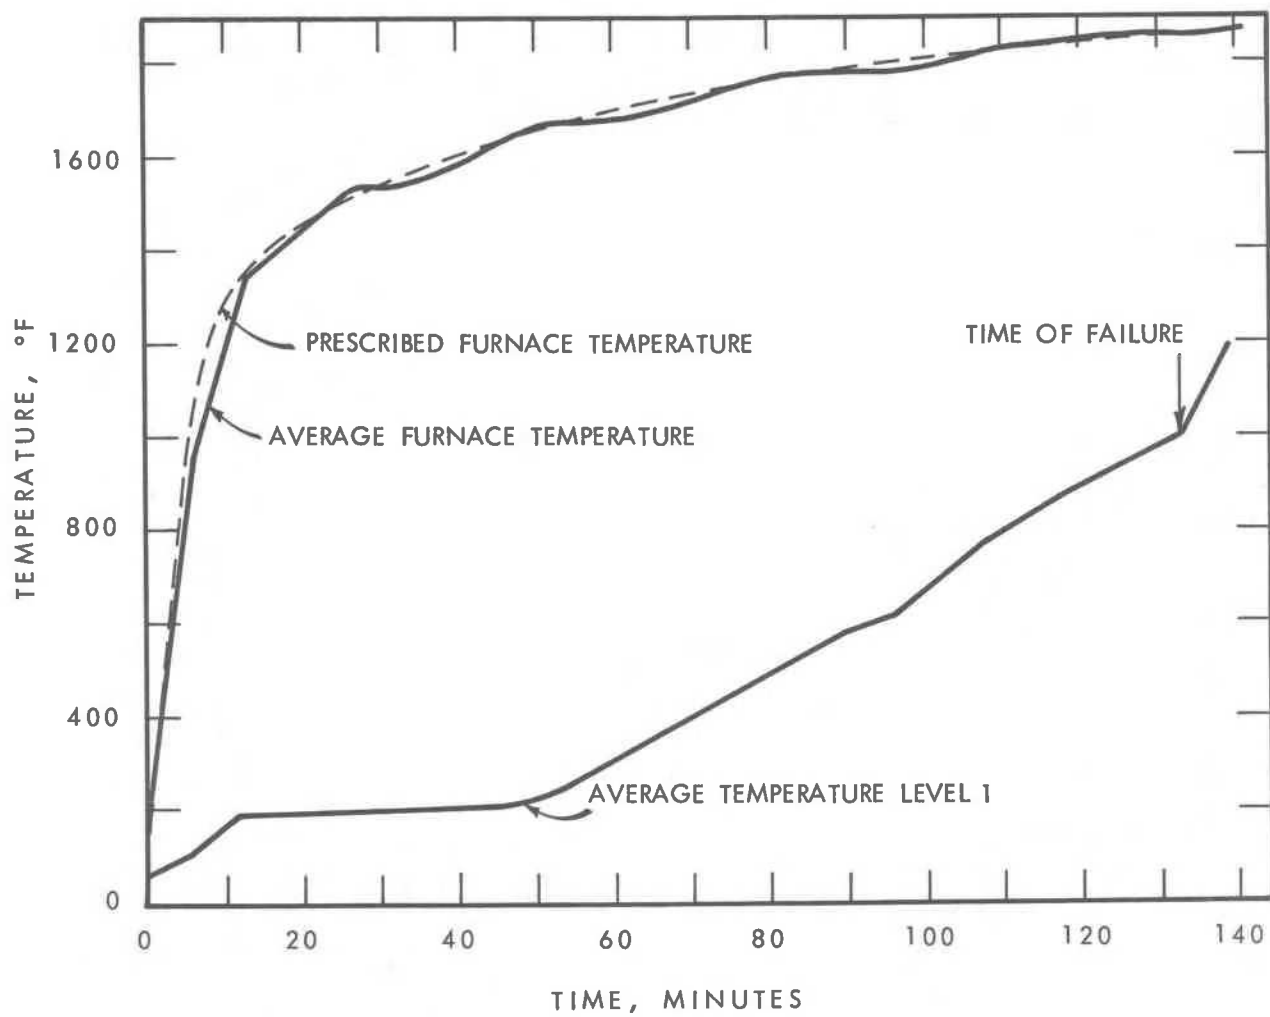
FIGURE 13 COLUMN TEST NO. 1

The average furnace temperature during the fire tests was always within the allowable limits, and a computation indicated that no time correction needed to be applied to the results. Figures 13 and 14 are plots showing the average furnace temperatures and the temperature rise of the columns at the cross-section causing thermal failure. Specimen No. 1 failed at level 1 (top, Figure 8) at 110 min. Specimen No. 2 exceeded the 1000°F allowable average temperature at level 1 at 139 min.

2. The ability of the sheet steel membrane to remain in place and the result of a protective membrane suddenly failing has again been clearly demonstrated. For specimen 1 the membrane burst about 3 min after thermal failure had occurred at level 1. Note the rapid rise of temperature at 113 min (Figure 13), after the column suddenly became unprotected.
