## **SLIDING RESISTANCE OF GROUNDED SPRAY ICE STRUCTURES**

**A. Barker and G.W. Timco  
Canadian Hydraulics Centre  
National Research Council of Canada  
Ottawa, ON K1A 0R6  
Canada**

**Technical Report  
CHC-TR-017**

**February 2004**

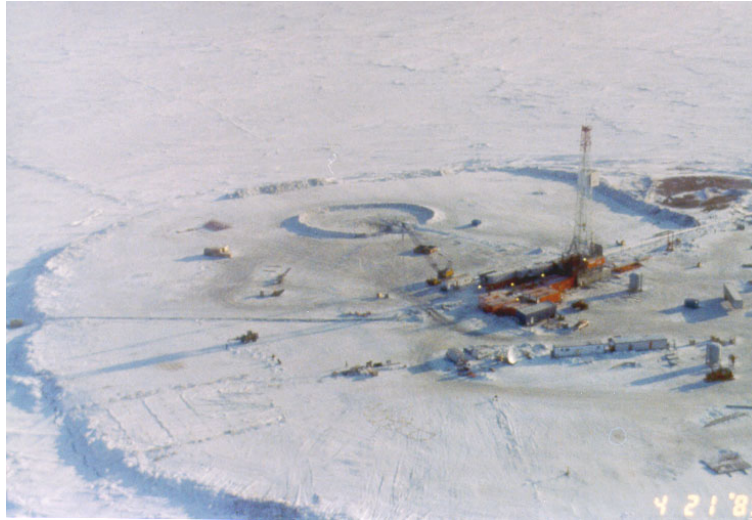
**Figure 1: Photograph showing the Nipiterk spray ice island. Note the high freeboard of the island compared to the surrounding ice sheet.**

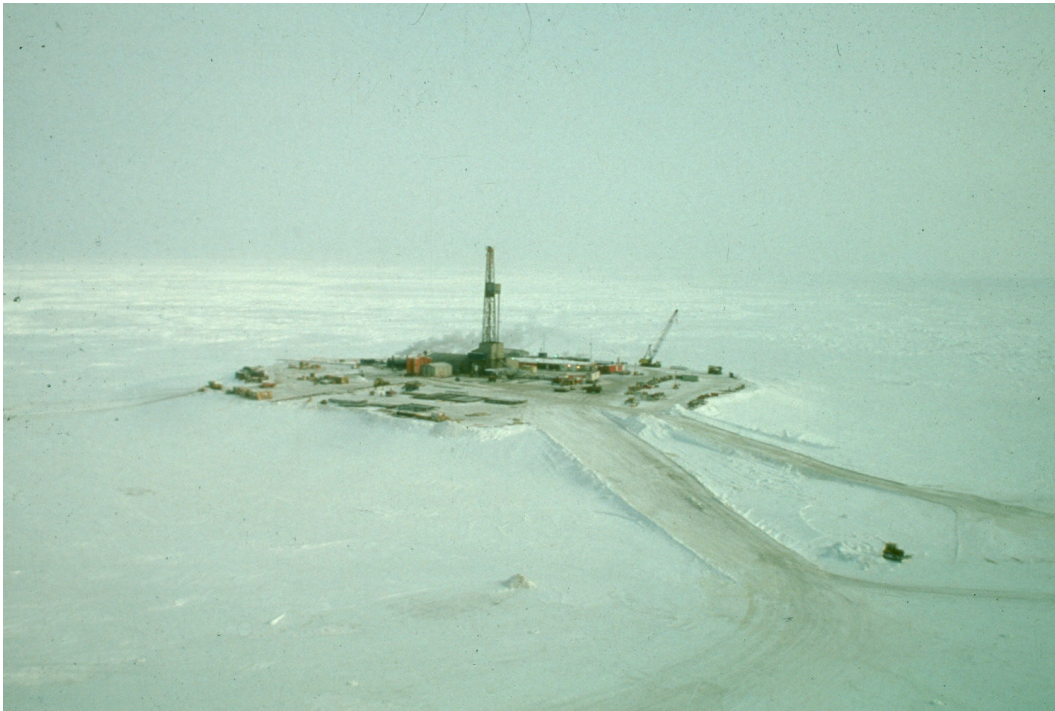
**Figure 7: Photograph of Mars Ice Island**

and Figure 7 is a photograph of the ice island. The island was roughly circular with a drill pad area of 215 m diameter and waterline diameter of 290 m.

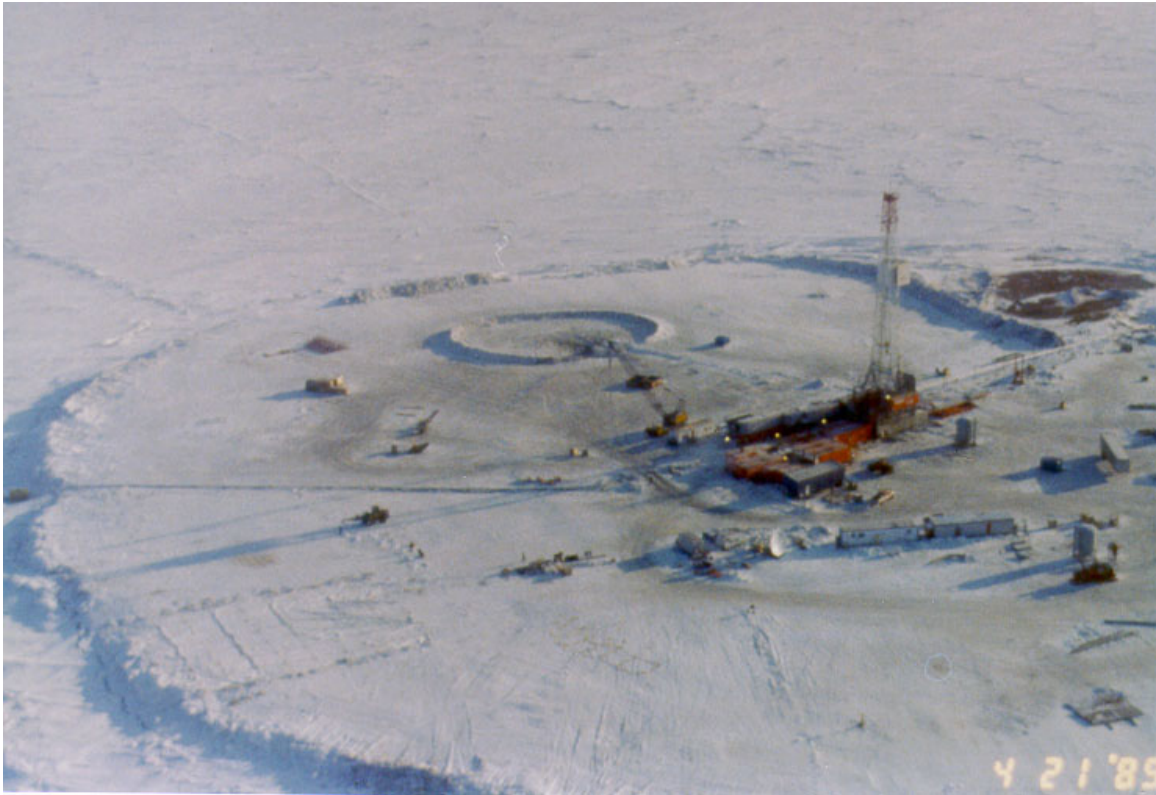
**Figure 17 Photograph of Nipiterk spray ice island**

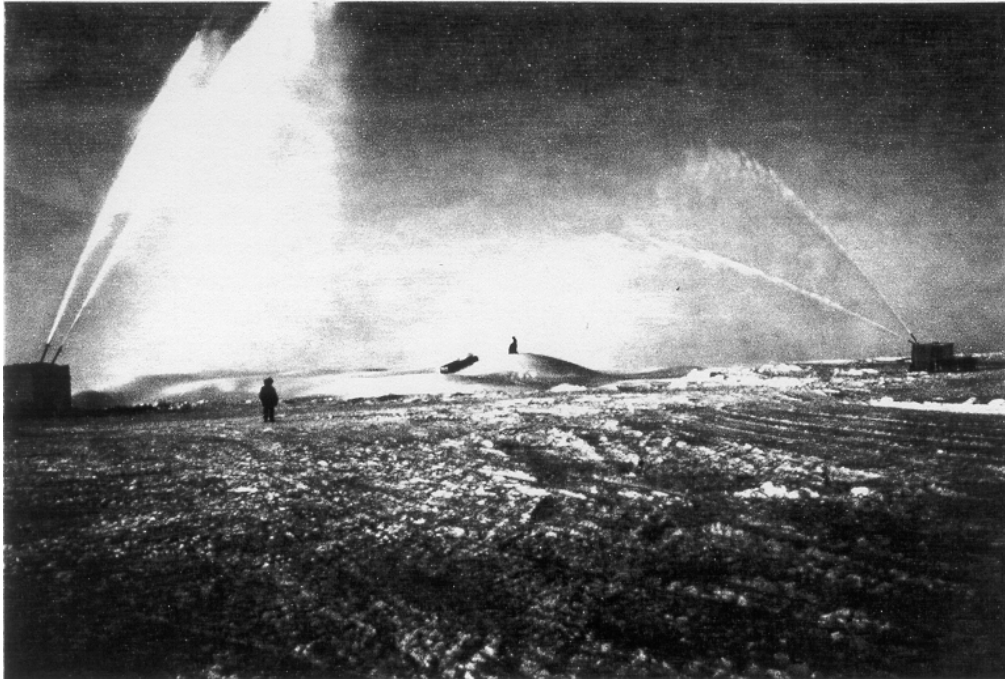
**Figure 36: Spraying ice at Kadluk**

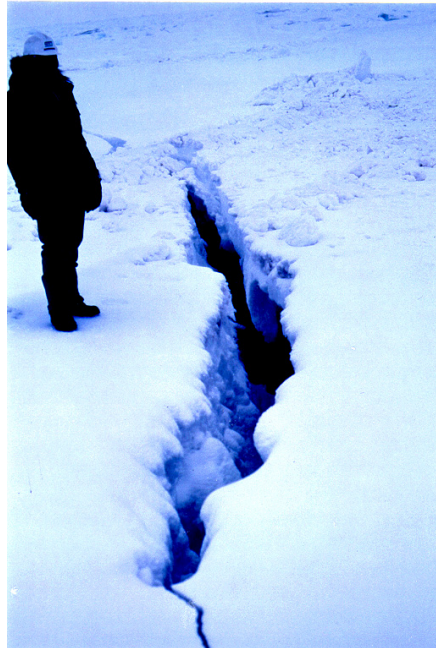
**Figure 37: Cracking on the ice pad surface during construction**

built upon floating first-year and multi-year ice. There was little attempt to ensure that the pad grounded evenly, which resulted in cracking as the pad settled on the bottom (Figure 37). Some of the cracks were up to 2.0 m across. Most cracks were filled with spray ice near the end of the construction period. The weather was very warm throughout this period, so occasionally spraying was halted, or only one pump was used. A total volume of 112 000 m<sup>3</sup> of spray ice was used.

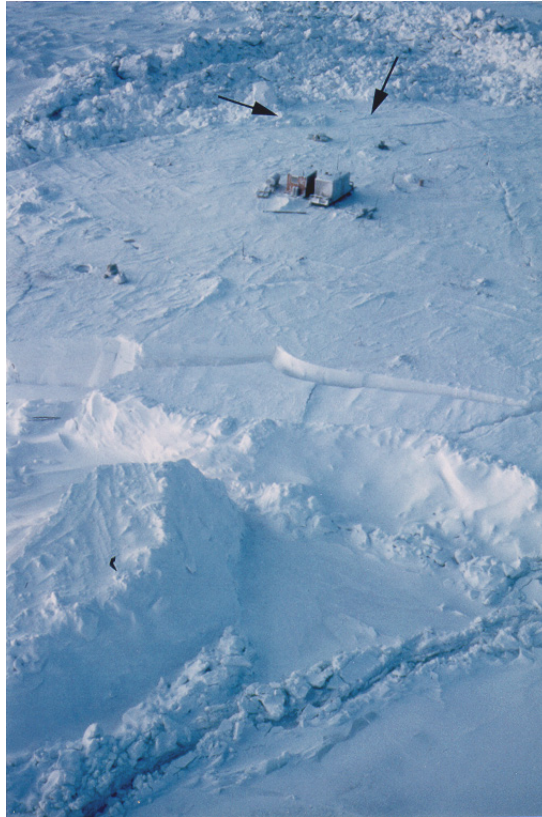
**Figure 40: Kadluk ice pad showing passive slope failures and rubble river after ice event**

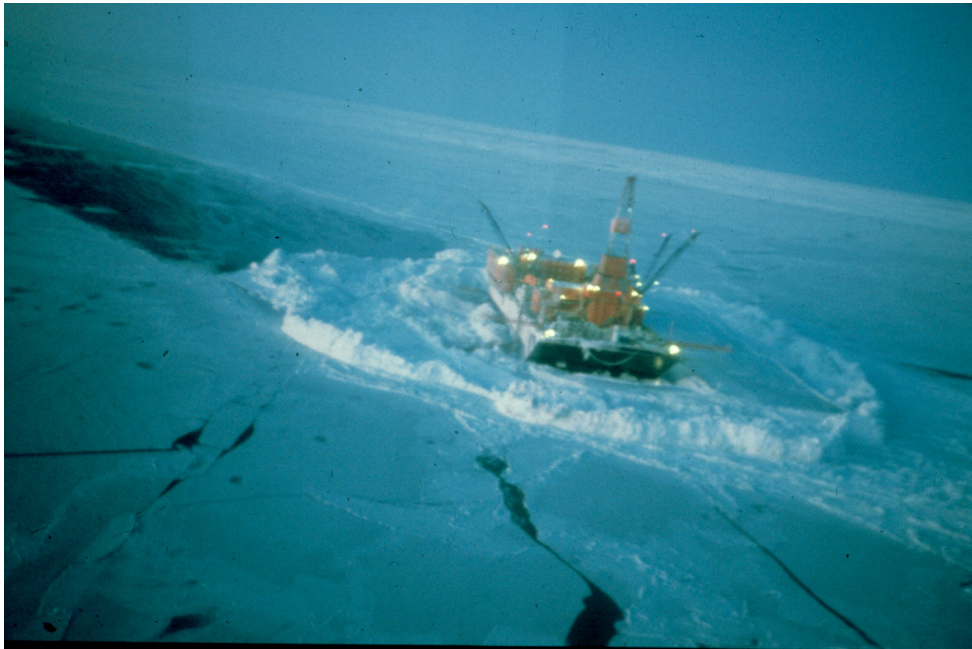
**Figure 46 Photograph of SSDC at Uviluk**

The maximum estimated freeboard for the ice pad surrounding the SSDC was 10 m, with an average keel depth of 10 m and a width of 50 m. A photograph of the site is shown in Figure 46 and a sketch of the site is shown in Figure 47. The design ice pressure at the edge of the ice rubble was 1 MPa. Maximum ice pad resistance was calculated to be 75 200 tonnes, for a 374 m wide rubble field with and ice load of 78 500 tonnes. The friction factor between the ice pad and the berm was assumed to be 0.5, taken to be a conservative value and suggesting that any failure would occur through the sand at a friction factor of 0.58 (30°). It was noted from observations at Tarsiut and Hans Island (not covered in this report), that a sail:keel ratio of 1 was required for rubble stability. Details about the SSDC at this location were found in Canmar (1982 and 1983).

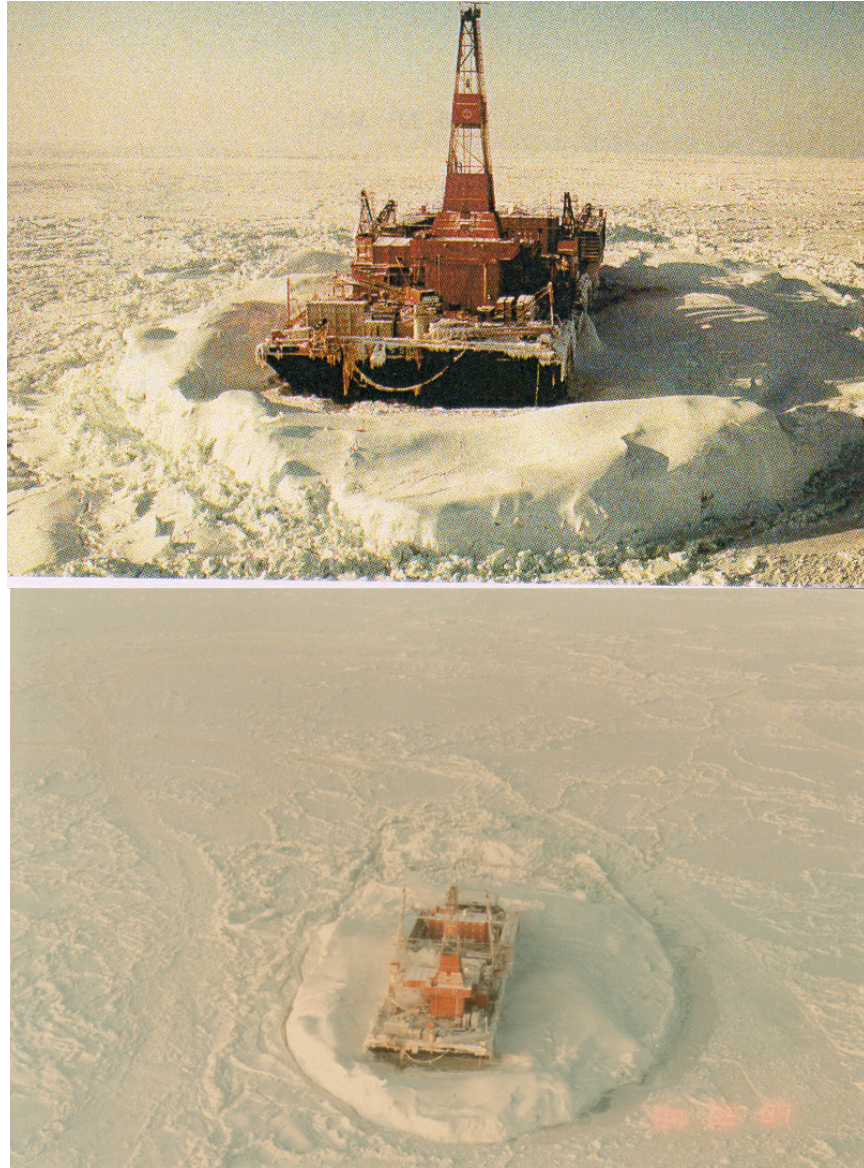
**Figure 48: Two views of the SSDC at Kogyuk location – spray ice pad on right side of photos**

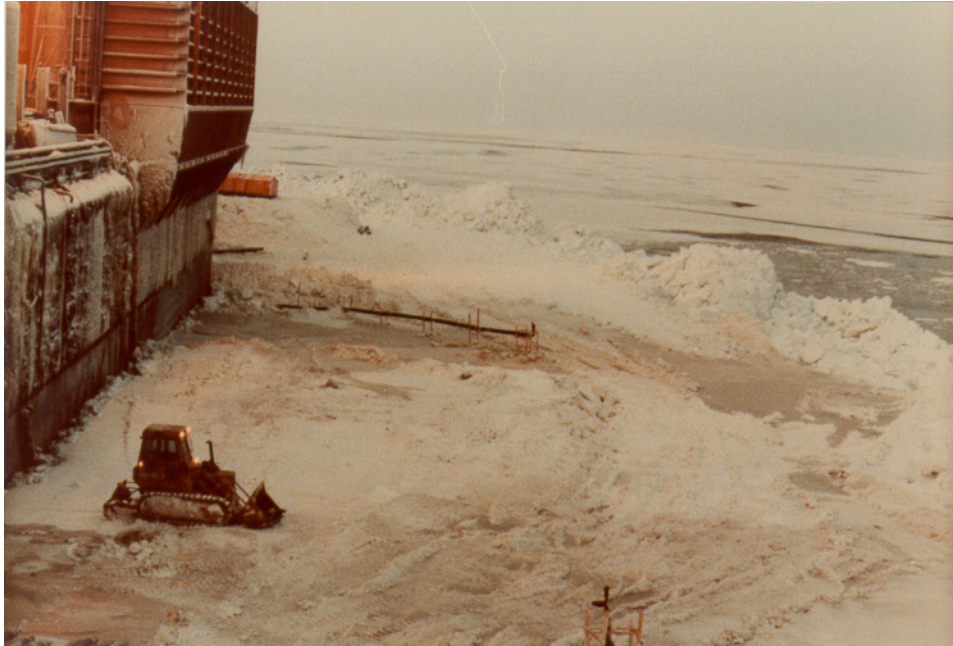
**Figure 49: Bulldozing the ice pad**

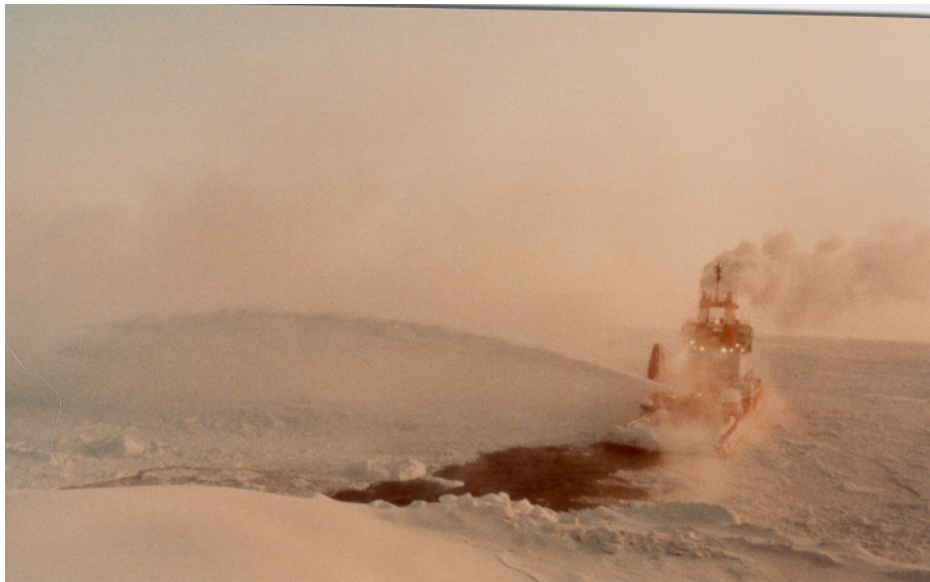
**Figure 50: Spraying ice from the Kigoriak**

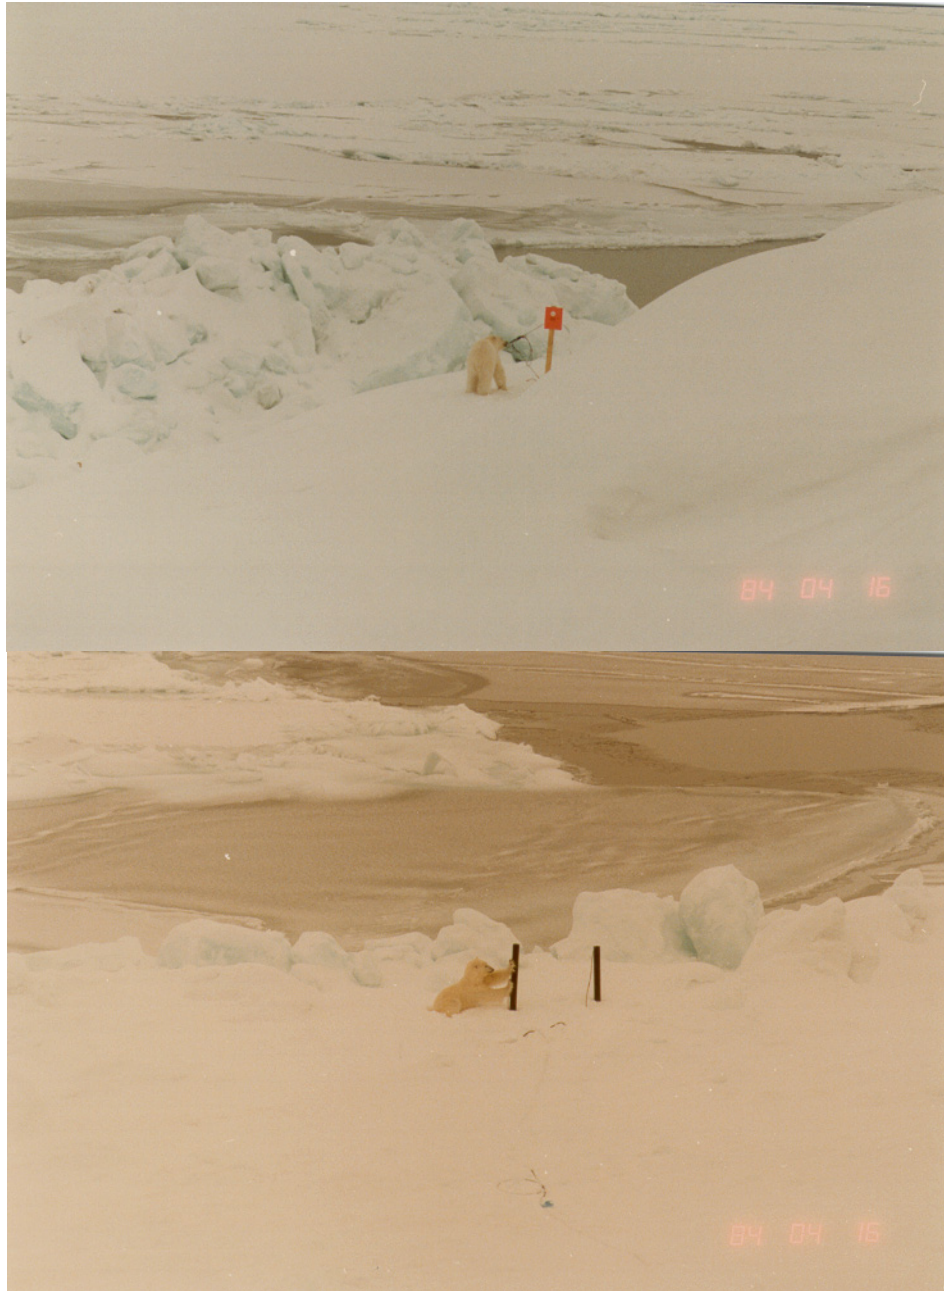
**Figure 54: Two photographs showing instrumentation hazards encountered at the Kogyuk drill site.**
