Snow on Sloping Roofs

by D.A. Taylor

Appeared in
Proceedings
1987 CSCE Centennial Conference
Montréal, Québec, May 19-22, 1987
Vol. 1, p. 145-158
(IRC Paper No. 1530)

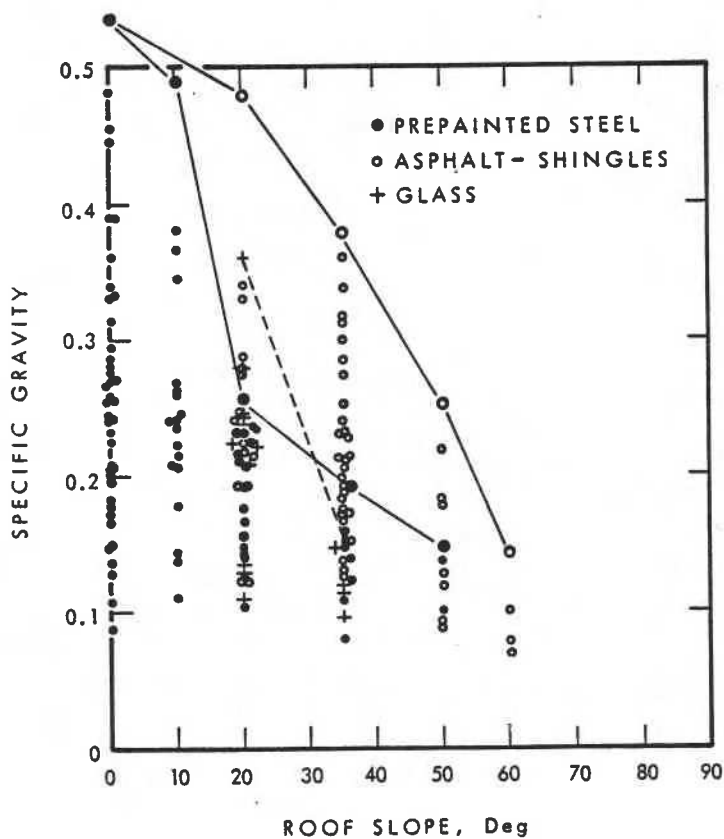
Snow depths were measured weekly at nine points on each roof and averaged. Density samples were taken, but not on each roof weekly, because the roofs are small and sampling disturbed the snow. The results (Fig. 2) indicate that the densities tend to decrease on steeper

Fig. 2. Specific gravity versus slope measured on experimental roofs at National Research Council Canada over 12 winters, 1974-1986.

slopes (Taylor 1985). Why? Because snow on steeper roofs slides more often, the snow on the roof when measurements are taken is usually newer and therefore less dense. Furthermore, steeper slopes drain off rain and meltwater more readily. There is, as well, another fundamental reason. With time the snow on flat surfaces settles and increases in density. On sloping roofs, the component of deformation parallel to the slope becomes shearing or creep deformation, and the component perpendicular to the slope contributes to increased density. Hence the steeper the slope, the less the perpendicular component, and the less the increase in density or specific gravity due to settlement.

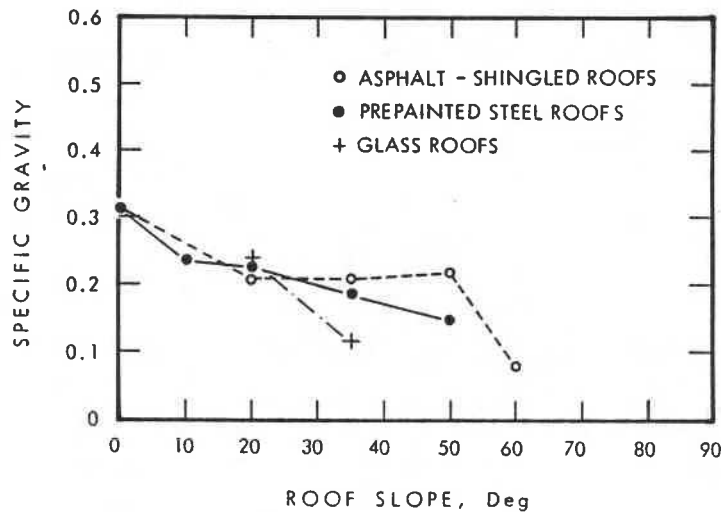
The general decline in specific gravity with slope is shown in another way in Fig. 3. These values were obtained by selecting the

Fig. 3. Specific gravity corresponding to the maximum roof load versus slope over 12 years at National Research Council Canada, Ottawa.

specific gravities corresponding to the maximum loads on the slopes. Higher specific gravities were recorded but they occurred late in the season when the loads had decreased markedly. Using only eight years of data, to 1982, Taylor (1985) reported that the decline for asphalt-shingled and steel roofs was almost linear. Now with more density data, collected over the last four years, there is more scatter. Nevertheless the trend towards lower density with increasing slope is clear.

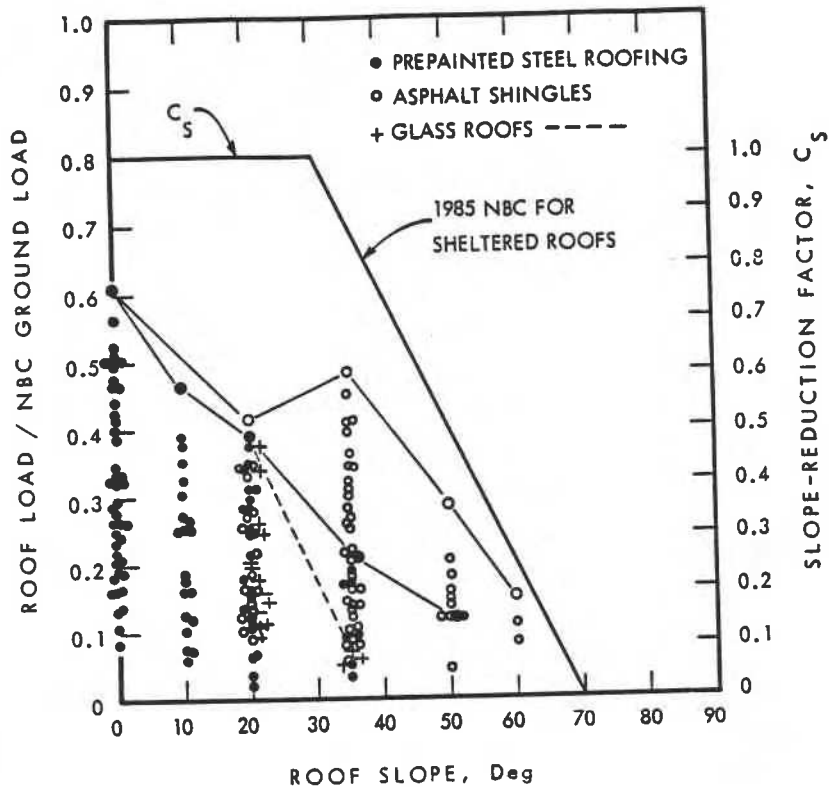
When the loads computed from measured depths and densities are plotted as in Fig. 4, it is clear that they drop as slopes increase, and

Fig. 4. Data from 1974-1986 plotted versus ratio of roof load to National Building Code ground loads. Axis on right is the slope reduction factor C_s . At 50° there were many measurements of zero snow on the steel roofs.

that loads on metal roofs decrease more rapidly than those on shingled surfaces. Preliminary indications are that snow on glass slides off earlier than on metal roofs even though the snow has to slide over two 10 mm high horizontal framing members on the glass.

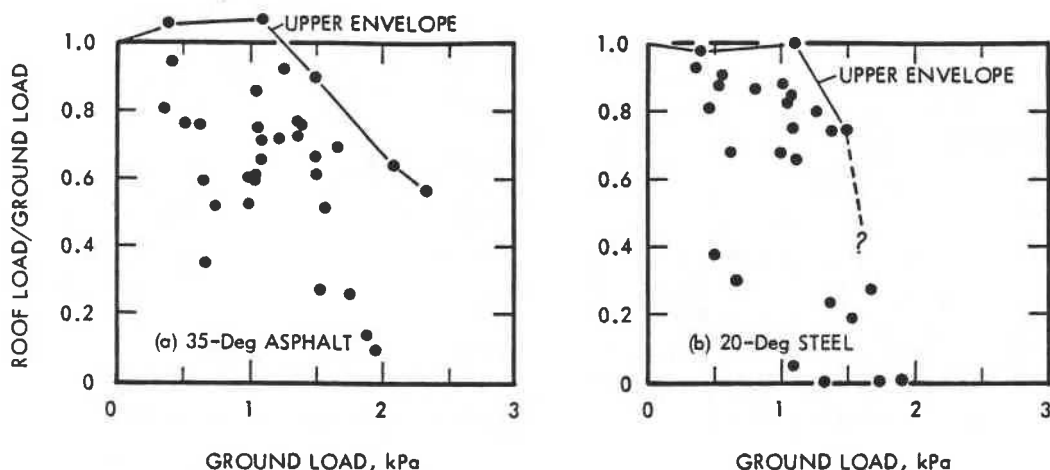
What is the explanation? As the roof load, W , increases, so does the tendency to creep and slide. Sliding or shearing resistance at the roof surface (F in Fig. 1) is composed of adhesion/cohesion and friction. Though the friction component, which is a function of the angle of internal friction of the snow, may increase with increasing load, the adhesive/cohesive resistance does not. The overall shear resistance will therefore increase less rapidly than the driving force $Q = W \sin \alpha$. The result is that the ratio of roof to ground load tends to decrease as the snow continues to accumulate (Fig. 5). In other words, the more snow there is, the more likely it will slide off.

Fig. 5. Reduction ratio of roof to ground load as ground load increases.
