### Liferaft performance under tow Phillips, M.

*Student Report (National Research Council of Canada. Institute for Ocean Technology); no. SR-2005-21, 2005*

## LIFERAFT PERFORMANCE UNDER TOW

SR-2005-21

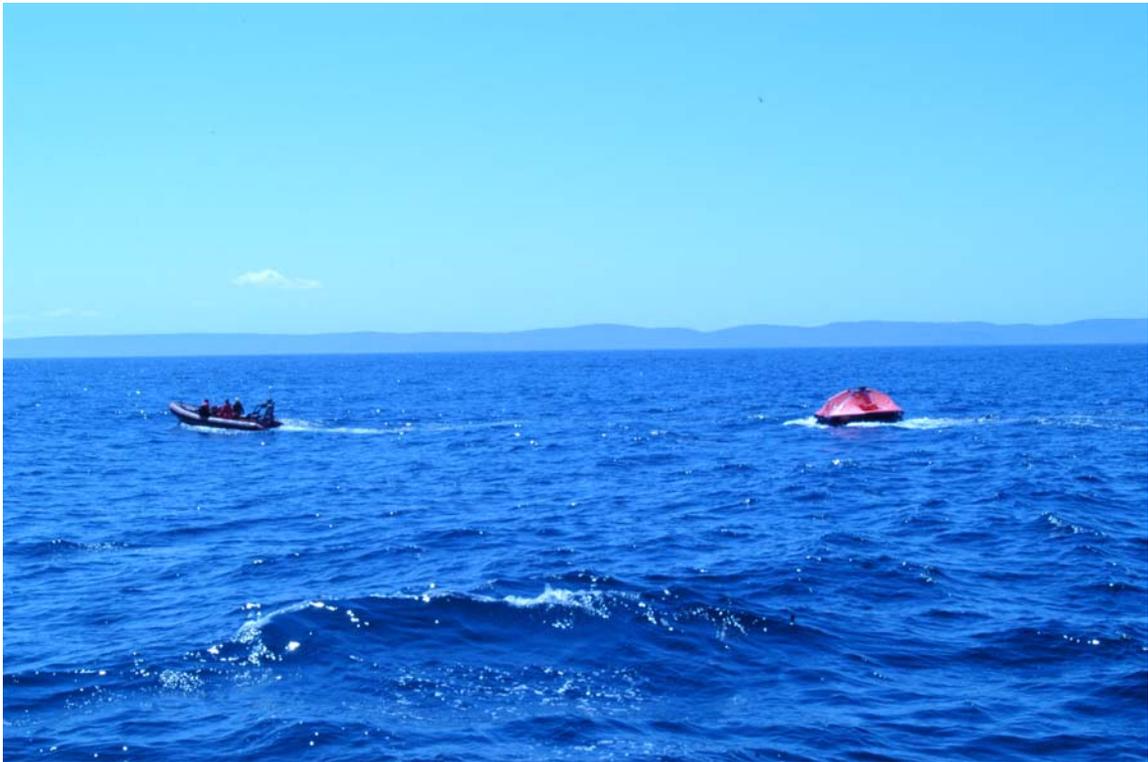
The sea trials were done from aboard the MV Louis M Lauzier and the tow craft used for the tests was a Zodiac Hurricane 640 FRC. The FRC can be seen towing the 16-person liferaft in Figure 1. The 16-person capacity liferaft used was a new year-2004 model from DBC Marine Safety Systems. The 42-person capacity raft was manufactured by RFD Beaufort in 1990 and had previously been on the MV Joseph and Clara Smallwood, although it was never used. The target load for the experiments was approximately 75%, which would represent 12 persons in the 16-person raft, and around 32 persons in the 42-person raft.

Figure 1: FRC Towing Liferaft

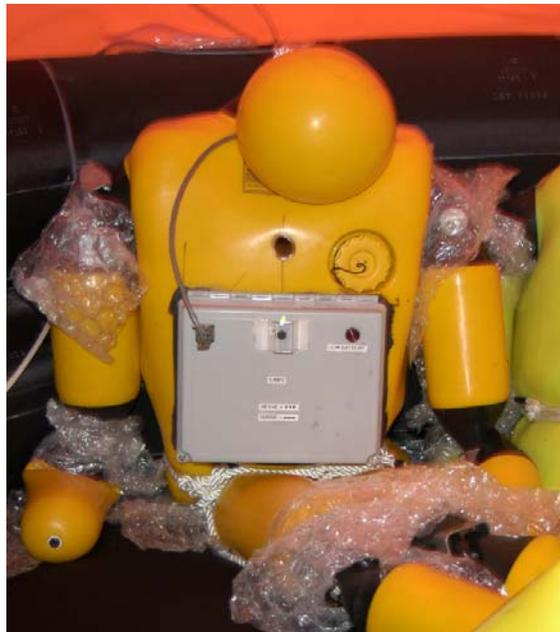
Three “MotionPaks” were used to record the heave, surge, and sway accelerations, as well as the roll, pitch, and yaw rates of the FRC, the raft, and of a mannequin sitting in the liferaft. The MotionPaks use an inertial sensing system to measure angular rates and linear accelerations. A picture of the mannequin equipped with a MotionPak is shown in Figure 2. GPS units were also fitted

Figure 2: MotionPak Mannequin

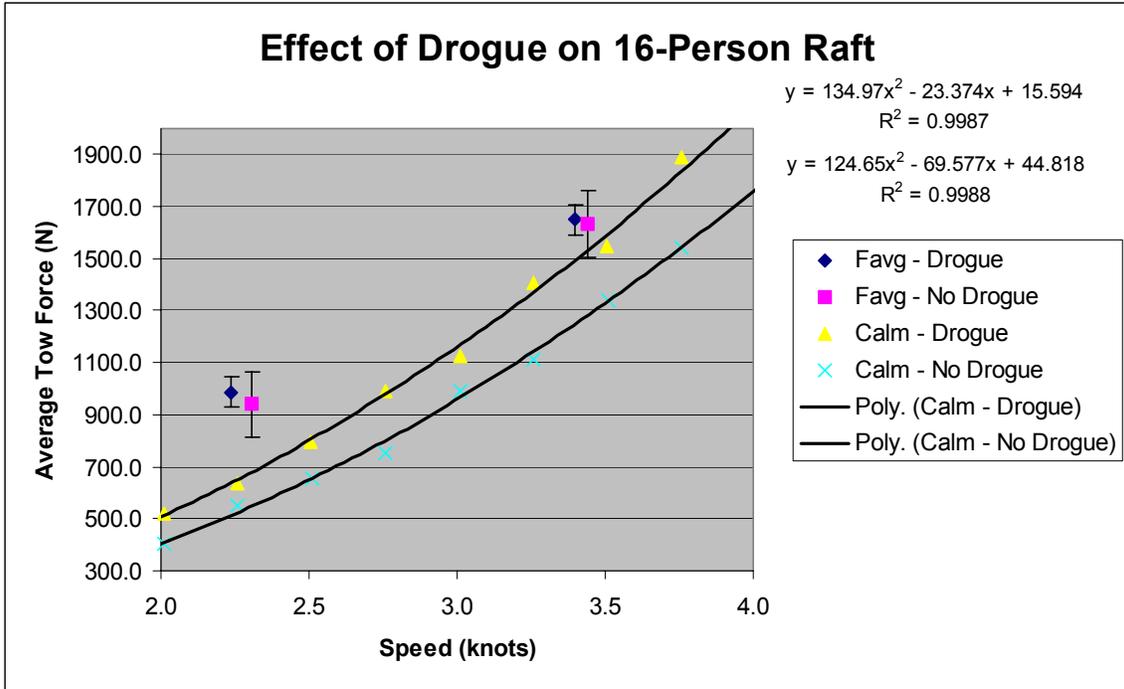
The use of a drogue was found to increase the required tow force, as expected. This also agrees with previous research done with the 16-person liferaft in the clear water tow tank at the Institute for Ocean Technology [2]. Results from the tow tank showed that the tow force at 3 knots with the drogue deployed was approximately 175N greater than without the drogue. Figure 4 clearly shows an increase in tow force when a drogue is used. The calm data shown in the figure is from the clear water tow tank tests. Figure 5 is a column chart of the same data. The equations of the polynomial lines of best fit shown in Figure 4 were used to predict tow force values at 2.2 and 3.4 knots in calm water for Figure 5. The average speed without the drogue is slightly higher than these two speeds, but since there were only two different constant shaft speeds tested, similar regressions to speeds of 2.2 and 3.4 knots were not possible, since a linear fit would be inappropriate. Instead, since the difference between the average speeds when using a drogue versus not using a drogue was small, the average tow forces with no drogue were left unchanged when forming Figure 5. Realistically, the average tow forces with no drogue would be slightly lower at these lower speeds. Therefore, the increase in load when using a sea anchor in ocean waves would be even greater than what is shown in Figure 5.

Figure 4: Effect of Drogue

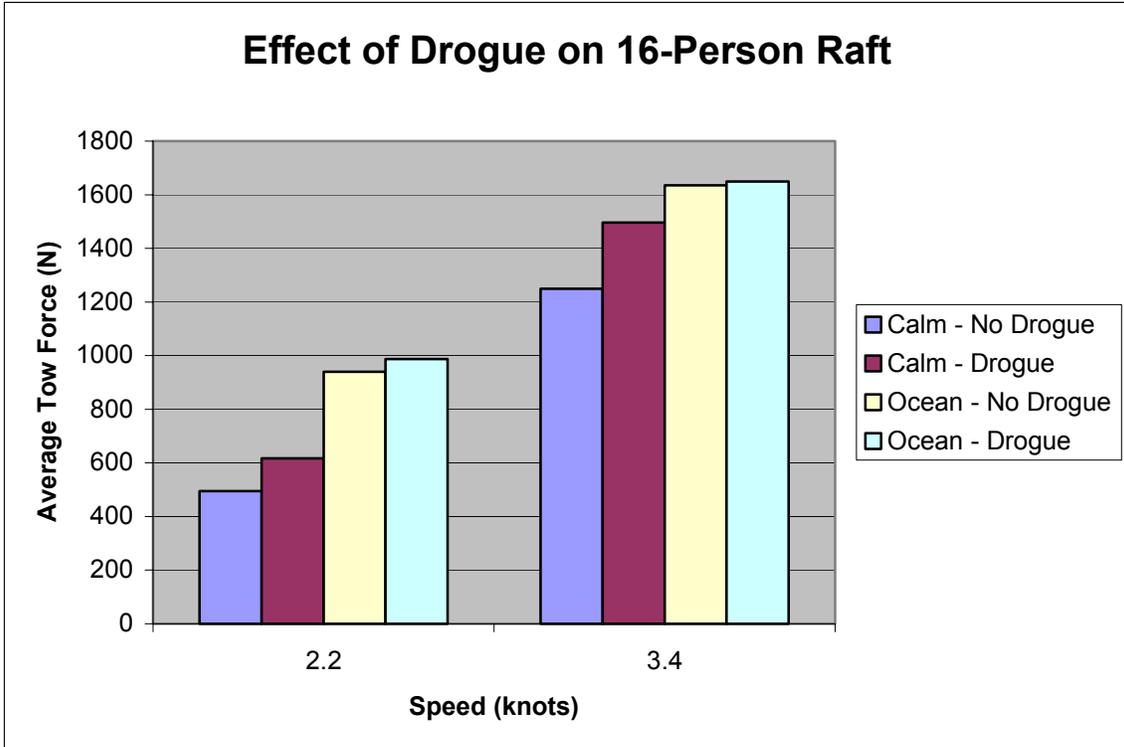
Figure 5: Effect of Drogue Column Chart

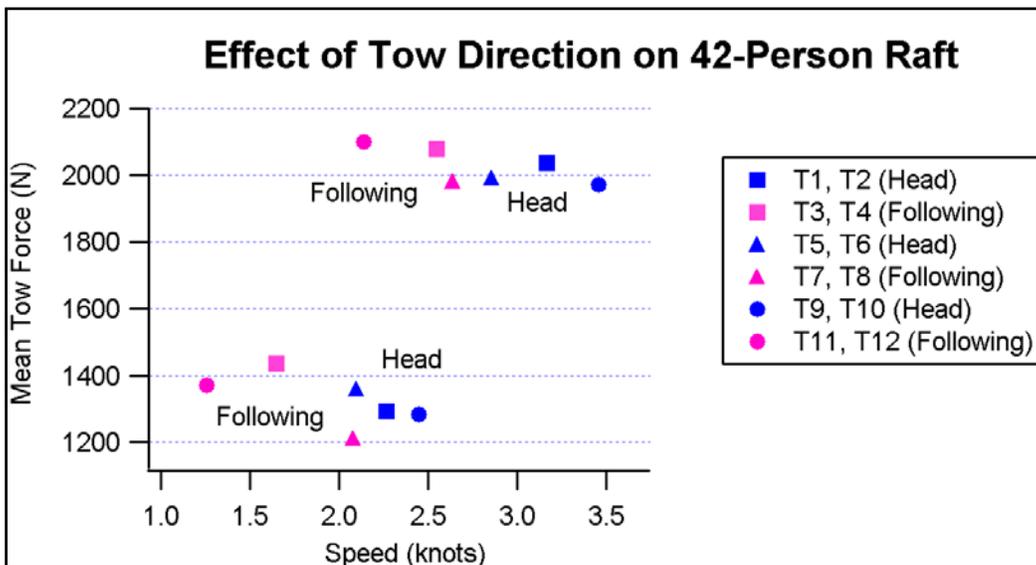
The effect of the tow direction was found to be different than what was initially expected. Upon inspection of Figure 6, it is observed that for a given tow load, it was possible to tow faster into head seas than in following seas. This effect is suspected to be due to a predominant current that was present at the testing location. This hypothesis remains to be verified.

Figure 6: Effect of Tow Direction

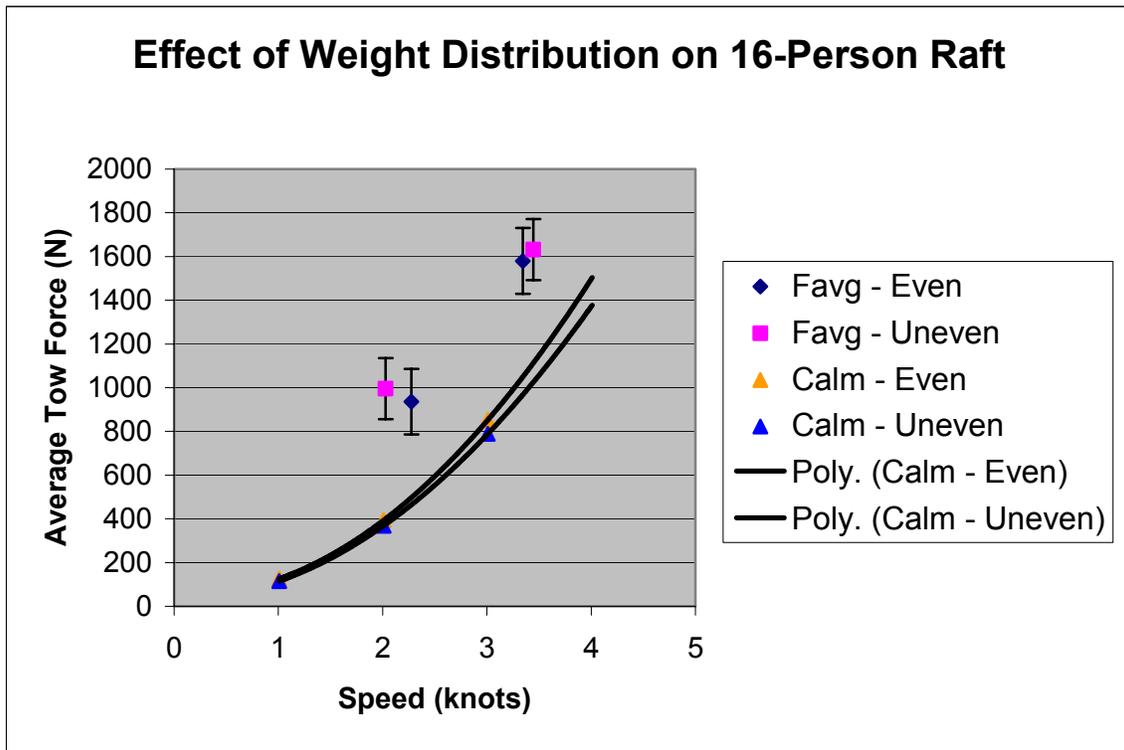
Results from the tow tank have shown a negligible difference in tow force between towing with an even weight distribution and an uneven distribution, when the floor was inflated [2]. When the floor was uninflated, the required tow force with an even weight distribution was found to be slightly higher than with an

uneven distribution. It is believed that the uneven distribution, which shifts weight aft, reduces the “plowing” of the bow of the raft into the waves by lifting up the bow, thus reducing the average tow force as well. The results from the sea trials shown in Figure 7, however, would initially seem to contradict those previous findings. Some possible reasons for this unexpected result become apparent when the individual differences between runs shown in Figure 8 are compared to the weather data that was acquired.

Figure 7: Average Effect of Weight Distribution

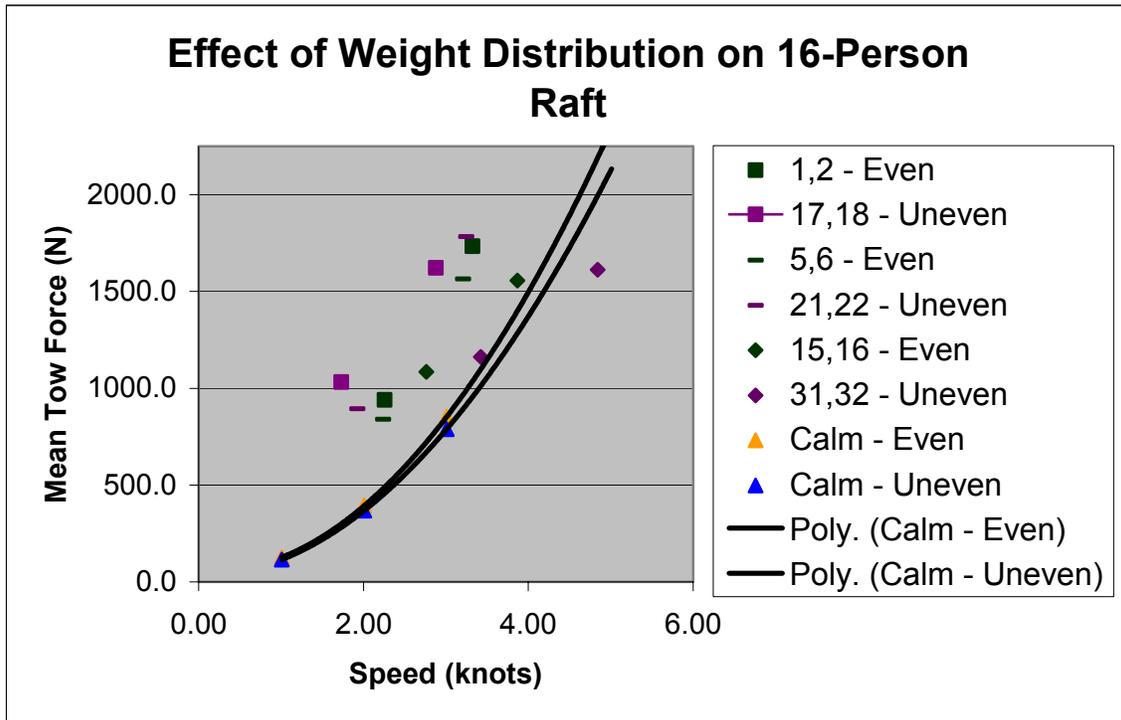
Runs 1, 2, 17, and 18 were all done into head seas, but runs 1 and 2 were completed on a different day than runs 17 and 18. The opposing wind during

runs 17 and 18 was nearly 10 knots stronger, and the opposing wind waves were an average height of 1.1m versus 0.4m for runs 1 and 2. The increased speed that was achieved with the even distribution may therefore be due to less severe weather. Also, the inflation tank normally located underneath the raft was lost prior to runs 1 and 2 being completed, which may have reduced the drag of the raft as well.

Runs 5 and 6 show a similar pattern when compared to runs 21 and 22. Both runs were completed straight into the weather, but the wind during runs 21 and 22 was approximately 8 knots stronger, and the wind waves were 1.0m high, which was greater than the 0.4m wind waves experienced during runs 5 and 6. The inflation tank was also missing during runs 5 and 6, which may have resulted in less drag during these runs as well.

Runs 15, 16, 31, and 32, on the other hand, would indicate that the tow force was reduced when towing with an uneven distribution. These runs were all completed following the weather. The tail wind was approximately 3 knots stronger for runs 15 and 16, the wind waves were equal, but the swell and combined seas (aiding) were slightly smaller. The weather thus does not appear to have significantly reduced the tow force for runs 31 and 32 (uneven), as it had for the even distribution runs in the previous two comparisons, and this combination of runs may in fact offer the fairest comparison between even and uneven weight distributions.

Figure 8: Effect of Weight Distribution for Individual Runs

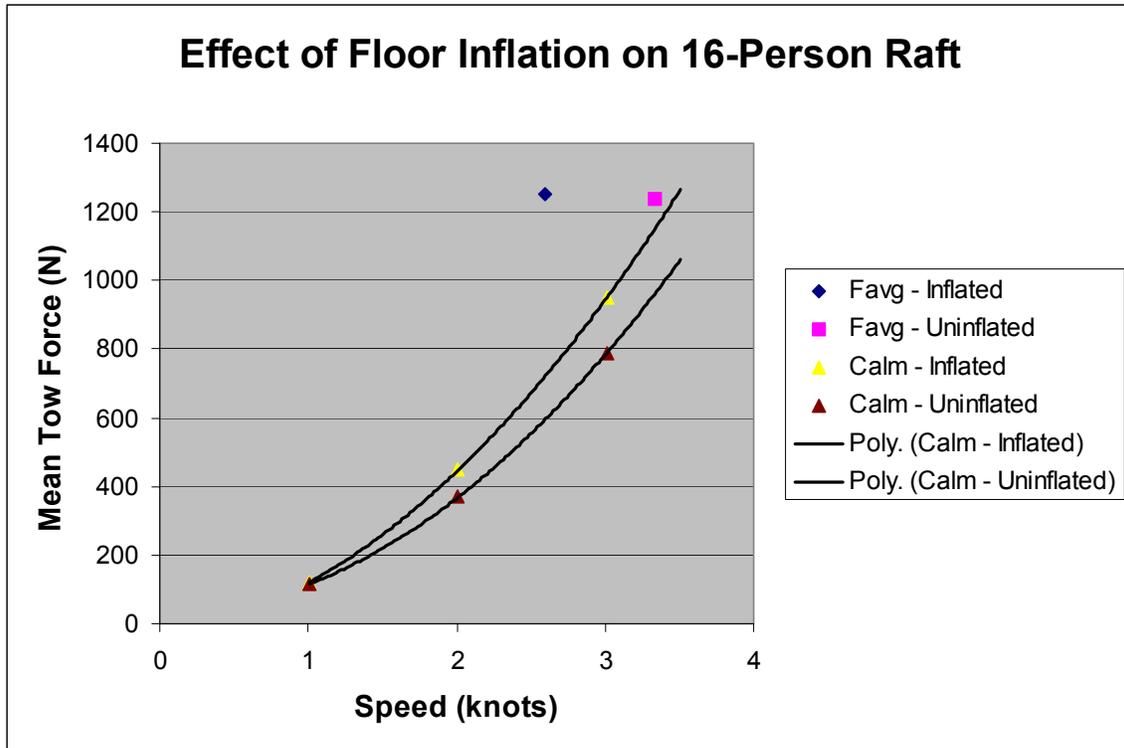
Data from the sea trials shows that for a given tow load, a greater towing speed may be achieved when the floor is left uninflated. This result agrees with previous experiments done in the clear water tow tank, which showed an increase in tow load when the floor was inflated. The data points shown in Figure 8 are both from an average of runs done at 1000rpm only, as no direct comparisons could be made at 1500rpm.

Figure 9: Effect of Floor Inflation

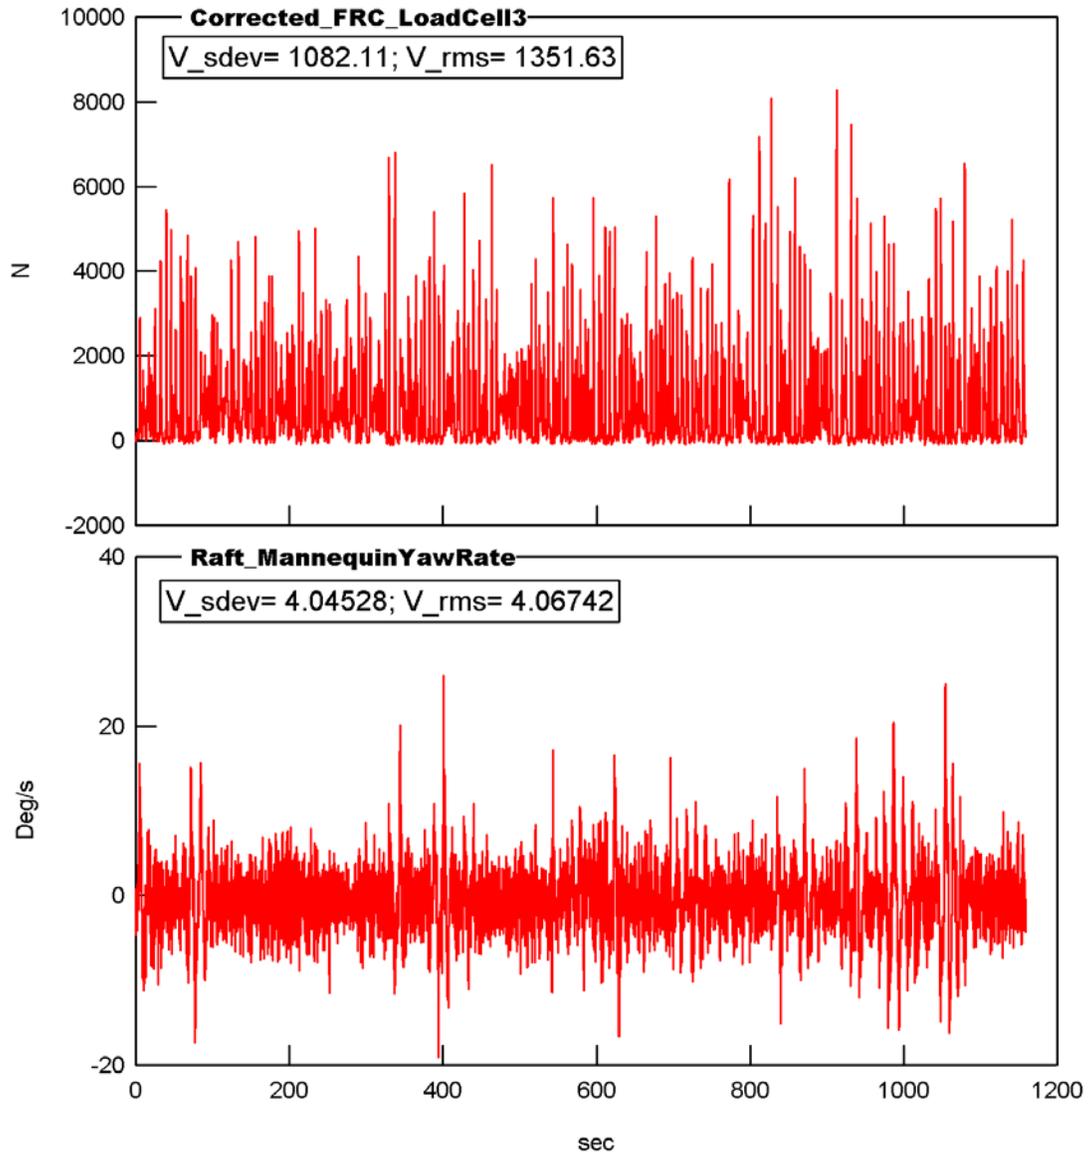
An examination of Figures 10 and 11 shows that both the tow load and the yaw rate could indeed be significantly reduced by adjusting the towline length to get the FRC and raft in phase. Figure 10 shows a run where the liferaft and FRC were observed to be out of phase and the raft was observed to be yawing a lot. Figure 11 shows the same run in similar weather, but with the towline length adjusted so as to get the FRC and raft in phase. The two figures show a drop in root mean square average yaw rate of approximately 25%. The tow load was also reduced by nearly 200N, or approximately 13%. The reason for this relates to the yaw rate of the raft and whether or not the system is in phase. When the raft is out of phase, there is much greater variability in the towline load. In this particular case, comparing the two figures shows a drop in the standard deviation of the tow load of 20% when the raft is in phase with the FRC. When the tow force becomes small, the raft yaws as it descends a wave. Therefore, when there is greater variability in the tow load due to the system being out of phase, the average yaw rate will also be greater. This in turn affects the tow load, as a force in the direction of sway is required to return the raft to a straight alignment as the raft begins to climb the next wave. The forward force in the towline also becomes

the surge component of the total tow force when an angle exists in the towline. The resultant of these two force components is significantly greater than if no yaw occurs. Therefore, significant reductions in the tow load, its variability, and in yaw are possible when the raft is in phase with the FRC.

Figure 10: System Out of Phase

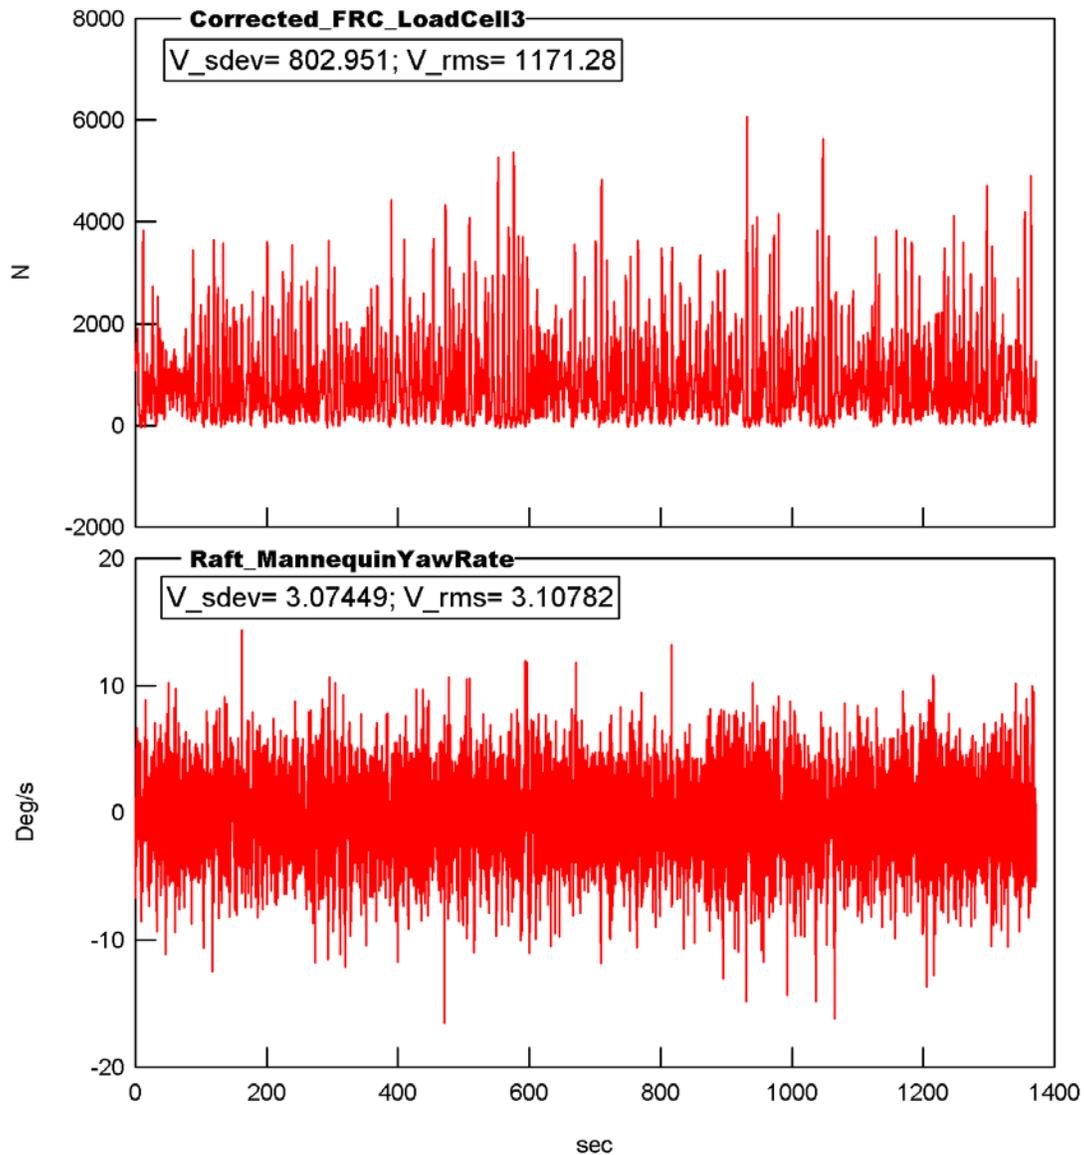
Figure 11: System in Phase

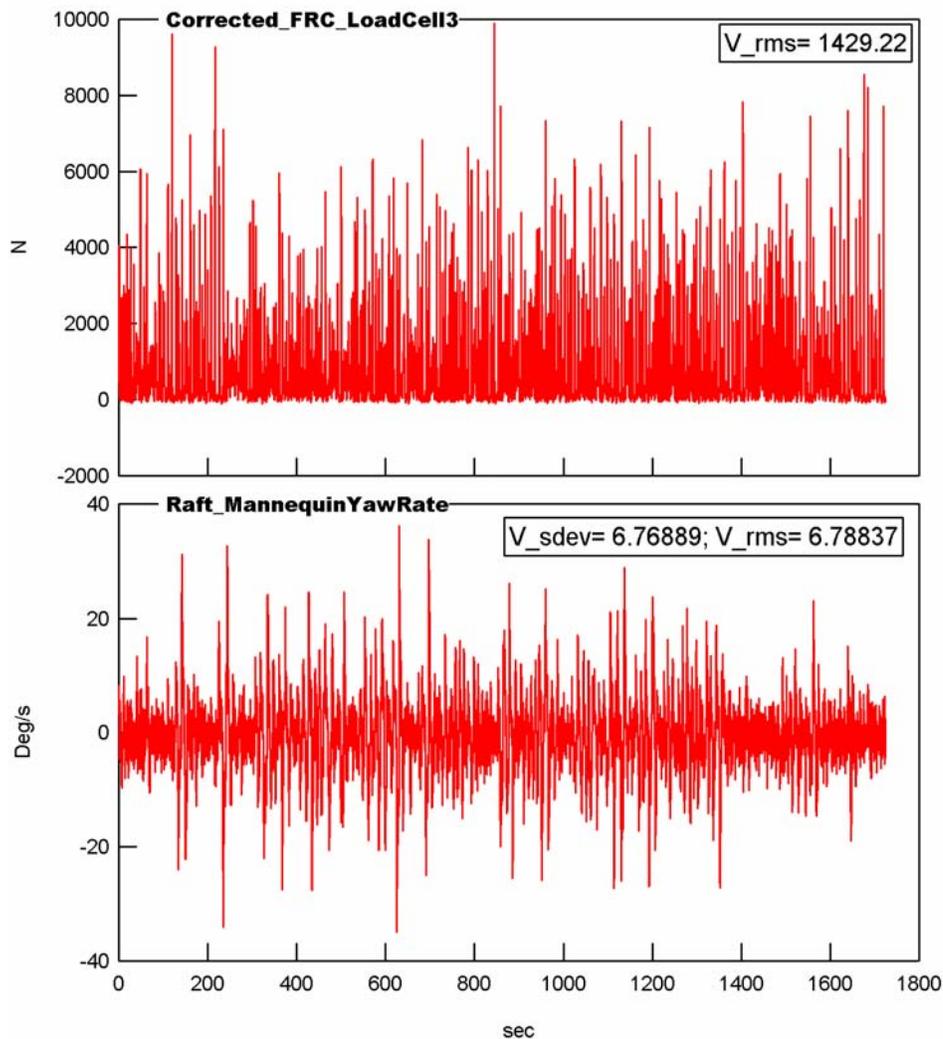
Increasing the speed of tow by increasing the shaft speed from 1000rpm to 1500rpm resulted in increased tow loads, as expected. An increase in speed, however, also often resulted in a more constant tow force, which had the effect of significantly reducing the yaw rate. An inspection of Figures 12 and 13 shows two

identical runs done at different FRC shaft speeds. There were fewer occurrences of the tow load dropping to zero at the higher FRC shaft speed. This more constant tow load in the run at 1500rpm in turn resulted in a reduction in the yaw rate of over 50% when compared to the run done at 1000rpm. Therefore, increasing the tow speed will increase the tow load, but will also often result in much lower yaw rates.

Figure 12: Run at Lower Shaft Speed

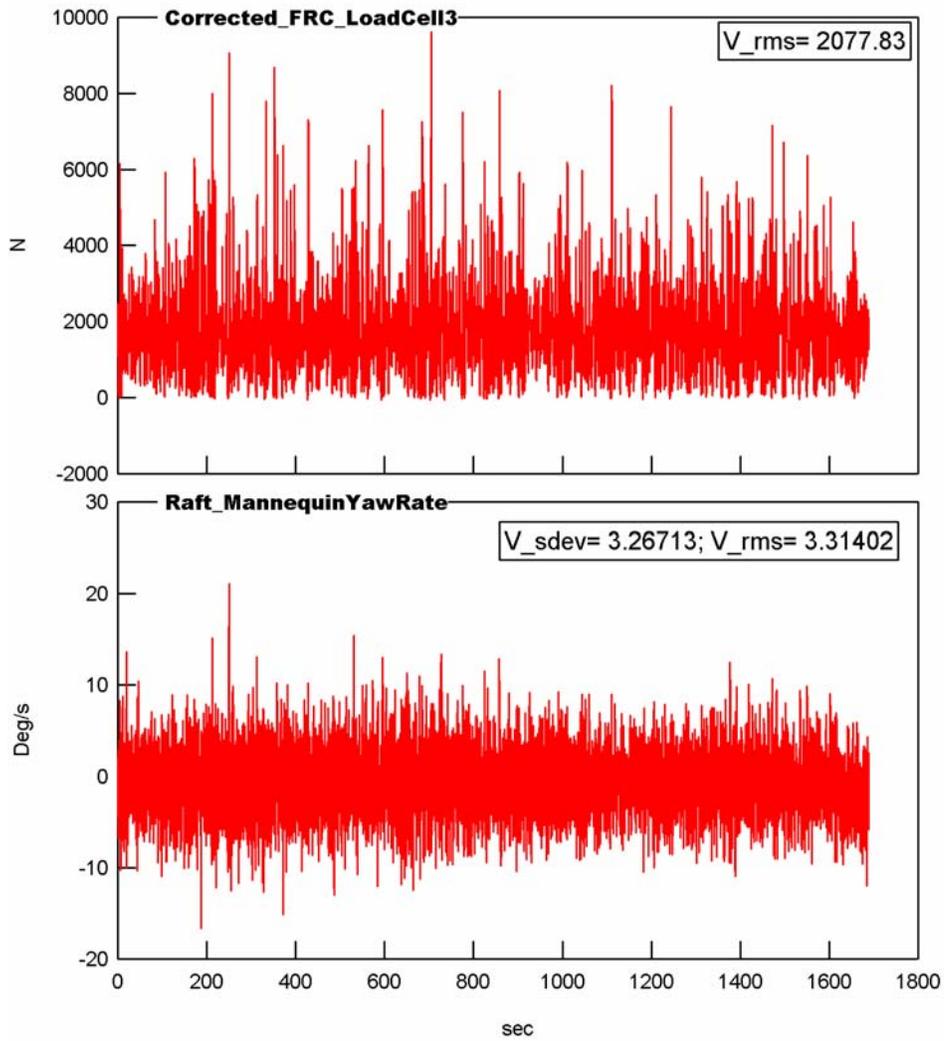
Figure 13: Run at Higher Shaft Speed

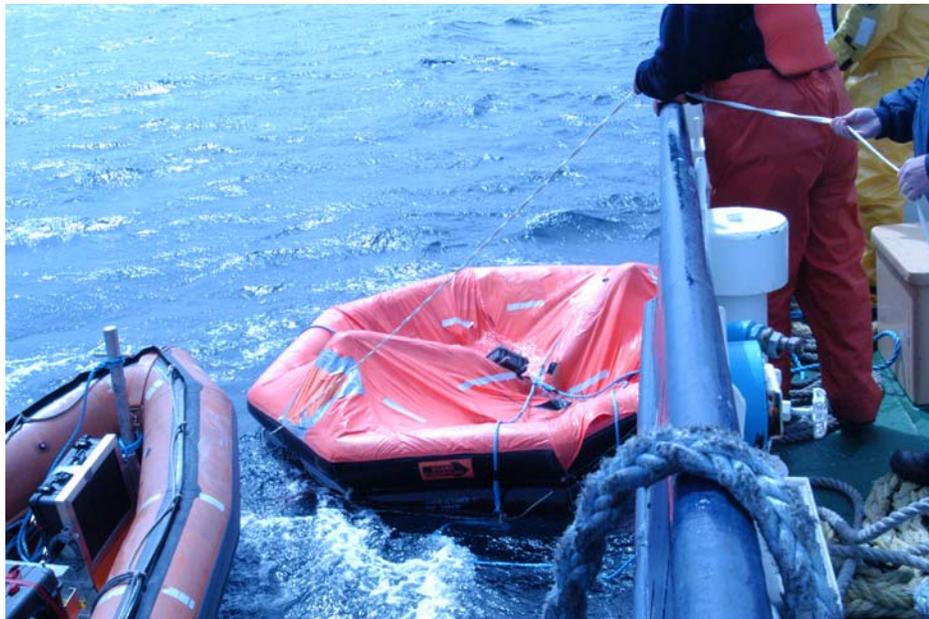
The canopy of the 16-person liferaft frequently collapsed during testing. This was due to water spraying onto the canopy when the bow of the raft plowed into the incoming waves when it was being towed into head seas. This problem occurred both when the floor of the liferaft was inflated and when it was uninflated. However, the problem was particularly severe when the floor was left uninflated. The 42-person liferaft experienced no such problems, which can be attributed to its higher freeboard and its slightly better structural canopy support. The greater freeboard that is gained when the floor is inflated explains why the problem was less severe when the floor of the 16-person liferaft was inflated. Figure 14 shows the 16-person raft with its canopy collapsed due to water accumulation on top of it. Figure 15 shows a pool of water on top of the canopy near the bow entrance.

Figure 14: Collapsed Canopy

The collapse of the canopy eliminates any headroom for the occupants and results in severe flooding of the liferaft. This situation is obviously unacceptable for the occupants. The water in the liferaft due to flooding would significantly reduce the potential survival time of the occupants, as heat would quickly be lost to the water. It also can not be assumed that the occupants will be capable of bailing, and therefore the canopy should prevent this occurrence from happening. Changes to the design of the canopy are obviously necessary.

Several failures also occurred during testing. The canopy of the 16-person liferaft frequently collapsed under the weight of the water that accumulated on top of it. This resulted in massive flooding into the liferaft and eliminated all headroom for the simulated occupants. This problem was more severe when the floor was left uninflated. The current structural design of the canopy was therefore deemed to

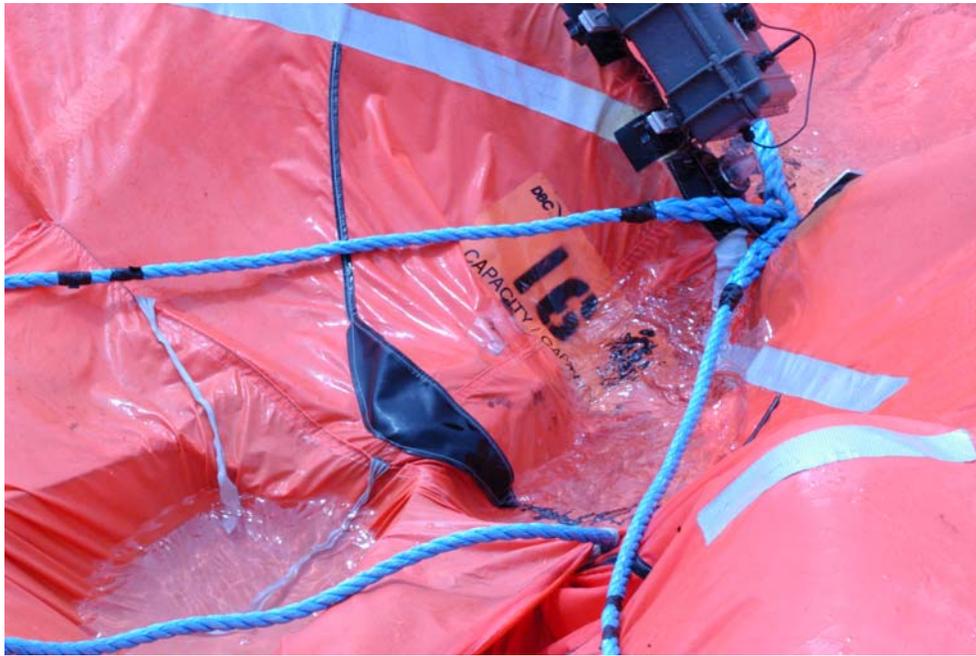
Figure 15: Accumulation of Water Near Entrance

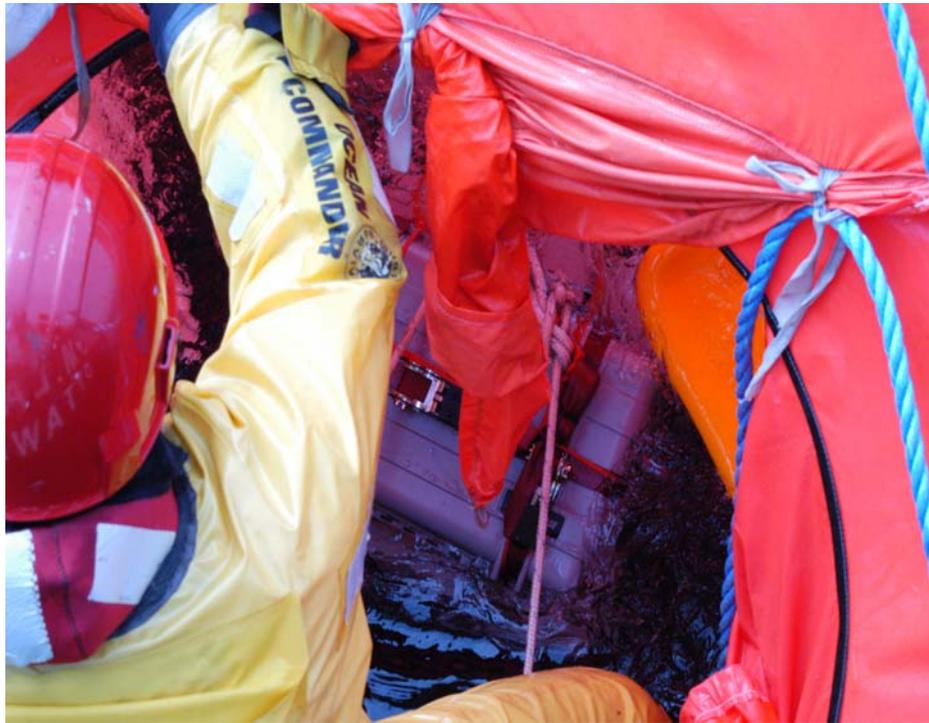
Once the canopy collapses, it loses its ability to effectively keep water out of the raft. The water is no longer deflected off the raft since the slope in the canopy no longer exists. Instead, the water pools on top of the canopy and begins to flow into the raft through the canopy closure. Severe flooding quickly ensues. The water that accumulated in the liferaft frequently needed to be pumped out during the sea trials. On one occasion, after towing up-weather for thirty minutes at 1000rpm, followed by another 30 minutes at 1500rpm, approximately 700L of water had accumulated inside the raft. Figure 16 shows this volume of water inside the raft.

Figure 16: Water Inside Lifteraft

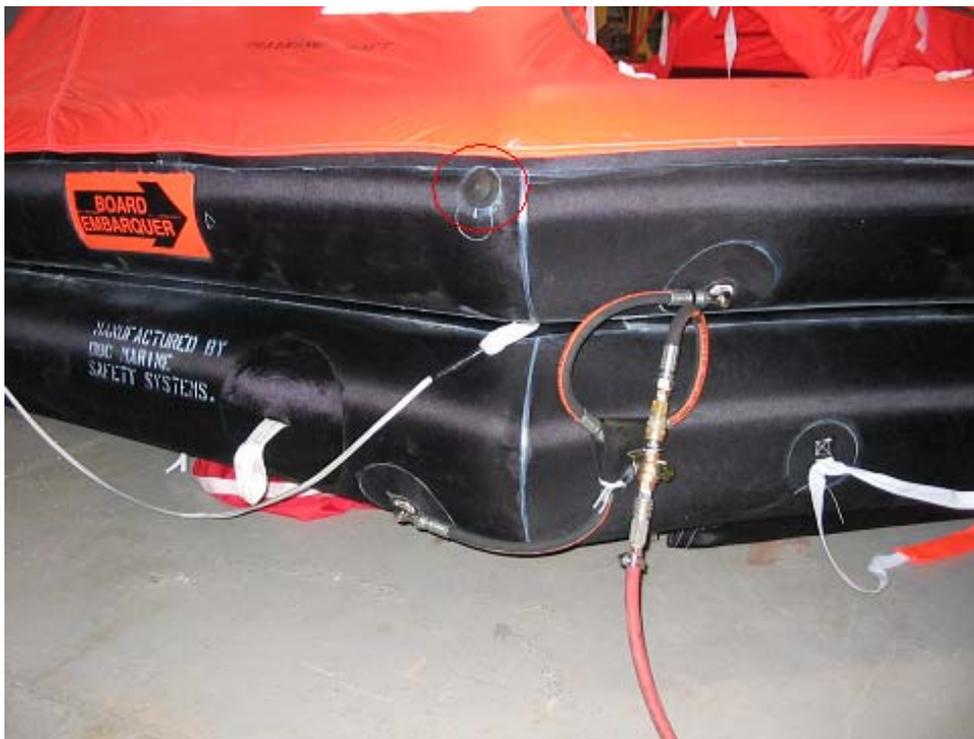
The securing points for the canopy closure also failed during the sea trials. A red ellipse in Figure 17 highlights one such point. The location of these securing points makes them vulnerable to friction damage during boarding of the liferaft

while it is alongside the vessel from which it is launched. All three securing points at the bow entrance were quickly lost due to friction during the sea trials. The weather-tight integrity of the entrance is compromised if any of the securing points are lost during boarding. Repairs were made for the sea trials, but this would not be possible during a real evacuation.

Figure 17: Canopy Closure Securing Point

The securing points in the existing design of the 16-person raft are very vulnerable to being lost due to friction between the liferaft and the ship during boarding. The 42-person liferaft employs zippers to close the entrances and does not experience any problems. If it is desired to avoid zippers for reliability or other reasons, then the securing points for the 16-person raft canopy closures should be moved to the top of the upper tube, or to a position within the raft. One possible way to do this would be to pass longer cords through loops similar to tow patches on the outside of the liferaft, and then to loop the cords around the securing points at the new locations. This would greatly improve the design, while only adding one additional task to the process of securing the canopy.

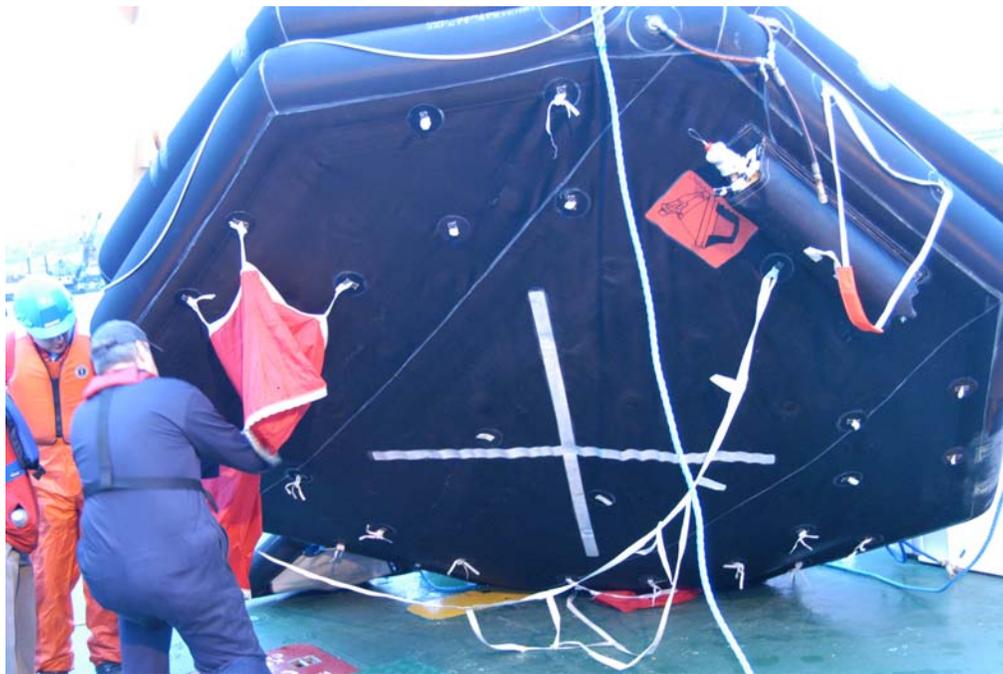
Another failure that occurred was that many of the water pockets with which the 16-person liferaft was equipped were also during the tow tests. These water pockets had to be frequently replaced. The current mode of attachment (tied on) of the water pockets to the raft is weak, as is much of the stitching that is used on

the water pockets themselves. The 42-person raft experienced no such problems as its water pockets were firmly stitched directly to the raft. The design of the 16-person liferaft's water pockets needs to be revised if these are to be relied upon to provide a righting moment. Figure 18 shows several of the water pockets on the 16-person liferaft missing after a day of testing.

Figure 18: Missing Water Pockets

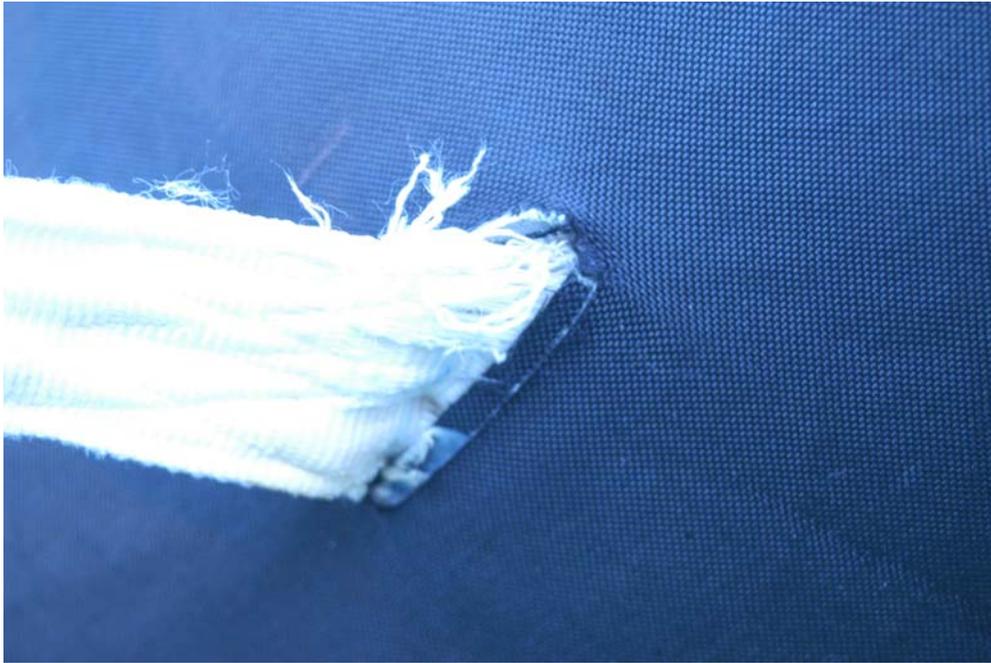
The factory-supplied towing bridle for the 42-person raft also experienced nearly immediate failure at the tow patch. Similar damage that was detected prior to a failure is shown in Figure 19. The supplied bridle had small angles at the two attachment points to the liferaft, and a deeper angle where the bridle attached to the towline. The failure is believed to be due to the large angle at the attachment

point to the towline. The reason for this is obvious from trigonometry. The load in each half of the bridle increases quickly with an increasing angle at the point of attachment to the towline. Therefore, a smaller angle is desirable.

Figure 19: Damage to Tow Patch

The supplied towing bridle for the 42-person liferaft was judged to have too large an angle at the point of attachment to the towline. This was the cause of near immediate failure when towing in waves. This problem could probably be rectified by reducing the angle at the point of attachment so as to decrease the load in both sections of the towing bridle. The attachment between the towing bridle and the towline should also be left free to move during towing so as to avoid excessive loading to one side of the bridle when the raft yaws.

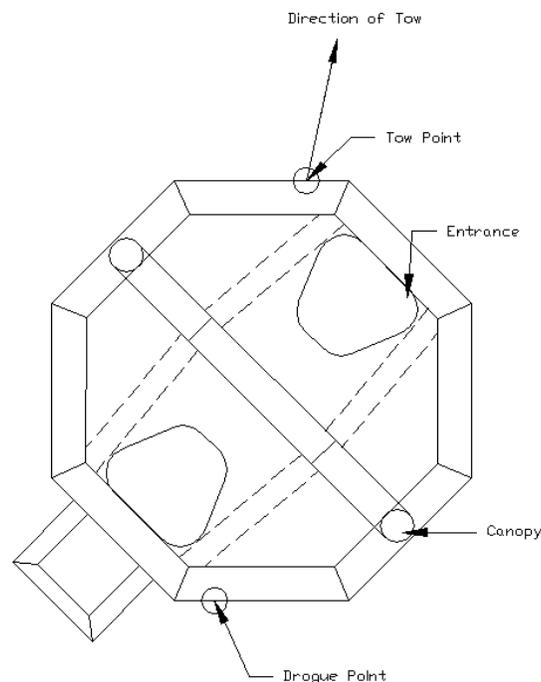
The structural design of the 16-person raft's canopy needs to be changed if it is to remain weather-tight in an ocean environment, especially when being towed. The current design provides little support in the area around the entrances. A single canopy arch tube across the middle of the liferaft supports it. Two possible solutions include significantly increasing the pressure in the existing arch tube or adding structural support. One possible modification that would provide the additional support required, especially around the entrances, is shown in Figure 20. The current design is shown and the dashed lines illustrate the proposed additions. Proper design of the new arch tubes would also allow the current shape of the canopy to be maintained if desired.

Figure 20: Proposed Canopy Design Change

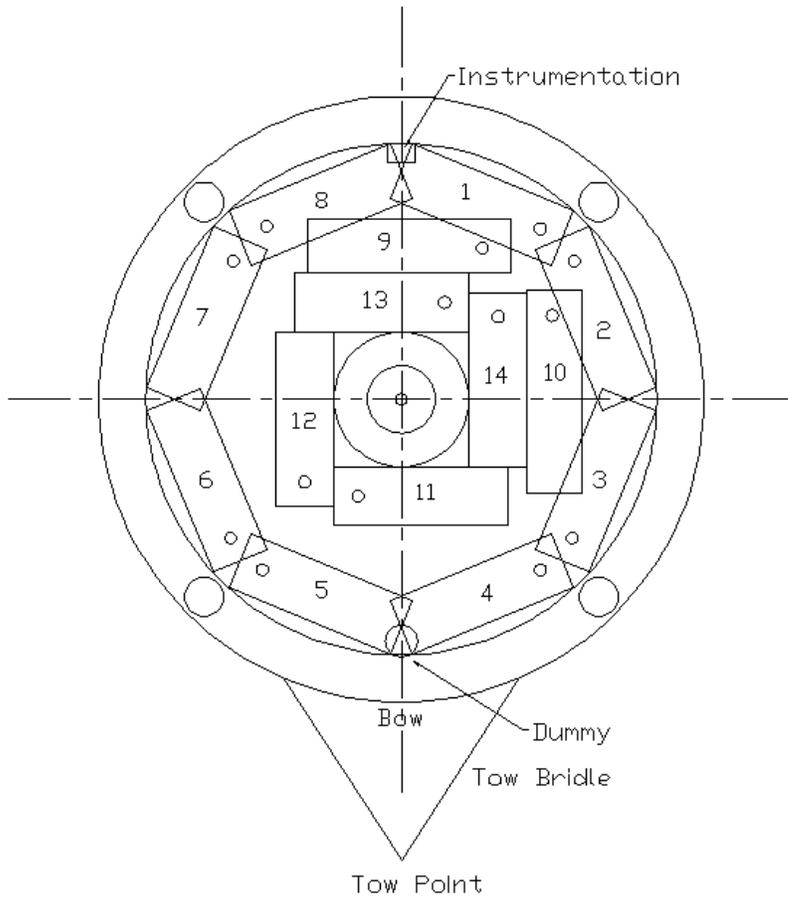
**16-Person Liferaft Ballasting Diagram**

**Evenly distributed**

Fill bags 1, 2, 3, 4, 5, 6, 7, 8, 11, 12, 13 and 14

**Unevenly Distributed**

Empty bags 4 and 5 and fill bags 9 and 10
