### **Orenda P.S. 13 combustion chamber (42-in. diam.): tests at atmospheric pressure**

LABORATORY REPORT LR-154

ORENDA P.S. 13 COMBUSTION CHAMBER (42-IN. DIAM.):  
TESTS AT ATMOSPHERIC PRESSURE

Laboratory Report: LR-154  
Date: 25 January 1956  
Lab. Order: 106-16A  
File: BM49-7-18

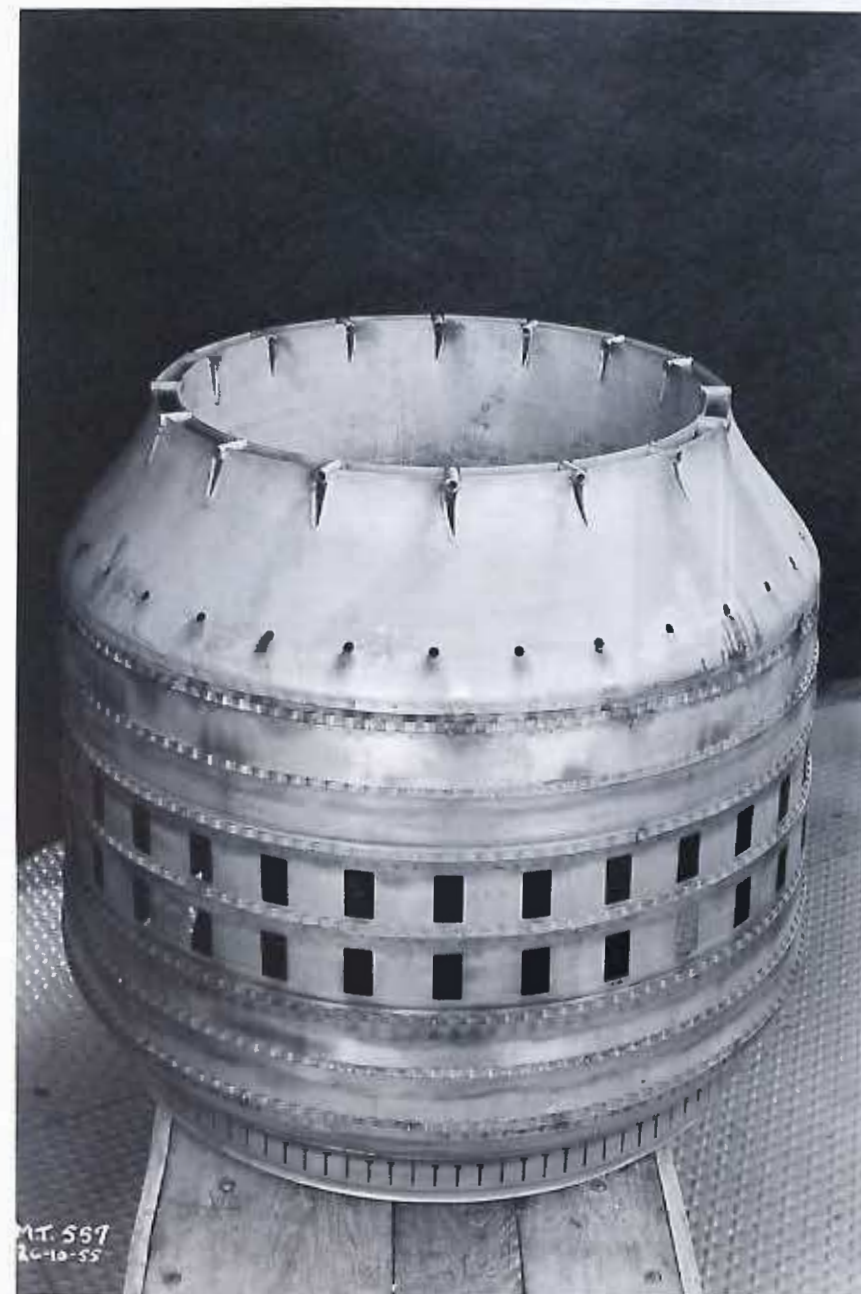
FLAME TUBE OF P.S. 13 ANNULAR VAPORIZING COMBUSTOR

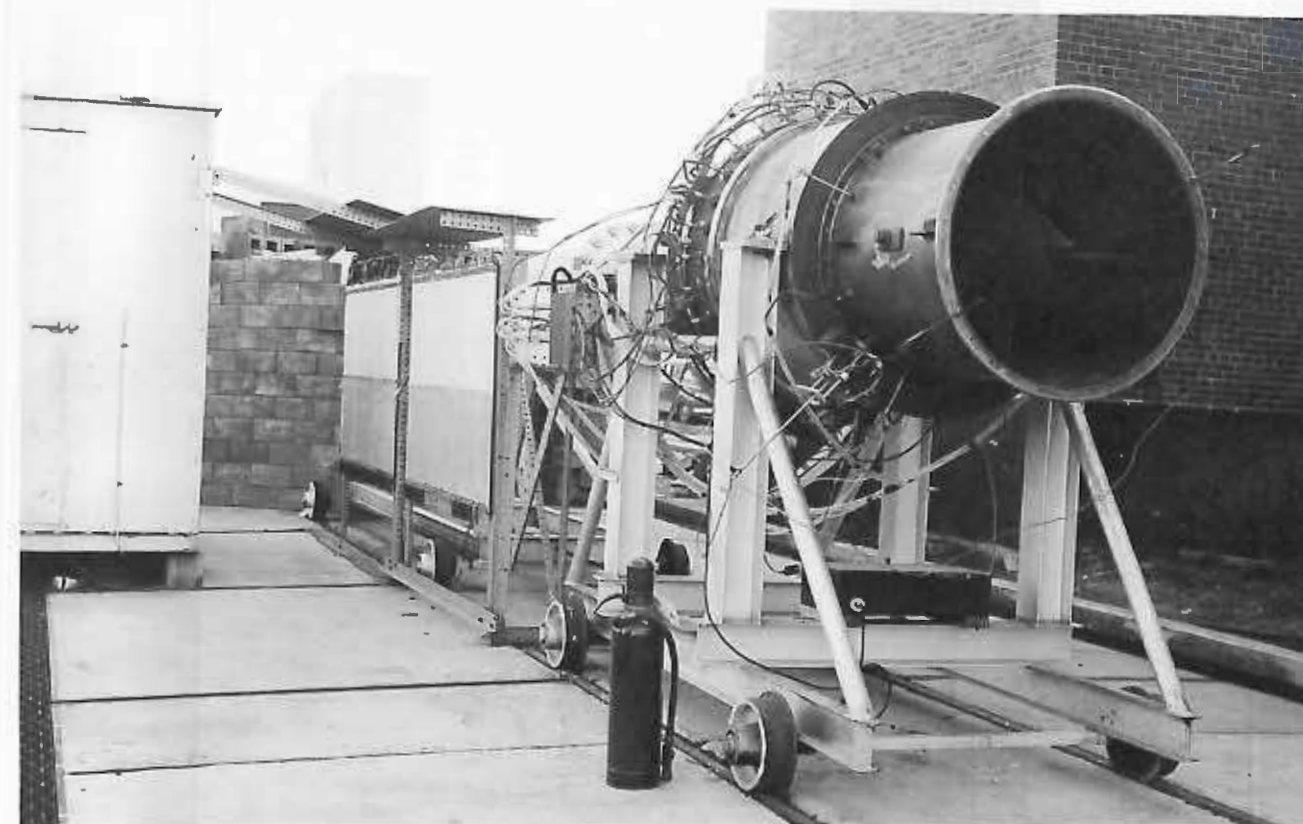
FIG. 3  
LR-154

P.S. 13 ANNULAR VAPORIZING COMBUSTOR  
ATMOSPHERIC PRESSURE TEST RIG WITH INSTRUMENTATION INSTALLED

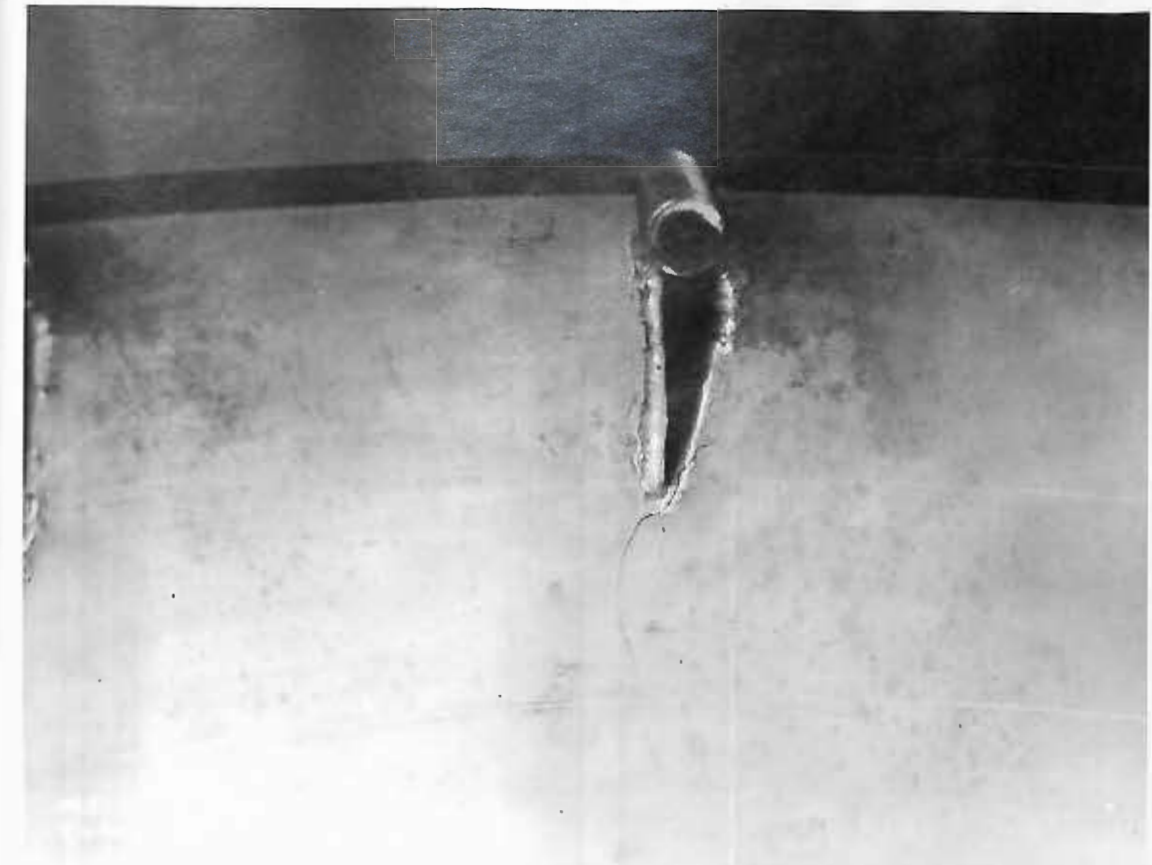
(a) CRACK IN WELD ON INNER WALL OF SNOOT

When the rig was dismantled after the testing was completed, several cracks were found at the entry of the flame tube snout. These cracks were all in the regions of the welds where the sections of the straightening vanes (A, Fig. 1) were welded into the snout. Photographs of some of these cracks are shown in Figure 27. The cracks did not interfere with the functioning of the flame tube during the testing.

The mechanical failures were probably due to vibrations caused by the injector noise rather than vibrations resulting from combustion roughness. The total length of time for which the combustor was operated at conditions of rough combustion was about 13 hours, whereas the total time that air was blown through the combustor by the injector was about 100 hours. During all this time the flame tube and presumably all parts of the rig were subjected to very intense vibrations at 720 cycles/sec.

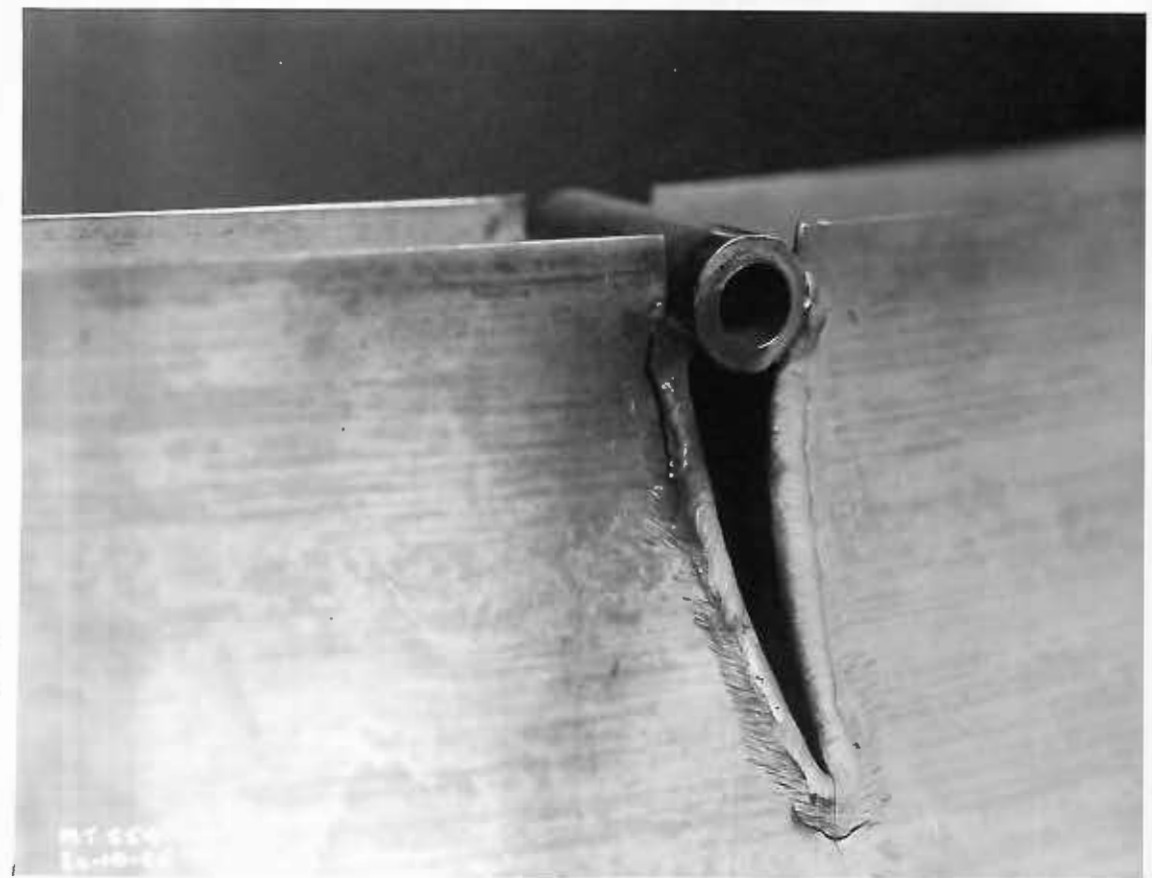
(b) CRACKS IN WELD ON OUTER WALL OF SNOOT

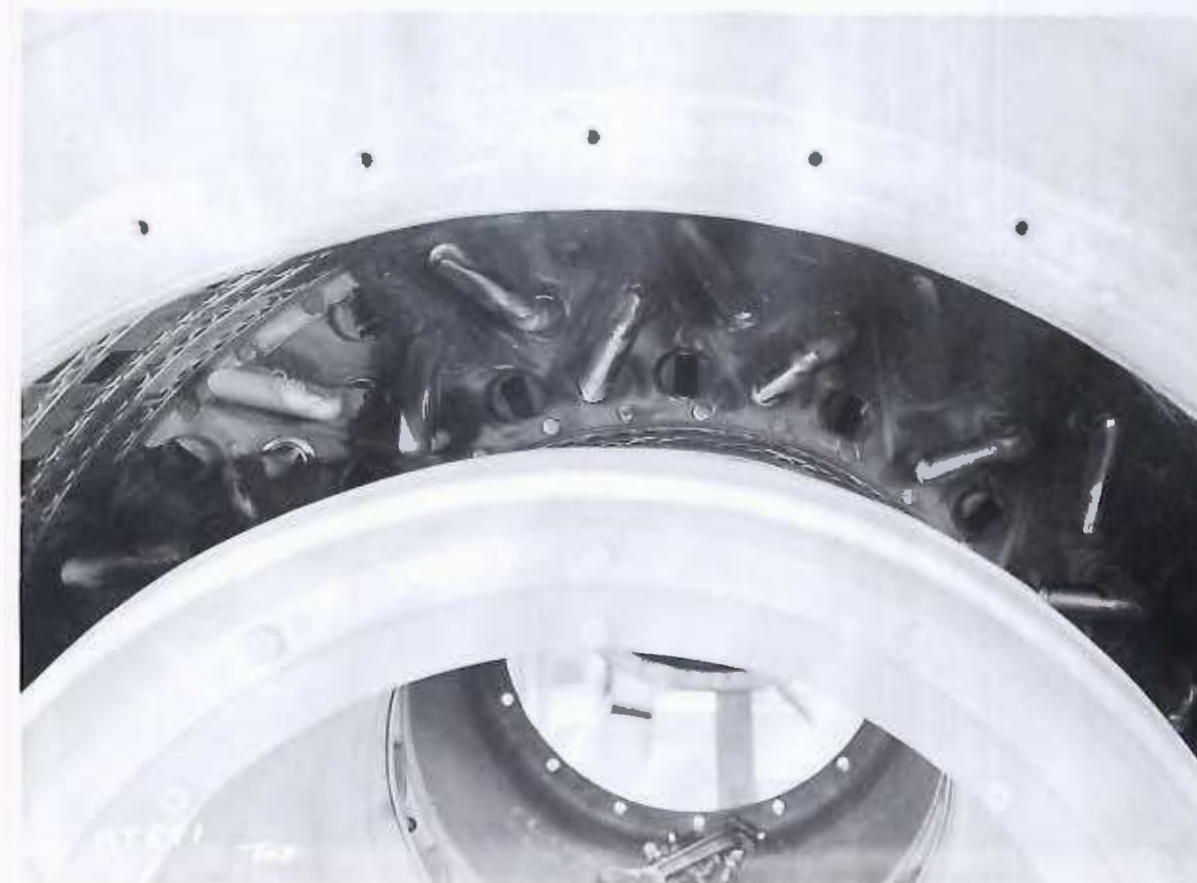
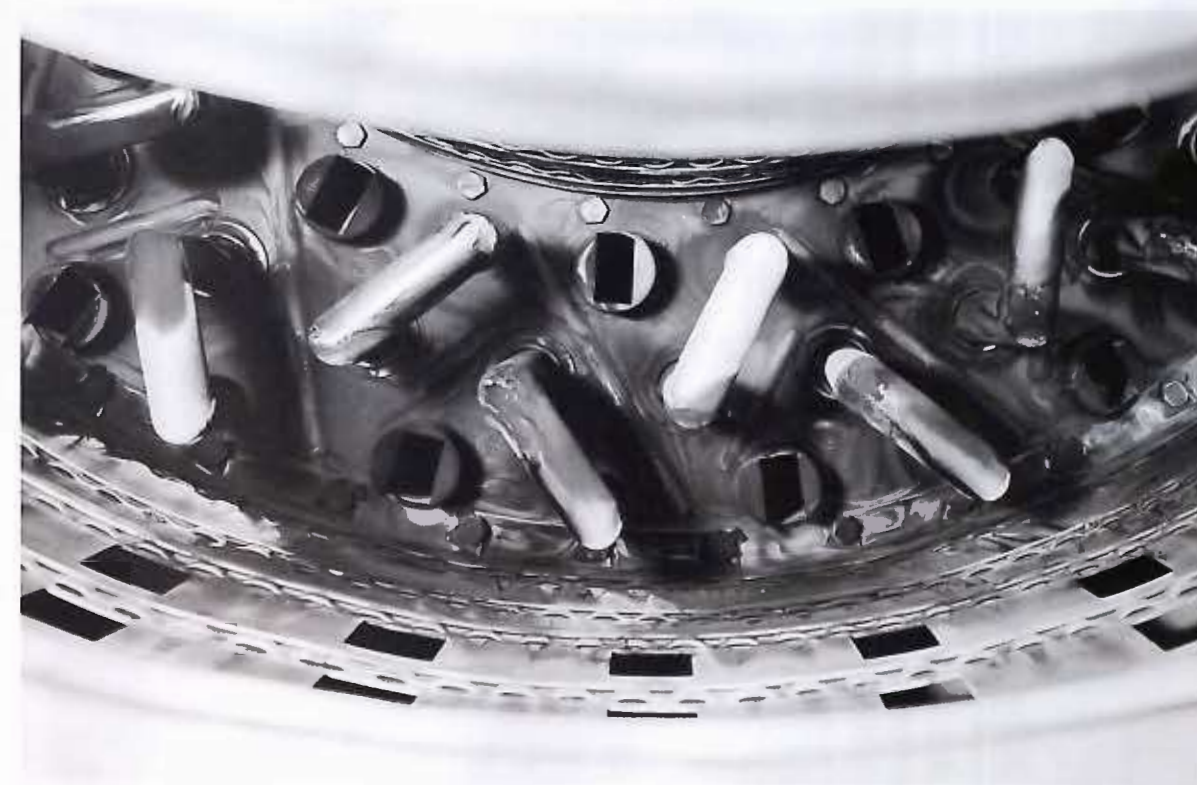
CARBON DEPOSITION ON BASE PLATE, VAPORIZER TUBES,  
TOTAL BURNING TIME = 22-23 HR. RICH BURNING TIME = 5

Operation of the combustor at high fuel/air ratio produced very light carbon deposition on the base plate, primary air mixing slots, vaporizer tubes, and parts of the flame tube walls adjacent to the base plate. This deposition can be seen in Figure 28. The pictures were taken at the conclusion of a test period involving 22 to 23 hours' actual burning time over a range of fuel/air ratios from .004 to .022 and chamber velocities from 40 to 110 ft./sec. About 5 hours of this time were spent at the high temperature condition. No serious carbon build-up in any part of the combustor was observed at any time during the testing.

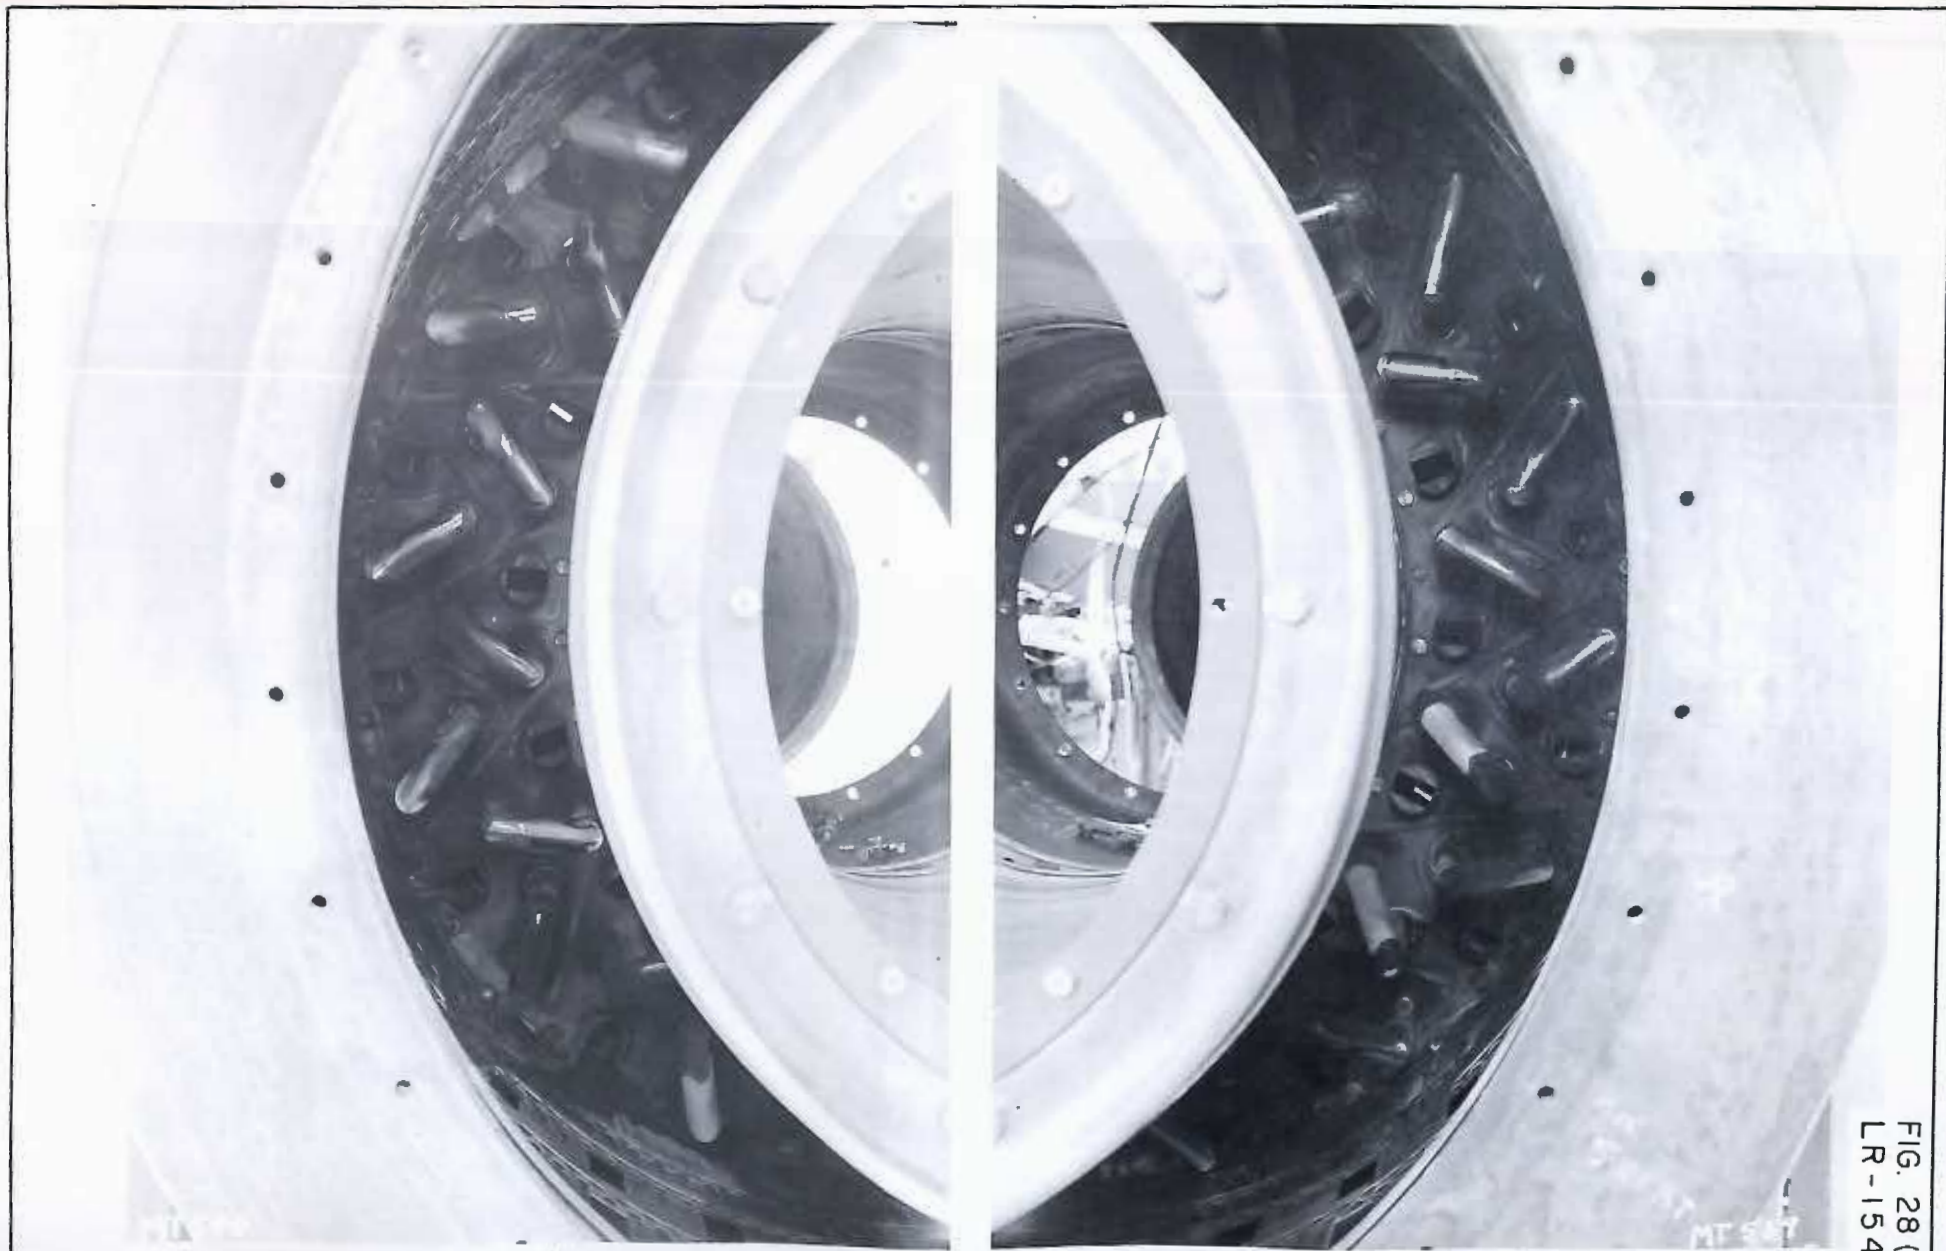
LEFT SIDE  
RIGHT SIDE  
CARBON DEPOSITION ON BASE PLATE, VAPORIZER TUBES, ETC.  
TOTAL BURNING TIME = 22-23 HR. RICH BURNING TIME = 5 HR.

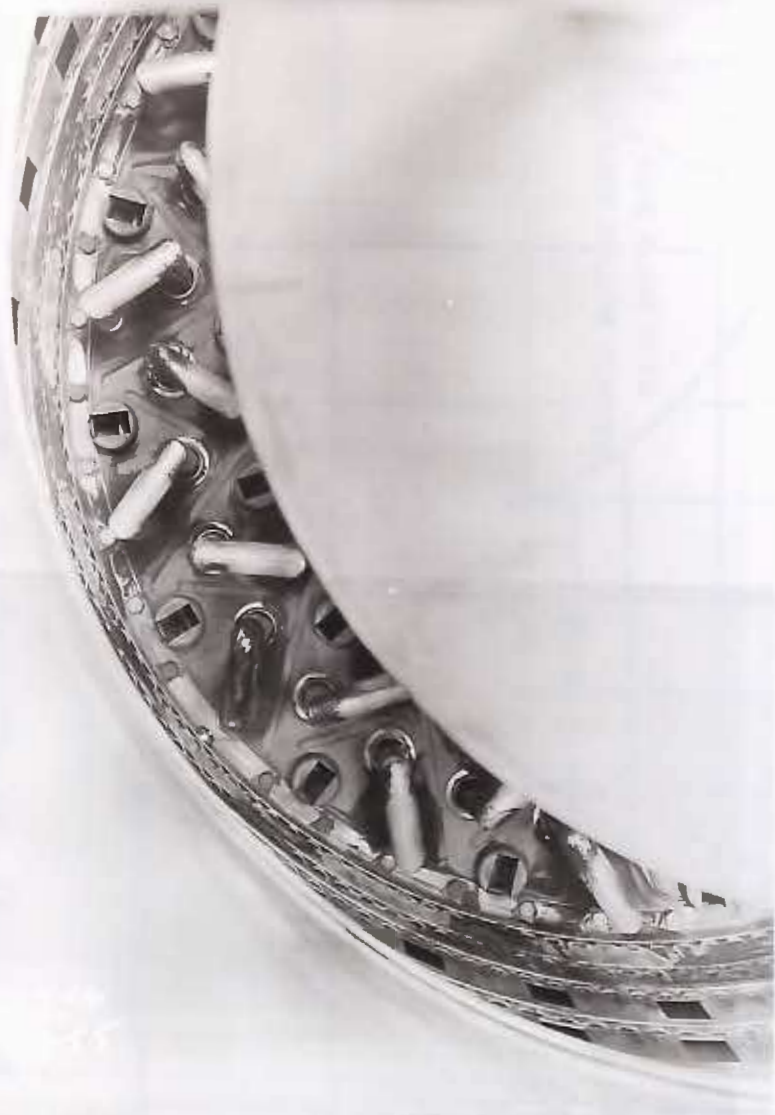
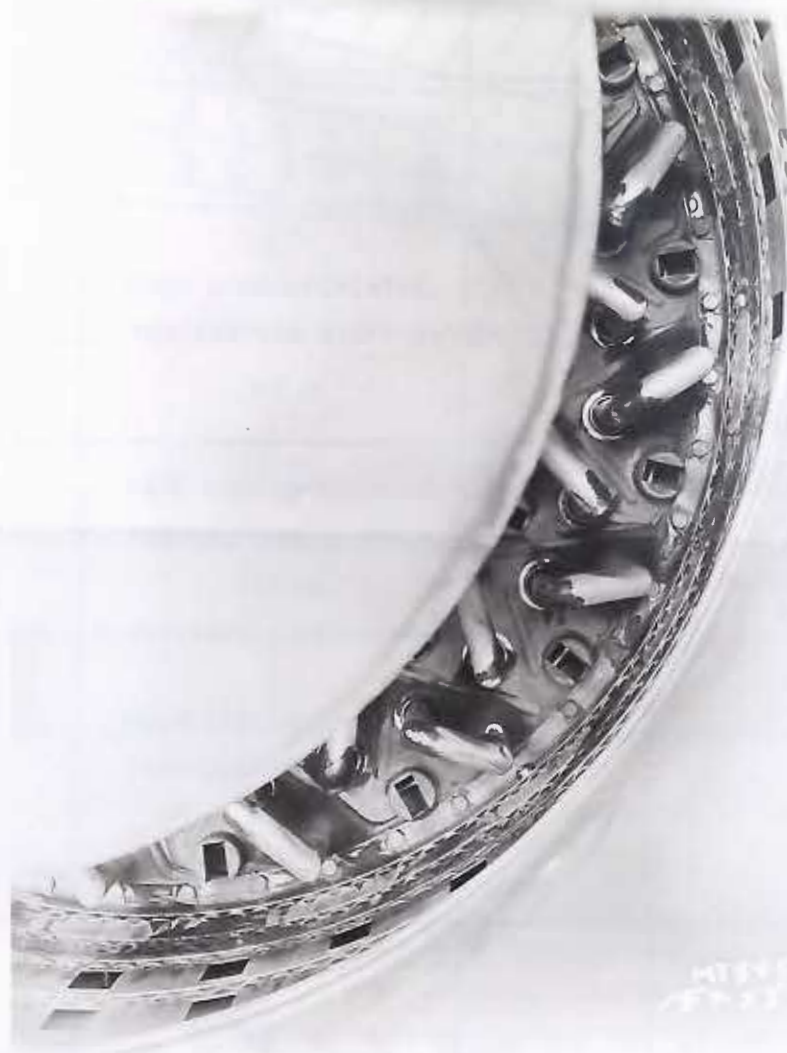
CARBON DEPOSITION ON BASE PLATE, VAPORIZER TUBES, ETC.

BURNING TIME OF A FEW MINUTES AT LOW FUEL/AIR RATIO FOLLOWING THE CONDITION SHOWN IN FIG. 28
