**Deep Snow at Mt. Washington,
Vancouver Island:
Implications for the NBC**

by Donald A. Taylor

Internal Report No. 725

Date of Issue: September 30, 1996

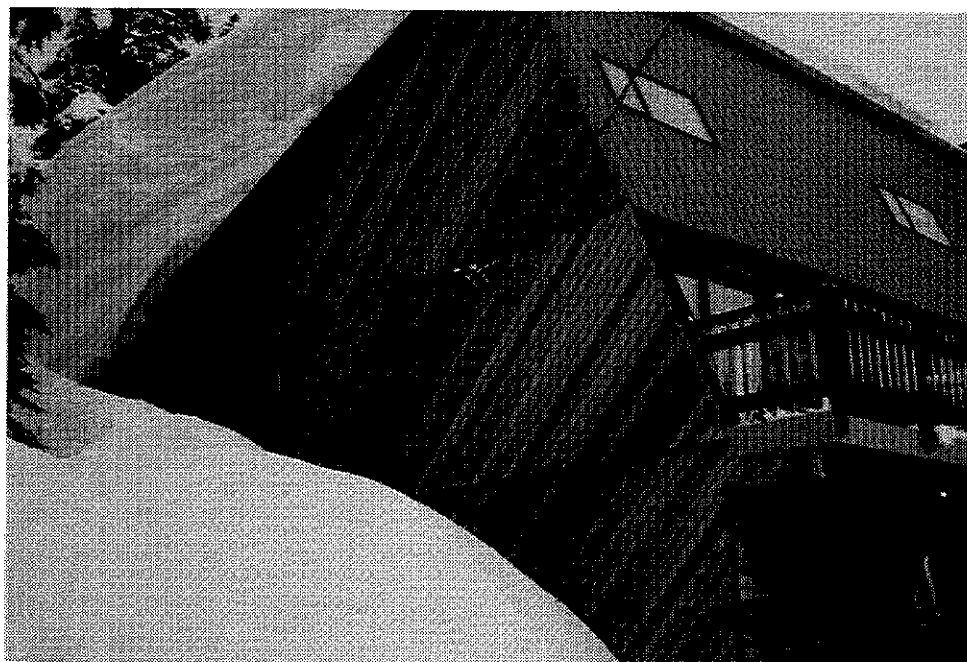
Figure 5. Condominium 81, April, 1983. Very deep snow cannot slide off because the roof slopes towards the hill.

As shown in Table 3, the only two buildings surveyed every year in which measurements were taken were the Day Lodge (Fig. 4) and Condo 81 (Fig. 5). The Day Lodge is a two-level flat roof which, prior to 1989, had an upper level roof, in plan, 18 by 14.5 m and a lower level roof of 31 by 21 m surrounded by a 1 m high parapet. After 1989 the lower roof was expanded by the addition of a section 14 by 21 m (leaving the original parapet between the old and the new sections). The original and new lower roofs are about 13 m high and are surrounded on three sides by 1 metre parapets; the upper level is 2 m higher than the lower roof and is located against the northwest corner of the building. Only results for the lower roof are given. The ground elevation at the Day Lodge is about 1179 metres, and the building is exposed to the wind on all sides. Condo 81 is 15 m by 15 m in plan and is further along the treed slope at 1173 m elevation. Because it is about three stories high, it is partially sheltered by the trees. Its roof is an asymmetrical gable roof with the longest side facing northwest into the hill and sloping at 20°. The other side faces southeast and is too steep for observations. The approximate geometry of all the buildings surveyed is described in Table 4.

(*For Condo 81 $C_w = 1.0$, as per the 1990 and 1995 NBC rules, and C_s is also 1.0 because at predicted design load levels it cannot be assumed that the snow will have room to slide completely off the roof [Fig. 5]).

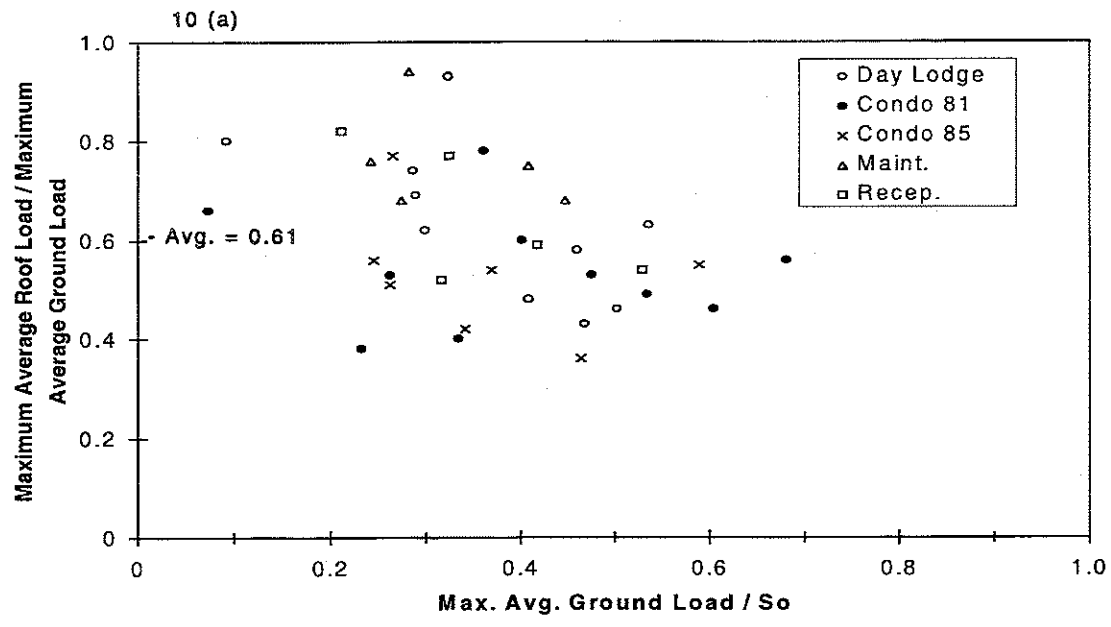
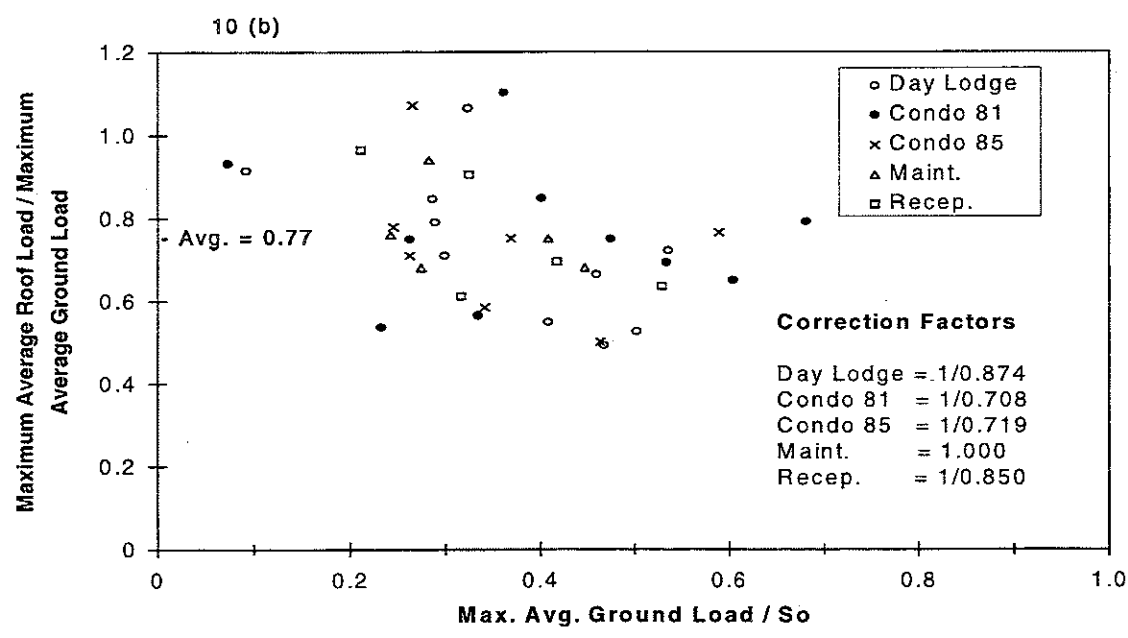
Figure 10. Normalized load data plotted to show the effect of the exposure corrections used to obtain the C_b factor.

Upper graph plotted prior to correction and lower graph after correction to obtain the C_b factor in equation [4].

The calculated exposure factors (Table 8) were applied to the annual maximum average roof loads for each of the roofs surveyed in the 10 years of record. The results are plotted in Fig. 10(a) before and in 10(b) after normalization. The average value of 'maximum average roof load/maximum average ground load' applicable over the full range of ground snow loads in Fig. 10(a) is 0.61 before normalization. This increases to 0.77 when the correction is applied to remove the effect of exposure, and decreases slightly to 0.76 when a partial correction for slippery sloping roofs, more appropriate for predictions of design loads, is made for Condo 81 using the 1990 NBC slope-reduction formula. In any case the effect is small. A full correction would reduce the figure slightly to 0.75 . Therefore the C_b factor in Equation [4] would be about 0.75 , as shown in the following, which is 94% of the NBC recommended value of $C_b = 0.8$. In Equation [4]

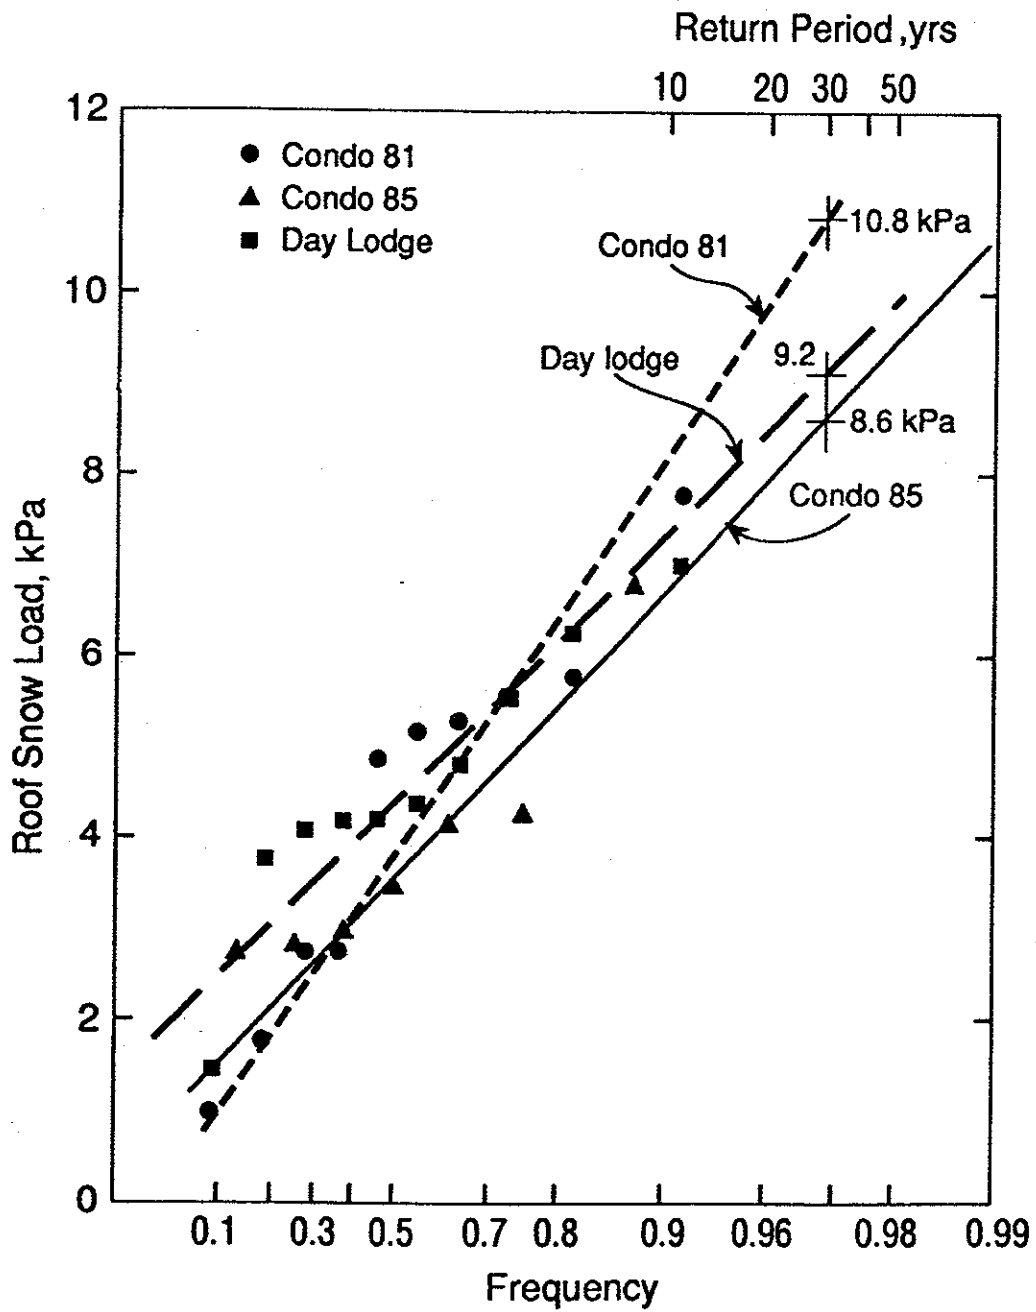
Figure 11. Predictions of 30-year return snow loads on roofs of Day Lodge, Condo 81, and Condo 85 using Gumbel plots.

The Gumbel predictions based on the survey data resulted in the following *average* roof loads with a 1-in-30 probability of exceedence per year (Fig. 11):

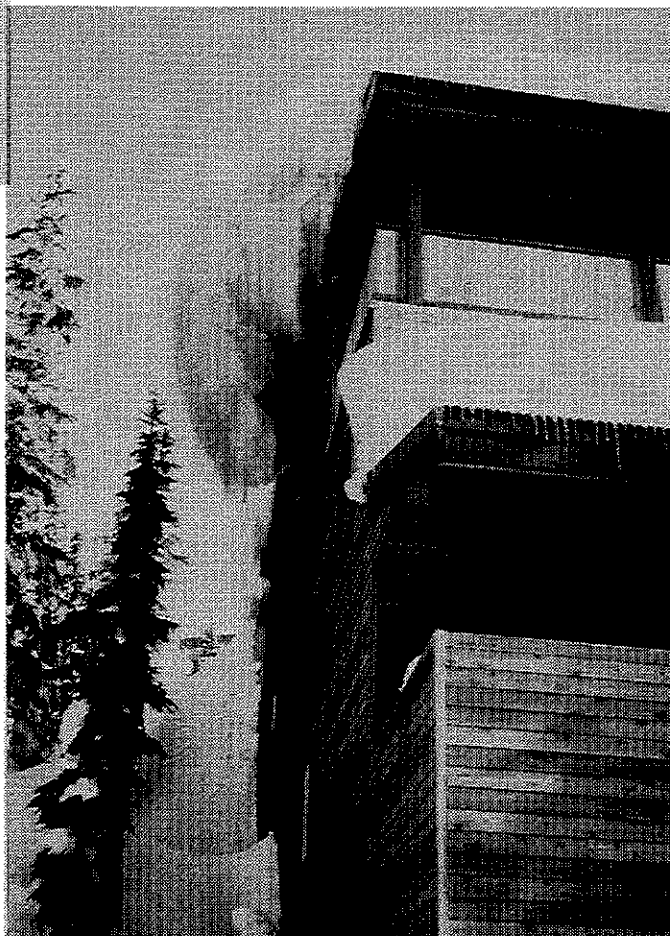
Figure 13. Heavy cornice,
February 2, 1982

- a) At Mt. Washington cornices can be enormous, (Figs. 12, 13, 14) equal to the roof snow in depth and may extend horizontally as much as 2.5 metres beyond the edge of the roof and hang down a metre or so. The extra weight exerted by cornices on the edge of the roof or the columns or walls beneath has been more than some could carry (Fig. 2). In order to avoid problems due to cornices, the owner of one flat-roofed building keeps a snow blower in a small penthouse (with a roll-up door) on the roof to remove the snow within about 1.5 metres of the edge of the roof (Fig. 15). Access is by a ladder inside the penthouse which extends down to the floor below inside the building.
- b) With single snowfalls as deep as one metre, cohesive wet snow may accumulate uniformly on steep gable roofs without sliding. The tensile strength of the wet snow across the ridge allows the snow on

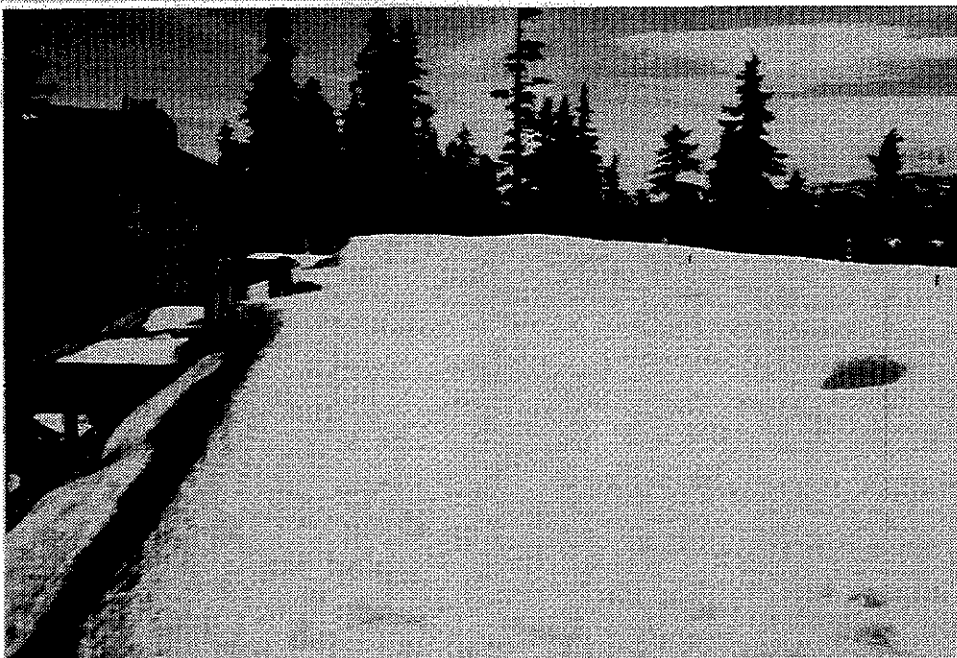
Figure 15. Perimeter of flat roof cleared by snow blower kept on roof.

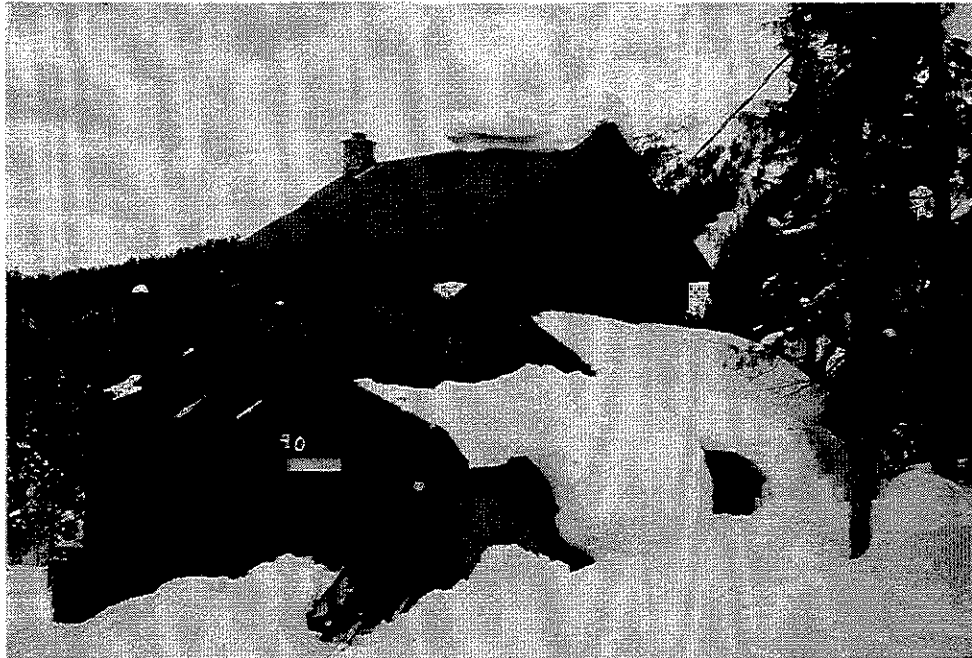
Figure 16. Slippery metal roof has shed snow. Notice "hat" of heavy snow at ridge posing danger below.

one side to anchor that on the other. The substantial loads that can be held on the roof should be considered in design as should the inevitable avalanching of this snow off the roof (Fig. 16).

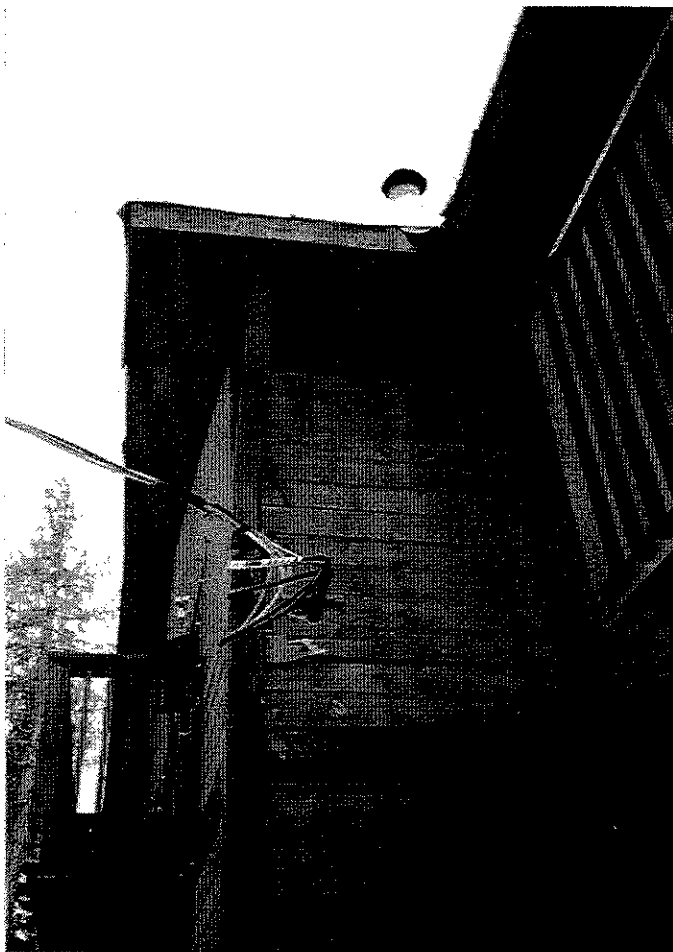
Figure 17. Power lines damaged due to falling cornices and sliding snow.

- a) If cornices break off they could injure or kill; furthermore they have damaged building components such as balconies or stairways below, or attachments of power lines to the building (Fig. 17). Because they sometimes rotate about the eaves when they break off, they have also cracked windows (Fig. 18) and damaged siding.

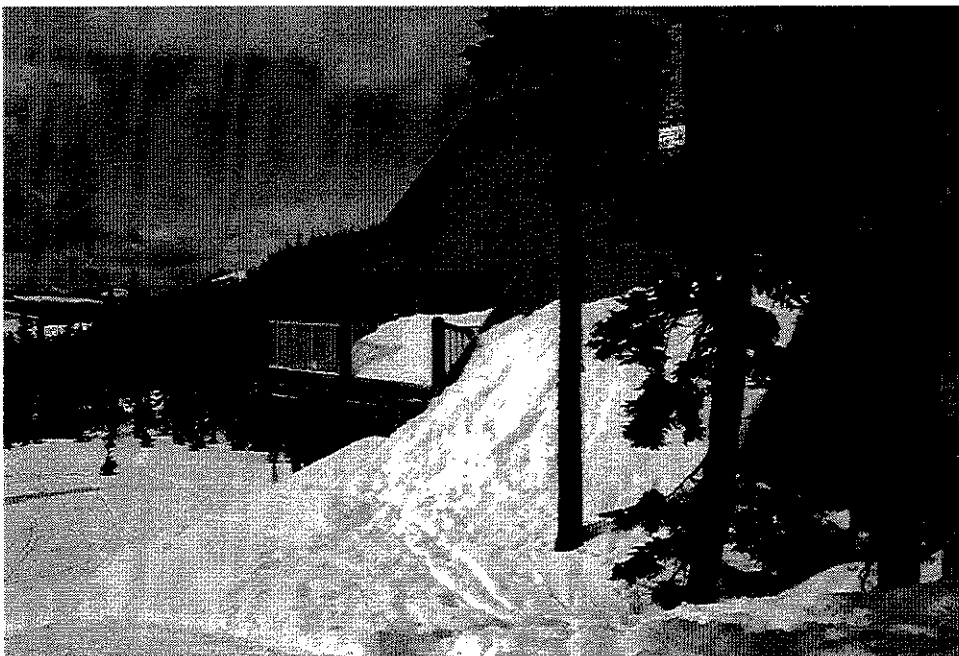
Figure 19. Railing around deck broken or removed to prevent breakage by sliding snow.
