**Caisson Structures in the Beaufort Sea 1982-1990:
Characteristics, Instrumentation and Ice Loads**

**G.W. Timco and M.E. Johnston
Canadian Hydraulics Centre
National Research Council of Canada
Ottawa, Ont. K1A 0R6
Canada**

**Technical Report
CHC-TR-003**

November 2002

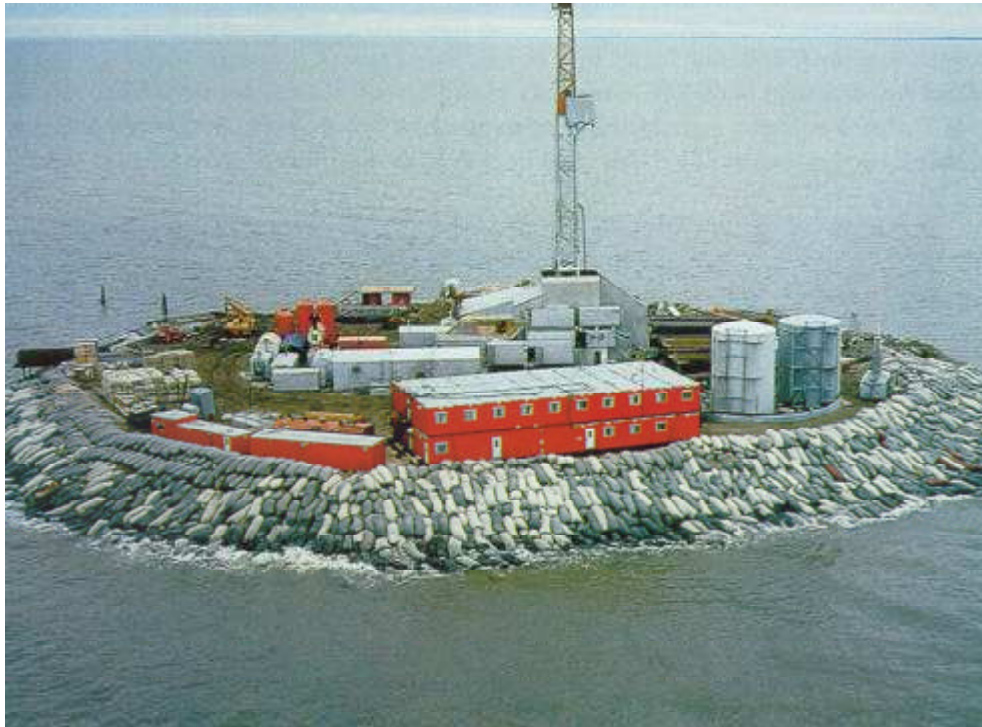
Figure 1: Photograph of sandbag protected artificial island

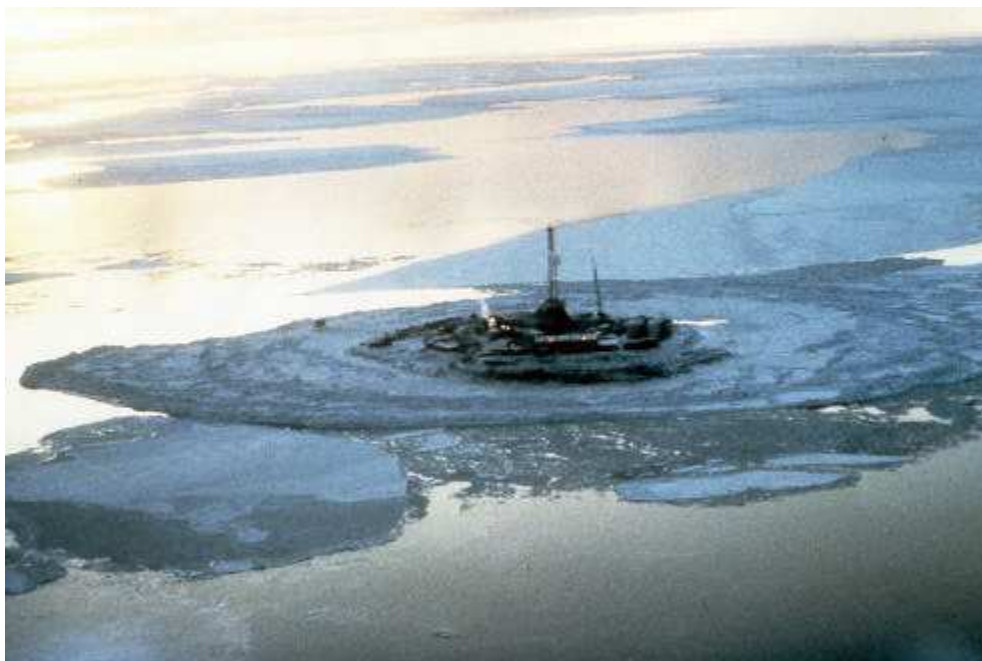
Figure 2: Photograph of the Esso artificial island at Issungnak

The development of the Beaufort was initiated in the early 1970s in quite shallow water (up to 12 m) using artificial islands. These islands were constructed by either dredging the local sea bottom and building-up an island, or by trucking gravel from the shore and dumping it to form an island. For most of these islands, the ice was landfast, first-year ice and had little movement during the winter months. In the early 1970s, Esso Resources Canada Ltd. and Exxon Production Research measured the *in-situ* ice pressures around their dredged exploration drilling islands at Adgo, Netserk, Arnak, Kannerk and Issungnak (see Figure 1 and Figure 2). Urethane button-type sensors were used to measure the pressure, with supplementary information on ice/island movements. These measurement programs often experienced electrical and environmental difficulties and little data are available from them in the open literature. The successful measurements indicated, however, that the ice load was applied relatively uniformly across the Island, with loading times on the order of one day. The field studies indicated that pressures up to about 1 MPa were measured on this type of structure (Ralston, 1979).

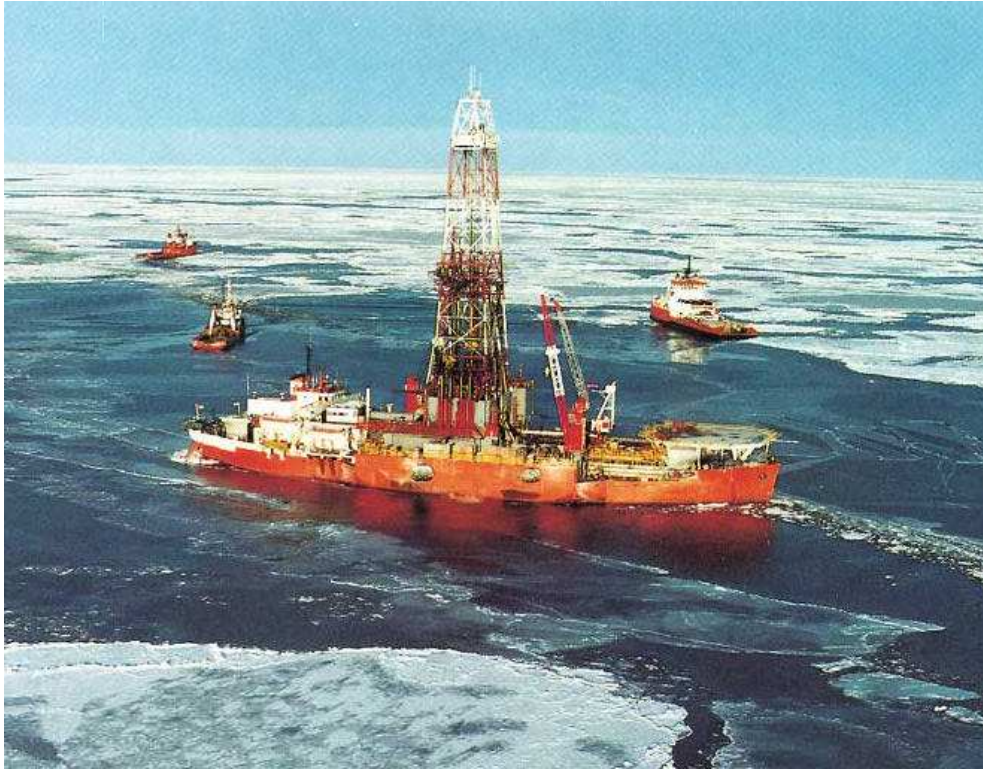
Figure 3: Photograph of a Canmar drillship

Starting in the mid 1970s, Dome Petroleum (Canmar) deployed floating drillships during the summer months (Figure 3). These were moored on site during the summer (open water) months. They encountered relatively light ice conditions, and there are no recorded ice loading events for these floating structures.

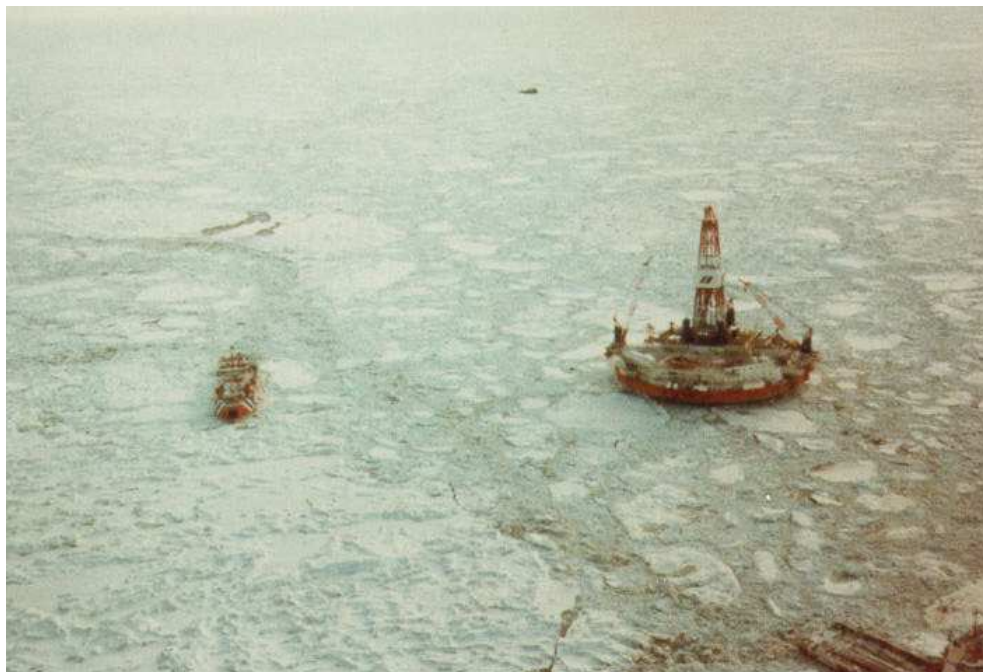
Figure 4: Photograph showing the ice management around the moored Kulluk structure in the Beaufort Sea.

In 1983, Gulf Canada Resources Ltd. designed and built an inverted-cone shaped floating structure (the “Kulluk”) that allowed drilling later into the winter season. This structure was exposed to moving pack ice. Active ice management around the Kulluk ensured that the ice conditions were not severe (see Figure 4). This structure was instrumented to measure mooring line forces. Wright (2000, 2001) summarized the measured forces on the Kulluk. Measured loads were up to 4 MN depending upon the ice thickness, floe size and ice concentration.

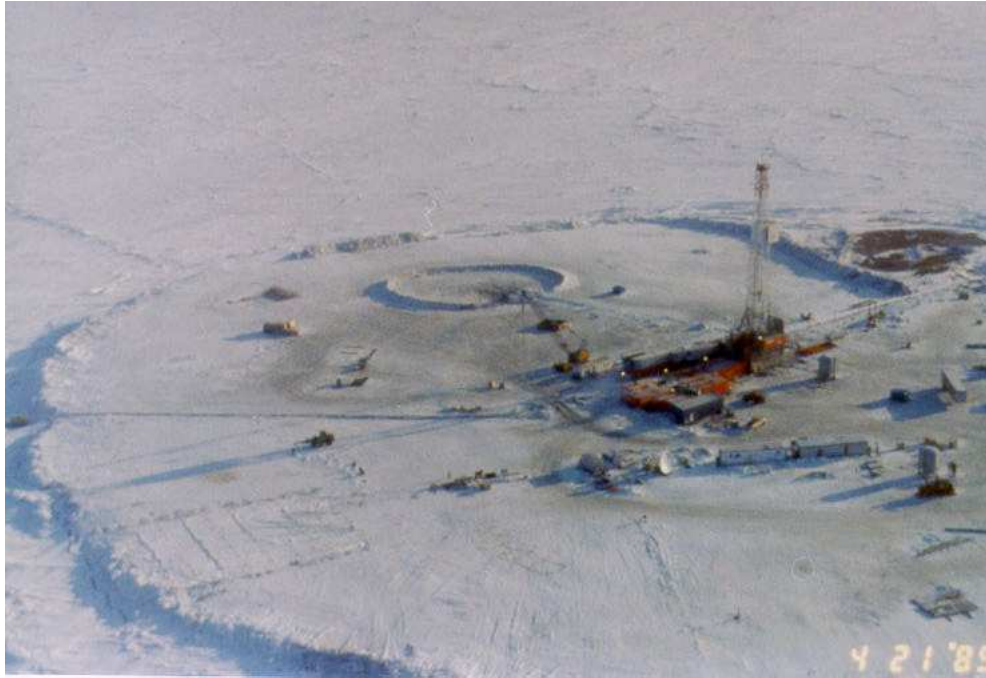
Figure 5: Photograph showing an overview of the Nipiterk spray island.

In the late 1980s, spray ice islands (Figure 5 and Figure 6 after Poplin, 1990) were used for a few wells. These were deployed in landfast ice in both the Alaskan and Canadian Beaufort Sea. The cost of these spray islands was approximately one-half the cost of a gravel island.

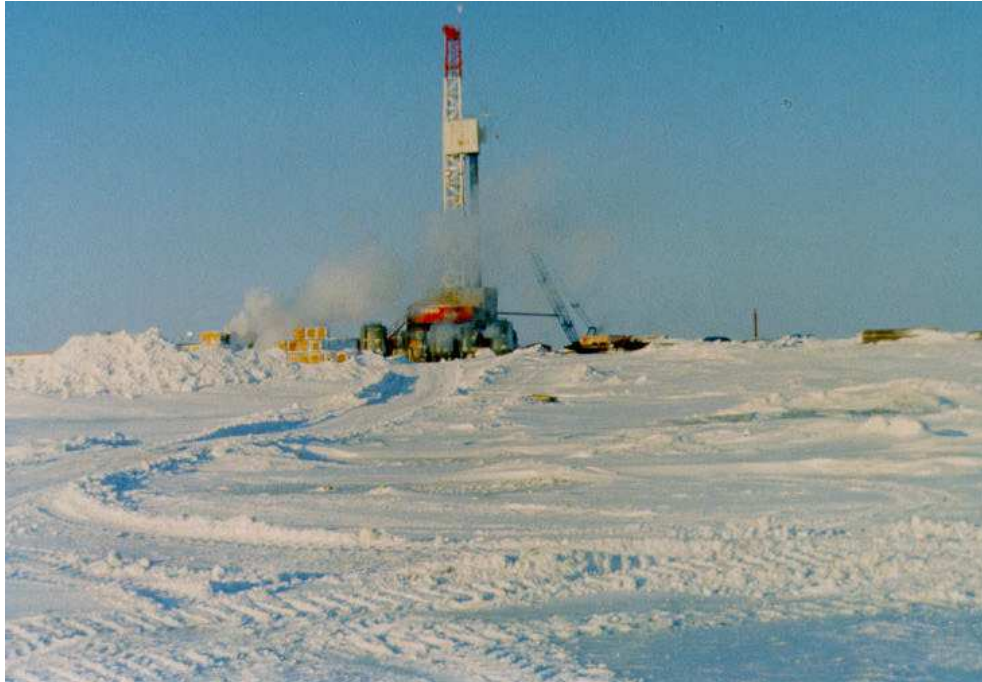
Figure 6: Photograph showing the Nipiterk spray island from ice level.

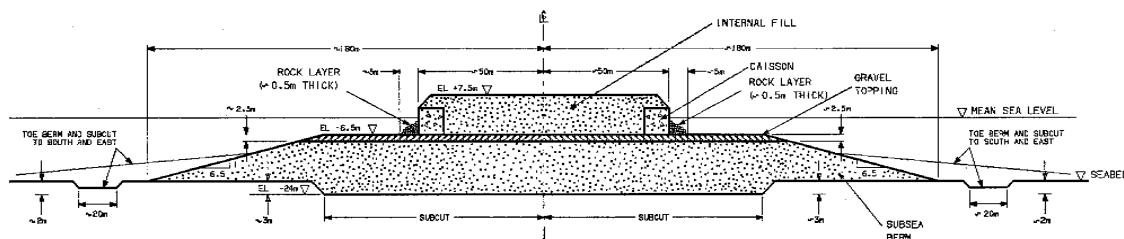
Figure 9: Side view through Tarsiut caisson structure

The structure consists of four individual concrete caissons. These caissons were floated to the drilling site and ballasted down with sand to form a square. The inner core was filled with dredge material (see Figure 9). This structure is not regarded as a "mobile" structure since the difficulty of resetting and connecting four caissons limits its mobility. The structure is about 100 m across at the water line and has a vertical outer surface (Figure 10). The caissons are 10 m high and rest on a berm that comes to within 6 m of the water surface. The structure was extensively instrumented to measure ice loads (Pilkington et al., 1983) both for operational safety reasons and for future design.

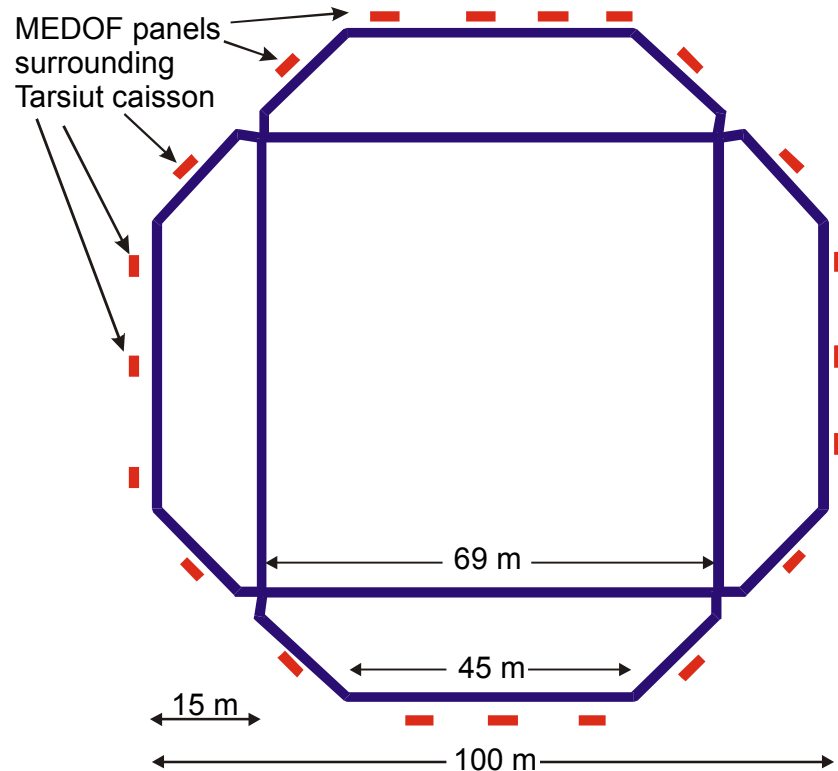
Figure 10: Illustration of MEDOF panel locations surrounding Tarsiut caisson during the 1982/83 season

¹ MEDOF panels, which are 1.1 x 2.7 m in area, are a total load type of panel, i.e. they sense the total ice load on them. The contact area of the ice on the panel has to be estimated in order to determine the effective ice pressure. The panels can be deployed in either vertical or horizontal arrays, which allows local load distributions and global loads to be determined. They are a sandwich of two steel plates (inner plate about 2 mm thick and the outer plate is about 10 mm thick) over an array of polymeric buttons. The panels are closed at the edges and filled with a calcium chloride solution. Load application to the panel causes the buttons to compress and the internal volume of the panel to change. This volume change causes the calcium chloride fluid level in a stand pipe attached to the panel to change. A sensitive pressure transducer is used to measure the hydrostatic head changes in the standpipe. The maximum frequency response is estimated to be about 1 Hz.

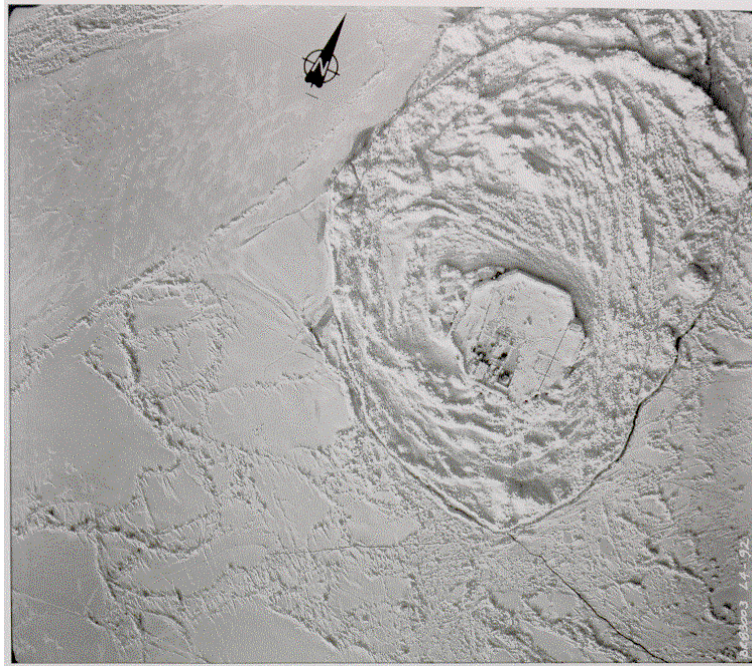
Figure 11: Overhead view of Tarsiut Caisson showing the grounded rubble field surrounding the structure (photo taken on March 2, 1983).

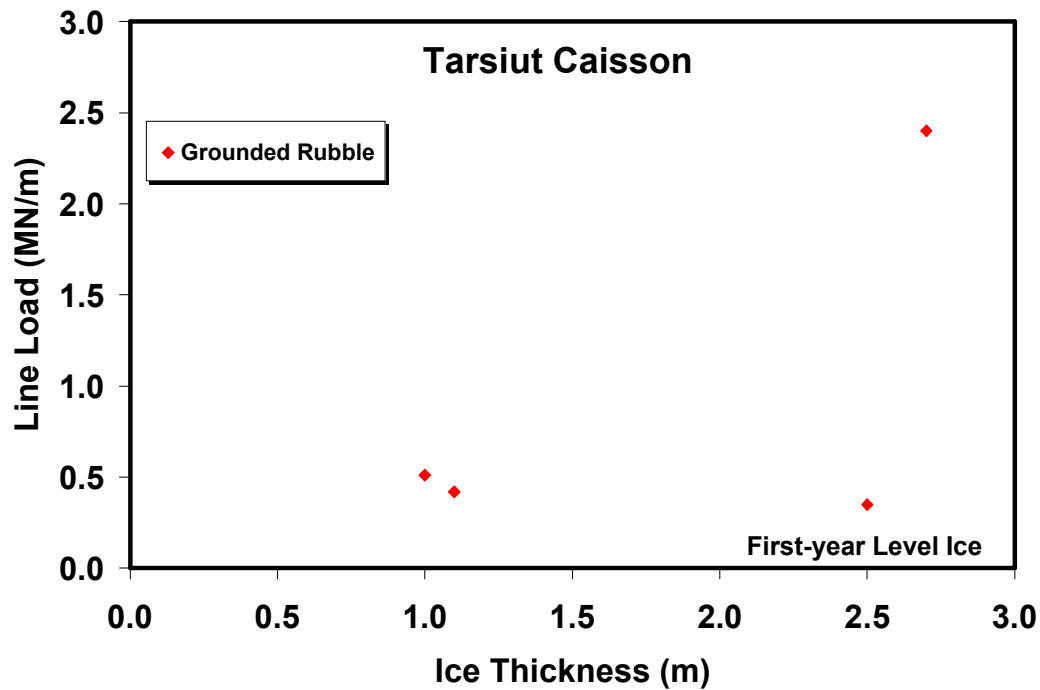
Figure 12: Line-Load on the Tarsiut Caisson as a function of ice thickness. Note that in all cases there was a 150 m grounded rubble field surrounding the structure.

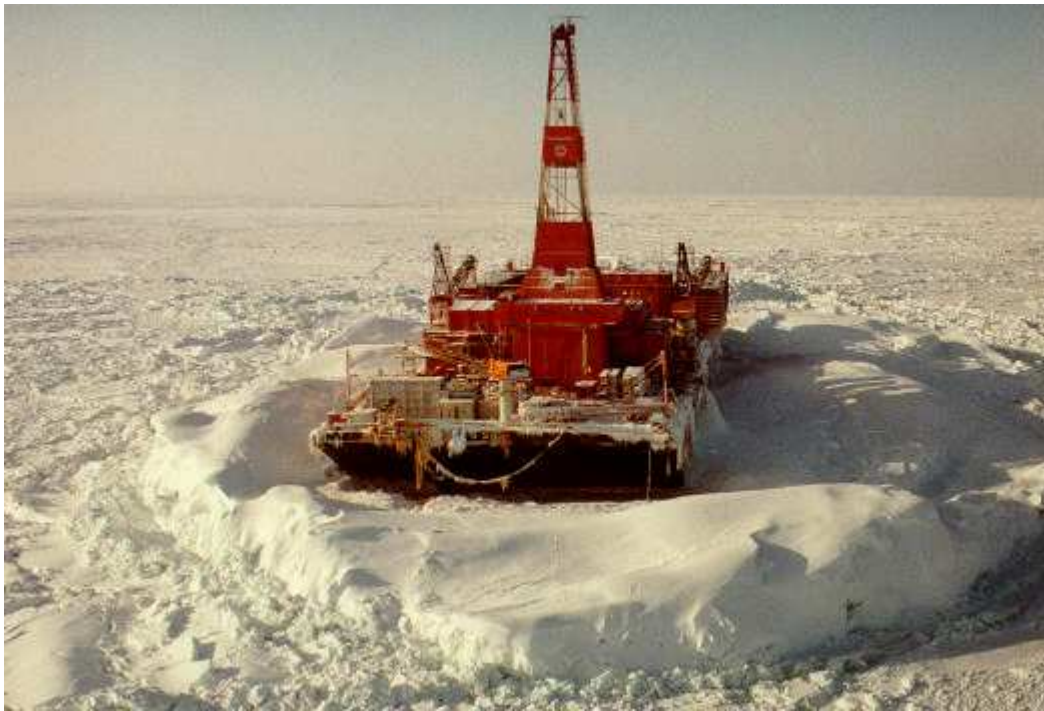
Figure 13: SSDC at the Kogyuk site in the Beaufort Sea. Note the sprayed ice rubble surrounding the structure.

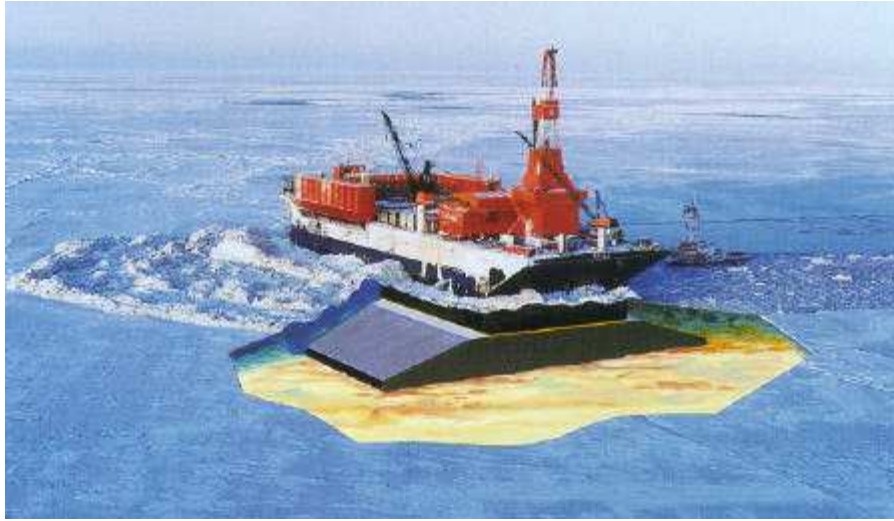
Figure 14: Artist's cut-away illustration of the SSDC and the MAT.

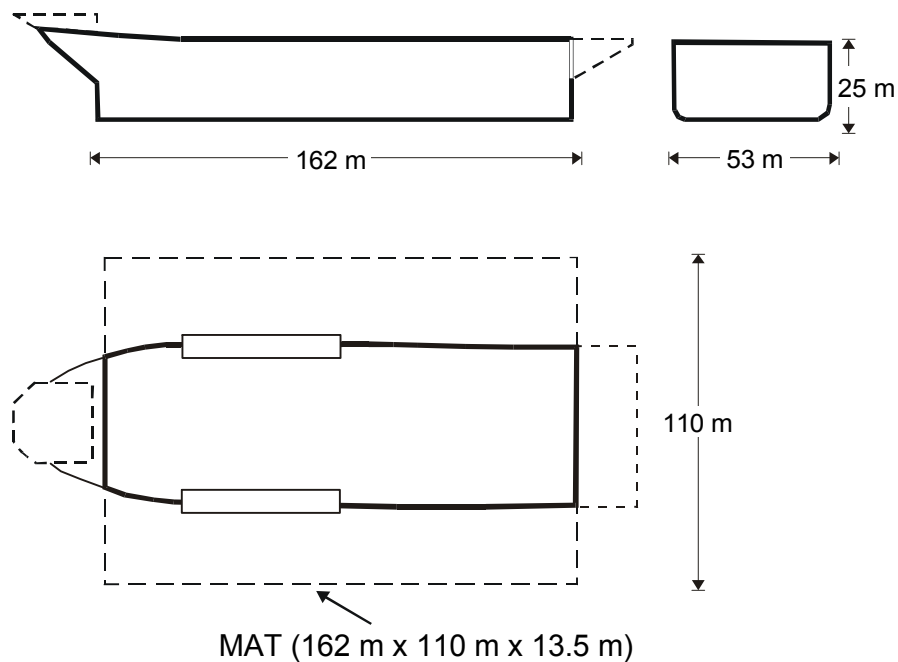
Figure 15: Dimensions of the SSDC and the MAT

Canmar owned and operated the SSDC. This structure was a converted super tanker that had undergone extensive modifications to adapt it for use as a support structure for year-round exploratory drilling in the Beaufort Sea (Figure 13). The structure is 162 m long, 53 m wide, and 25 m high. All sides are vertical at the waterline. It was initially designed to rest in a water depth of 9 m. From 1982 to 1984, the SSDC was installed in the Canadian Beaufort Sea at the Uviluk and Kogyuk sites, where it rested on a submerged berm. In August 1986, the SSDC was modified in preparation for installations in the U.S. Beaufort Sea (1986-1988). Modification of the SSDC involved mating the drilling vessel to a semi-submersible steel base, the “MAT” (Figure 14). This steel base alleviated the need for a dredged berm, and gave it the capability to operate year-round in water depths of 7 to 24 m, and a wide variety of soil conditions. The SSDC was deployed with the MAT at the Phoenix, Aurora, Fireweed and Cabot sites in the US. Beaufort Sea. A sketch of the SSDC and MAT is shown in Figure 15.

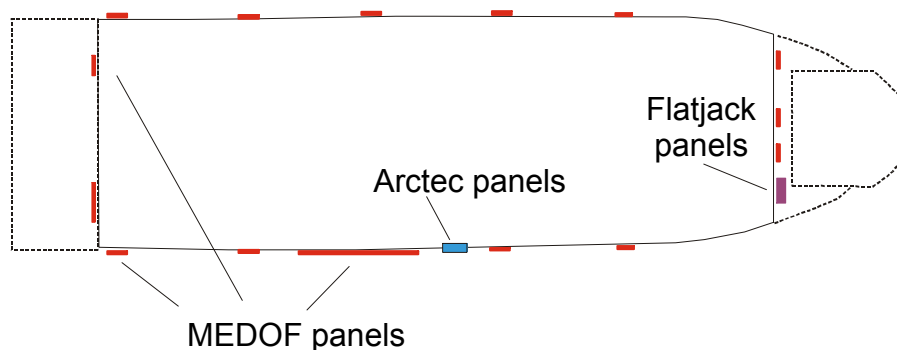
Figure 16: Location of the load measuring sensors on the SSDC at the Uviluk site.

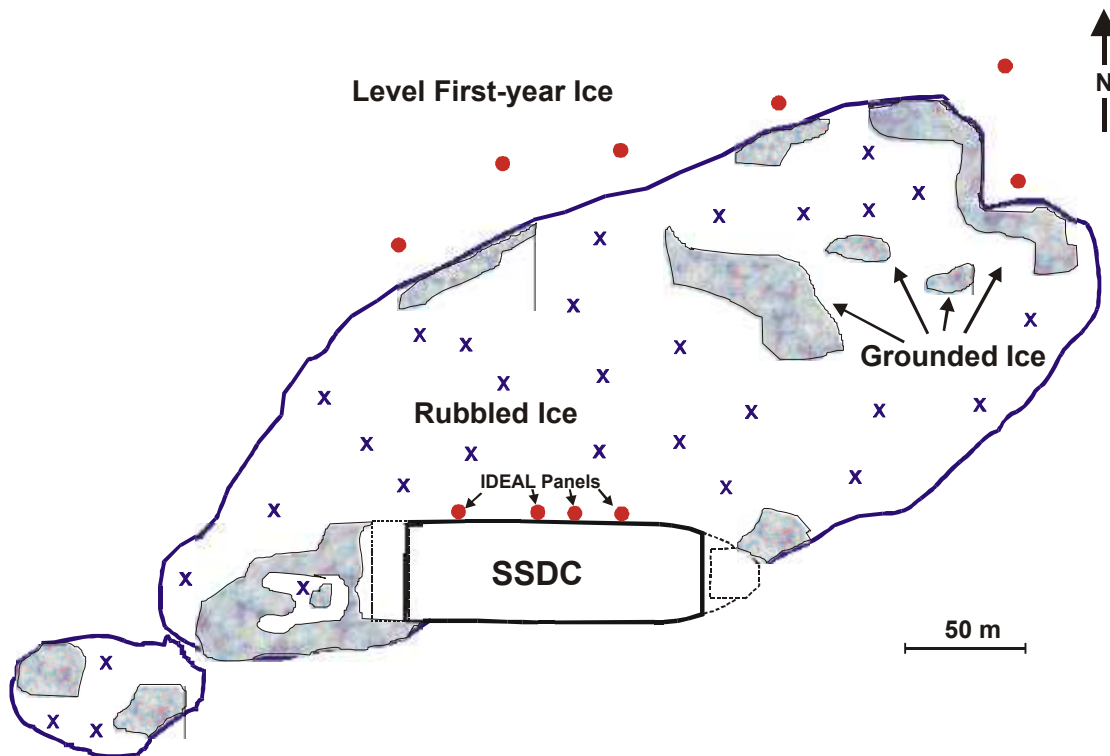
Figure 17: Location of instrumentation in the ice surrounding the SSDC/MAT at the Phoenix site (1986-87).

The ice load panels installed on the hull of the SSDC while deployed at Uviluk and Kogyuk were not functioning at the Phoenix site. Instead, load panels were placed in the ice and used to monitor the ice loads. In early March 1987 four IDEAL ice force panels (0.5 m by 2.0 m) were installed in the rubbled ice surrounding the SSDC on the north side, and six additional load panels were located in the level first year ice, as shown in Figure 17. Ice loads were measured continuously from installation of the panels in March to their removal in June, 1987. In addition, the ice conditions at Phoenix were monitored via ice movement reflectors, crack displacement stations and thermistor strings. Information about the ice was also provided by aerial photography, ice rubble profiles, ice thickness, ice salinity measurements and ice observations (Blanchet and Keinonen, 1988).

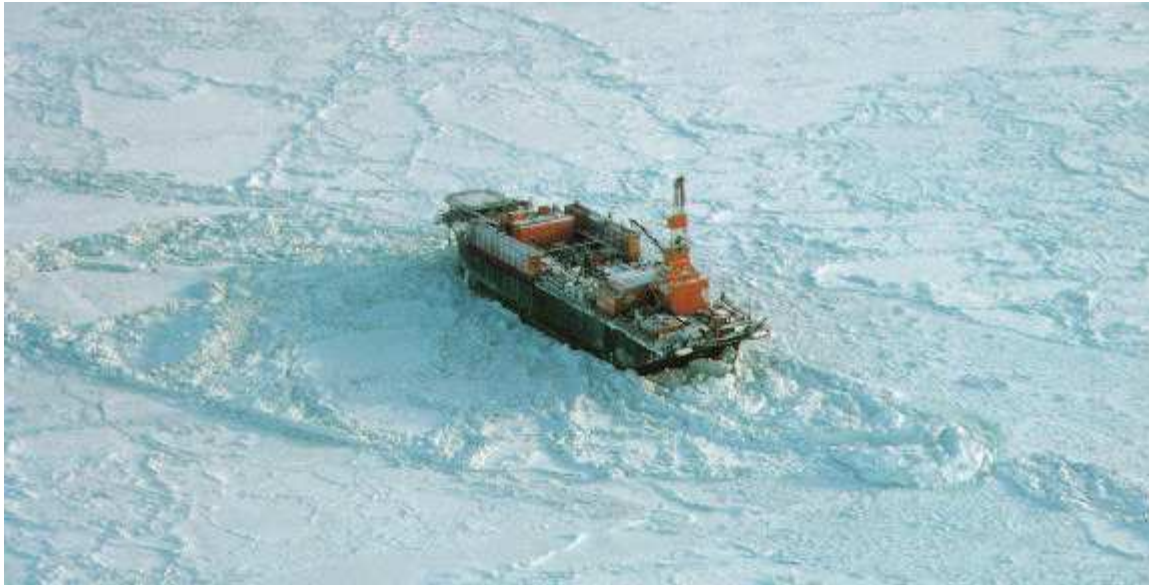
Figure 18: Photograph of the SSDC at the Phoenix site. Note the large rubble field surrounding the structure.

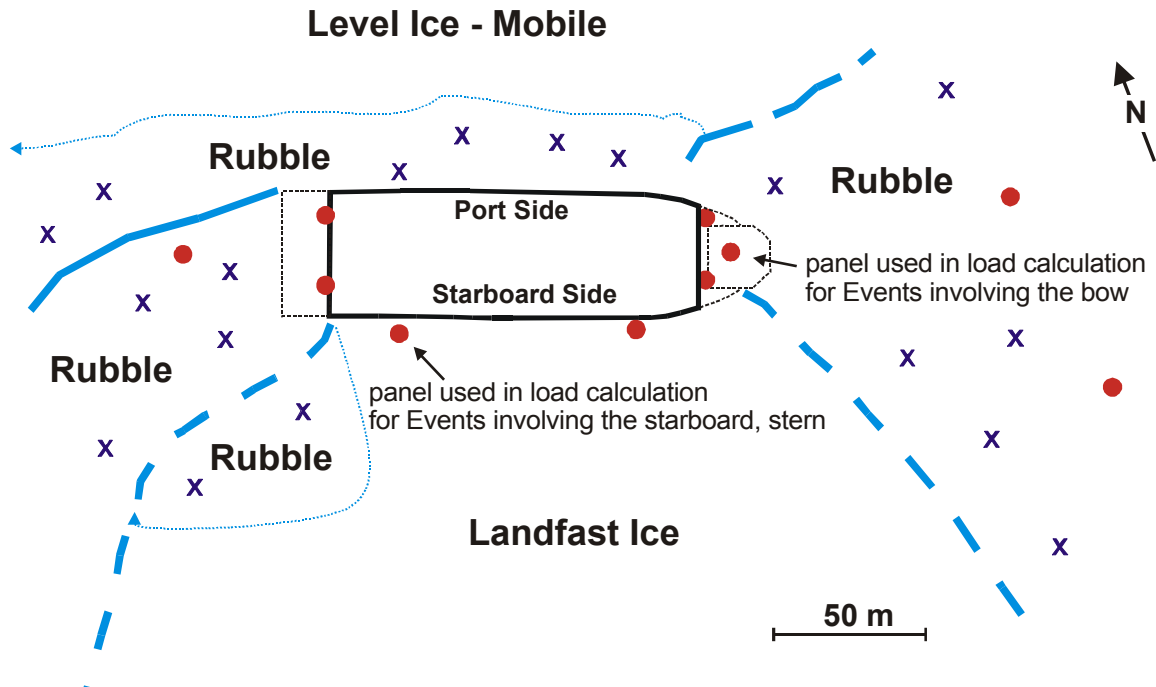
Figure 19: Location of instrumentation in the ice surrounding the SSDC/MAT at the Aurora site (1987-88).

Ice adjacent to the SSDC developed cracks that extended 45° from the centerline of the SSDC, and divided the surrounding ice into four regions classified as the *bow*, *starboard*, *stern* and *port* sectors (Figure 19). Ice at the *bow*, *stern* and *port* side of the structure moved with the predominant wind direction, which was generally in the east-west direction³. Ice in the *port* sector remained unstable throughout winter until breakup, with daily movement from 0 to 20 m. The ice sheet in the *starboard* section had a cyclical motion between the shoreline and structure (normal to the longitudinal axis) that was wind and temperature driven.

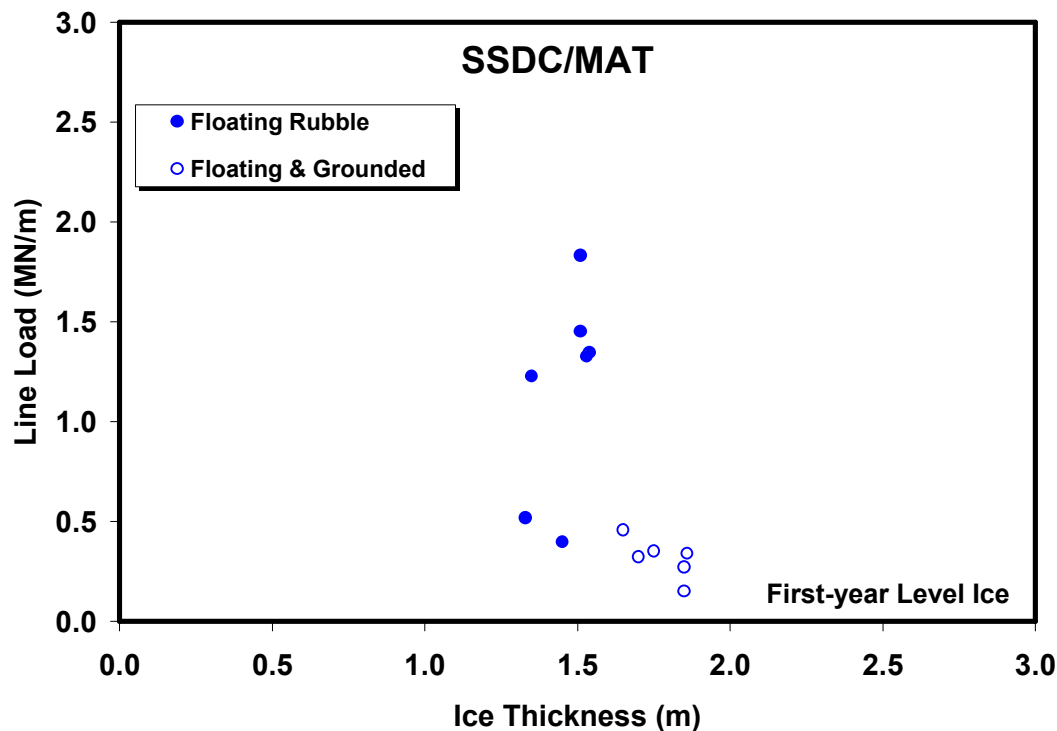
Figure 20: Line Load on the SSDC as a function of the ice thickness.

Figure 20 shows a plot of the Line Load as a function of the ice thickness for all of the events in which load information was available (Phoenix and Aurora sites). Note that for all of these events, a rubble field surrounded the SSDC. The data in the plot have been subdivided according to the state of the rubble surrounding the SSDC. Although the rubble fields were mostly floating, there were grounded regions close to the SSDC at the Phoenix site.

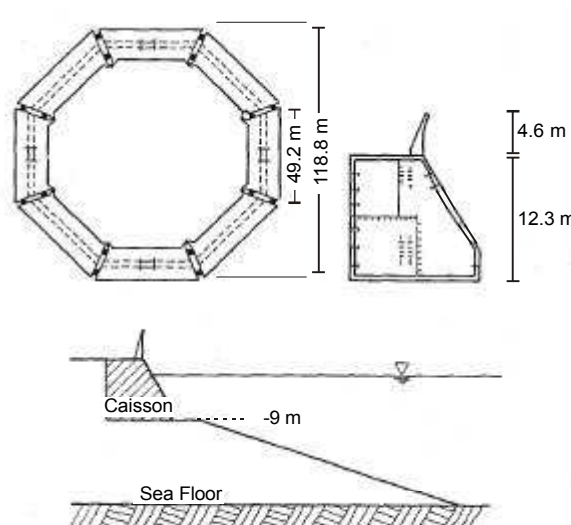
Figure 21: Illustration of the Caisson Retained Island (after Croasdale, 1985)

Esso Resources Canada Ltd. originally built this structure, but it is now owned by Arctic Transportation Ltd. It was developed as a means of reducing dredge quantities, as compared to the more traditional sand island. The CRI was built in 1982-83 and first deployed in the Canadian Beaufort Sea in the summer of 1983. The design has 8 individual caissons (43 m long x 12.2 m high x 13.1 m wide) in a ring (see Figure 21). Two pre-stressed bands of steel wire cable hold the caissons together. The central core, which is 92 m across, is filled with sand to provide a surface for drilling operations and to provide stability against applied loads. The CRI is an 8-segment octagonal-shaped steel structure about 118 m across on the flats, 12 m high and the outer face is inclined (30° from the vertical).

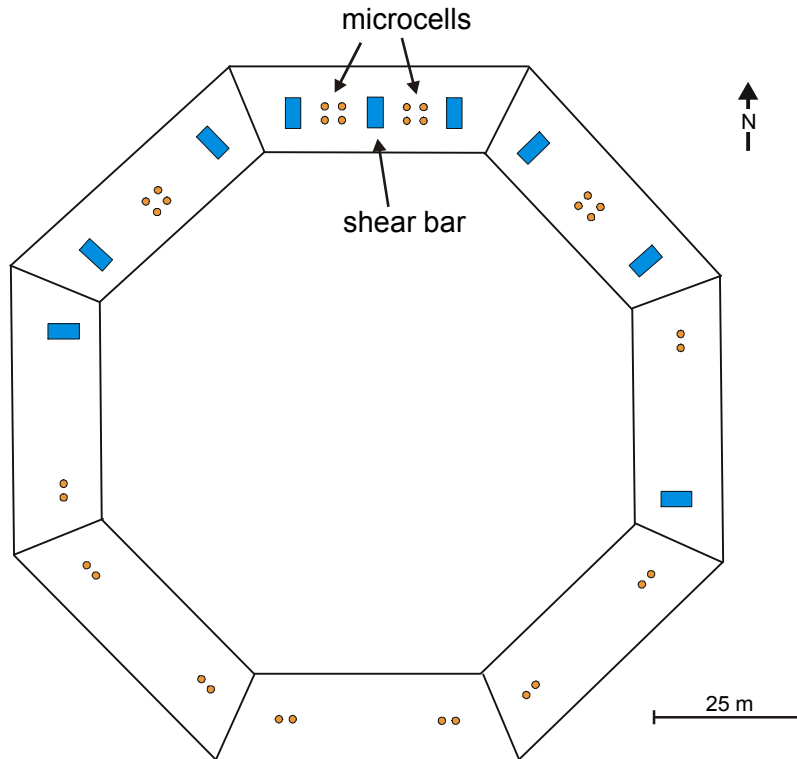
Figure 22: Illustration of the location of the instrumentation on the hull of the CRI.

Instrumentation on the CRI consisted of sensors for ice loads on the outer surface of the caisson, strain gauges on structural elements of the caisson and geotechnical sensors in the sand core and under the foundation (Hawkins et al., 1983). A schematic of the layout

The internal structure of the caissons was also instrumented with 156 weldable strain gauges. The locations were determined from a finite element analysis that also provided a means for interpreting ice loads from the measured strains. Geotechnical sensors were used to measure the response between the caisson and the sand and foundation. This instrumentation included total pressure cells, pore pressure cells and inclinometers. The instrumentation was sampled at a frequency of either 0.1 Hz or 1 Hz. To reduce the quantity of stored data, real-time data processing techniques were used. This involved storing the average, variance and peak reading for each sensor over a five-minute interval.

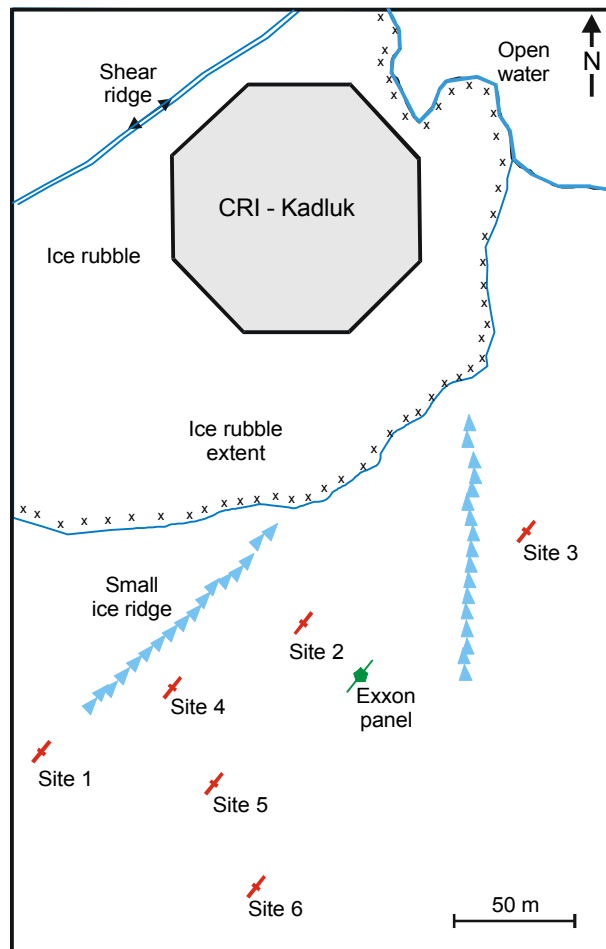
Figure 23: Ice conditions and instrumentation at Kadluk, spring 1984 (after Johnson et al., 1985 with adaptations).

During the spring of 1984, 18 cylindrical, biaxial ice stress sensors⁴ were installed in the level ice south of the CRI, beyond the rubble (Cox, 1987). Due to complications, the *in-situ* sensors were not finally positioned until the first week of April. Since ice north of the CRI remained thin and continued to move offshore at that time, the sensors were deployed at six sites south of the island (on the shoreward side, Figure 23). At each of the six sites, the sensors were located at ice depths 0.3 m, 0.8 m and 1.3 m. An Exxon pressure panel was installed on the south side of the structure, about 20 m from Site 2, with the panel facing 6° from north. In addition, the ice temperature, ice movement and wind speed and direction were monitored.

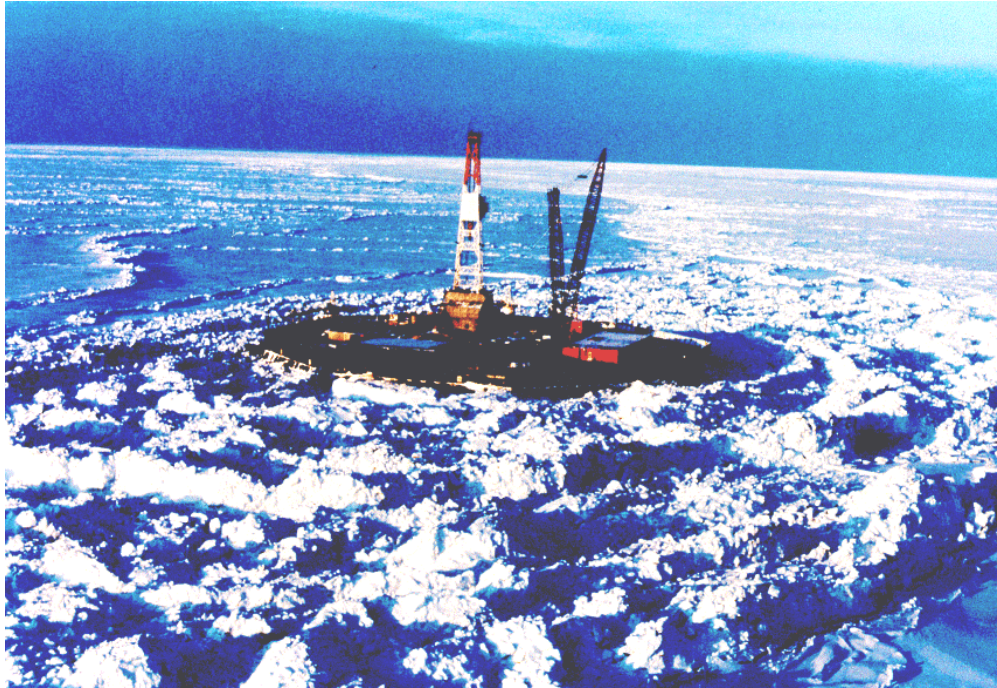
Figure 24: Ice rubble surrounding the CRI at the Amerk site.

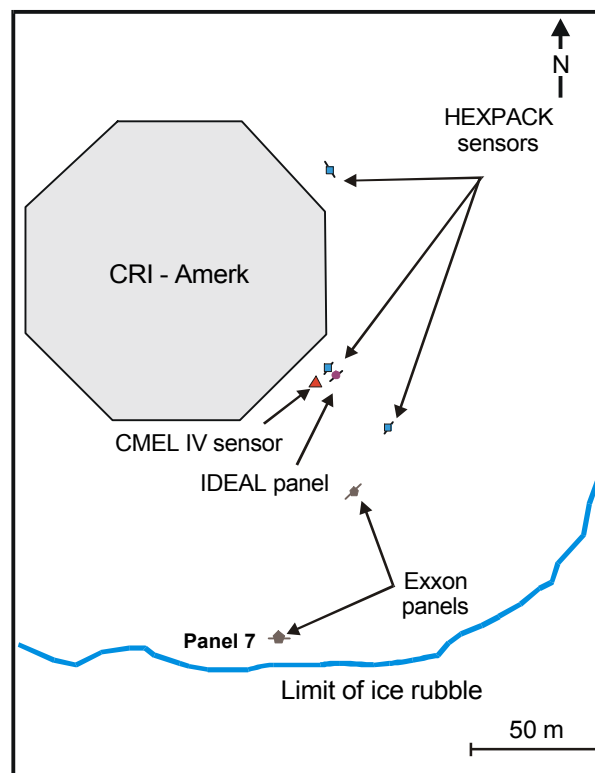
Figure 25: Instrumentation around the CRI at the Amerk site.

When the CRI was deployed at Amerk, over the winter of 1985-86, only the Exxon panel along the southern edge of the rubble (panel 7 in Figure 25) yielded appreciable results. All other sensors installed in the ice around the CRI showed no response. The stress-time trace for panel 7 is presented in Figure 26. During the period of instrumentation (March to May), the panel showed heightened activity during April 1 to 7, and then again beginning on April 22, 1985. During that period, the thickness of the refrozen rubble layer was 2.5 m. Sayed et al. (1986) estimated the load per unit length to be 500 kN/m, assuming the stresses were uniform across the frozen rubble. Since negligible stresses were measured near the caisson, it was concluded that the presence of grounded rubble resulted in significant attenuation of the applied load at Amerk (Sayed et al., 1986).

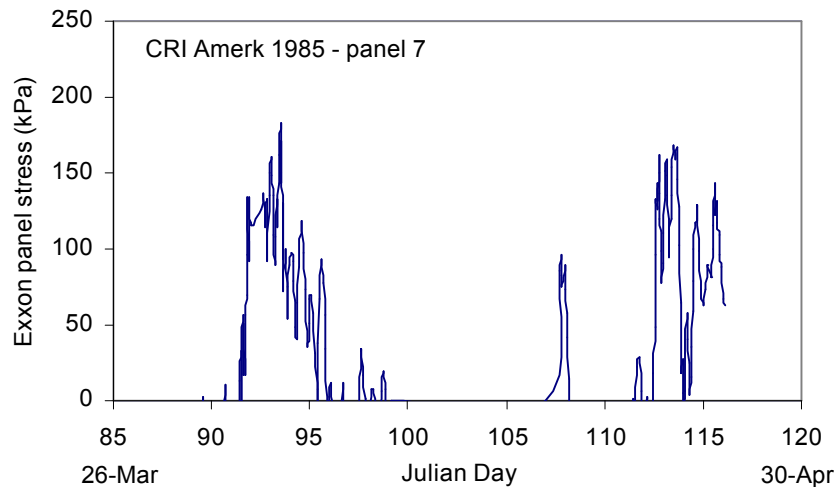
Figure 26: Stress measured on Panel 7 at the Amerk site from Julian Day 85 (March 26) to Julian Day 120 (April 30), 1985 (after Sayed et al., 1986 with adaptations)

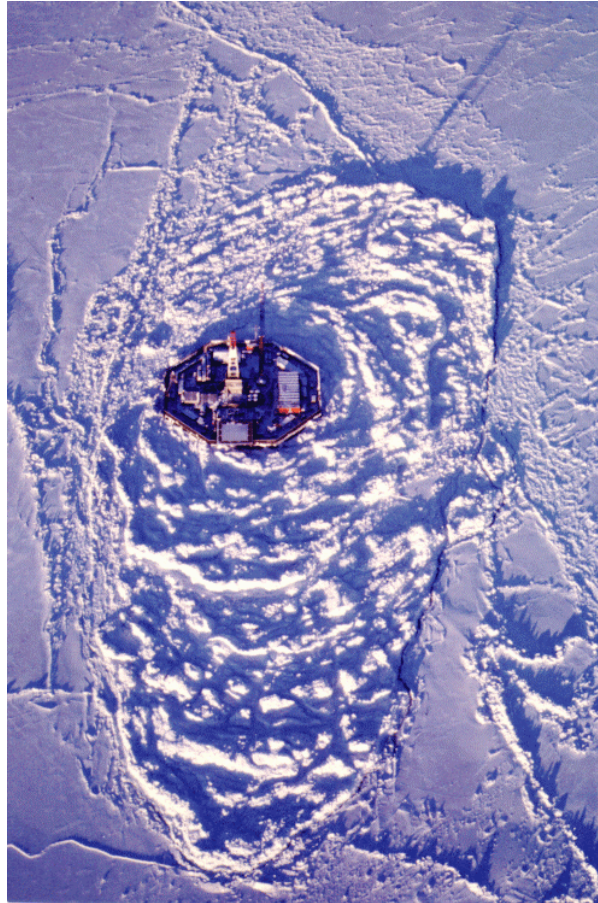
Figure 27: Photograph of the grounded rubble field around the CRI at the Kaubvik site.

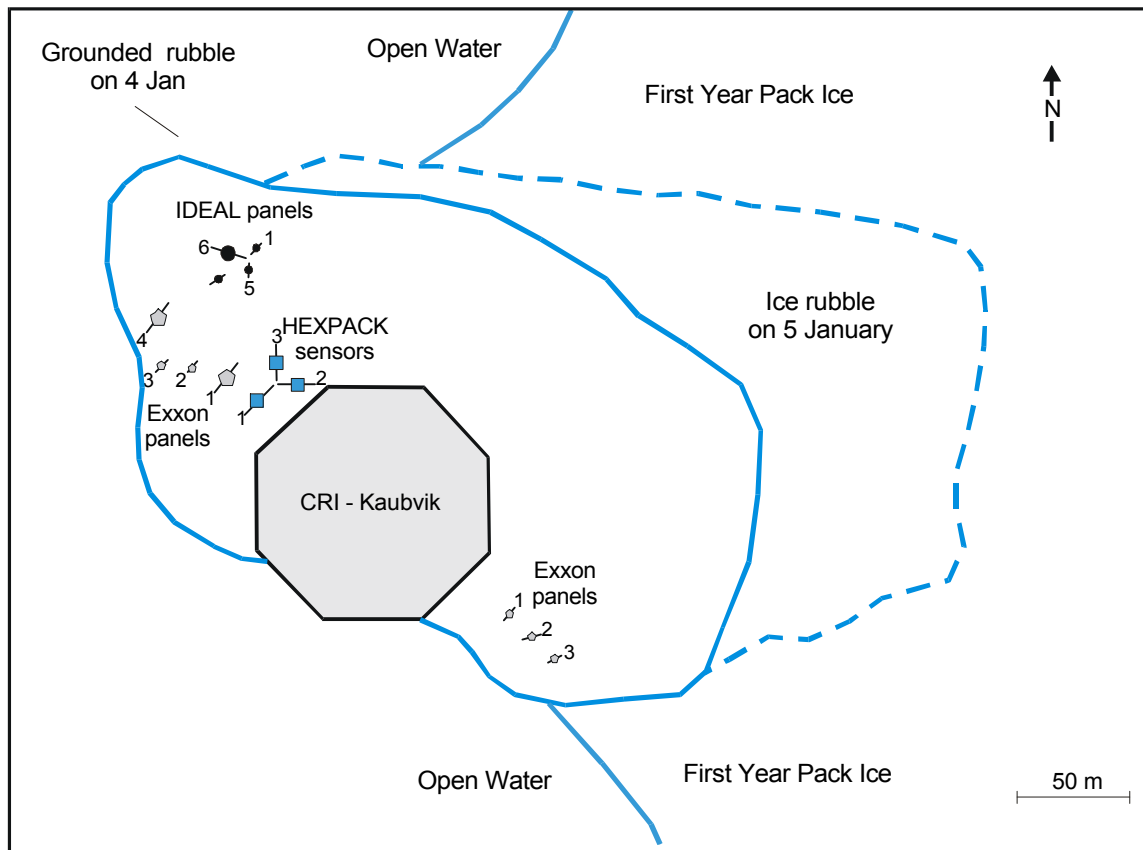
Figure 28: Location of the in-situ stress sensors in the rubble field surrounding the CRI at the Kaubvik site.

Four types of stress sensors were used to monitor the *in-situ* pressures in the ice rubble. The sensors were placed along radial lines extending away from the CRI, in order to measure the lateral stress profile of the load transmitted through the rubble field (see Figure 28). Three Exxon panels were oriented south-east of the caisson, extending to the outer edge of the rubble, where they would experience the effect of thermal expansion of the ice.

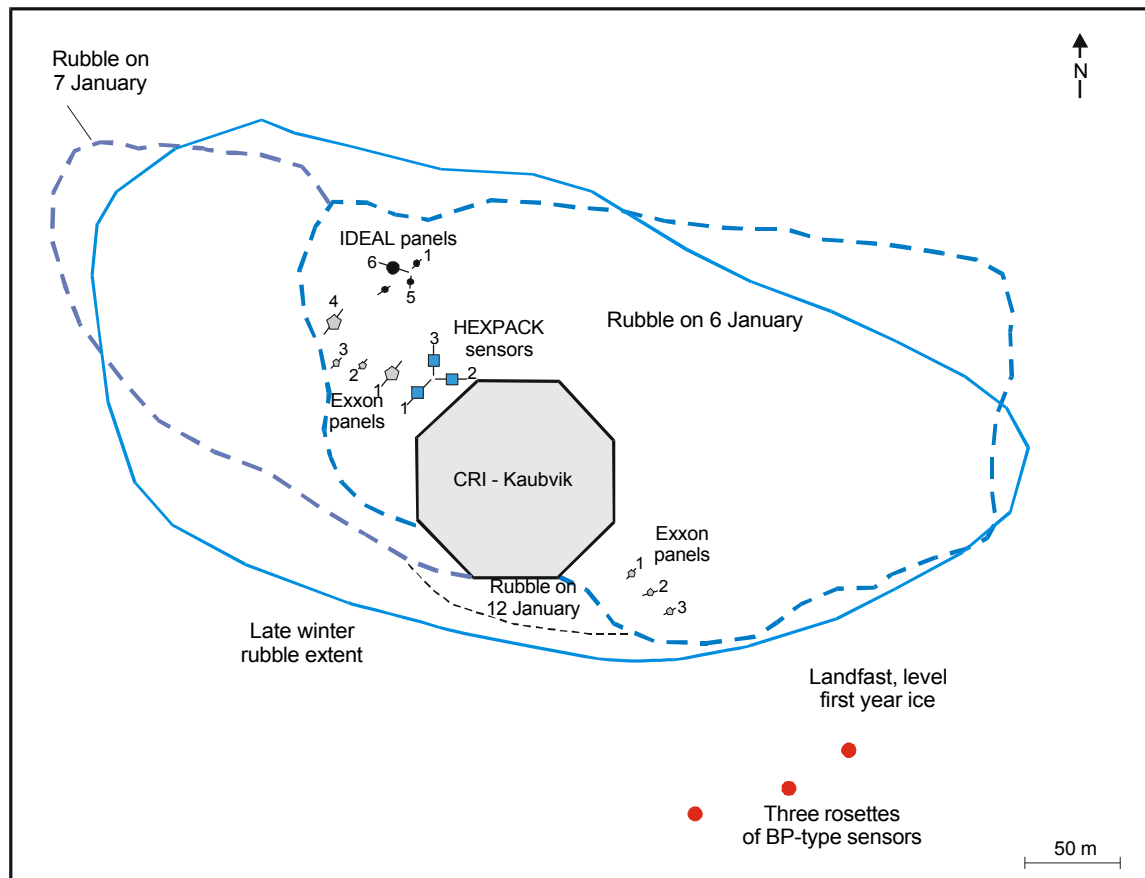
Figure 29: Late winter map of rubble extent around the CRI-Kaubvik showing location of BP-type sensors (after Frederking and Sayed, 1988; Marshall, 1990; with adaptations).

In the late spring, the output from the BP-TYPE sensors that were installed by Memorial University in the level ice to the south of the CRI (see Figure 29) indicated two events. The Exxon panels that were installed in the rubble south of the CRI (Figure 29) also indicated these events on March 31 to April 4, and the other event beginning on April 28. Figure 31 shows the measured panel stress during the spring months. The two events were believed to be due to thermal and/or wind induced stresses (Frederking et al., 1988). During this time, Exxon panels 1 to 3 showed sporadic output (with pressures up to 2.5 MPa (Frederking and Sayed, 1988). Due to their sporadic nature, they are not included on Figure 31.

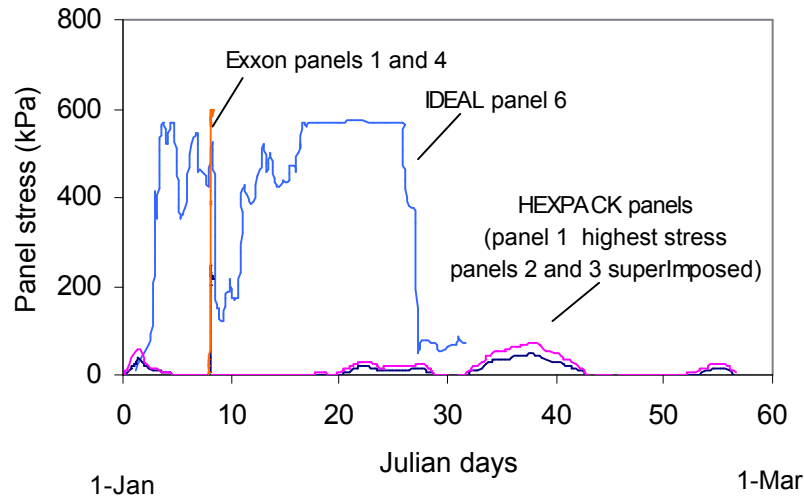
Figure 30: Output from the *in-situ* load panels installed around the CRI at Kaubvik (after Frederking and Sayed, 1988 with adaptations).

As the winter progressed, an extensive rubble field developed around the CRI at Kaubvik. The ice load panels that were installed in the rubble measured the *in-situ* ice stress (Figure 30). During the January 1987 field trip to Kaubvik, field personnel noted the occurrence of two rubble building events, one on the east side on the evening of January 5, and the other on the north-west side on the evening of January 7. The load panels registered a response to the January 7 event, at which time the rubble extent was in the vicinity of Exxon panels 3 and 4. Exxon panels 1 and 4 showed that the stress increased over a period of 2.5 hours, whereas Exxon panel 2 increased only slightly and

Exxon panel 3 first decreased and then increased to spuriously high values (Frederking et al., 1988). Figure 30 presents the output of panels 1 and 4 for this event, which are indistinguishable due to the temporal compression of the plot.

The rosette of HEXPACK panels recorded almost equal values of the normal stress in the three directions. The stress was approximately hydrostatic (Frederking et al., 1988). The output of the three HEXPACK panels is shown in Figure 30.

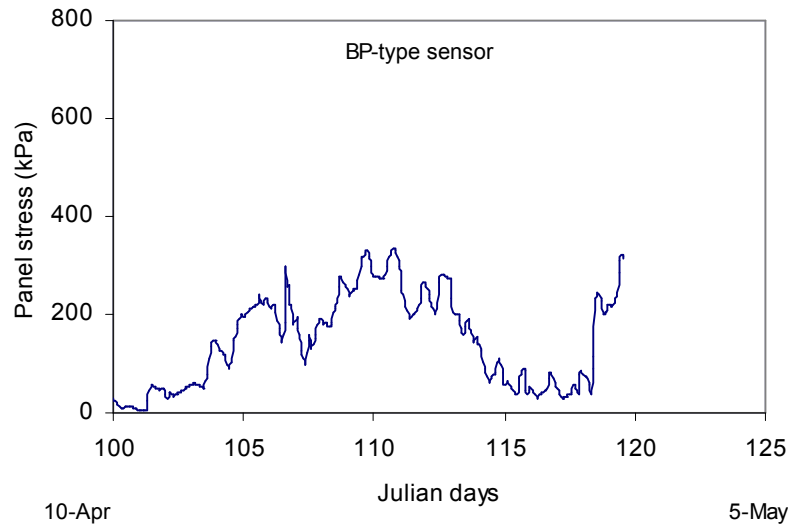
Figure 31: Output from the BP-type sensors installed south of the CRI at Kaubvik (after Marshal, 1990 with adaptations).

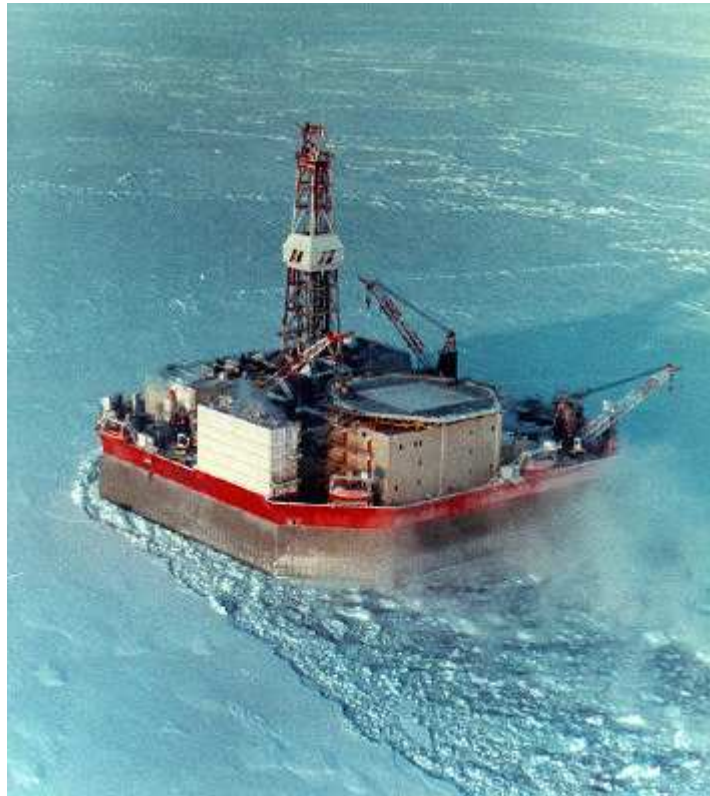
Figure 32: Photograph of the Molikpaq in the Canadian Beaufort Sea.
