**Caisson Structures in the Beaufort Sea 1982-1990:
Characteristics, Instrumentation and Ice Loads**

**G.W. Timco and M.E. Johnston
Canadian Hydraulics Centre
National Research Council of Canada
Ottawa, Ont. K1A 0R6
Canada**

**Technical Report
CHC-TR-003**

November 2002

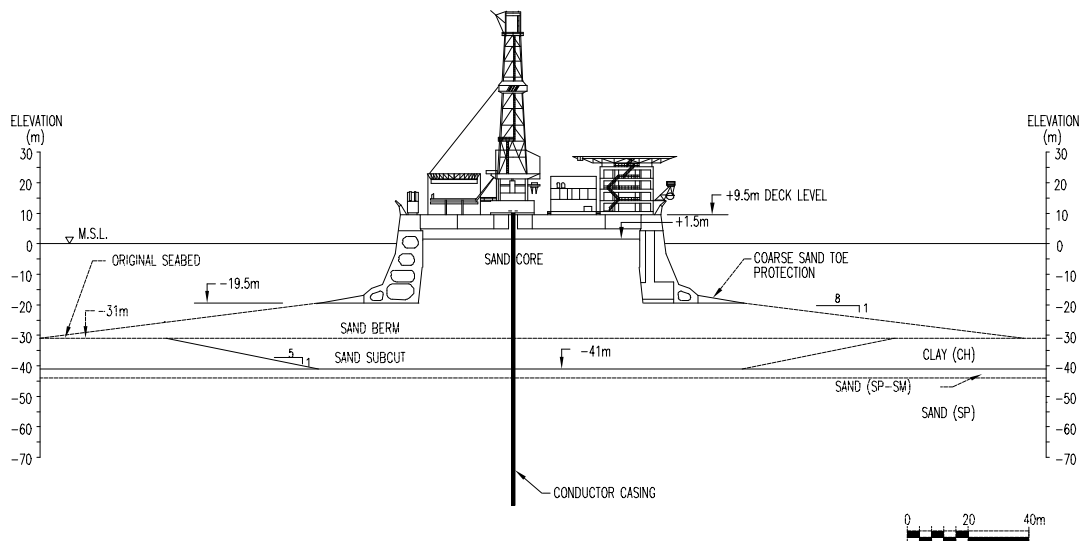
Figure 33: Cross-section view of the Molikpaq at the Amauligak I-65 site in 1985-86.

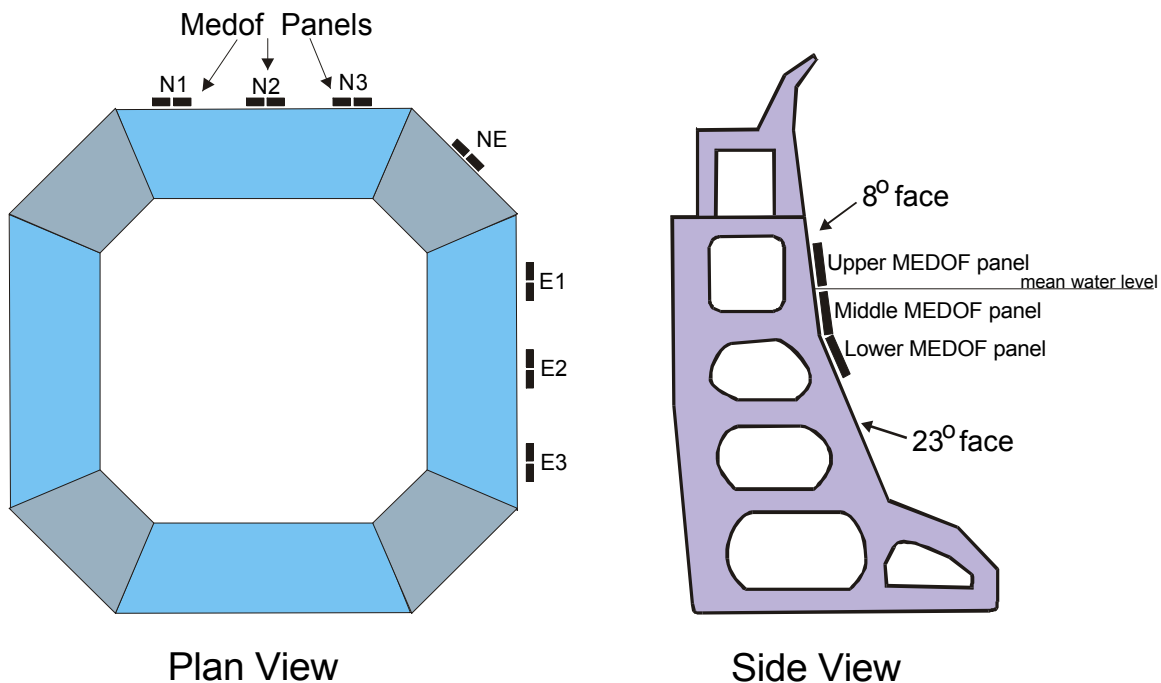
Figure 34: General location of the MEDOF panels on the Molikpaq. Each MEDOF panel sensor group has a sensing width of two panels, each 1.135 m wide and 2.7 m high. The detailed locations of individual panels are shown in Figure 35.

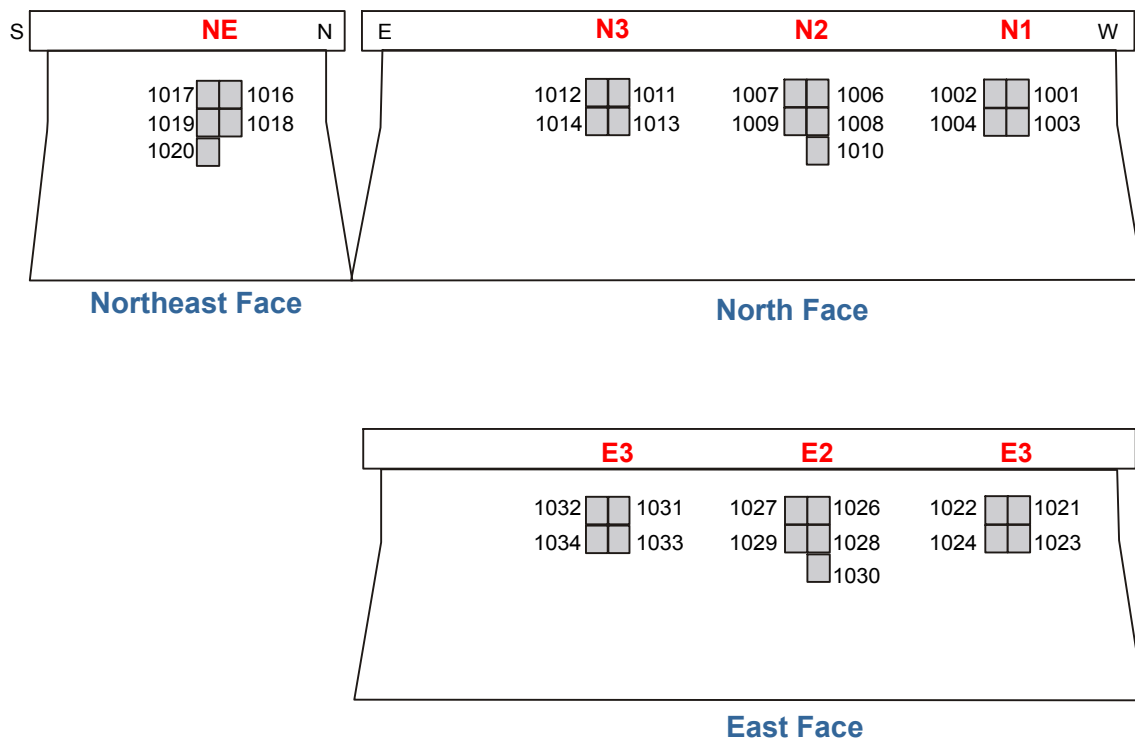
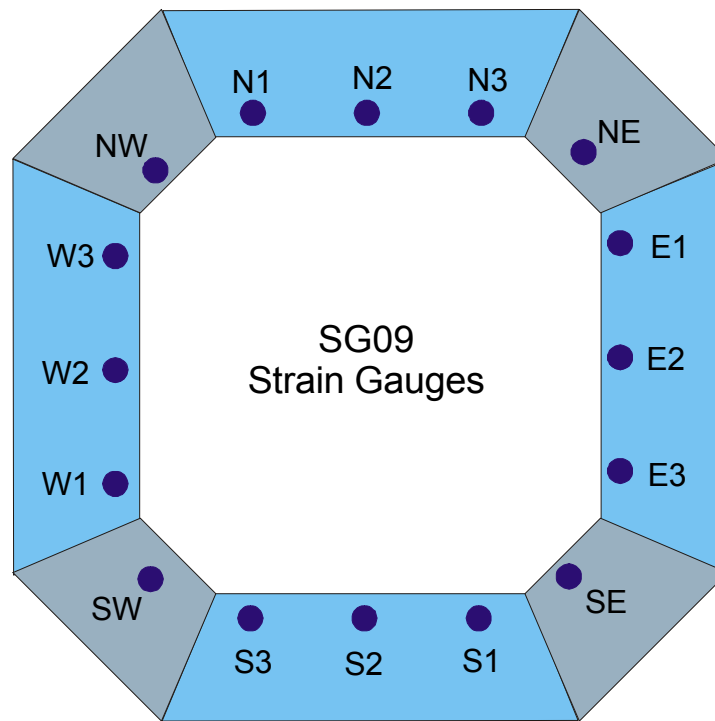
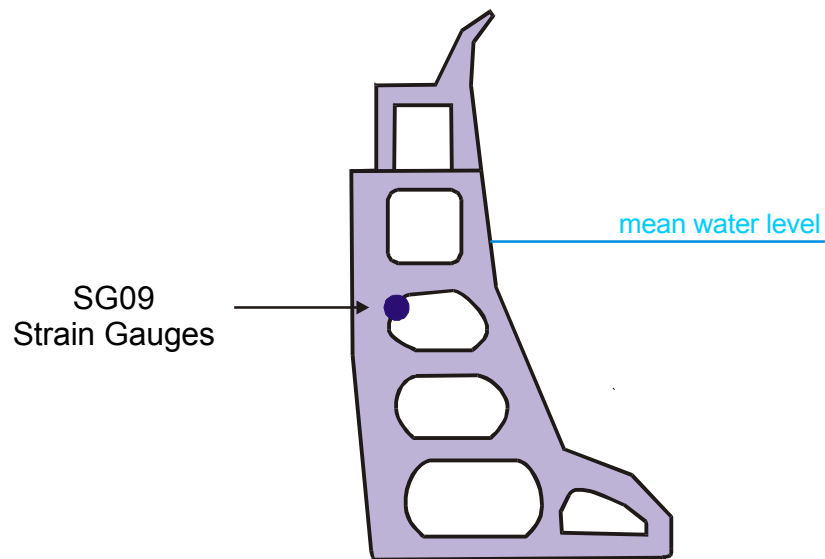
Figure 35: Location of the individual MEDOF panels on the Molikpaq.

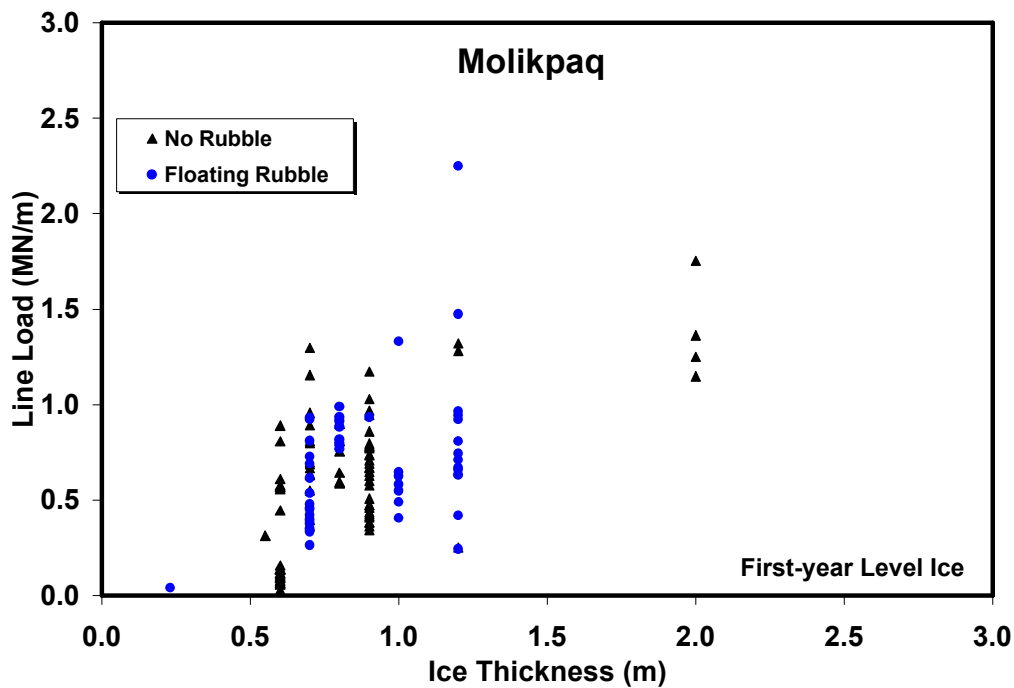
Figure 37: Line Load versus ice thickness on the Molikpaq. This plot shows only data relevant to level, first-year sea ice.

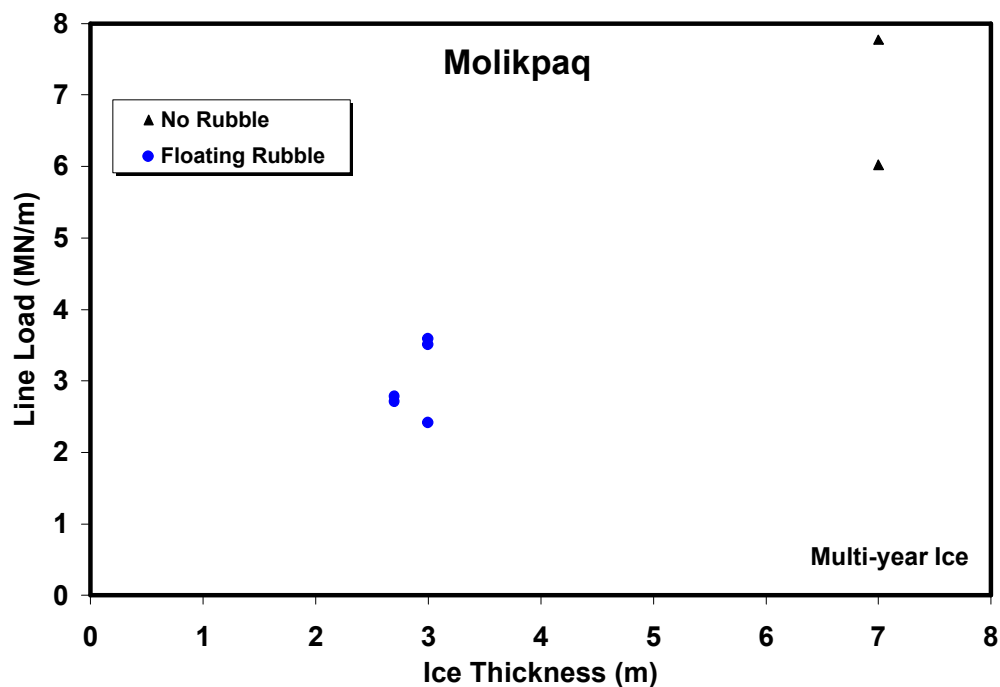
Figure 38: Line Load as a function of ice thickness for multi-year ice interacting with the Molikpaq

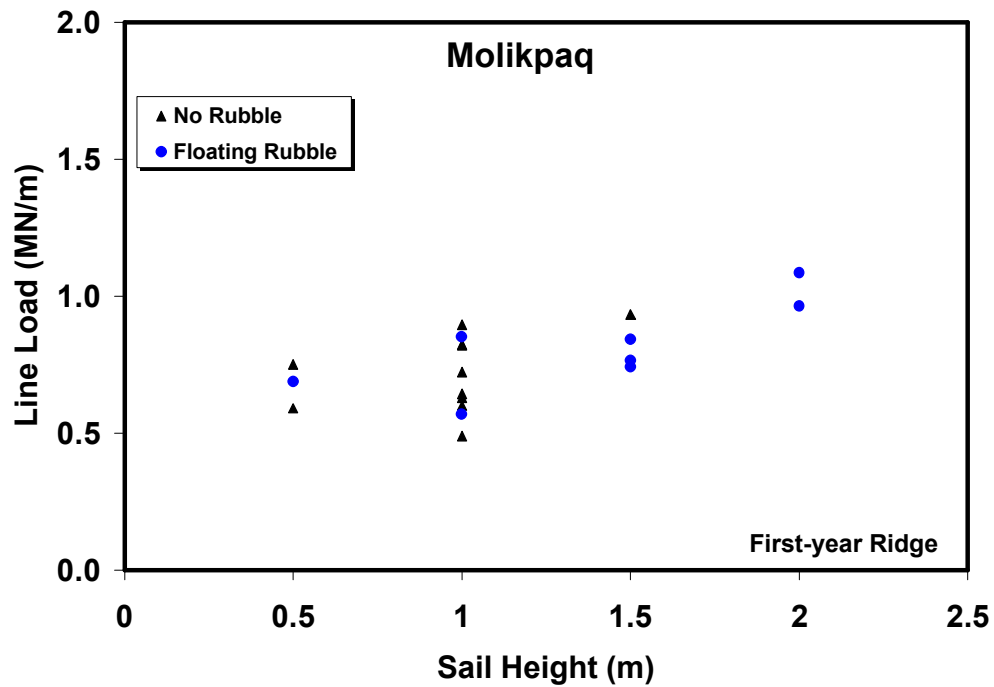
Figure 39: Line Load as a function of sail height for first-year ridge interaction with the Molikpaq.

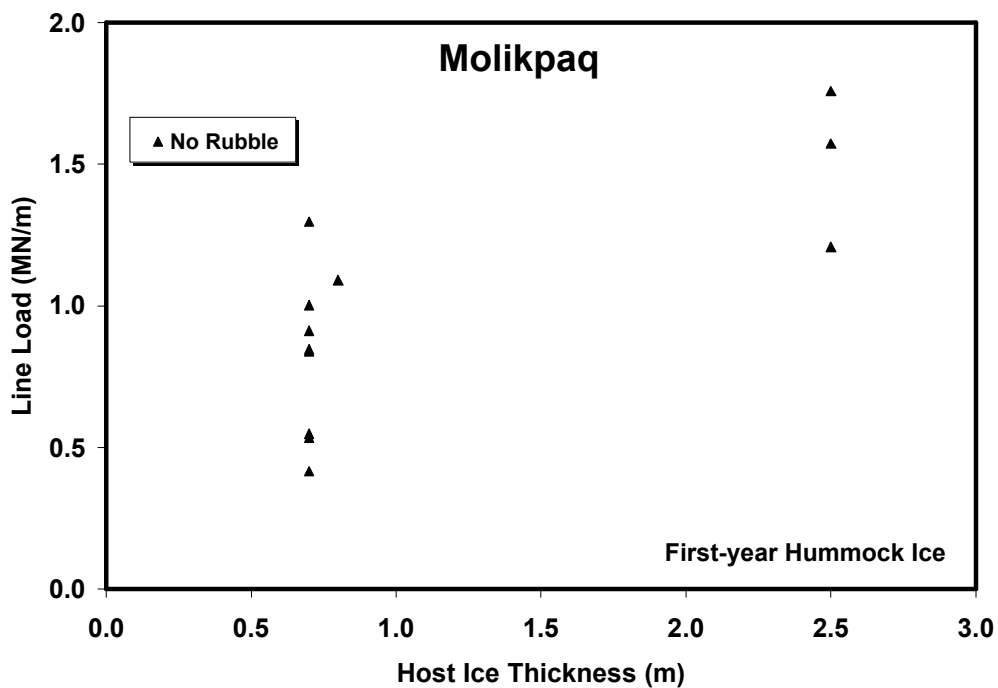
Figure 40: Line Load as a function of the host ice thickness for first-year hummock ice.

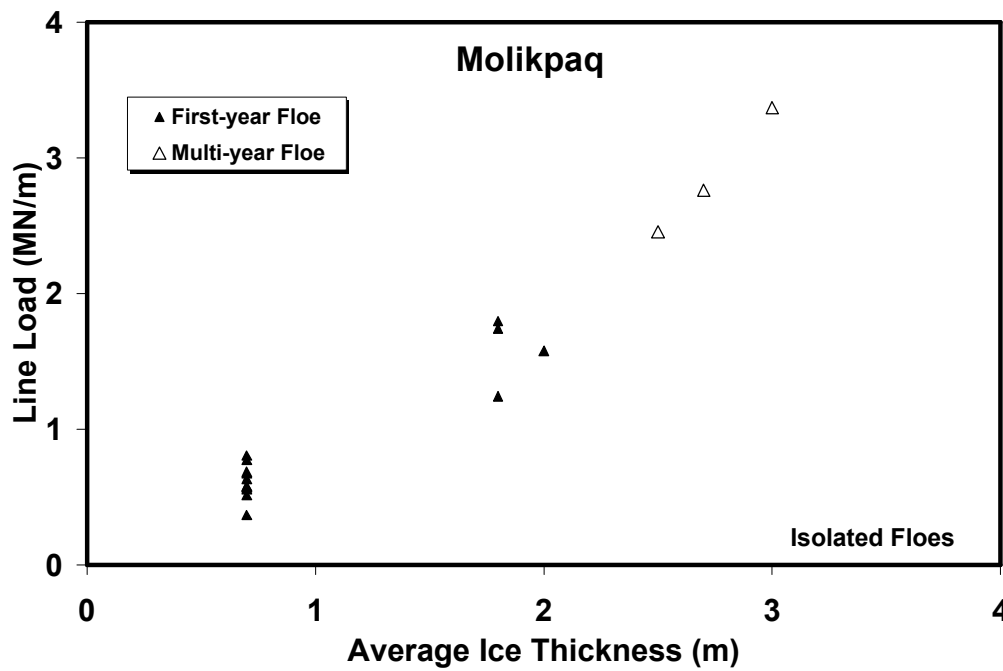
Figure 41: Line Load as a function of the average ice thickness of large isolated floes impacting the Molikpaq. The graph shows data for both first-year and multi-year ice.

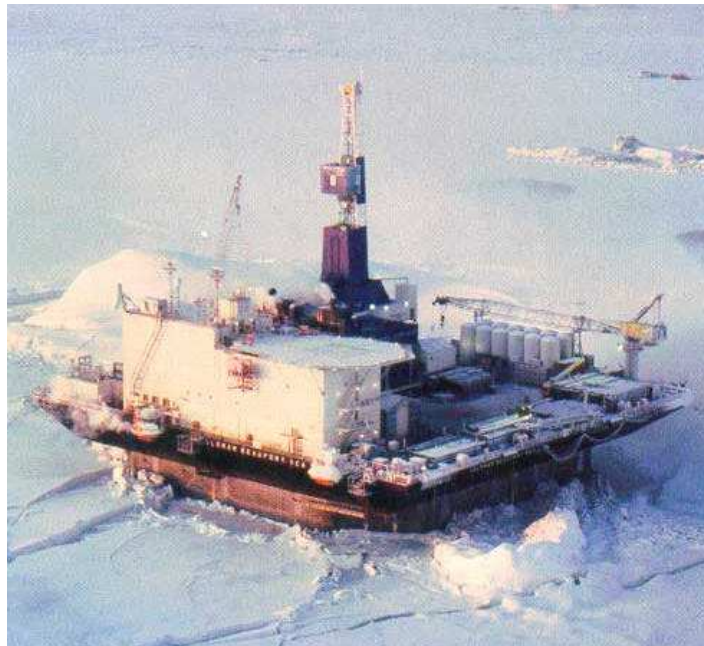
Figure 42: Photograph of the CIDS in ice.

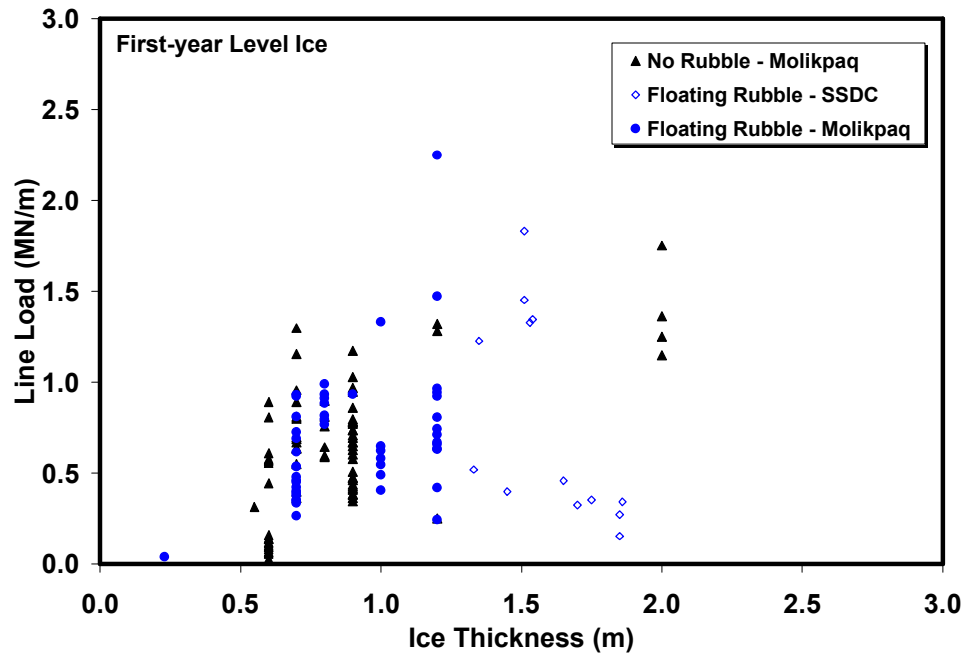
Figure 43: Line Load as a function of ice thickness for first-year level ice. The figure shows that there is little influence of floating rubble on the loads on the structure.

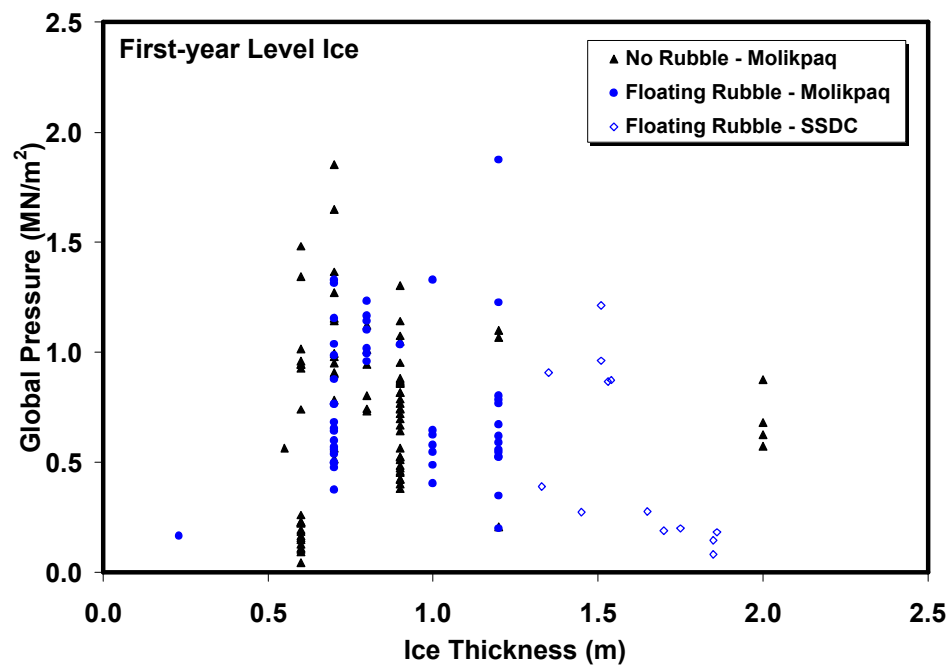
Figure 44: Global Pressure versus ice thickness for level first-year sea ice.

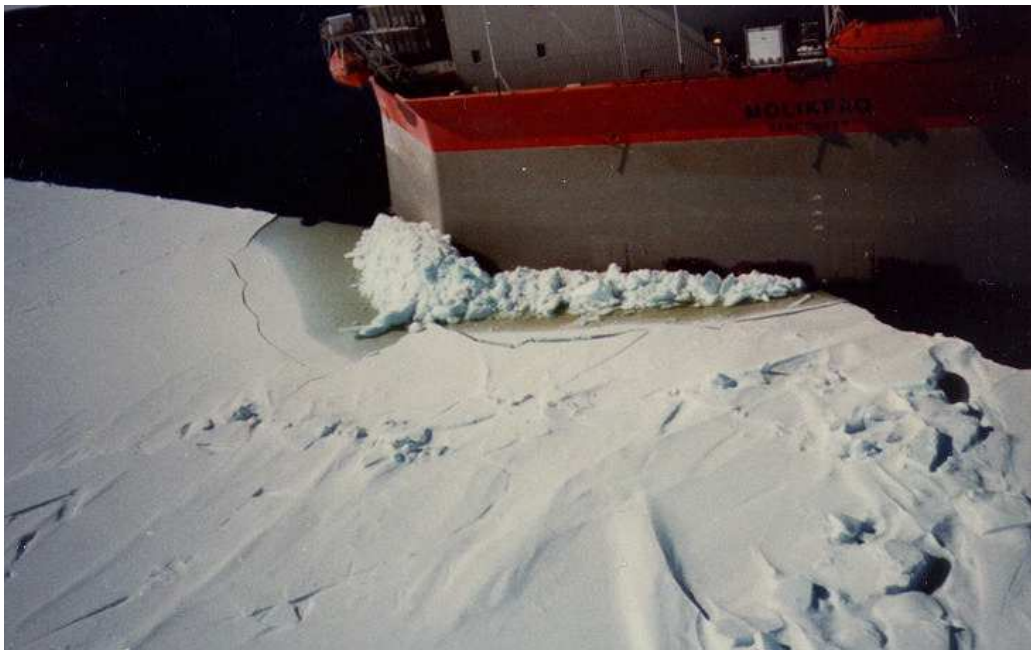
Figure 45: Crushing along the corner of the Molikpaq. Note that the large build-up of ice rubble has caused a subsequent large flexural failure of the ice sheet.

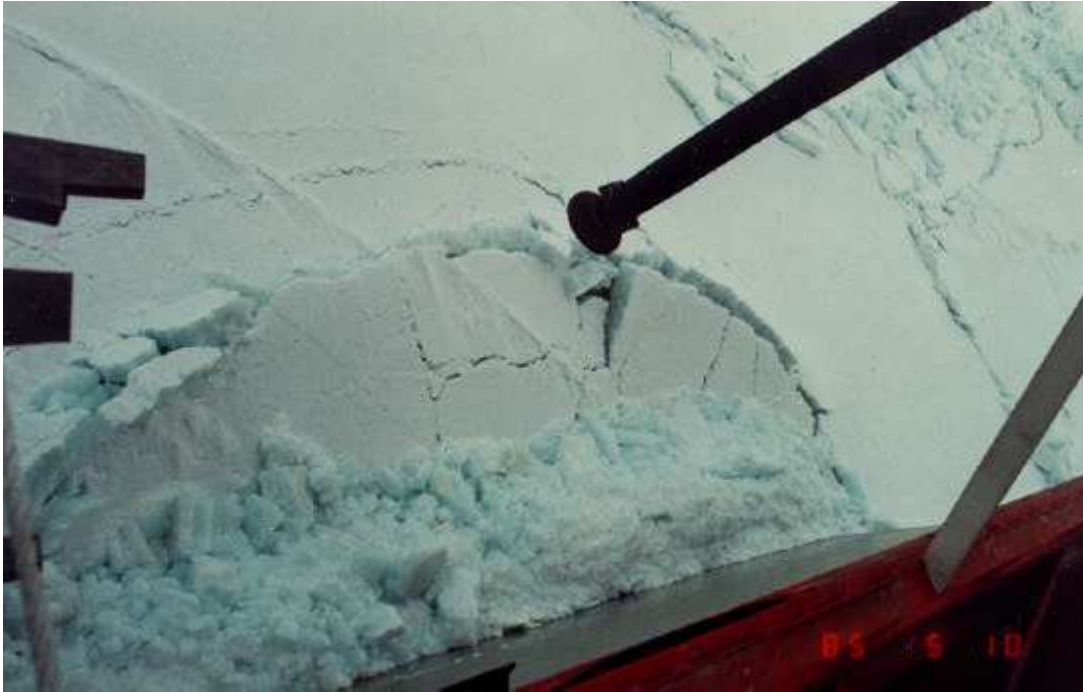
Figure 46: Local flexural failures along the side of the Molikpaq.

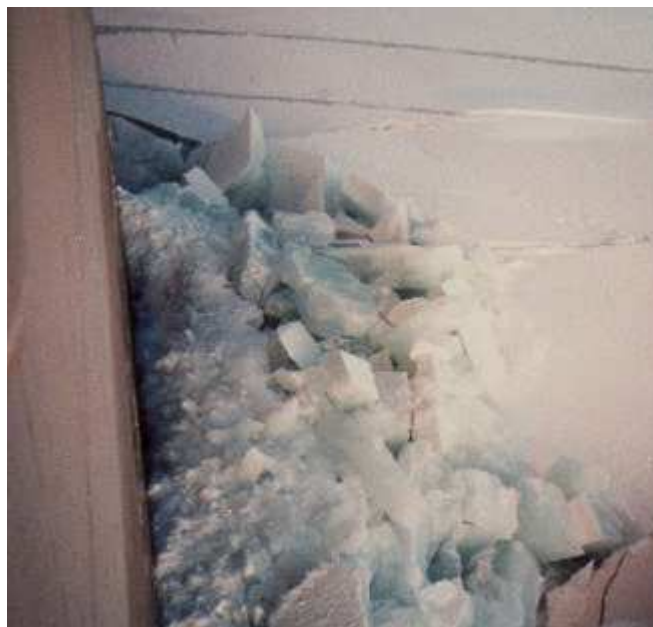
Figure 47: Mixed mode failure along the side of the Molikpaq. Note the large cracks in the parent ice sheet.

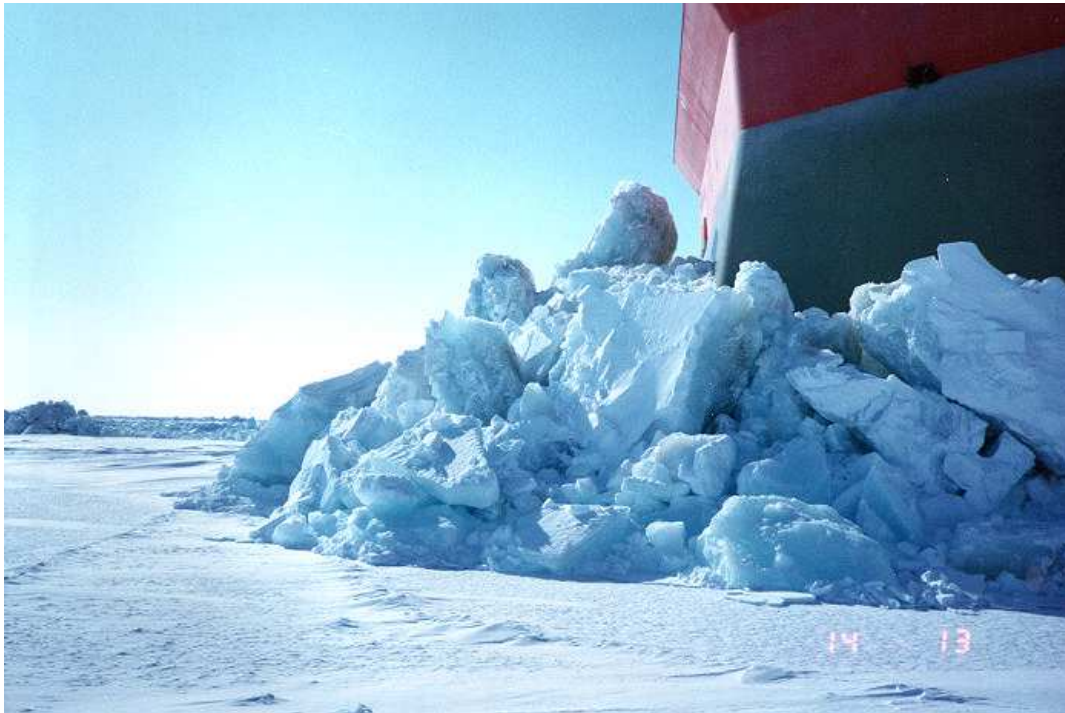
Figure 48: Pile-up alongside the Molikpaq.

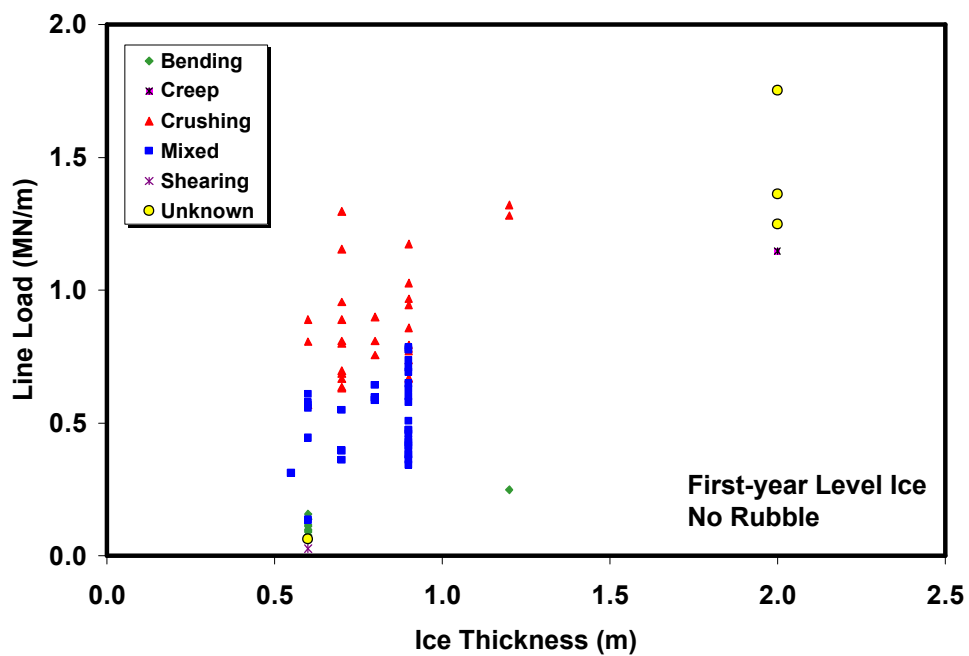
Figure 49: Line Load as a function of ice thickness showing the influence of the failure mode of the ice on the measured load.

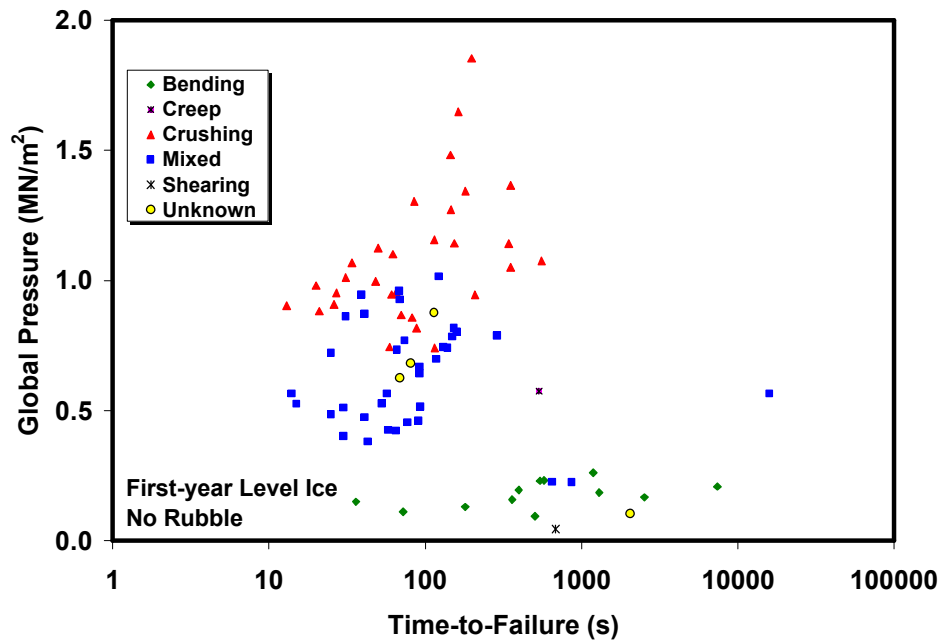
Figure 50: Global Pressure versus the time-to-failure for first-year sea ice.

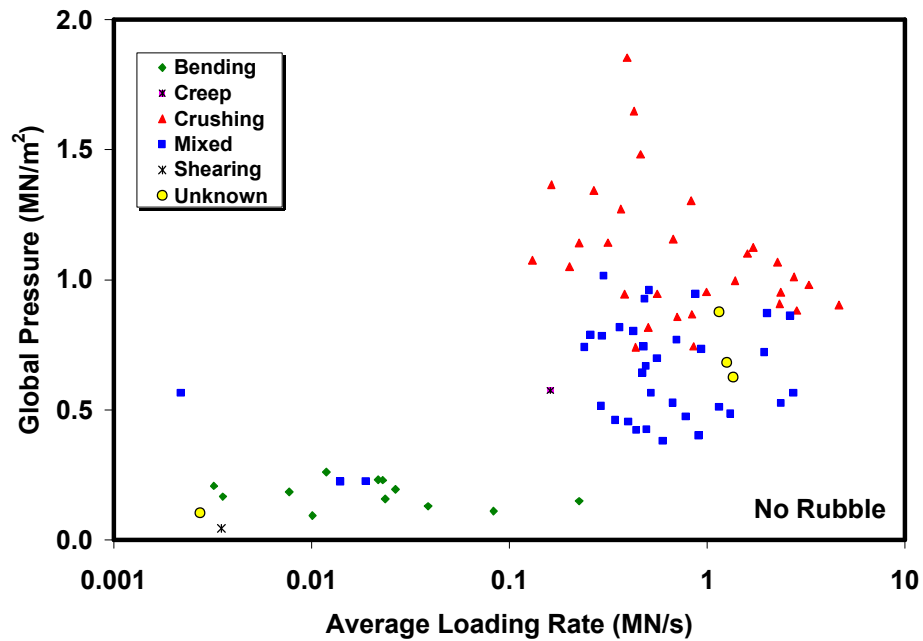
Figure 51: Global Pressure versus the average loading rate for first-year level sea ice.

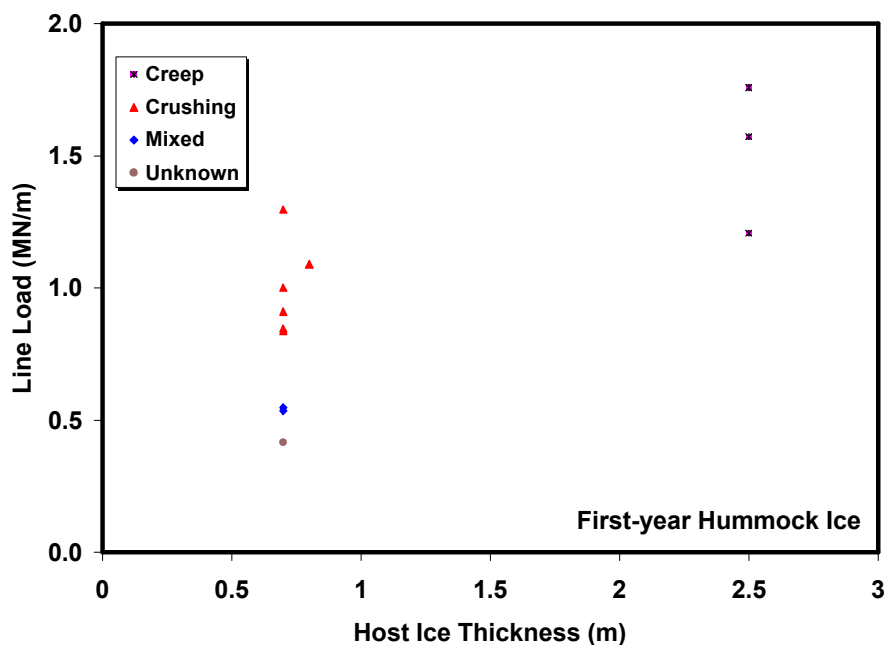
Figure 52: Line Load as a function of the host ice thickness for first-year hummock ice showing the associated failure modes for the ice.

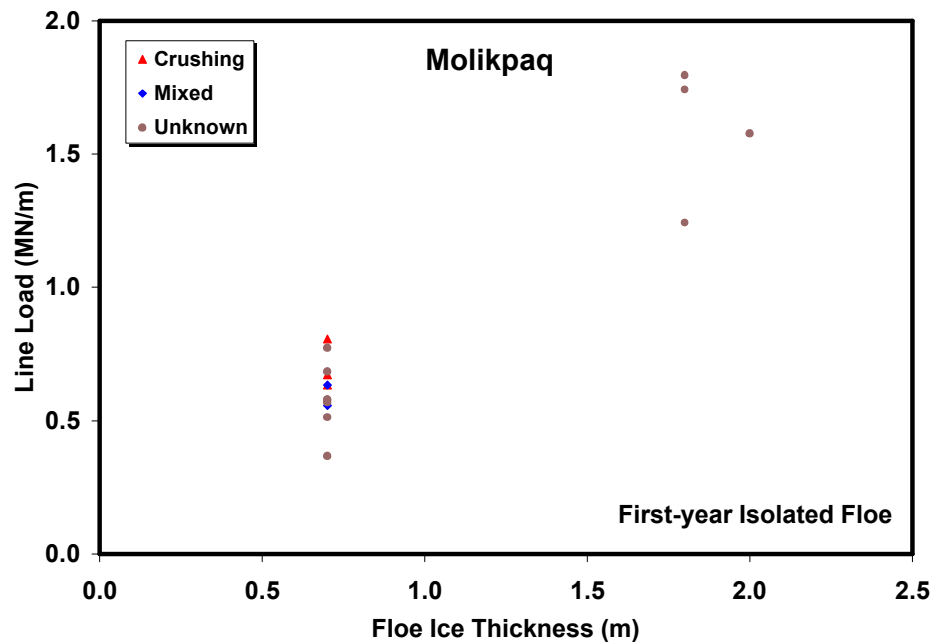
Figure 53: Line Load as a function of the floe ice thickness for first-year isolated floes showing the associated failure modes for the ice.

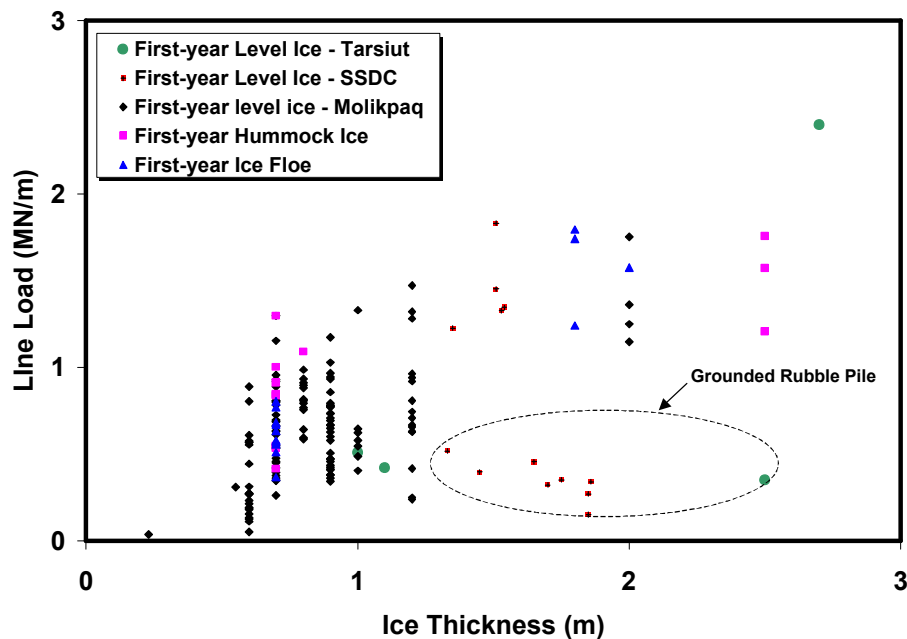
Figure 54: Line Load as a function of ice thickness for different ice macrostructures for first-year ice only.

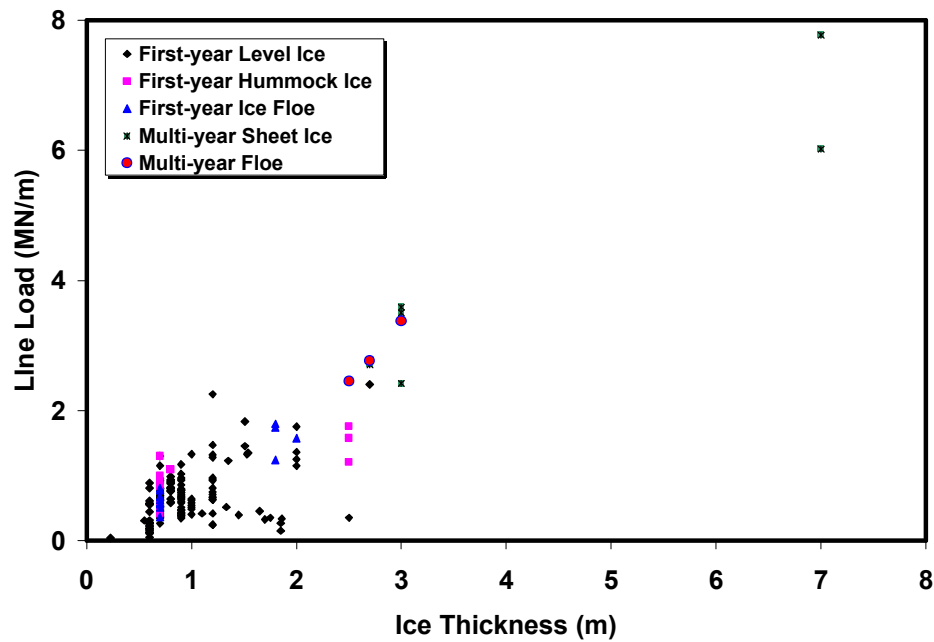
Figure 55: Line Load as a function of ice thickness for different ice macrostructure for both first-year and multi-year ice.

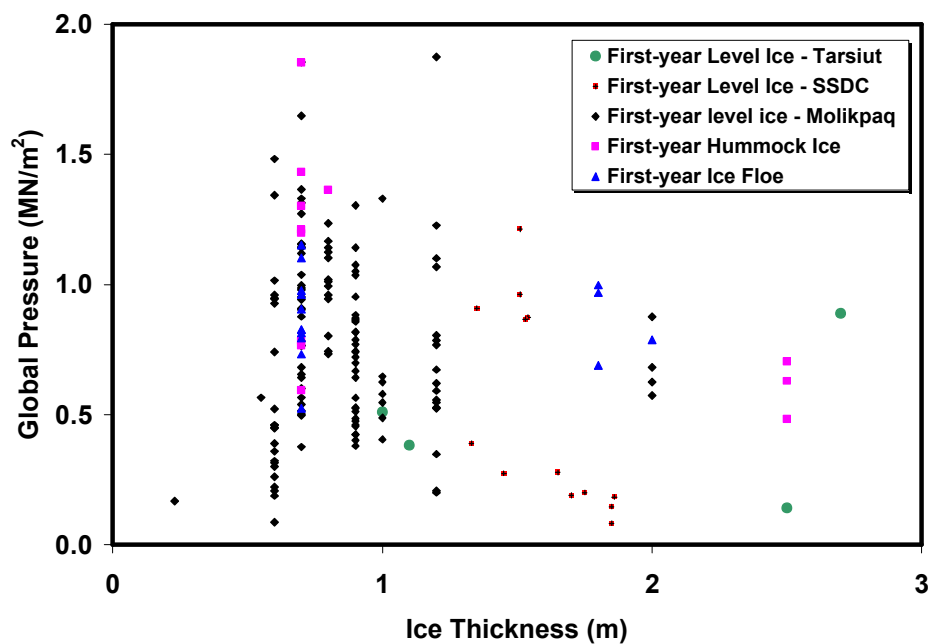
Figure 56: Global Pressure as a function of ice thickness for different ice macrostructure for first-year ice only.
