On the increasing danger of frost damage to our highways Schaible, L.

Technical Translation TT-568

Title: On the increasing danger of frost damage to
our highways.
(Über die zunehmende Gefahr der Frostschäden
für unsere Verkehrswege).

Author: Lothar Schaible.

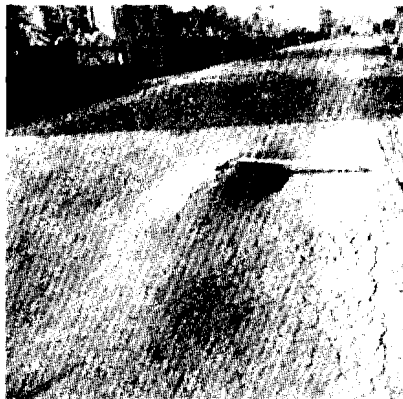
Fig. 9. Frost damage. Appearance of cracks in a 15-year old, medium-heavy pavement as a result of heavy truck traffic.
