## AVALANCHE CONTROL, 1958 - 1971

G. NEAL

ERB - 877

The history of NRC's involvement with the Avalanche Control Program at Rogers Pass, B.C., is given, as well as a brief description of some of the hardware produced for it.

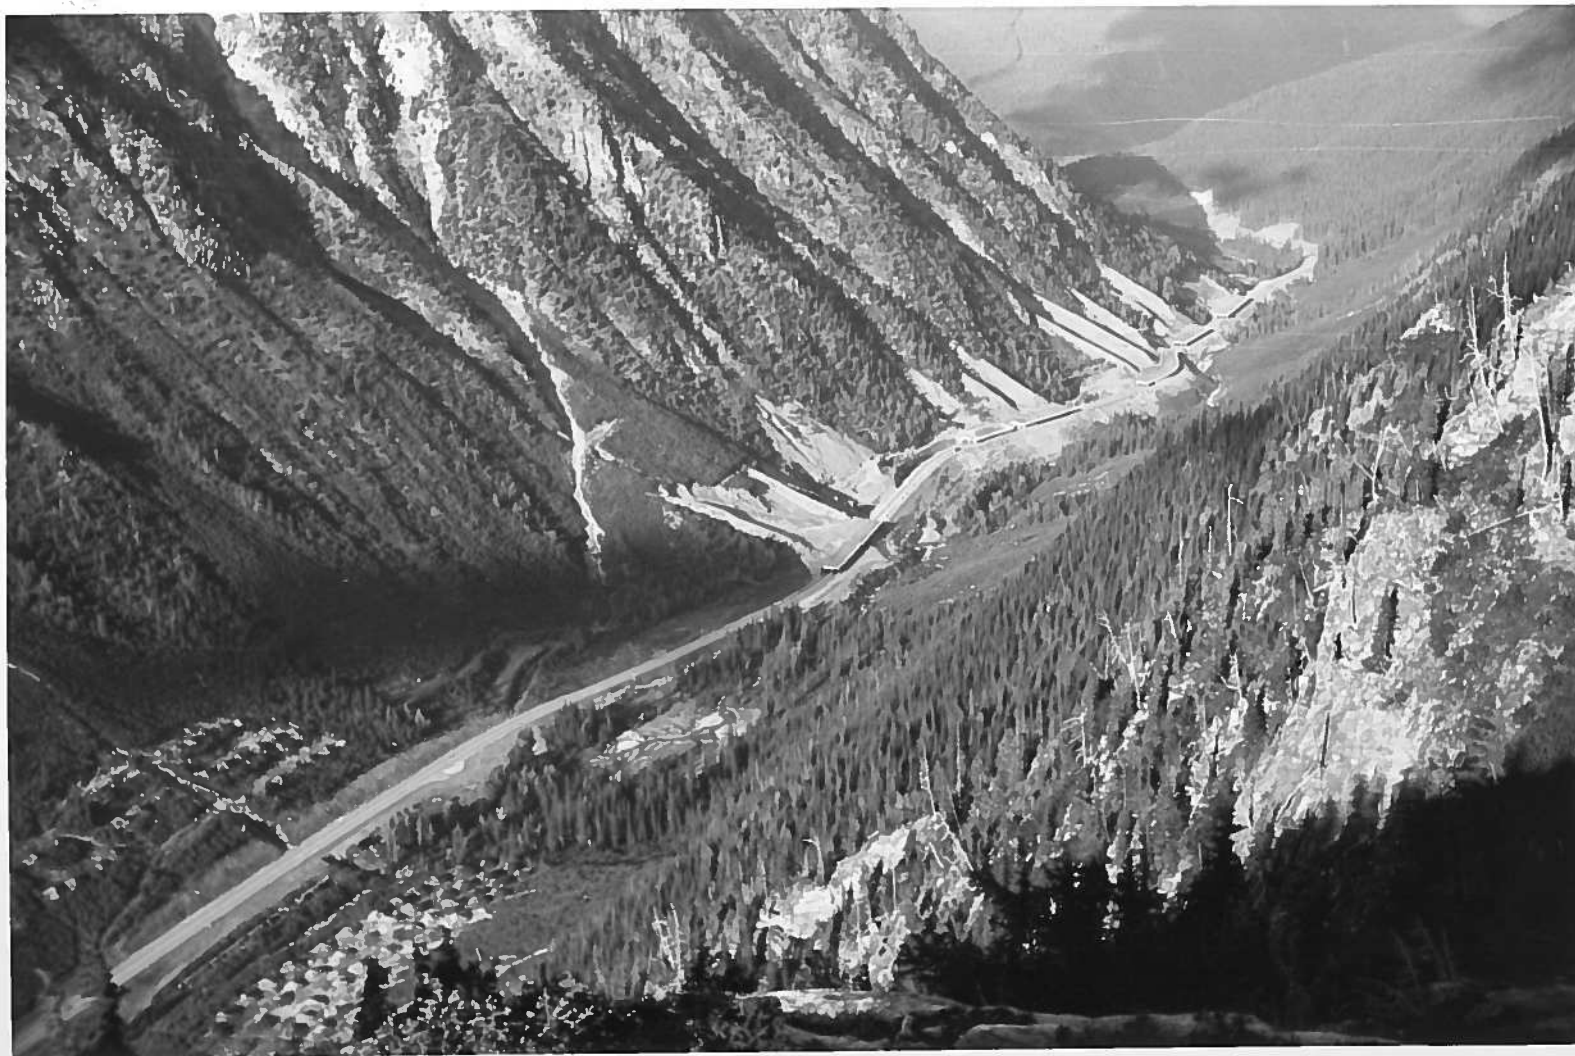
Plate 1.

View of Trans-Canada highway from West shoulder of Mount MacDonald showing avalanche defences. Mounds and gun position along highway in lower left of photo.

of Building Research at NRC, were adopted. These consisted of "benches" (or terraces), mounds, and reinforced concrete snowsheds covering the highway (Plate I.) The first two were designed to dissipate, through turbulence, the energy of an occasional avalanche before it reached the highway, while the third was to be built in areas where many avalanches per season could be expected to cross the road. Owing to the high cost of these structures long lengths of the highway had to be left with no such protection.

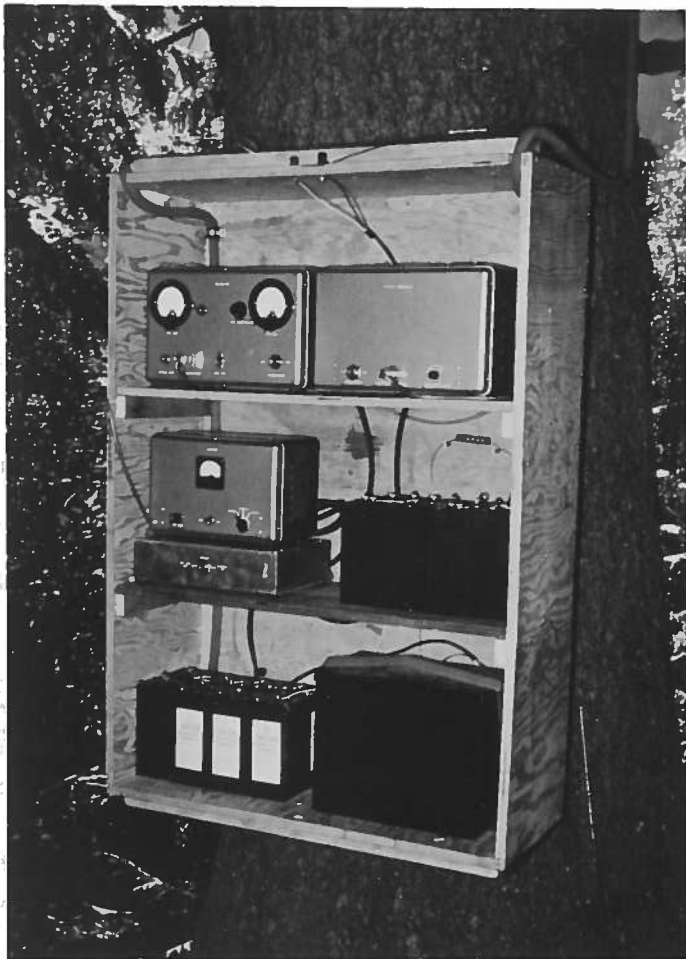
### Plate 3.

Transmitting and receiving equipment  
for avalanche detector.

Above - transmitter

Upper right - photocell

Lower right - receiving equipment

The breaking of a closed loop of wire (Figure 2) strung across a known avalanche path near the highway initiated the operation of a low-frequency radio transmitter located safely off to one side among the trees (Plate 3). Sequential two-tone modulation was transmitted, and at a central receiving point was decoded and operated an alarm and recorder (Figure 3). Details of the circuits are given in Figures 4, 5 and 6. A daily test signal was sent (triggered by a photosensor)

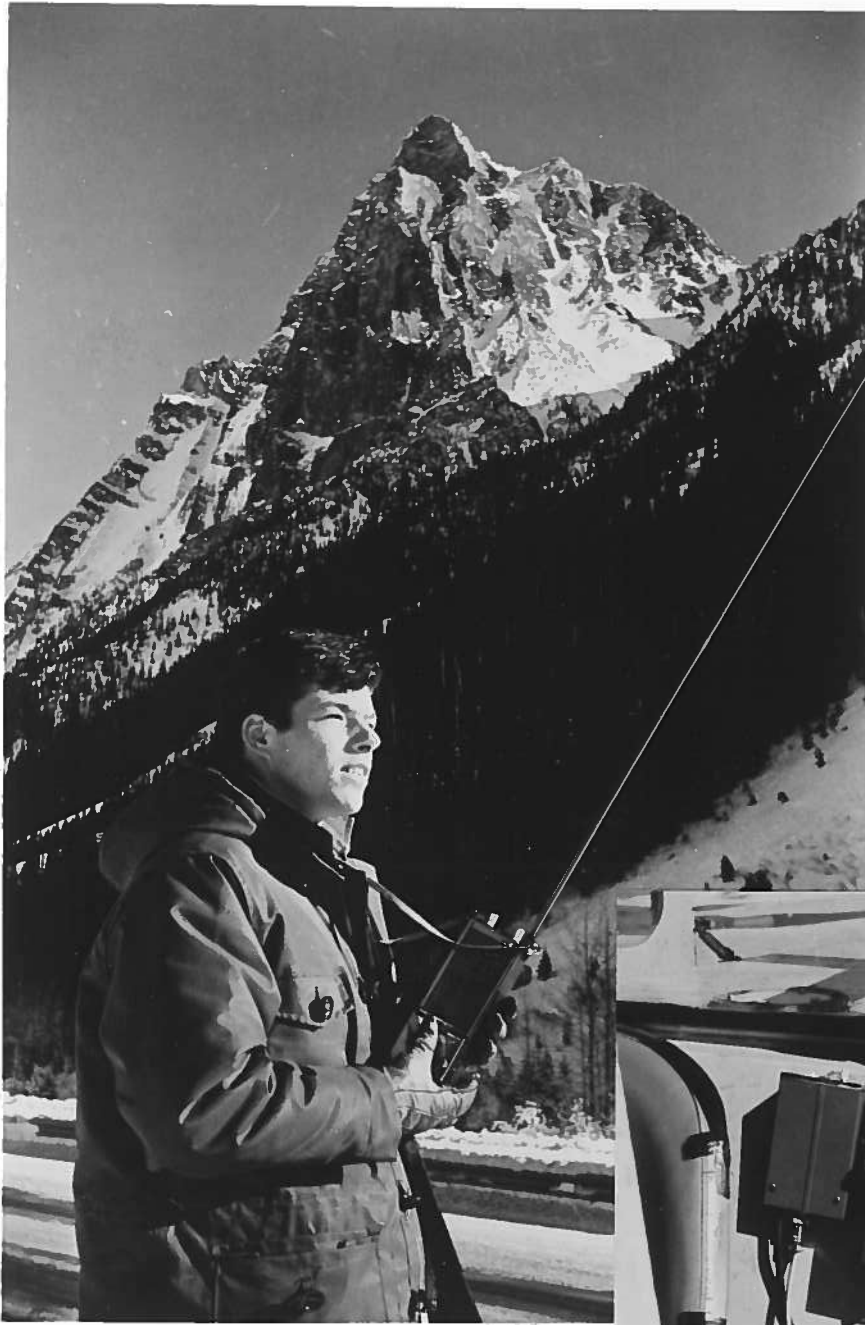
Plate 4.

Trained observer holding modified GRS transceiver used in vehicle operator warning system. Lower right - receiving equipment and bell mounted in snow-plowing vehicle.

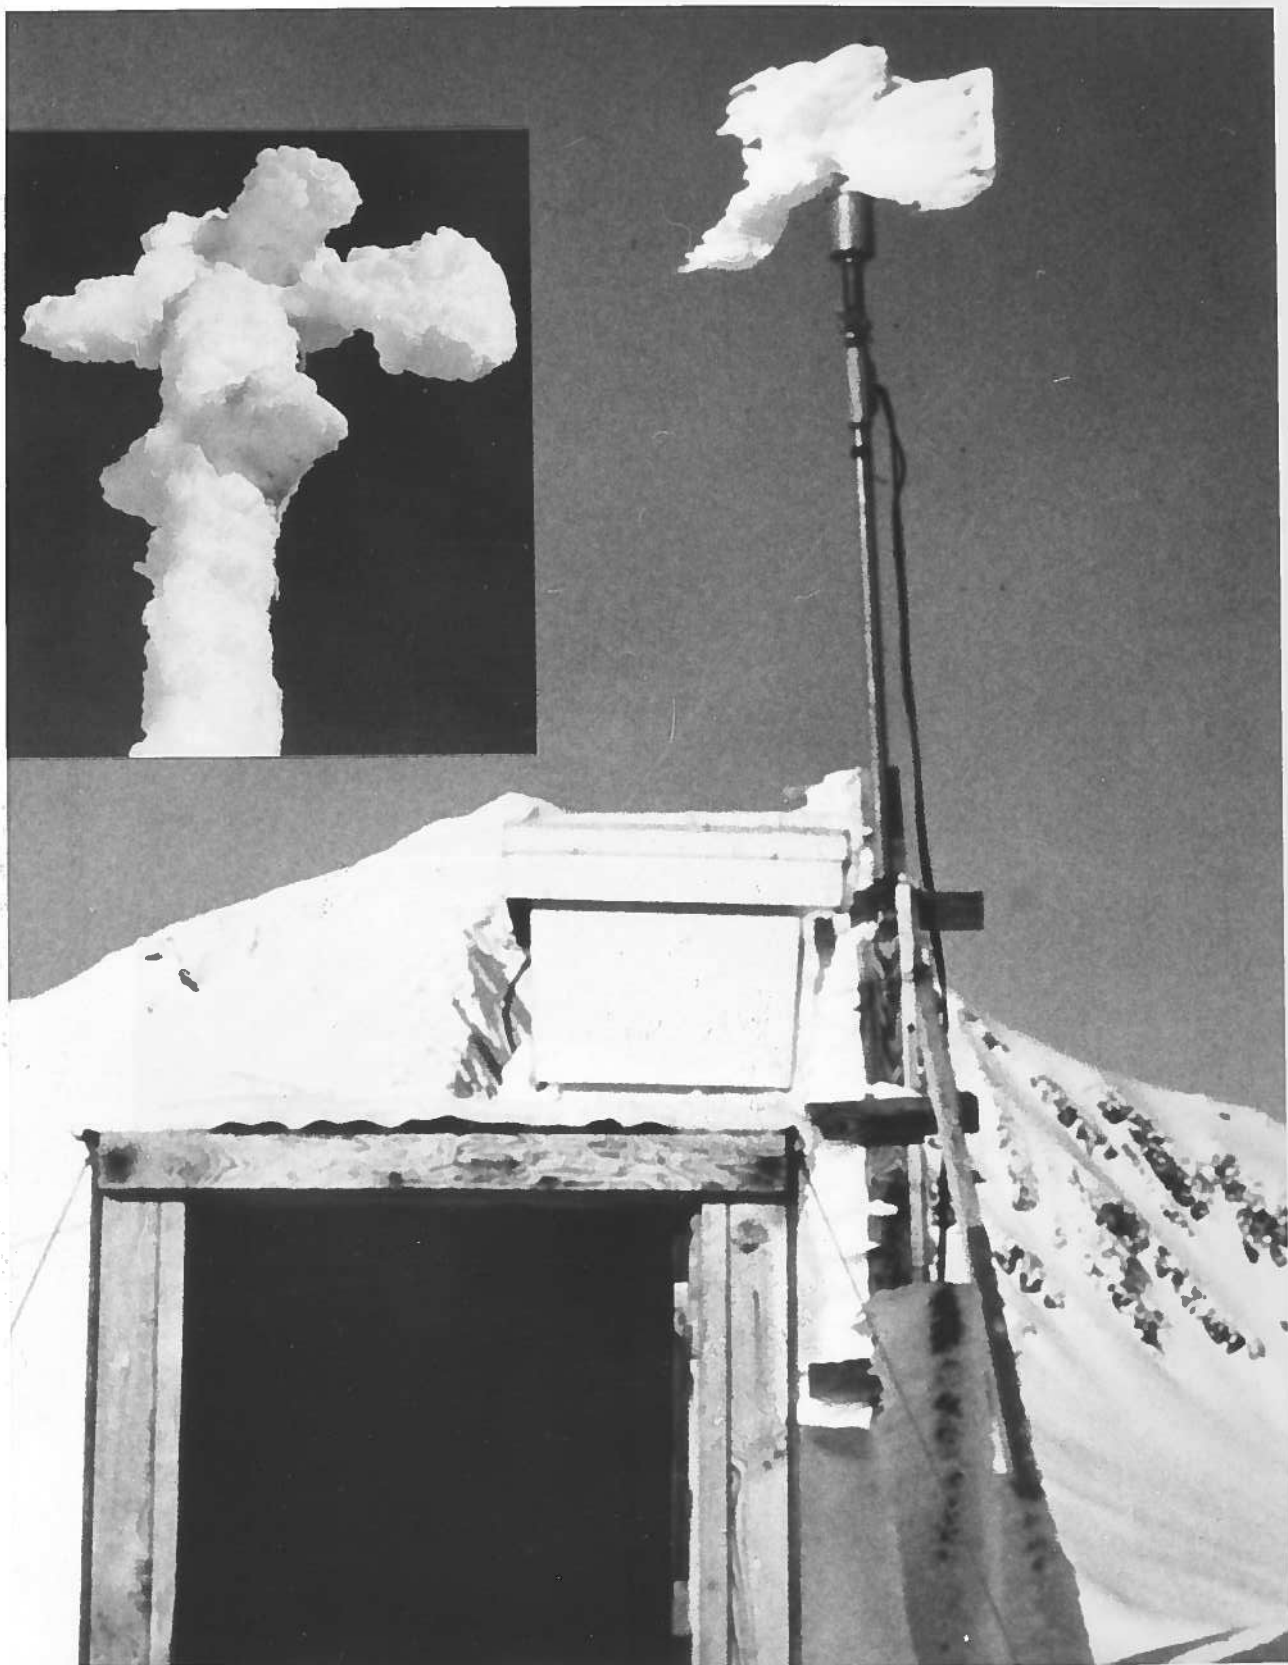
Plate 5.

Two examples of anemovane icing conditions encountered at the South Peak of Mount Fidelity in Glacier National Park, B. C.

Much difficulty was experienced with icing of the anemovane when the remote telemetry equipment was situated on the South Peak of Mt. Fidelity (Plate 5). Several methods of de-icing were known at the time but any that were effective required a large amount of electric power, which, of course, was not readily available on a mountaintop.

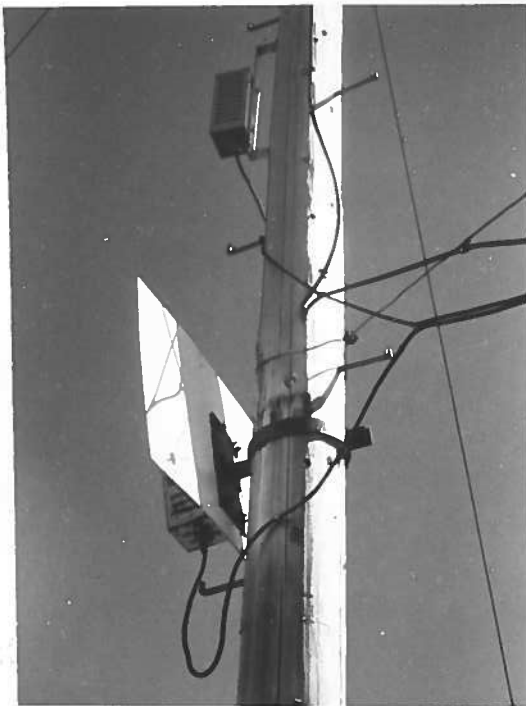
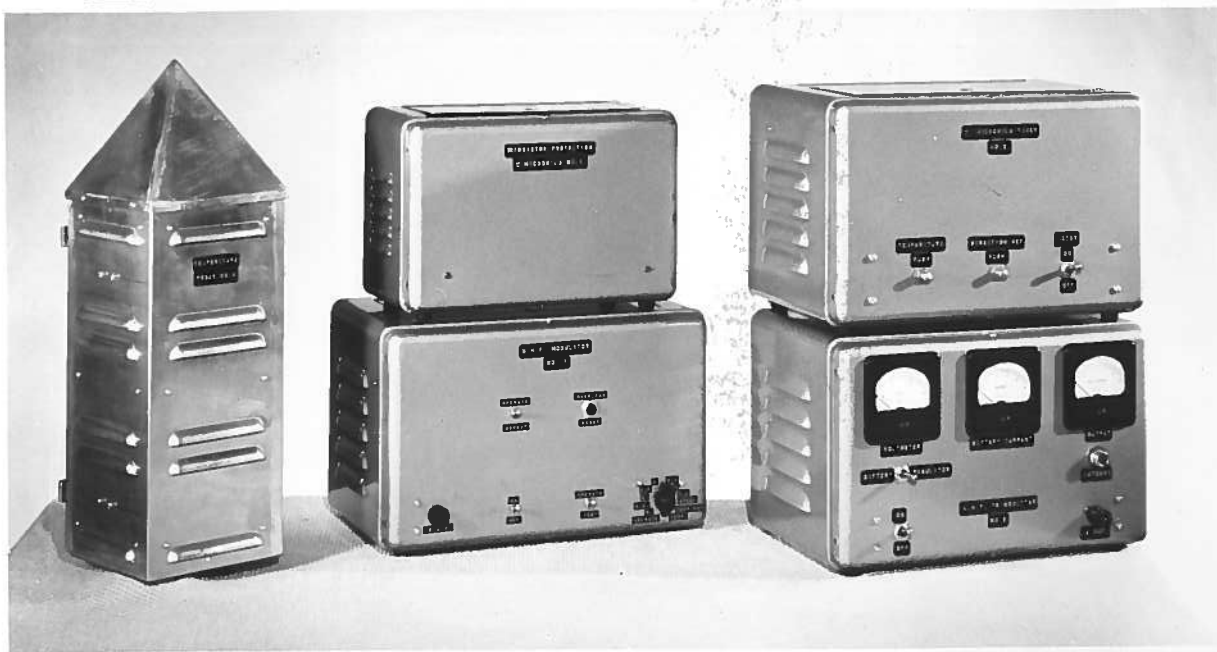
Plate 7.

- Upper left - Remote telemetry transmitting equipment in operation West MacDonald Shoulder showing caustic potash battery Supply.
- Upper right - Temperature and humidity probes.
- Below - Remote transmitting equipment.

Signals from a standby AM system on 219.4 MHz consisting in part of a 1.3-W transmitter and a 10.5 dB corner reflector were received at Mt. Fidelity on a whip antenna and at the Summit on a pair of 10-element stacked Yagis. Vertical polarization was used throughout with all frequencies. As well as these back-up systems for use in case of receiving equipment failures, a complete set of spare units was available for all the remote chassis in the 460-MHz and 174-MHz systems. See Plates 6, 7, and 8.
