FULL SCALE EXTERIOR WALL TEST ON NORDIC CROSS-LAMINATED TIMBER SYSTEM

Report No. A1-006009.1
Report date: January 22, 2015
Contract No. A1-006009
Reference:
Program: Mid-Rise Wood Buildings

This report describes a full-scale exterior wall fire test conducted on December 16, 2014 on a Nordic cross-laminated timber (CLT) wall system. The test was conducted in accordance with CAN/ULC-S134-13, Standard Method of Fire Test of Exterior Wall Assemblies.

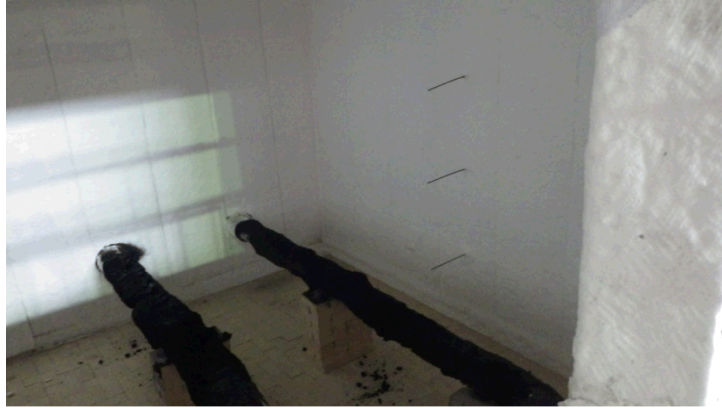
Figure 3. Propane burners and room thermocouples.

The fuel source in the burn room consisted of four 3.8 m long linear propane burners spaced equally along the width of the room and mounted 0.6 m above the surface of the paving stones (see Figure 3).

Room Temperatures – The burn room air temperature was monitored by six Type K thermocouples, enclosed in 6 mm outside diameter Inconel sheaths. The thermocouples were introduced through the side walls with the measuring tips 0.6 m from the inner surface of the wall. All room thermocouples were located on the vertical centerlines of the side walls (see Figure 3).

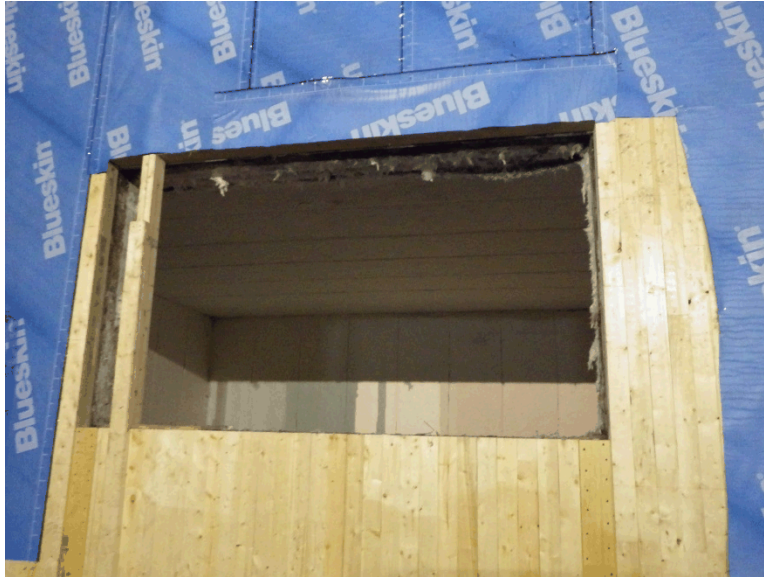
Figure 4. Wall system under construction.

1. 15.9 mm thick Type X gypsum board on the test facility
2. 3 Ply, 105 mm thick Cross Laminated Timber wall panels manufactured by Nordic, including Glulam header (CLT wall panels can be thicker than the panels used. However, a thickness of 105 mm was considered adequate for this testing.)
3. BlueSkin self-adhesive membrane attached to the CLT panels as a water resistant barrier
4. 89 mm Horizontal Z-Bar at 600 mm spacing
5. 89 mm Roxul Cavity Rock DD insulation
6. 19 mm Vertical Hat Channel at 600 mm spacing

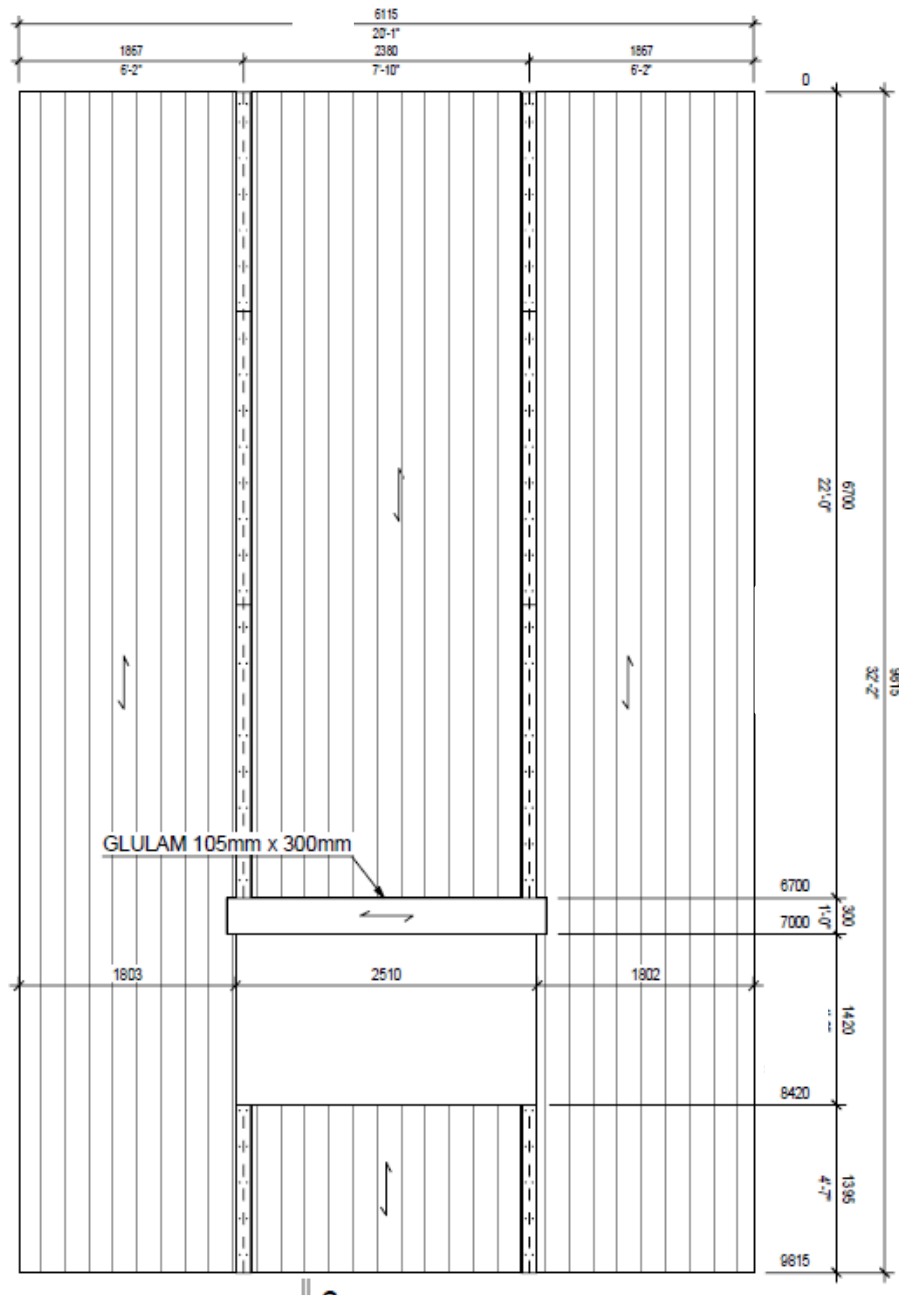
Figure 6. CLT construction detail.

The CLT assembly consisted of 4 panels of varying sizes and one laminated header (see Figure 6). The vertical CLT joints were connected using 12.7 mm thick, 120 mm wide plywood strips glued on each side of the joint with lines of 6 mm wide polyurethane construction adhesive and nailed on each side every 300 mm with common 76 mm metal nails. The full test specimen was 9.8 m high and 6.0 m wide, with a window opening 2.51 m wide and 1.42 m high. The edges of the wall assembly at the window opening were covered with galvanized steel flashing followed by a layer of 25 mm thick ceramic fiber insulation. The CLT panels incorporated a horizontal joint at 0.3 m above the window (top of Glulam Header). It also included two vertical joints, aligned with the window edges, which extended to the top of the wall (see Figure 6).

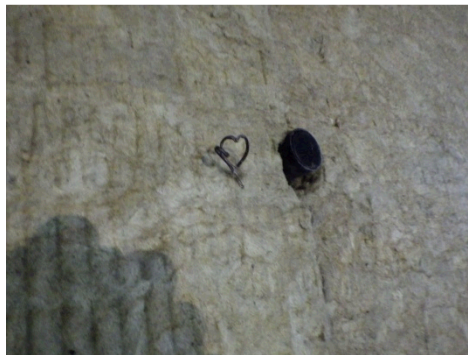
Figure 7. Wall thermocouple installation.

Wall Temperatures – The wall temperatures were monitored using Type K bare-beaded thermocouples on the vertical centerline of the wall. They were located five levels above the top of the window at 1.0 m intervals, starting at 1.5 m above the window opening (see Figures 1 and 7). Three thermocouples were used at each level, one was tension mounted on the exterior surface of the Roxul insulation, the second was fastened to the vapor barrier and the third was on the surface of the 15.8 mm drywall.

Tension mounted TC and heat-flux transducer

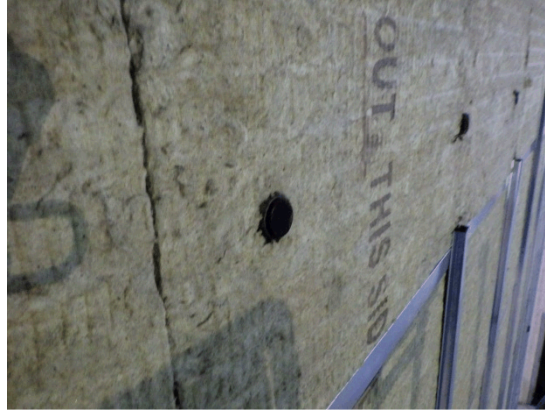
Figure 8. Heat flux transducers.

Heat Flow – The total heat flux density to the wall above the window was monitored by three water-cooled heat flux transducers (Medtherm Corp. Series 64) installed in the test wall, 3.5 m above the top of the window, one on the centerline of the wall and one on each side, 0.5 m from the centerline (see Figures 1 and 8).

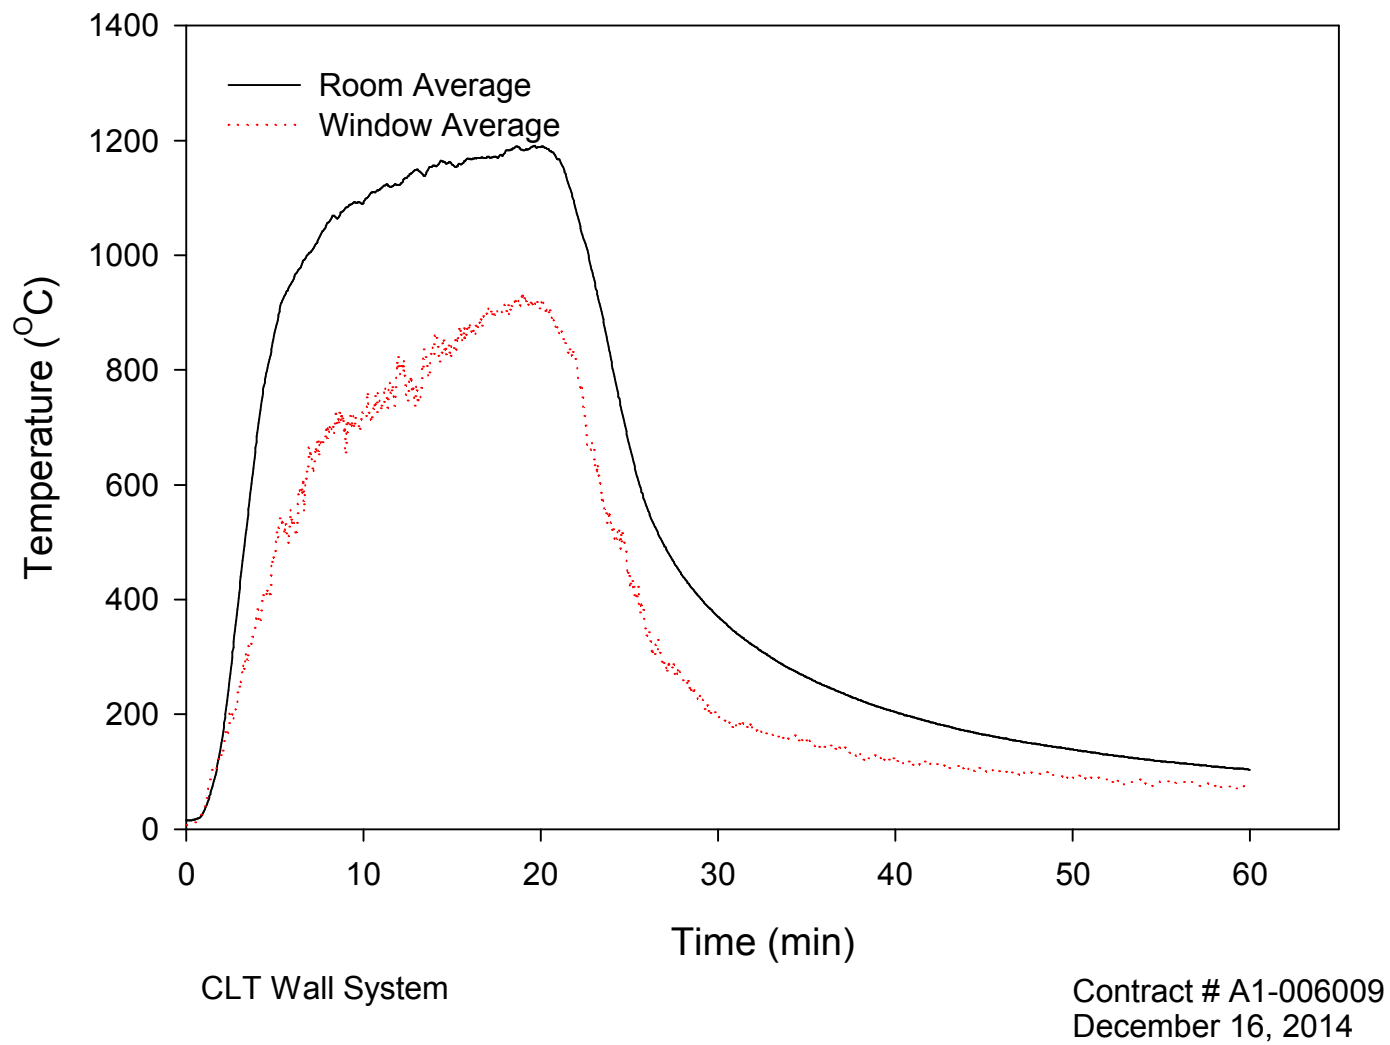
Figure 9. Average room and window temperatures.

Room Temperatures – Figure 9 shows the average gas temperature in the burn room (average of six thermocouples).

Window Temperatures – Figure 9 shows the average temperature of the fire gases emerging from the window.

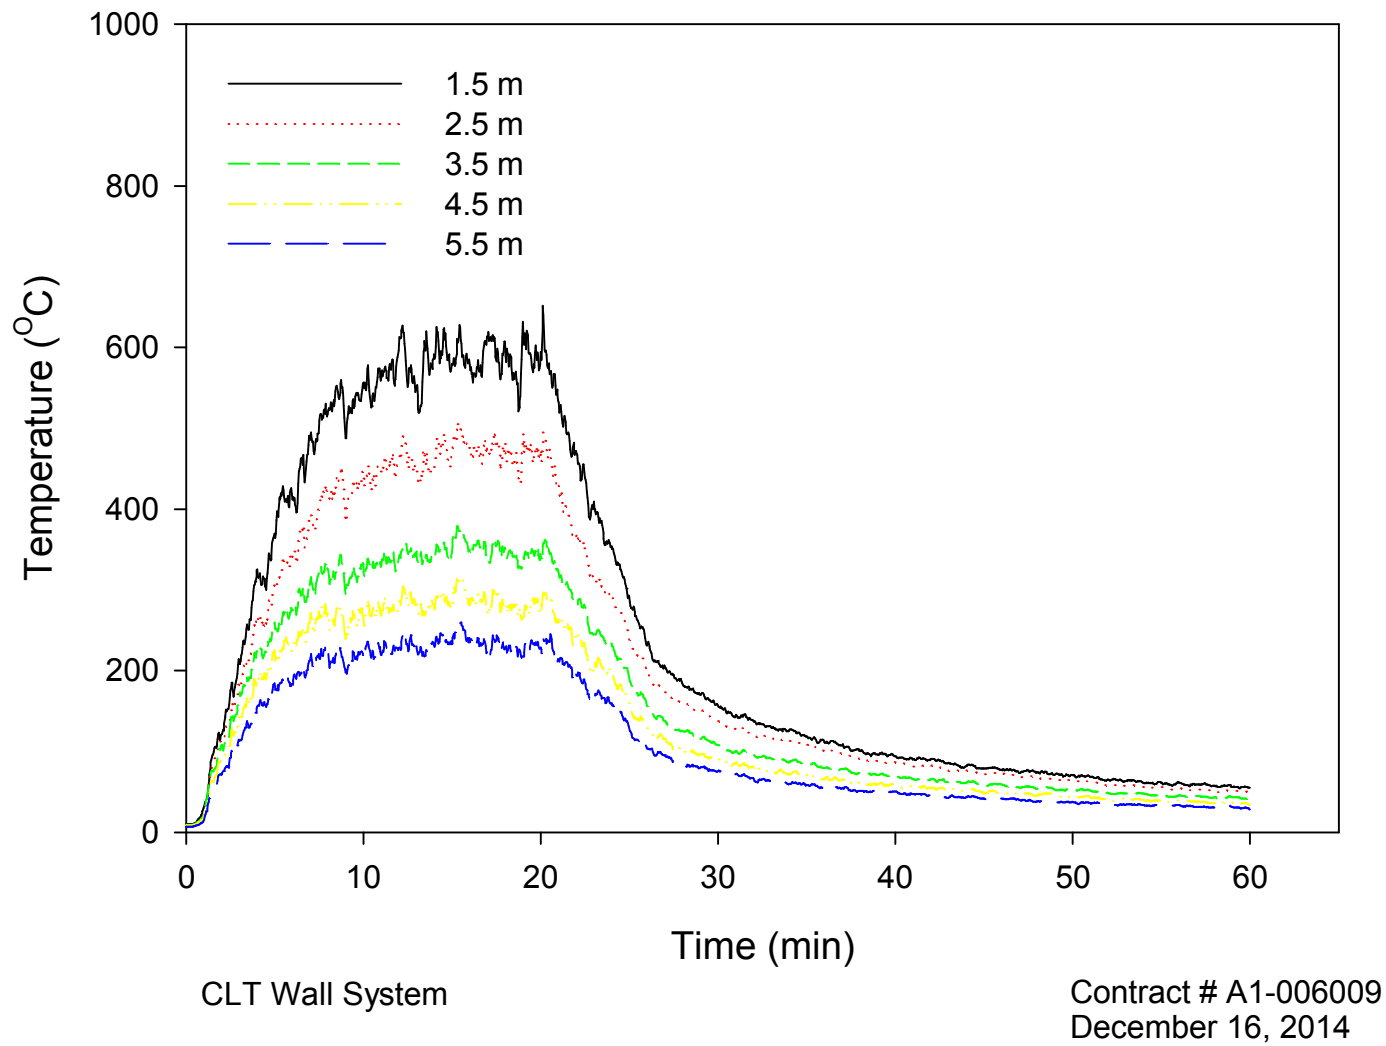
Figure 10. Temperatures on the surface of the insulation.

Wall Temperatures – The temperatures recorded on the outer surface of the test assembly are shown in Figure 10. A maximum temperature of 652°C was recorded at 1.5 m above the window opening. The maximum temperatures at 2.5 m, 3.5 m, 4.5 m and 5.5 m above the window opening were 508°C, 379°C, 315°C and 260°C, respectively.

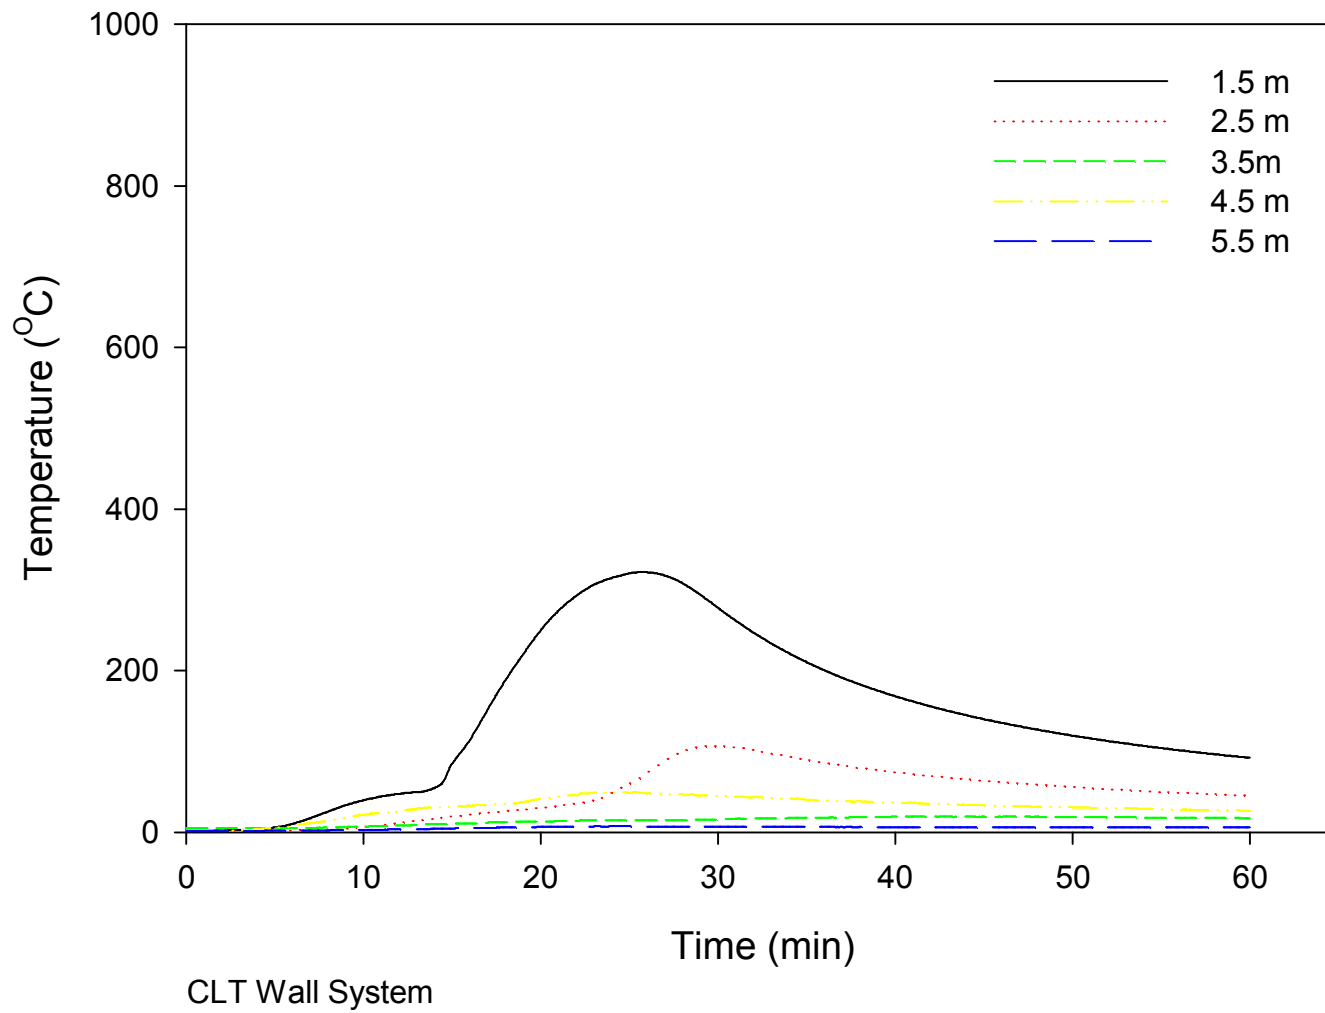
Figure 11. Temperatures on the surface of the vapor barrier.

The temperatures recorded by the thermocouples installed on the vapor barrier are shown in Figure 11. The maximum temperatures at 1.5 m, 2.5 m and 3.5 m above the window opening were 322°C, 107°C and 50°C, respectively. The thermocouples at 4.5 m and 5.5 m showed no significant increase in temperature.

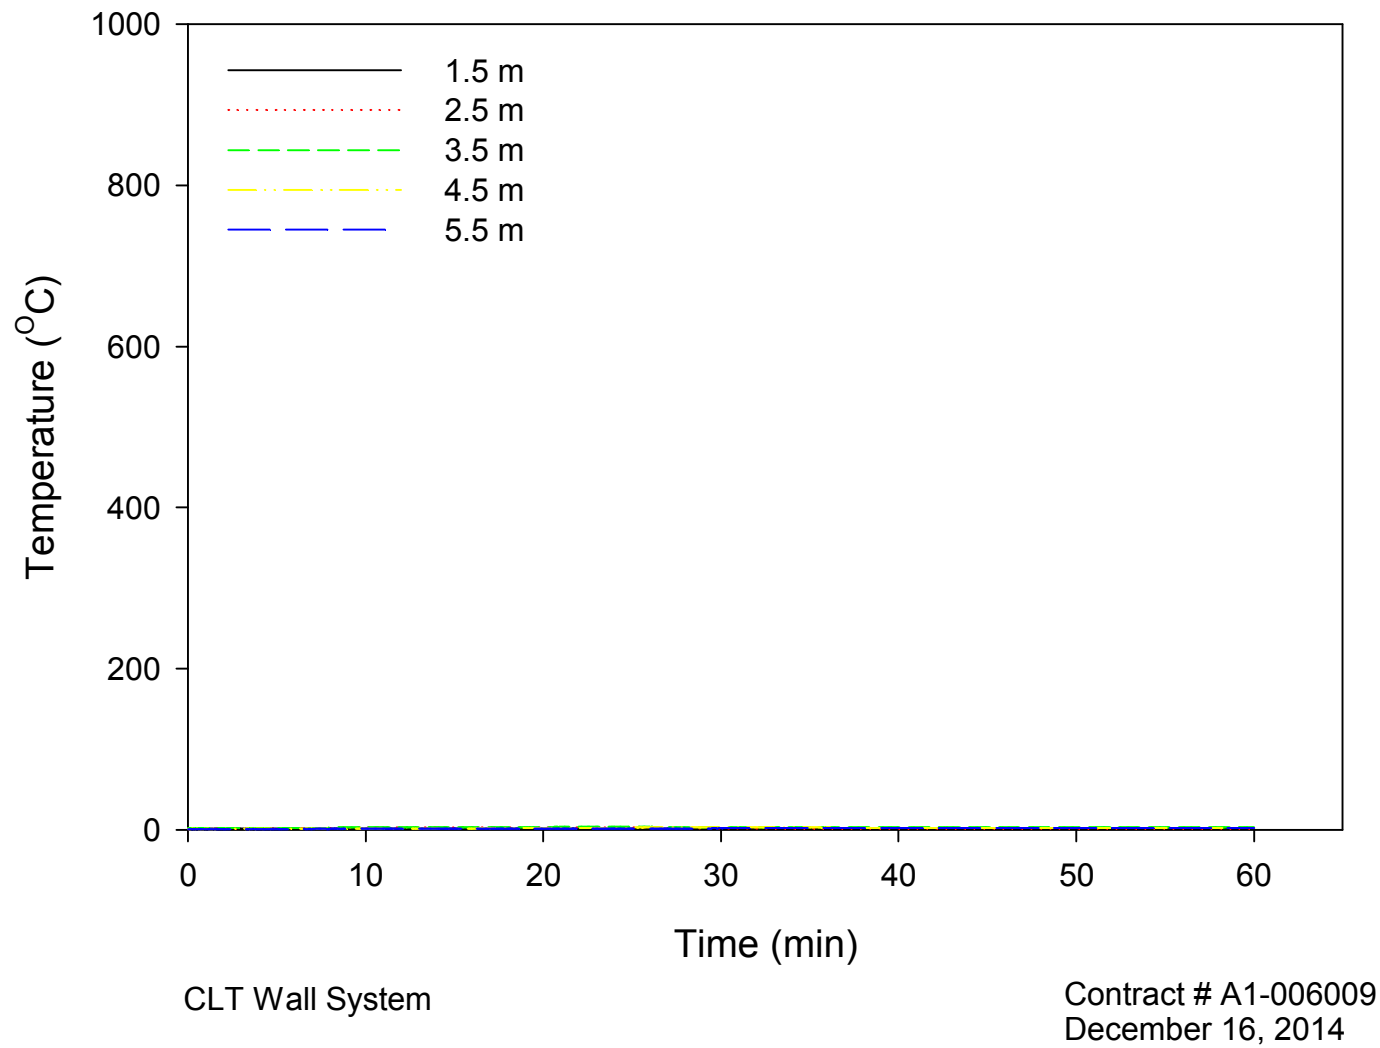
Figure 12. Temperatures on the surface of the 15.8 mm drywall.

Temperatures recorded by the thermocouples on the surface of the 15.8 mm drywall are shown in Figure 12. There was no significant increase in temperature.

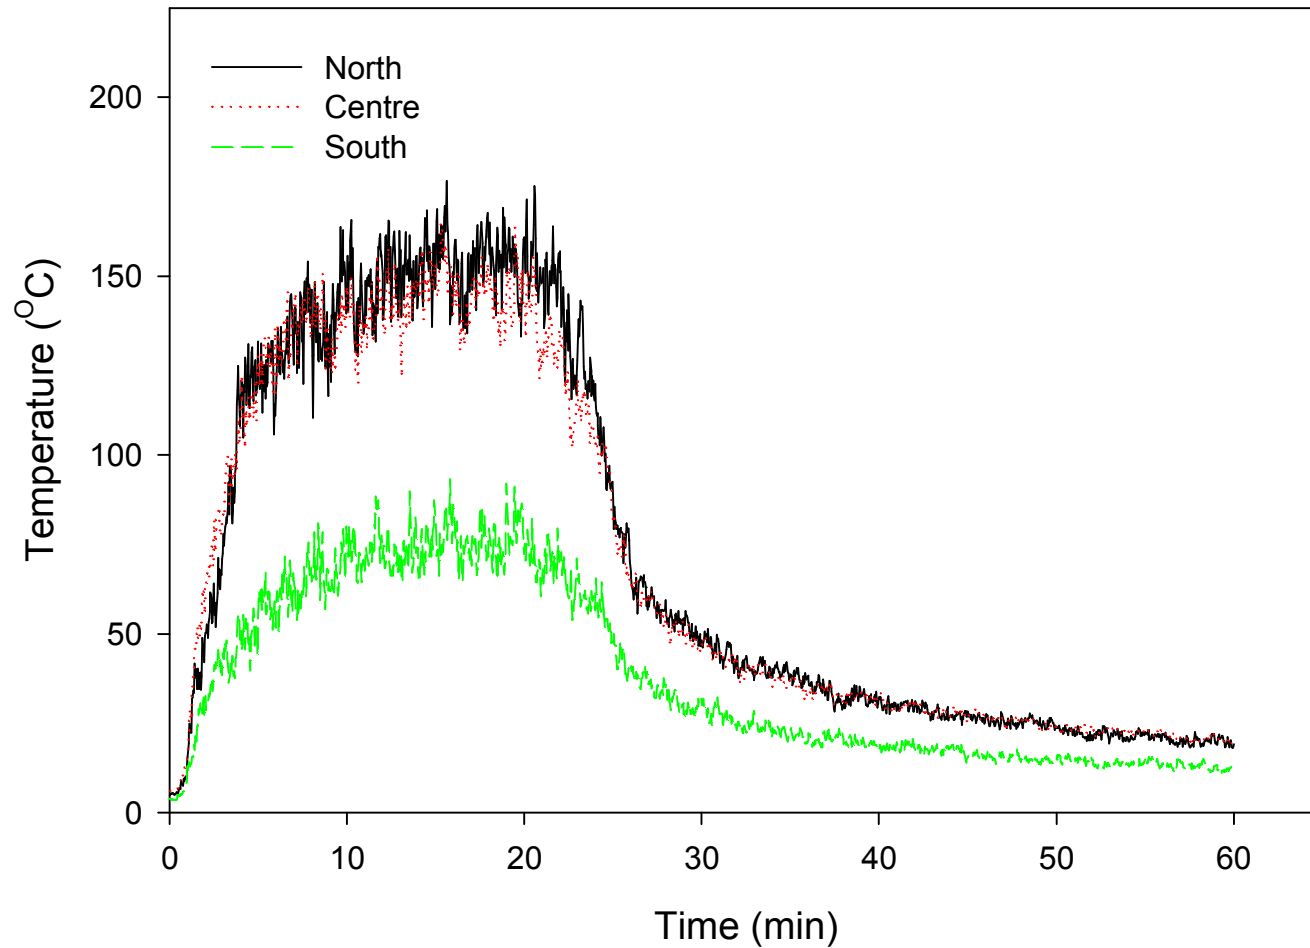
Figure 13. Temperatures at the top of the Wall.

The temperatures measured at the top of the wall are shown in Figure 13. The temperatures at the top of the wall reached a maximum of 177°C.

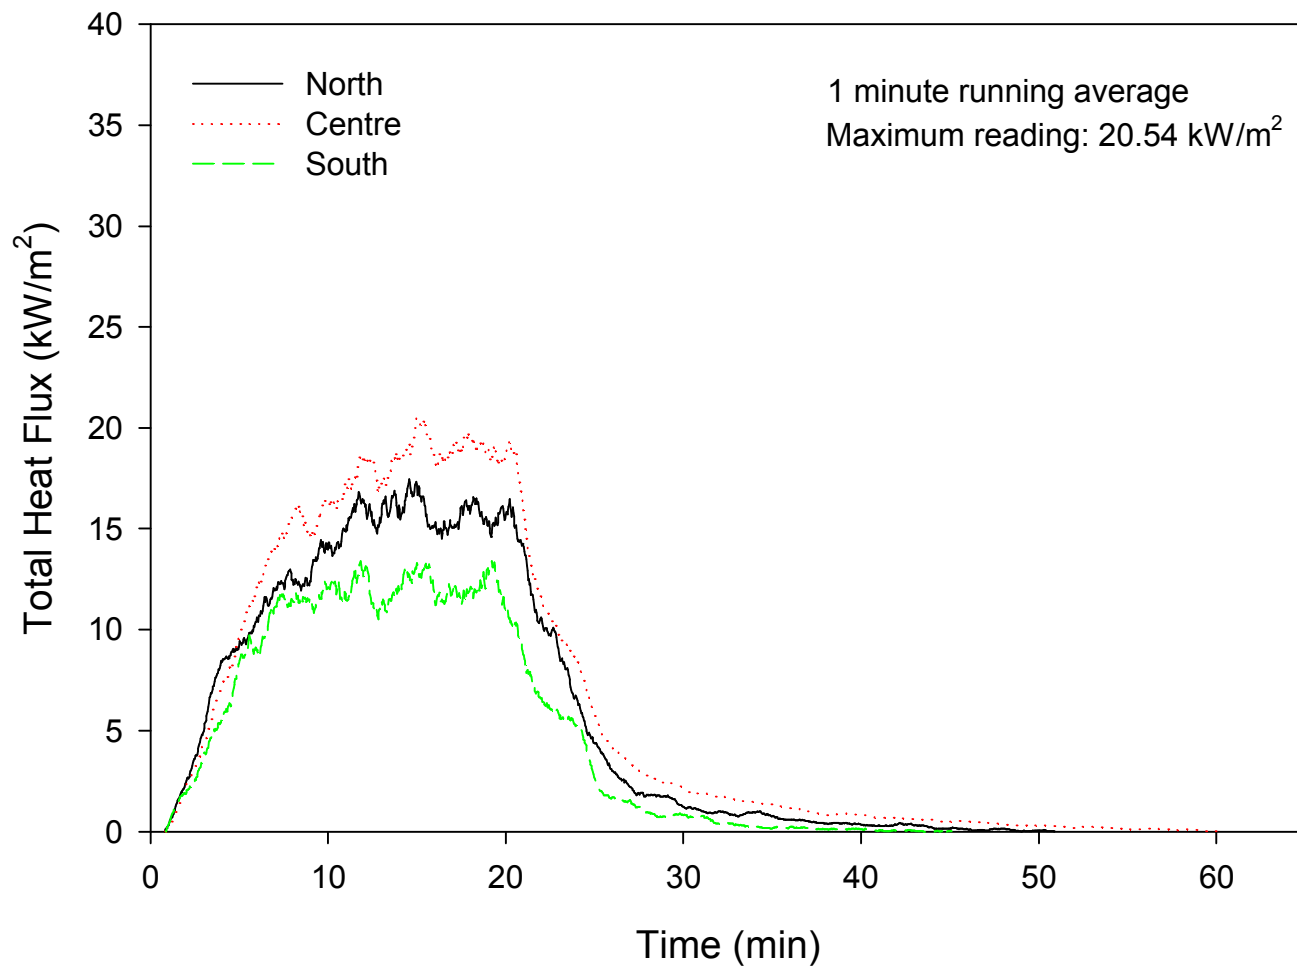
Figure 14. Heat flux on the wall.

Heat Flux – The total heat flux density to the wall, as measured 3.5 m above the top of the window, is shown in Figure 14. The data shown in this figure has been smoothed using the procedure of a running average over one minute.

The maximum one-minute averaged values recorded at the 3 locations: the centre, the south, and the north were 20.54 kW/m², 13.4 kW/m² and 17.45 kW/m², respectively.

The maximum one-minute averaged value of the total heat flux density on the test wall, at 3.5 m above the top of the window, was 20.54 kW/m² compared to 16 kW/m² for a non-combustible wall (Marinite). This is less than the 35 kW/m² specified in Sentence 3.1.5.5.(4) of the National Building Code of Canada (2010 Edition).

4. The maximum one-minute averaged value of the total heat flux density on the test wall, at 3.5 m above the top of the opening during the fire exposure was 20.54 kW/m². This is less than the 35 kW/m² specified in Sentence 3.1.5.5.(4) of the 2010 edition of the National Building Code of Canada.

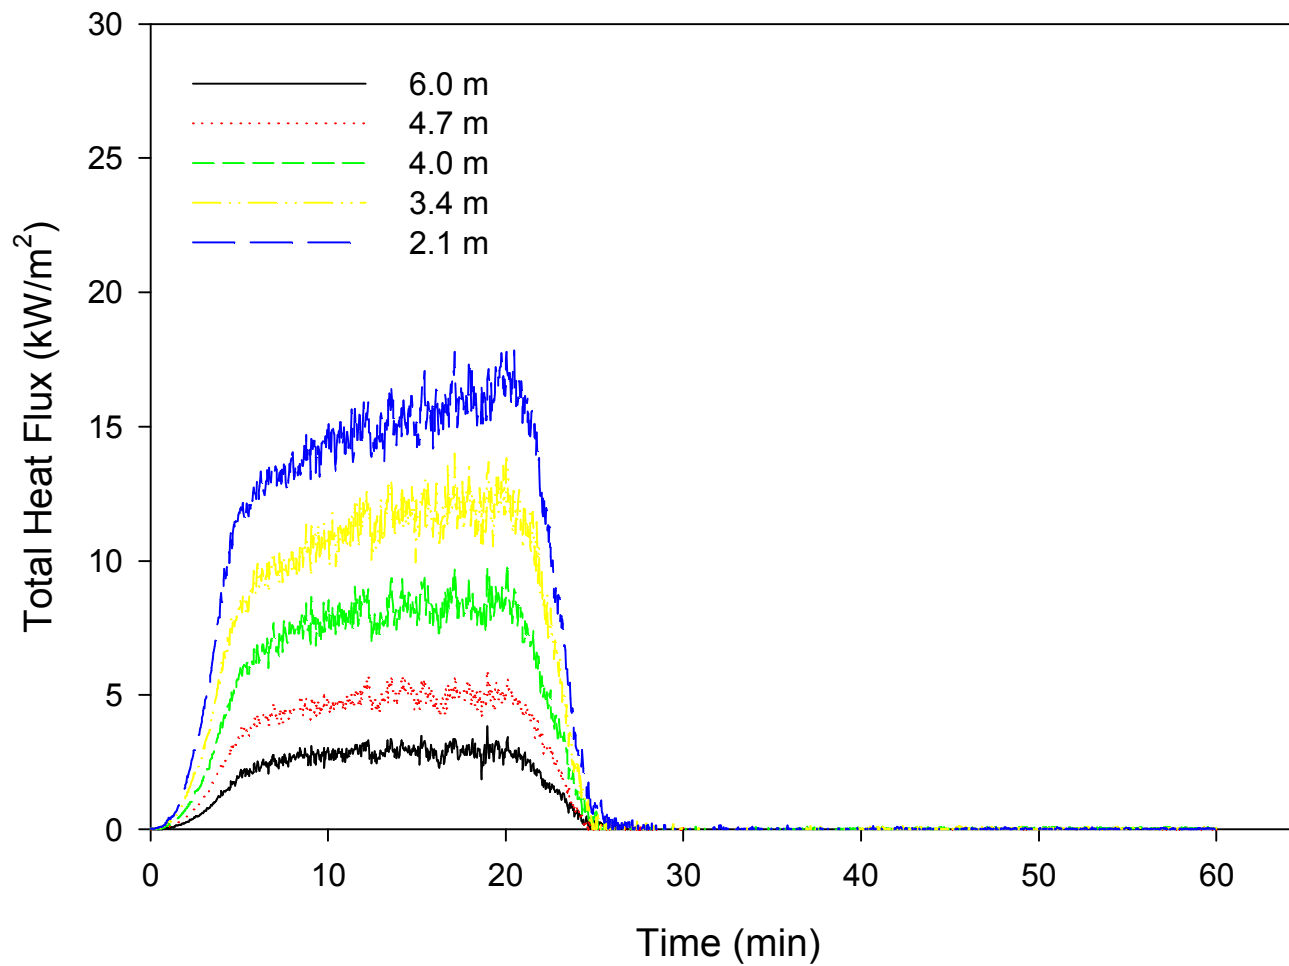
Figure 15. Heat flux on the mast.

The heat flux densities measured by the heat flux transducers installed on the mast are shown in Figure 15. The heat flux at the 2.1 m height reached 17.8 kW/m², at the 3.4 m height it reached 14.0 kW/m², at the 4.7 m height it reached 6.0 kW/m² and at the 6.0 m height it reached 3.8 kW/m². The heat flux density at 2.4 m from the wall at the 4.0 m level reached 9.9 kW/m².

- at 2.1 m above the burn room floor, the average was 14.7 kW/m² vs. 15.9 kW/m² for the non-combustible wall
- at 3.4 m above the burn room floor, the average was 11.1 kW/m² vs. 11.2 kW/m² for the non-combustible wall.
- at the 4.0 m level (2.4 m from the wall), the average was 7.8 kW/m² vs. 8.2 kW/m² for the non-combustible wall.
- at the 4.7 m level, the average was 4.7 kW/m² vs. 4.7 kW/m² for the non-combustible wall.
- at the 6.0 m level, the average was 2.8 kW/m² vs. 4.7 kW/m² for the non-combustible wall.

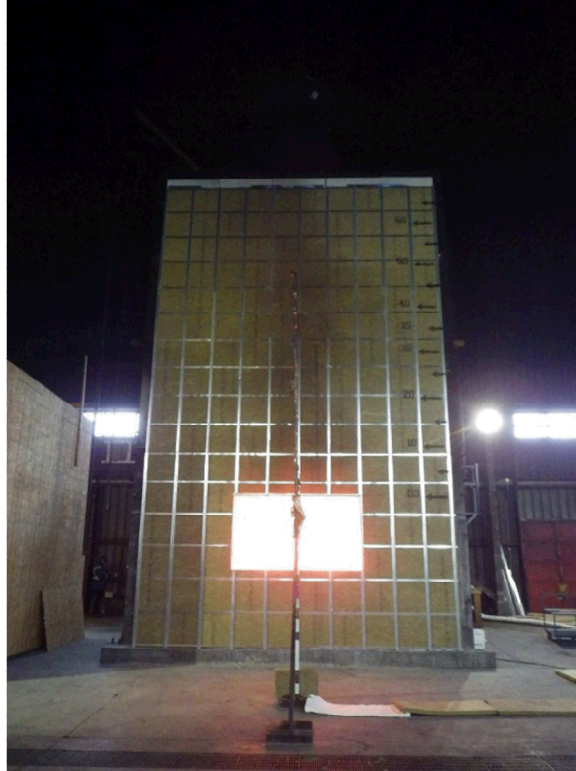
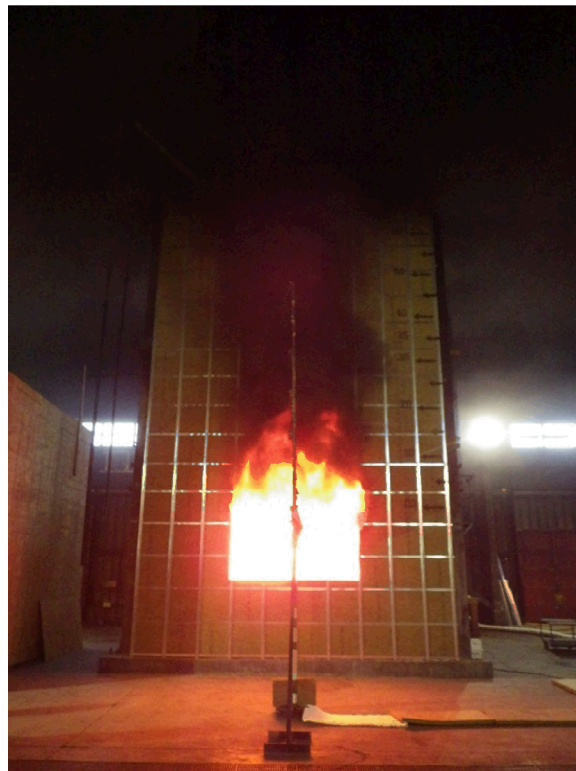
Figure 16. Wall sample during the fire exposure.

Figure 16 shows the wall assembly during the fire exposure.

(a) 3 Minutes after ignition

(b) 10 Minutes after ignition

3. During the fire exposure, there were flames up to the 2.5 m mark. This is less than the 5 m limit for flame spread distance specified in Sentence 3.1.5.5.(3) and defined in Appendix A (A-3.1.5.5.(3)) of the 2010 edition of the National Building Code of Canada.

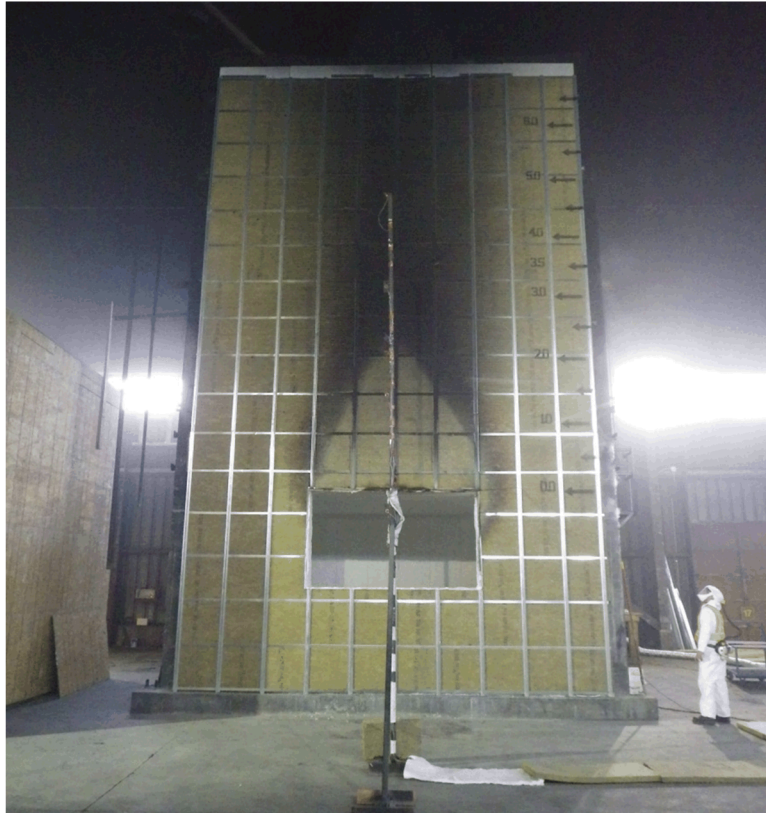
Figure 17. Wall sample after fire exposure.

Figure 17 to Figure 20 are photographs taken after the fire test to show the extent of the damage to the wall sample. In order to observe if there was any fire damage to the CLT panels, the insulation was removed, and the water resistant barrier above the window opening was partially removed, after the fire test. As shown in the photographs, other than limited charring around the window opening and the Glulam header, there was no fire damage to the CLT panels and the water resistant barrier over CLT panels was still intact.

2. The extent of damage on the specimen was limited to the insulation above the window to a height of 2.5 m and charring around the window opening and the Glulam header during the fire exposure. There was no fire damage to the CLT panels.
