Field energy performance of an insulating concrete form (ICF) wall

Maref, W.; Armstrong, M. M.; Saber, H. H.; Rousseau, M.; Ganapathy, G.; Nicholls, M.; Swinton, M. C.

IRC-RR-326

March 2012

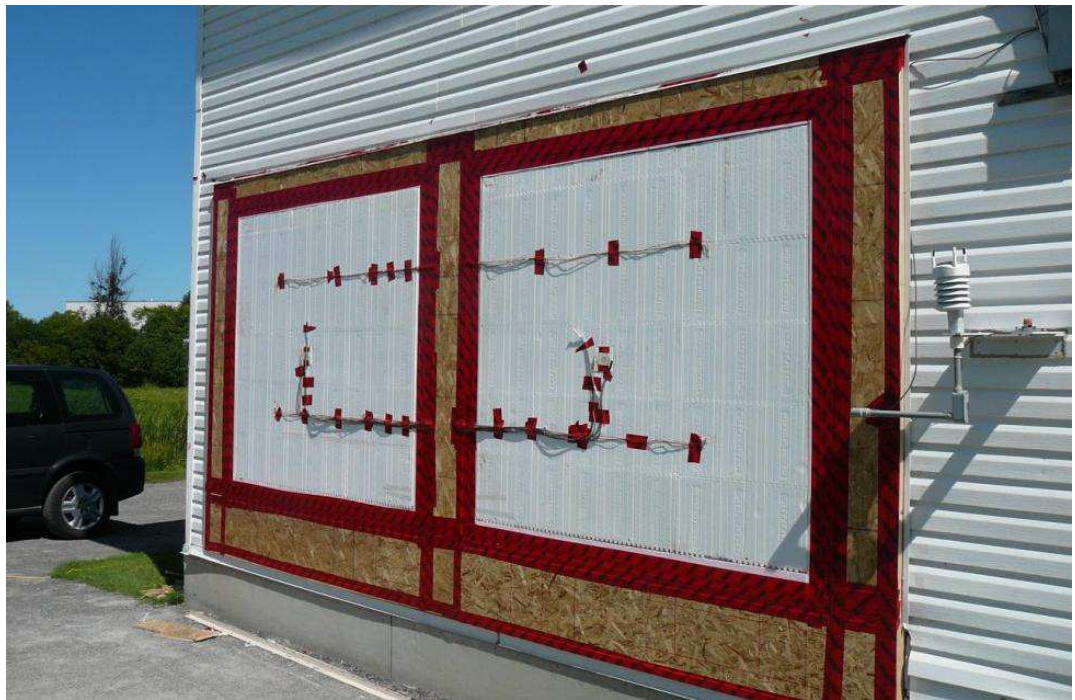
Figure 1. View of the ICF wall specimens before installation of siding

Two identical ICF wall specimens were installed side by side in the FEWF test bay on the NRC Campus in Ottawa, Canada. The walls were located on the first floor of a two storey facility, with West exposure (Figure 1). A chamber provided controlled indoor conditions ($\sim 21^{\circ}\text{C}$, 30% humidity), and the walls were exposed to naturally occurring Ottawa climate (with an average of 4602 heating degree days $< 18^{\circ}\text{C}$ (Environment Canada, 2010). Data was collected at 15-minute intervals from October 13th, 2009 to September 16th, 2010.

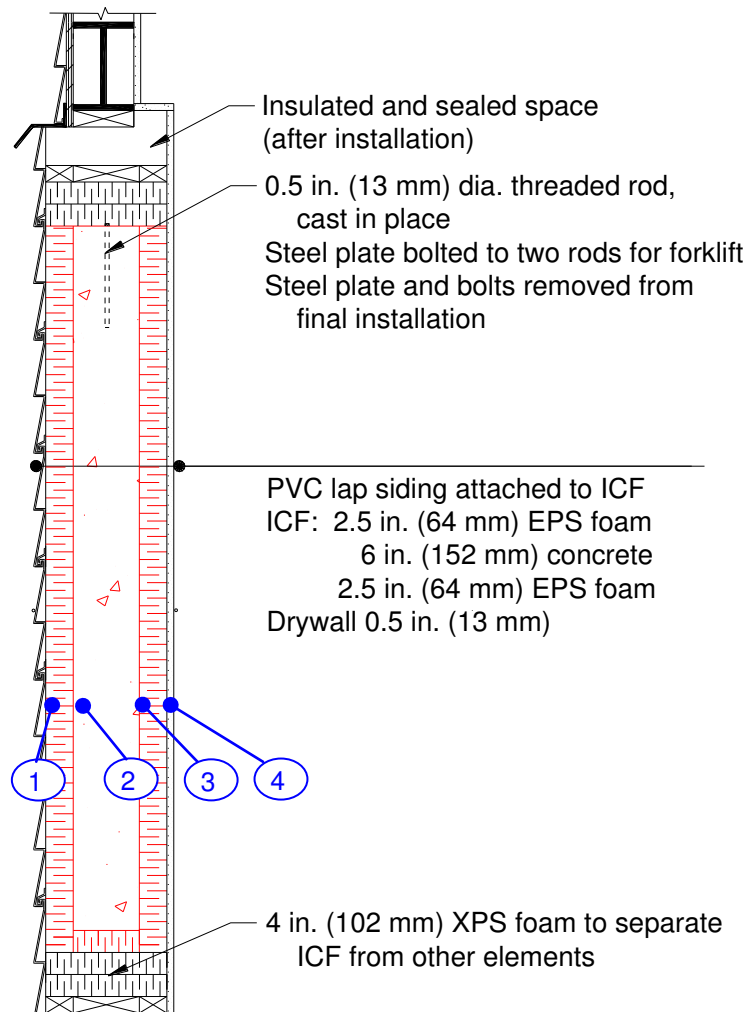
Figure 2. ICF wall vertical cross section

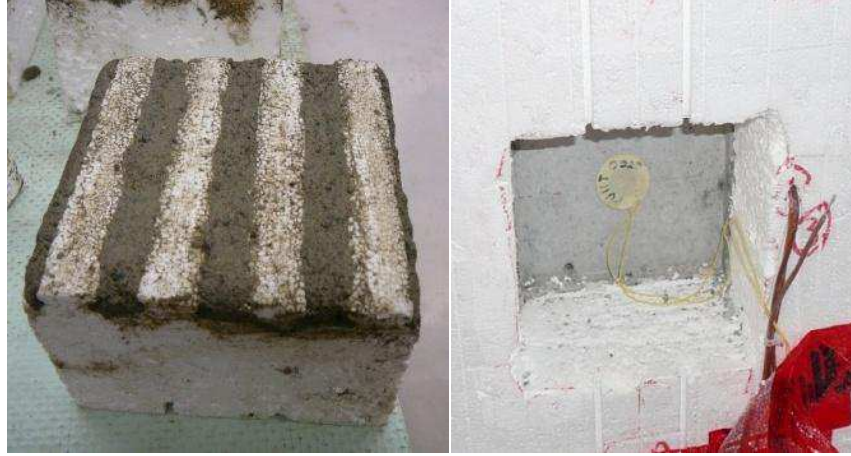
Figure 4. Removed section of EPS foam for heat flux transducer installation

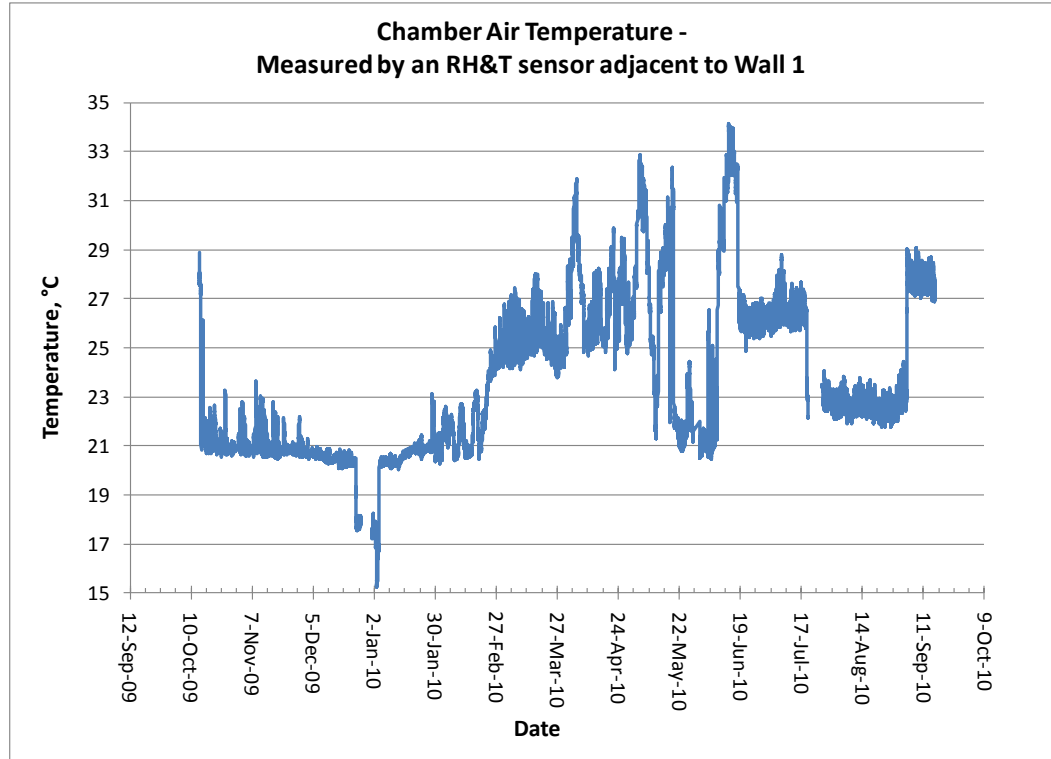
Figure 7. Chamber Air Temperature, as measured by an RH&T sensor adjacent to the interior surface of Wall 1

In summer, the chamber was opened and the maximum air temperature was controlled by the house's central cooling system.

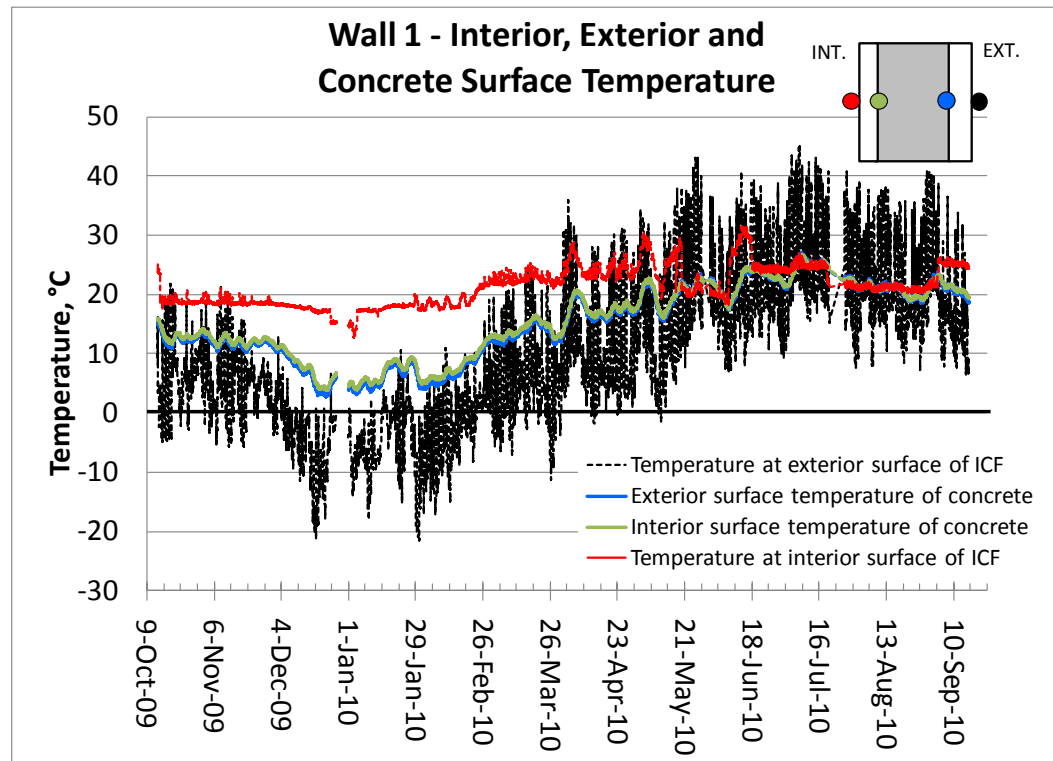
Figure 8. Measured 15-minute temperature data

The temperature at the exterior of the ICF (behind the cladding) follows outdoor air temperature, and is also influenced by solar gains on the cladding in the afternoon/evening.

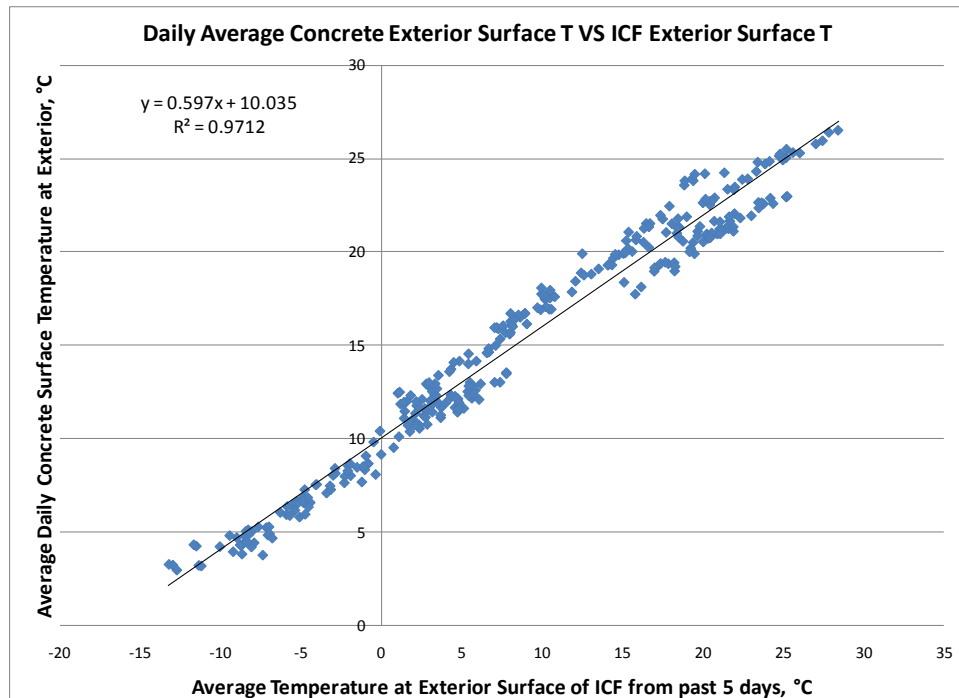
Figure 12. Average daily concrete exterior surface temperature vs. 5-day moving average of ICF exterior surface temperature

The average daily temperature at the exterior surface of the concrete is plotted alongside the moving 5-day average of the exterior surface temperature of the ICF in Figure 13. As expected from the high correlation factor (Figure 12), the two trends have a similar shape.

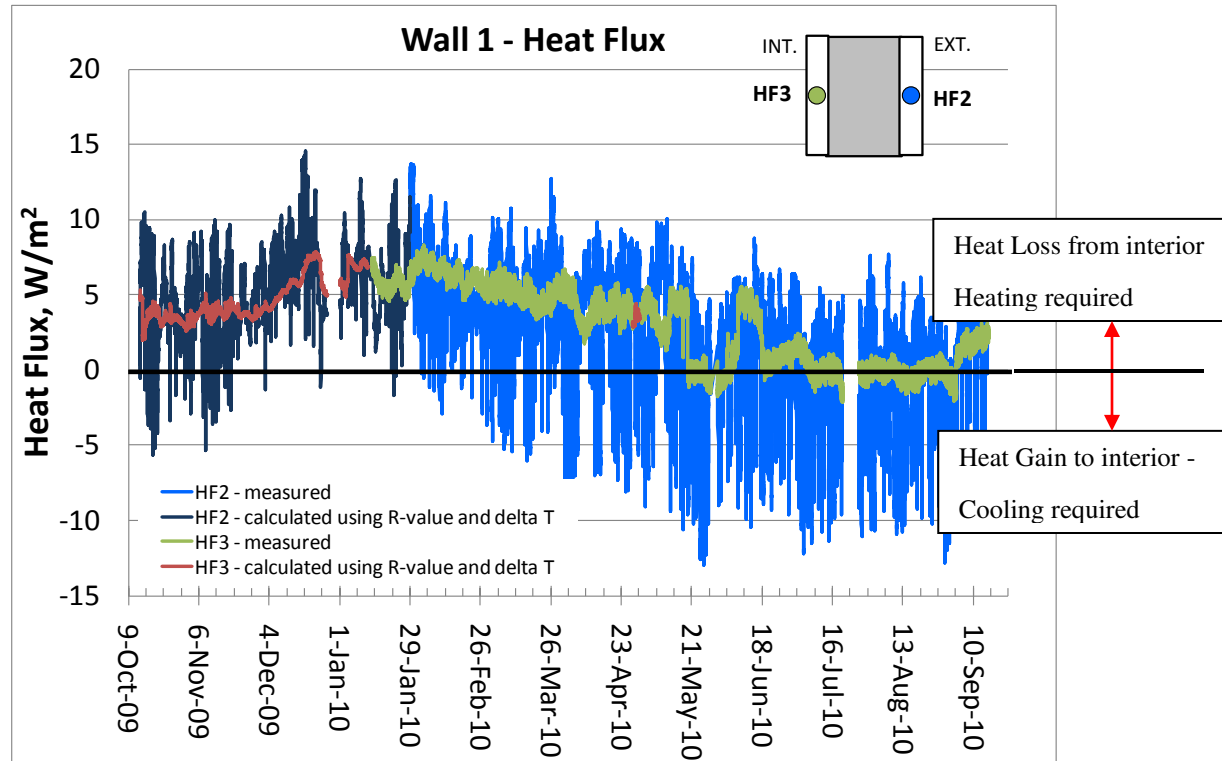
Figure 14. Heat flux at the interior and the exterior of the ICF (15-minute data)

First, the average R-value of the foam either side of the concrete was calculated using the measured heat flux data (from the period following the repositioning of the heat flux sensors) and the delta T across the foam insulation, using Equation 1. The resulting R-values were: RSI 1.73, $\sigma=0.09$ (R 9.81, $\sigma=0.52$) for the interior foam, and 1.79 $\sigma=4.32$ (R 10.2 $\sigma=24.5$) for the exterior foam. The R-value for interior foam is in close agreement with the expected R-value of RSI 1.716 (R 9.74) based on ASHRAE's published value of thermal conductivity, 0.037 W/mK, (ASHRAE, 2009) and the thickness of the EPS, 64 mm (2.5 in.). The R-value of the exterior foam has a very high standard deviation due to large fluctuation in heat flux, and periodic low delta T across the exterior foam leading to reduced accuracy. Since both foams are identical, RSI 1.73 (R9.81) was assumed for both the exterior and interior insulation. This R-value was then combined with measured delta T across the interior and exterior insulation to predict the heat flux at location 2 and 3 for the first half of the experiment. This is referred to as "calculated" heat flux in Figure 14.

The heat flux at the exterior of the ICF followed daily temperature swings caused by outdoor air temperature and solar effects in the afternoon, and ranged from 14.5 W/m^2 to -13.0 W/m^2 . By contrast, the heat flux from the interior side of the ICF did not respond to the daily fluctuations in temperature, but rather followed the general temperature trend. The concrete mass evidently provided a buffering effect. As a result, the heat flux from the interior ranged from -2.2 W/m^2 to 8.3 W/m^2 , primarily flowing from interior to exterior during the experiment period.

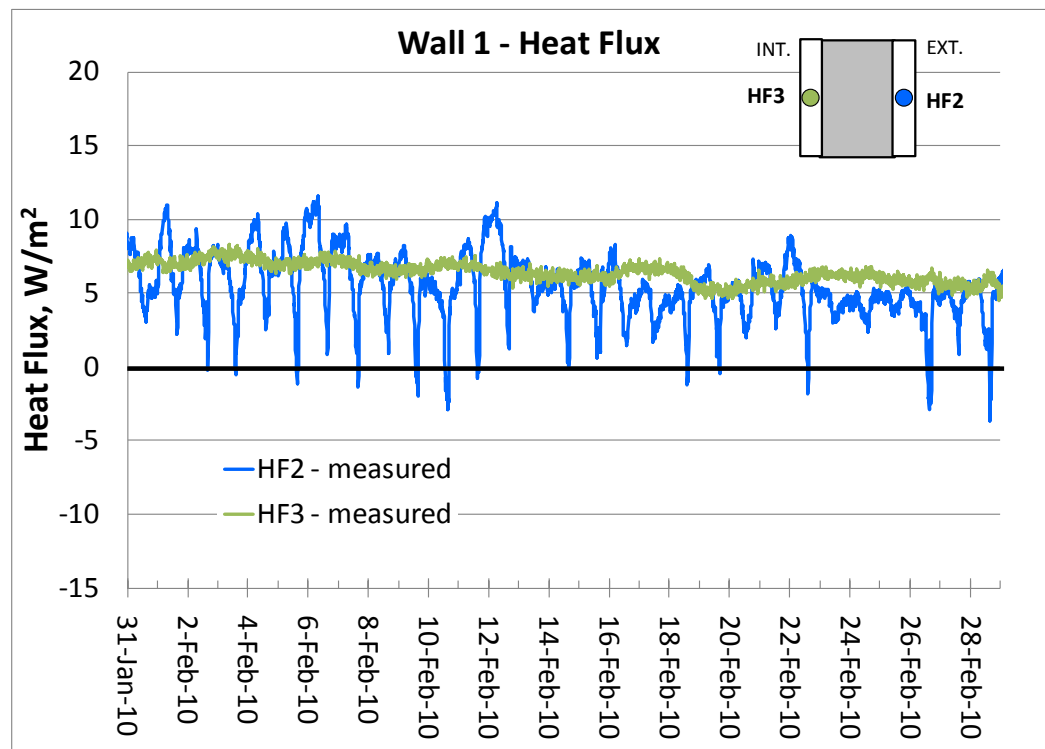
Figure 15. Detail of winter heat flux at the interior and the exterior of the ICF (15-minute data)

A detail of measured heat flux at the interior and exterior of the ICF during February is shown in Figure 15. The heat flux at the exterior of the concrete (HF2, plotted in blue) varies with outdoor conditions. When conditions outside are cold, heat flux is high, and when conditions outside are warm, heat flux is low. By contrast, heat flux leaving the room (HF3, plotted in green) is fairly constant since the concrete maintains a relatively steady trend in temperature, as seen in Figure 9. The heat flux leaving the room through the ICF wall is not immediately affected by cold nights outside, but also does not get the immediate benefit of reduced heat losses on warm days (Figure 15).

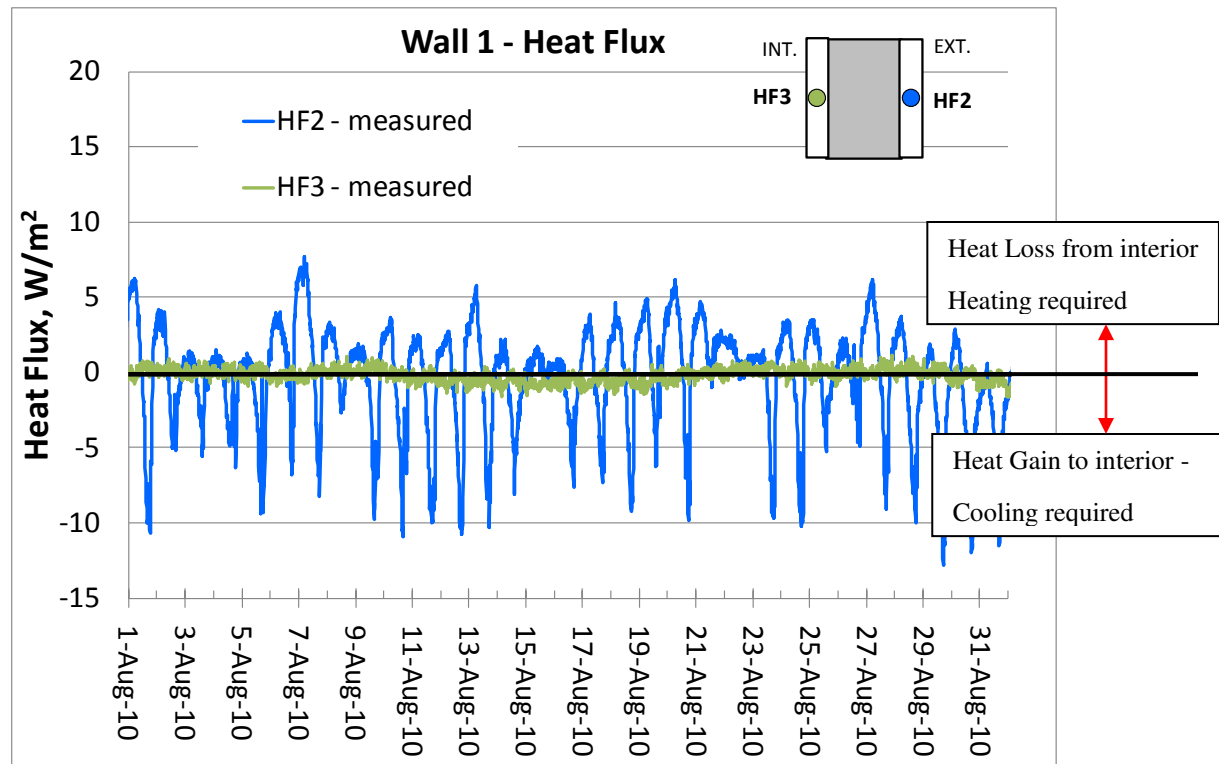
Figure 16. Detail of summer heat flux at the interior and the exterior of the ICF (15-minute data)

Since the ICF wall has very little heat flux from the interior during this time period, it would not experience a significant contribution to the peaks in cooling load from the ICF wall, as would be expected without the mass effect. However, the room does not immediately experience the benefit from free cooling overnight: rather, the free cooling is absorbed by the mass and presumably this helps to temper the effects of high outer surface temperature swings during the day, at times when peak air-conditioning would normally be experienced, both by the house and by the electric utility.

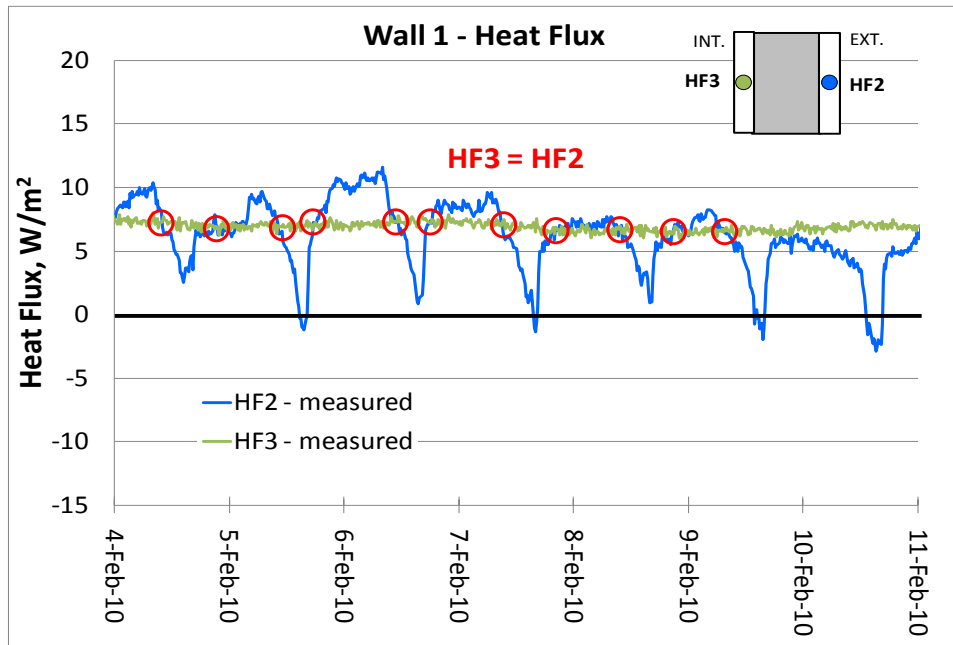
Figure 17. Example of occasions where the ICF wall is in “Pseudo Steady State”

On occasions where the heat flux on the exterior and the heat flux on the interior of the ICF are equal, the mass in the wall is neither storing nor releasing heat at that particular instant in time because its average temperature is temporarily constant (for example at the top or bottom of a temperature swing). During this condition, the wall is considered to be in a temporary or ‘pseudo’ steady state condition, where all of the heat transferred during that small time period is due to R-value only (see example in Figure 17). Using the measured data (delta T across the assembly and the heat fluxes) and Equation 1, the pseudo steady state R-value was calculated for all occasions where the absolute difference in measured heat fluxes (HF3-HF2) was less than 0.3 W/m^2 . The result for Wall 1 is plotted in Figure 18. The average steady state RSI is $3.77 \text{ m}^2 \text{ }^\circ\text{C/W}$, $\sigma = 0.15$ (R 21.4, $\sigma = 0.84$).

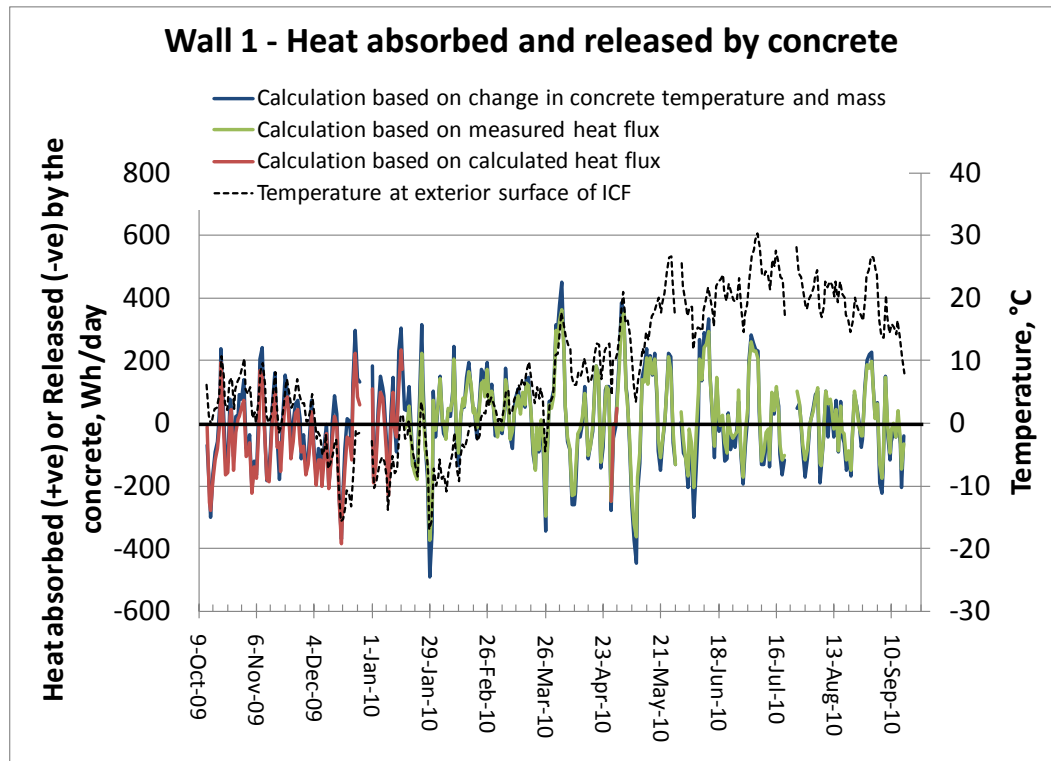
Figure 19. Daily heat absorbed and released by the concrete

The total daily heat absorbed (+ve) or released (-ve) by the concrete in the ICF is plotted in Figure 19. Both methods of calculating the heat absorbed and released give an approximately similar result. Small differences are present, and may be due to the assumed properties for the concrete ($C_p=880 J/kgK$, $\rho=2350 kg/m^3$), or the accuracy of the heat flux transducers. The similarity of the two trends gives confidence in the heat flux transducer readings.

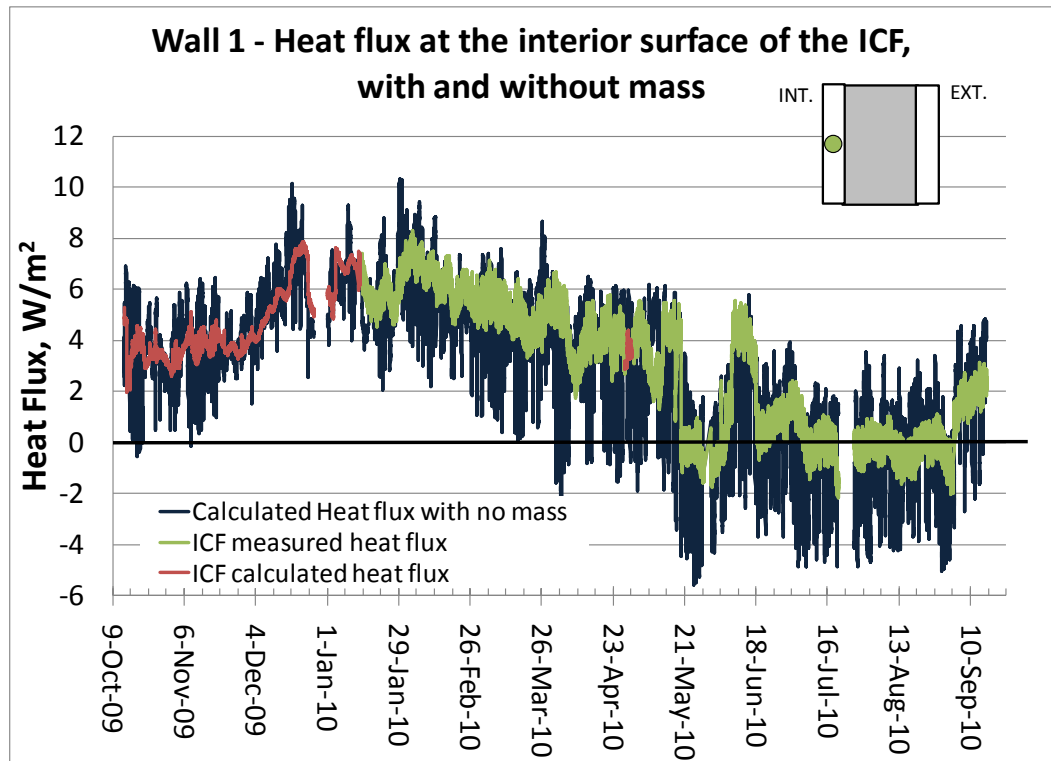
Figure 20. Heat flux at the interior surface of the ICF, with and without mass (15-minute timestep)

The resulting comparison of the wall with and without mass is shown in Figure 20. Without thermal mass, the heat flux varies significantly with change in outdoor temperature, following daily swings. With the effect of thermal mass, however, the heat flux varies only slightly during each day.

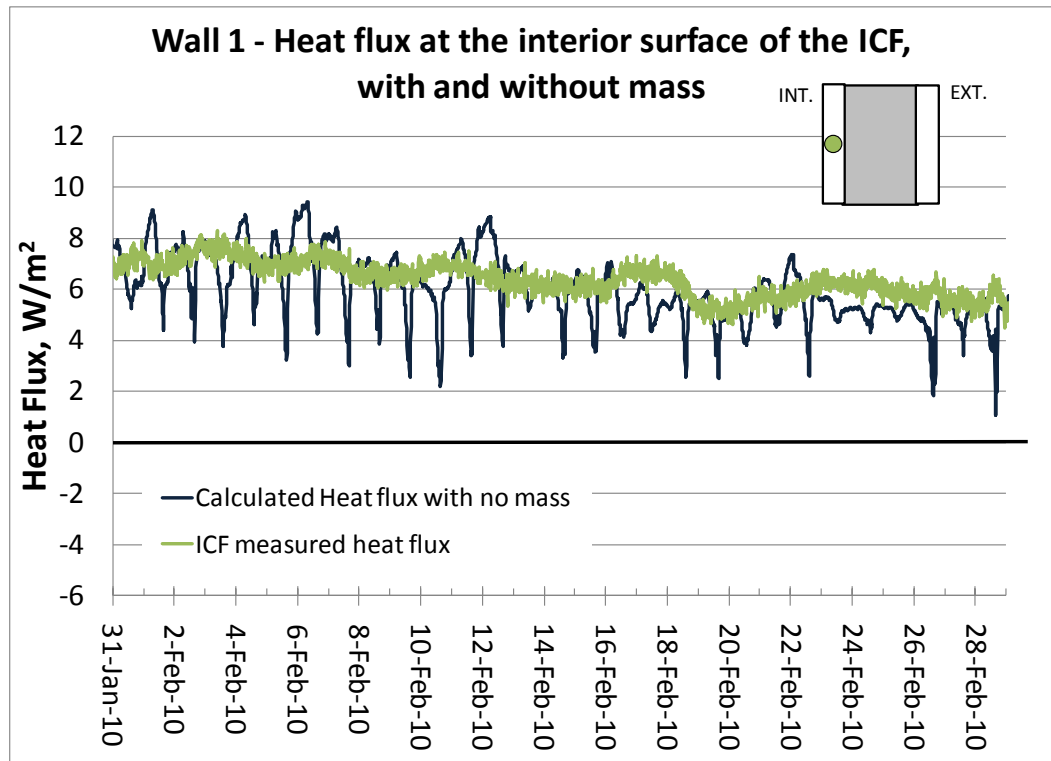
Figure 21. February detail of heat flux at the interior surface of the ICF, with and without mass (15-minute timestep)

Details of this mass/no mass comparison for February and August are provided in Figure 21 and Figure 22 respectively. In February, heat flux on the interior side of the ICF wall is fairly steady. Whereas, predicted heat flux at this same location in a wall with no mass fluctuates on a daily basis with changes in outdoor temperature. In August, the measured heat flux at the interior of the ICF is close to zero. During this same period, the calculated heat flux for the wall with no mass cycles daily above and below zero: at night heat is lost from the room (+ve heat flux), and during the day heat is gained by the room (-ve heat flux). Heat gains in summer contribute to the cooling load of the air conditioning system i.e additional cooling is required in the room to maintain constant temperature.

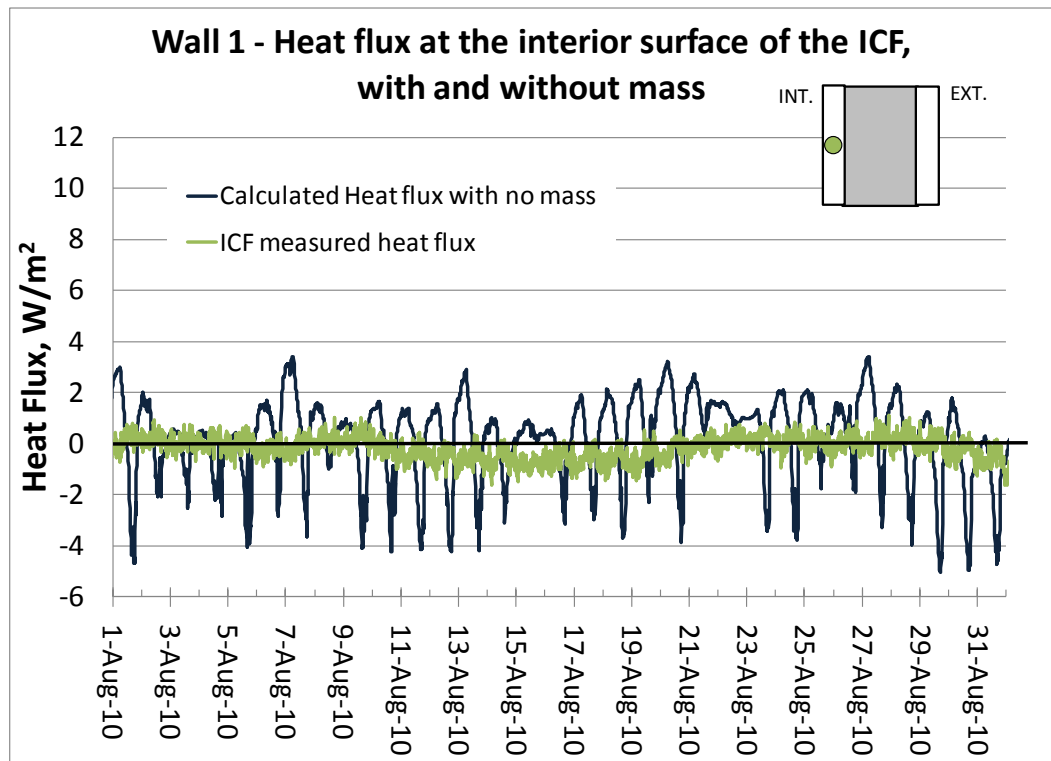
Figure 22. February detail of heat flux at the interior surface of the ICF, with and without mass (15-minute timestep)

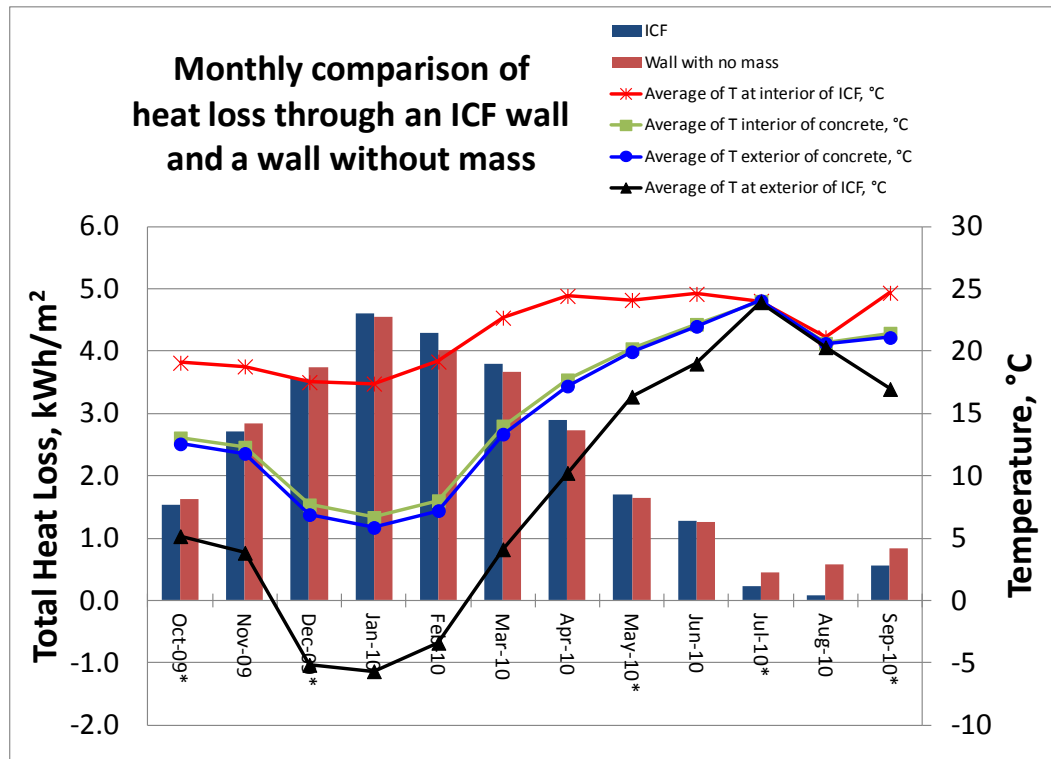
Figure 23- Monthly comparison of heat loss through an ICF wall and a wall with no mass.

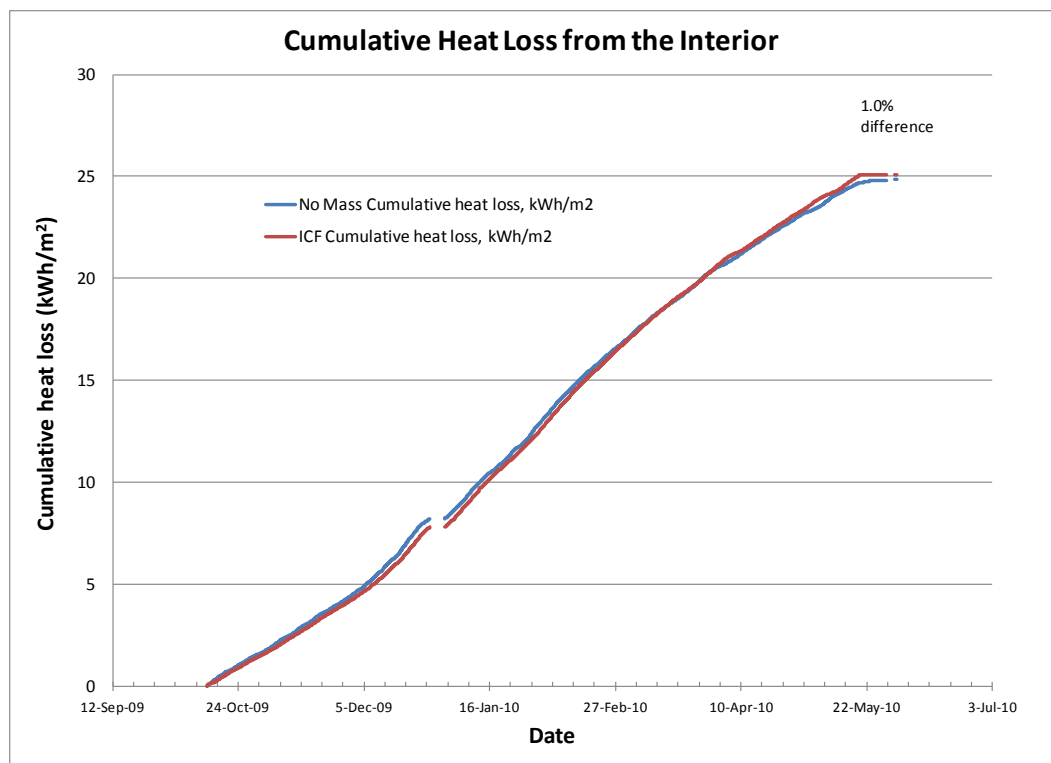
Figure 24- Cumulative energy loss for walls with and without mass (heating season only).

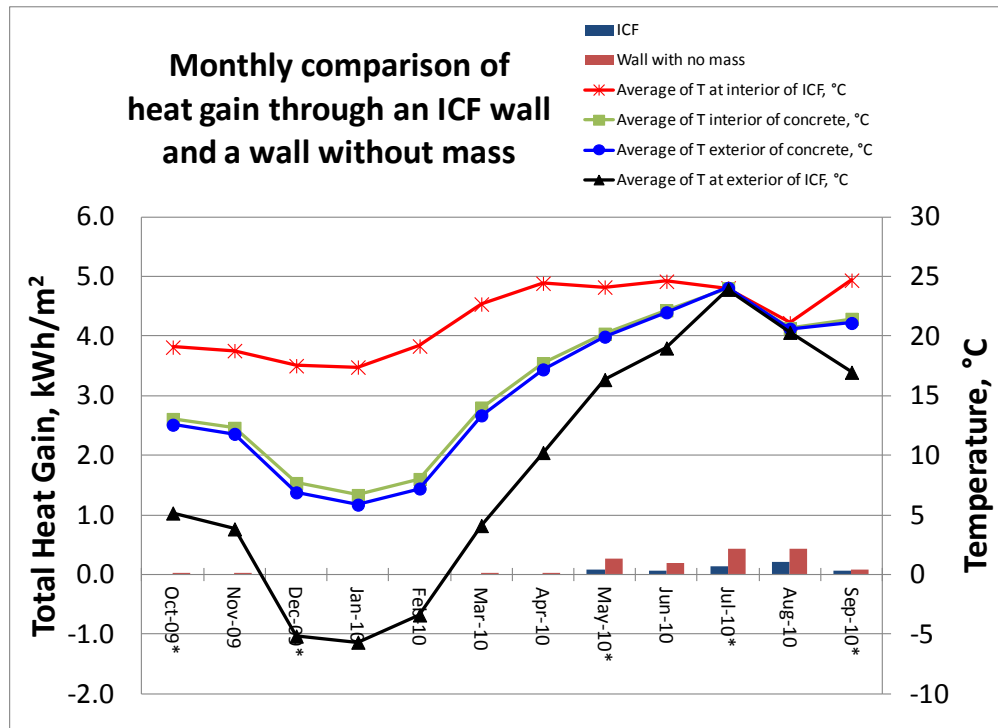
Figure 25. Monthly comparison of heat gain through the ICF, and a wall without mass

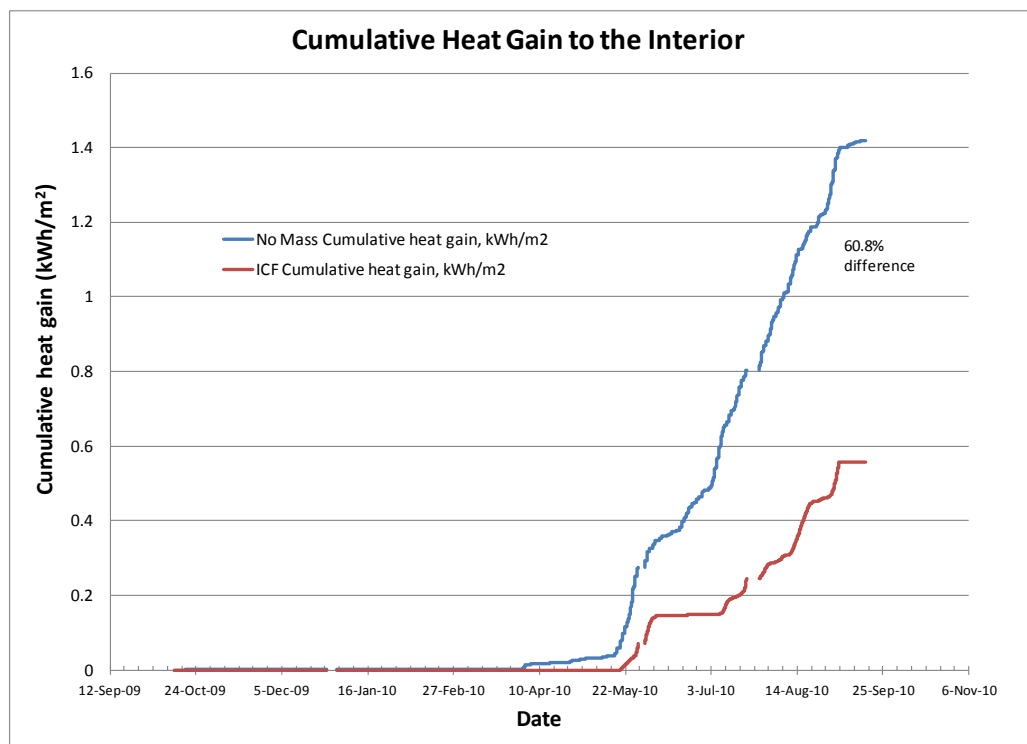
Figure 26 - Cumulative energy gain for walls with and without mass.

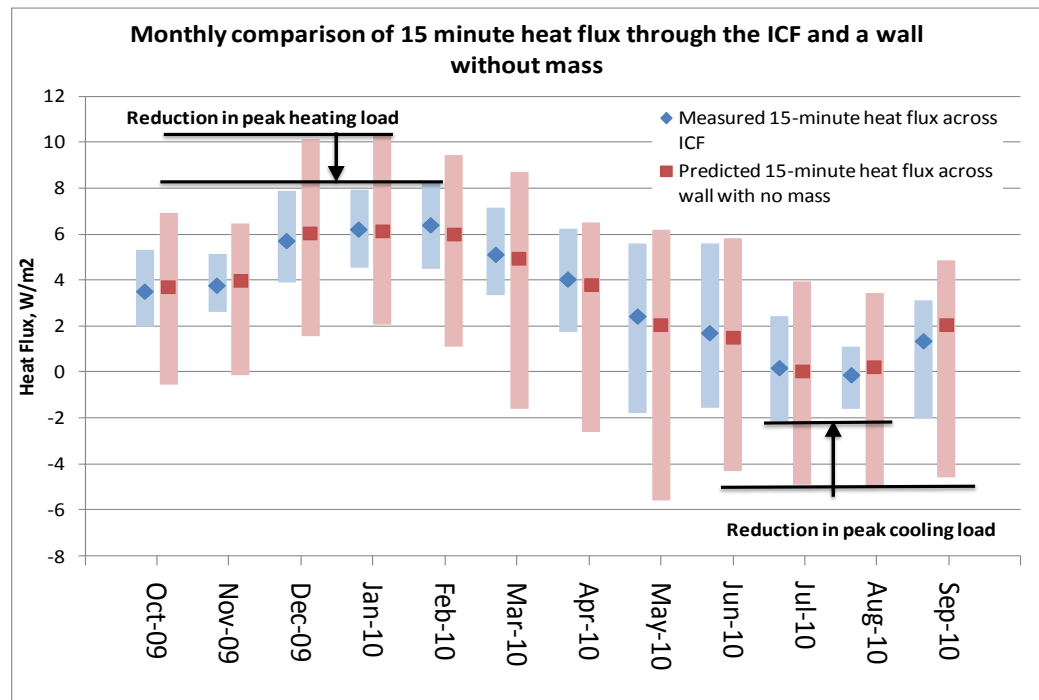
Figure 27. Monthly comparison of 15-minute heat flux through the ICF and a wall with no mass. (Each point represents the average monthly heat flux, with the bars indicating the monthly maximum and minimum heat flux values.)

In summer, the minimum heat flux for the ICF wall was -2.2 W/m^2 . The expected minimum heat flux across the wall with no mass is -5.6 W/m^2 , resulting in a 3.4 W/m^2 higher cooling load. Again, this could have implications for the sizing of an air conditioning system.

The monthly maximum and minimum 15-minute heat flux values are provided in Table 4.

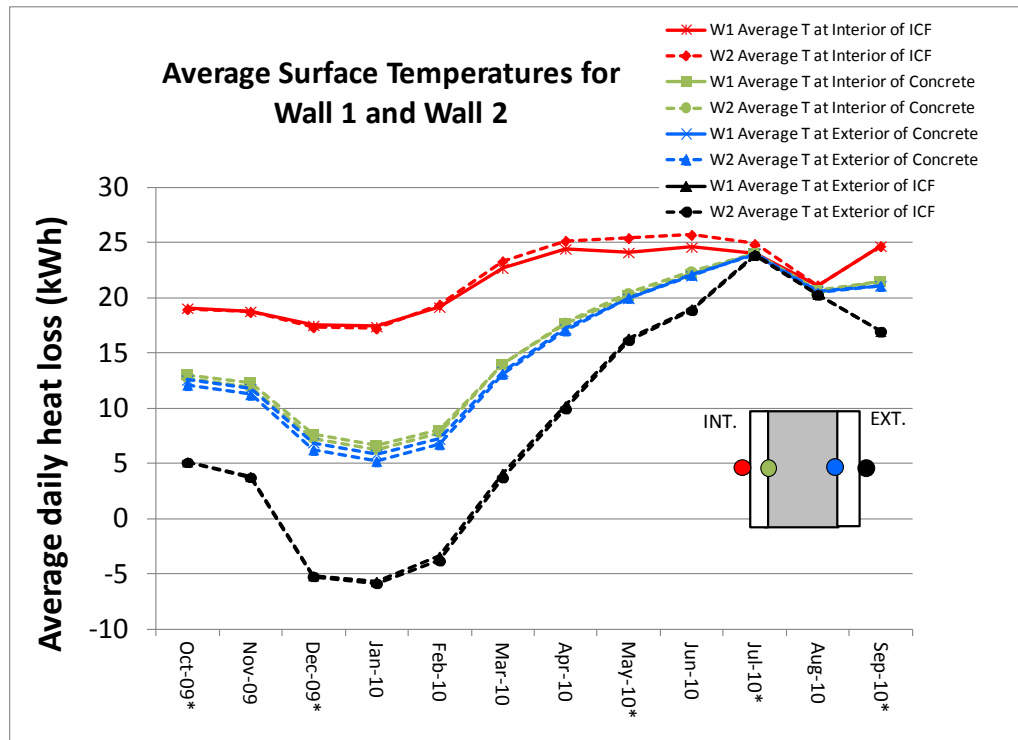
Figure 28. Comparison of Wall 1 and Wall 2 temperature measurements

Even though Wall 1 and Wall 2 were exposed to the same naturally occurring outdoor conditions, and the same interior controlled chamber conditions, there were significant differences in measured temperatures. The average monthly surface temperatures of the two ICF walls are compared in Figure 27. The largest difference between the two walls is seen at the interior surface of the ICF. This difference is shown in greater detail in Figure 28. In this graph, the 15-minute average interior surface temperature is plotted for the two ICF wall specimens on the secondary y-axis (right axis), and the difference between the two curves is plotted in blue on the primary y-axis (left axis). Starting in February, The Wall 2 ICF interior surface temperature was warmer than the Wall 1 ICF interior surface temperature – typically between 0.5 and 1°C warmer. For a short period between mid-May and mid-June Wall 2 temperature was up to 3°C warmer than the Wall 1 ICF interior surface temperature.

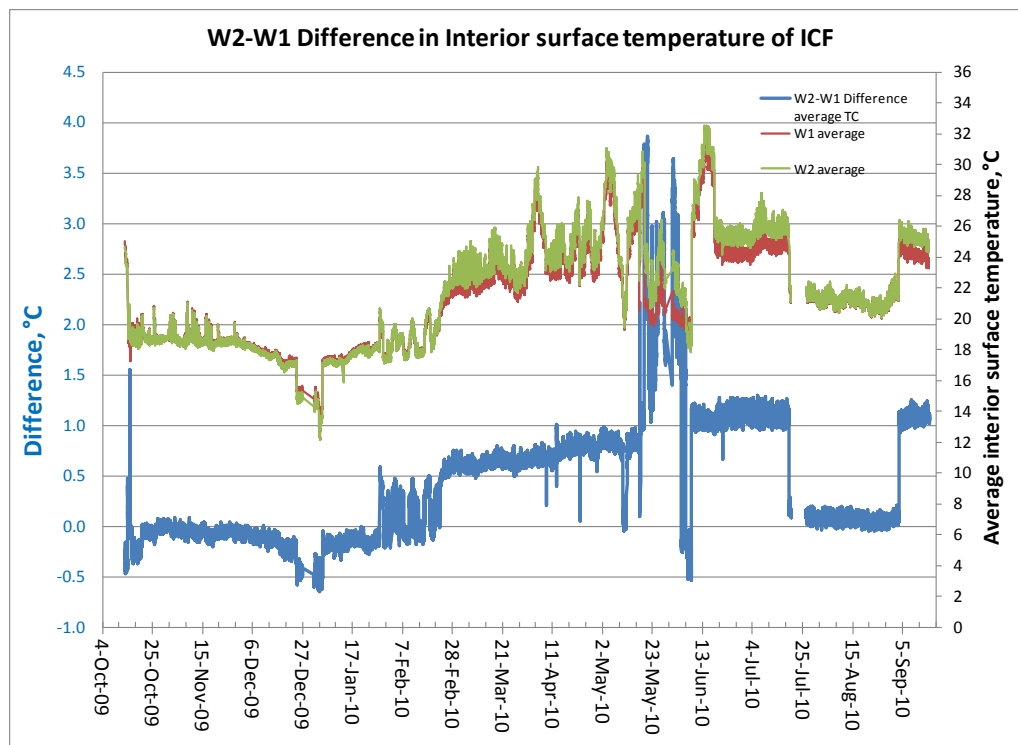
Figure 29. Difference in the ICF interior surface temperature for Wall 1 and Wall 2

The location of the heater in the interior chamber and its mode of operation is a likely explanation for the difference in interior ICF surface temperature. The heater in the chamber is a standard home space heater with internal fan. When the setpoint temperature in the chamber is satisfied (as measured by an RH&T sensors mounted centrally in the chamber), the power to the heater is shut off. As a result, both the heater's heating coil and the internal fan shut off. Natural operation of the heater would require the internal fan to run to dissipate heat for a short period of time after the heat coil was shut off. However, the control system simply shut off the power to both at once, thereby leaving the heating coil warm. The chamber heater is located near Wall 2. The heater is aimed away from the surface of Wall 2. However, when the heater turns off abruptly heat that would otherwise be circulated to the full chamber potentially has a larger impact on the surface of Wall 2 (in closer proximity) than the surface of Wall 1. This could potentially explain why differences in surface temperature between the two walls increased in warmer weather (in the spring), when the heater (and fan) would operate less frequently, and also why the temperature difference disappeared in August.

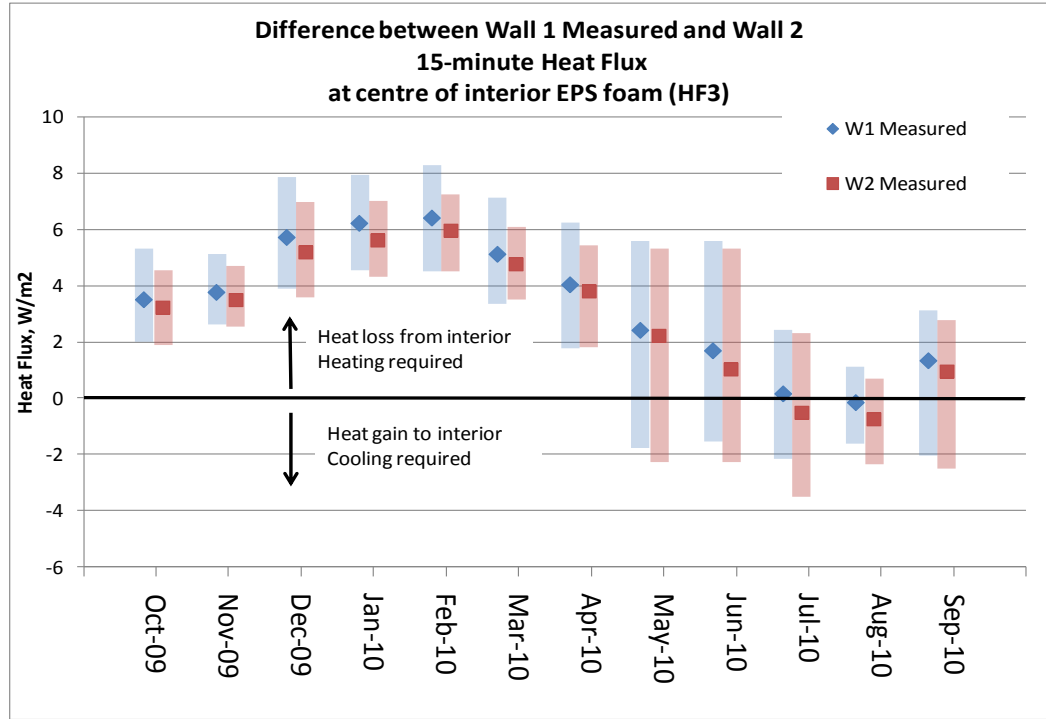
Figure 30. Comparison of Wall 1 and Wall 2 measured Heat Flux at the Centre of the Interior EPS Foam (HF3). Each point represents the average monthly heat flux, with the bars indicating the monthly maximum and minimum heat flux values.

Measured 15-minute heat flux from Wall 1 and Wall 2 are compared in Figure 29. Each point on this graph indicates the average monthly heat flux for either the Wall 1 (blue) or Wall 2 (pink). The top and bottom of the bars associated with each point indicate the monthly maximum and minimum 15-minute heat flux values. The average, maximum and minimum measured monthly heat flux values for Wall 2 are generally lower than the measured monthly heat flux for Wall 1.

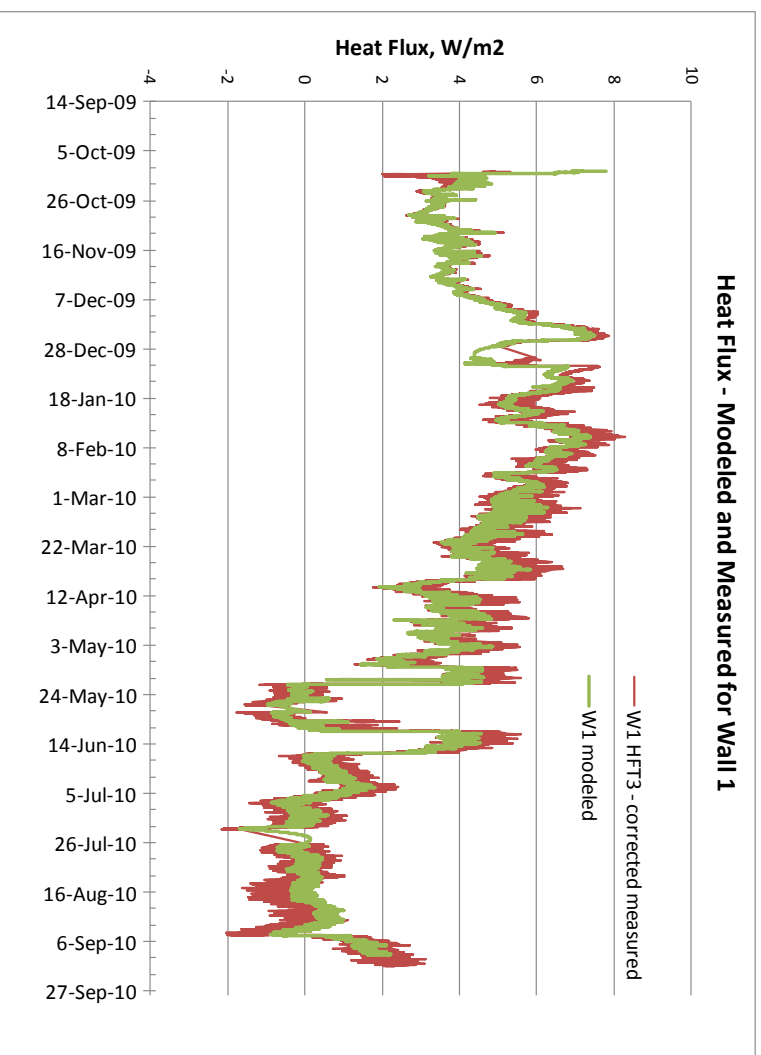
Figure 31. Comparison of the modeled heat flux and measured heat flux at location HFT3 for Wall 1.

In order to determine which heat flux values (Wall 1 or Wall 2) are most accurate, the values were compared to modeling results. For a full description of the model and comparison, refer to the ICF model report by Saber, 2011. The model-predicted heat flux is compared to the measured heat flux in Figure 30 and Figure 31 for Wall 1 and Wall 2 respectively. The initial conditions for the model were different than the conditions at the start of the experiment – thus the comparison can only be considered after the first two weeks. Wall 1 measured heat flux compares closely to the modeled heat flux for the full period. Wall 2 measured heat flux is also close to the model prediction for the first portion of the experiment, but differs from 17-May-10 onwards. On this date, the heat flux transducer at location HFT3 in Wall 2 was replaced, and unfortunately this resulted in erroneous data.

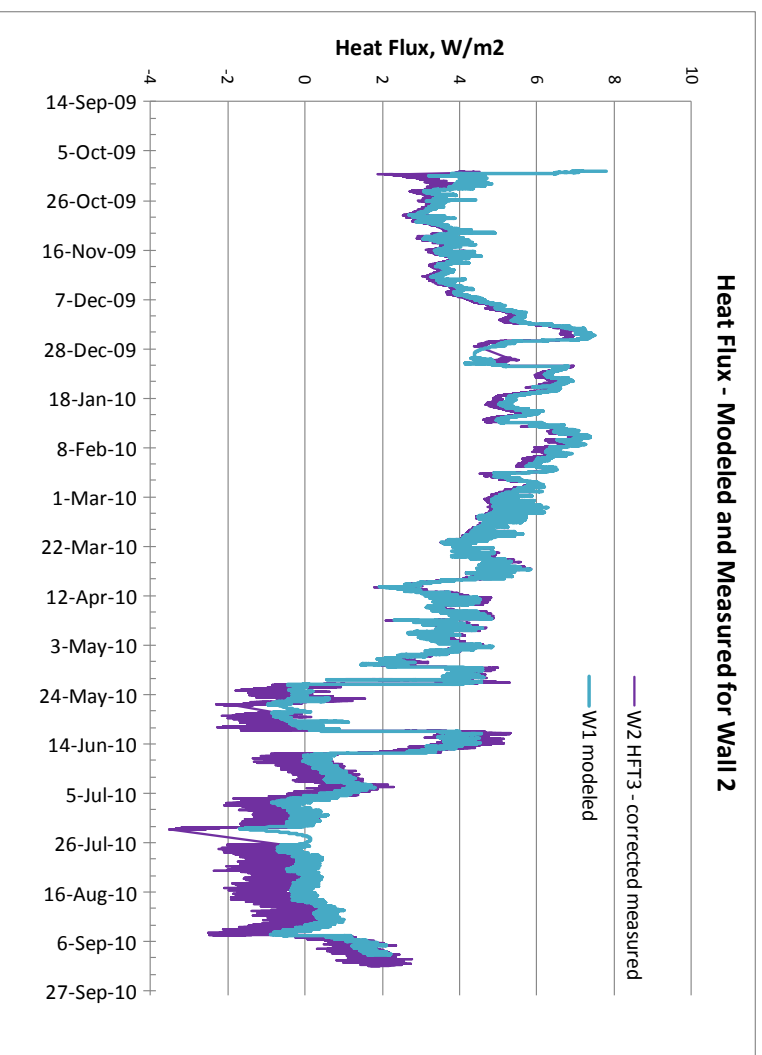
Figure 32. Comparison of the modeled heat flux and measured heat flux at location HFT3 for Wall 2.

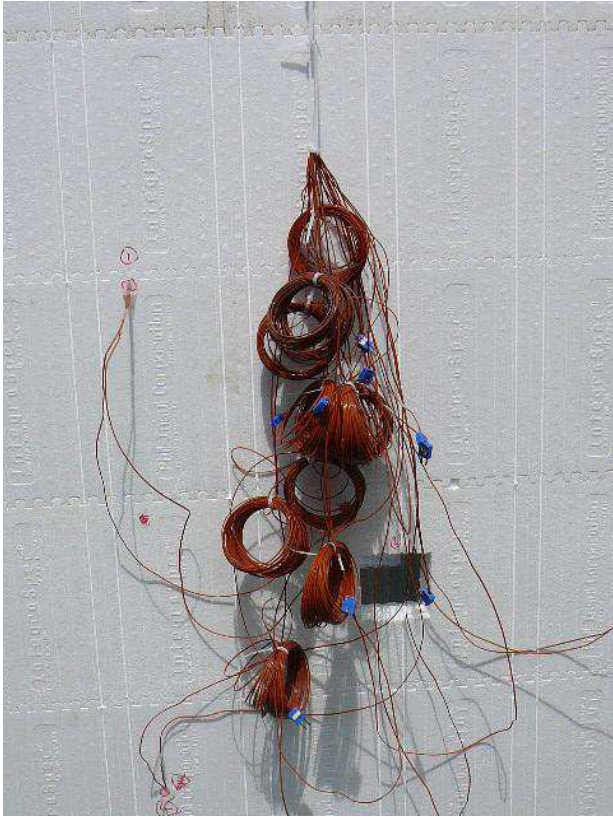
Figure A-5. Thermocouples installed on the exterior and interior surfaces of the foam prior to pouring the concrete.
