Field energy performance of an insulating concrete form (ICF) wall

Maref, W.; Armstrong, M. M.; Saber, H. H.; Rousseau, M.; Ganapathy, G.; Nicholls, M.; Swinton, M. C.

IRC-RR-326

March 2012

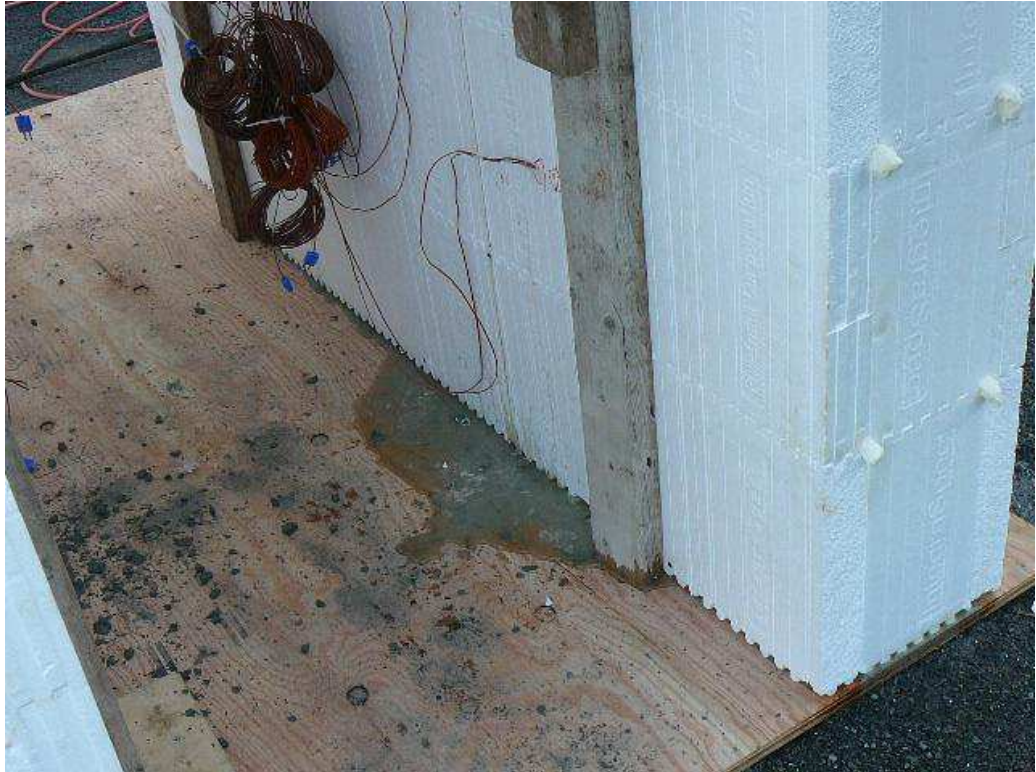
Figure A-13. Water pooling at the base of the ICF wall specimen after pouring the concrete.

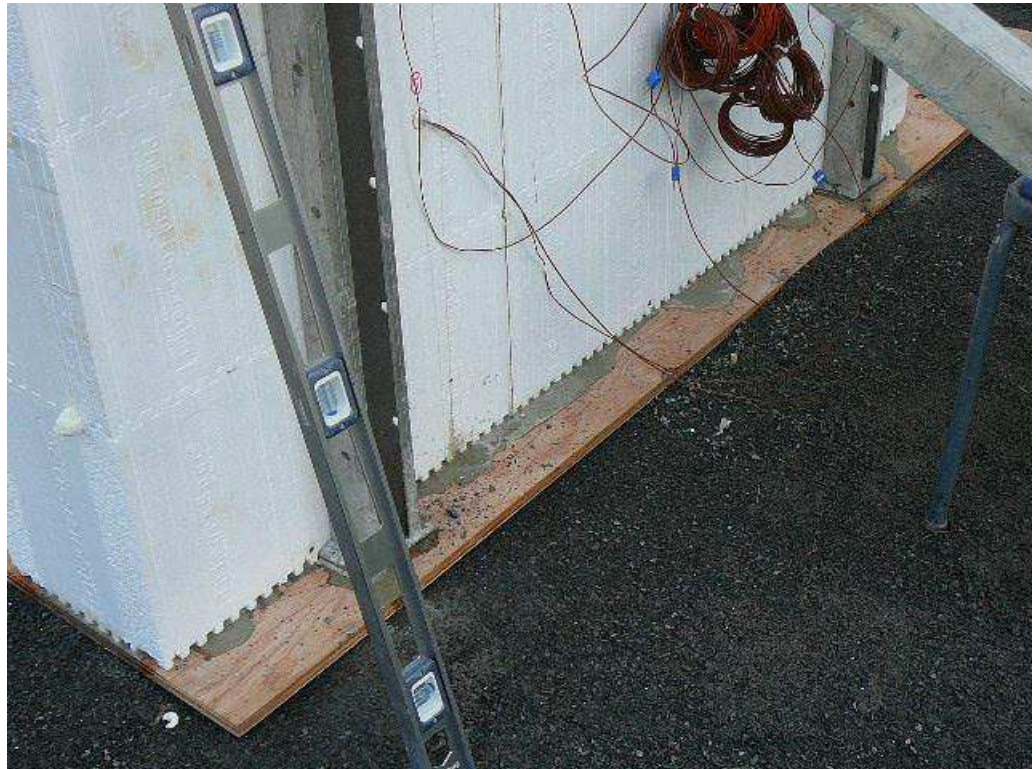
Figure A-14. Water pooling at the base of the ICF wall specimen after pouring the concrete.

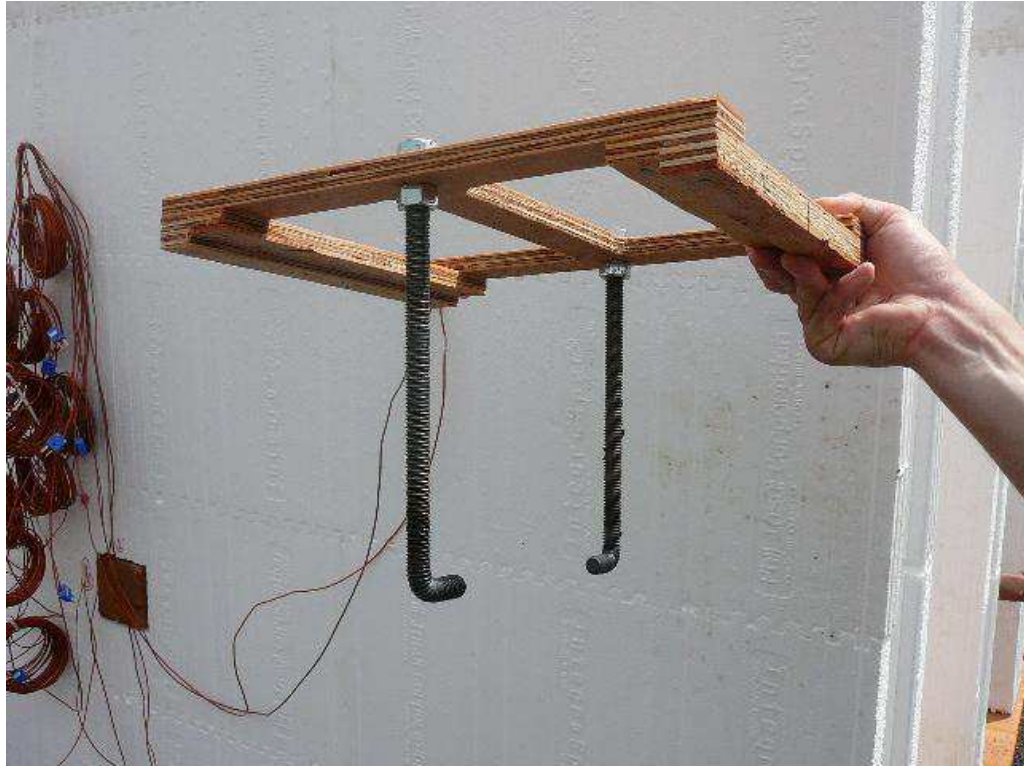
Figure A-15. Wooded alignment jig with threaded rods for the forklift lifting points.

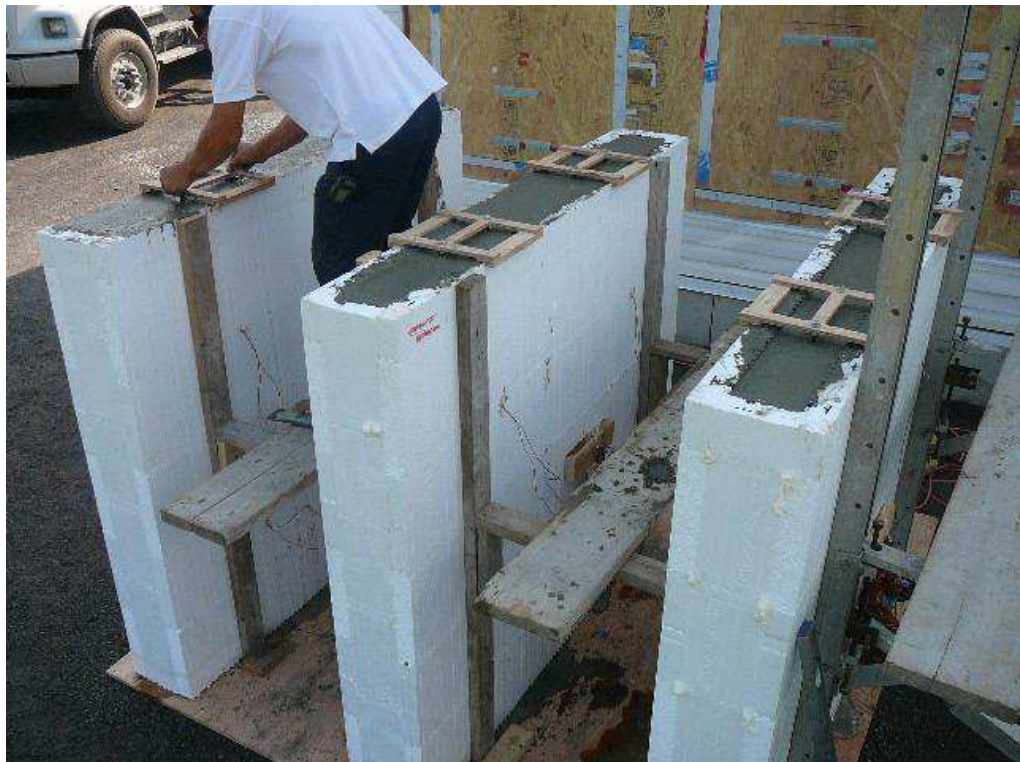
Figure A-16. The alignment jig holds the metal rods in place while the concrete cures.

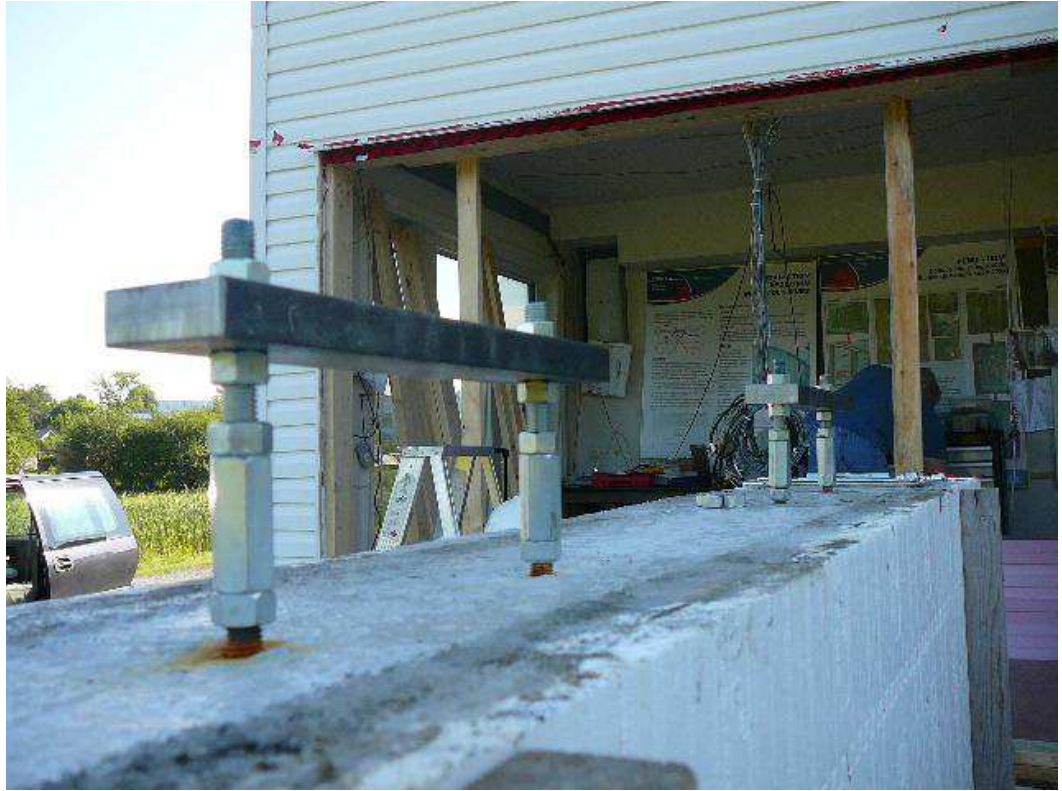
Figure A-17. Once the concrete was cured, the wooded jig was removed, extensions were added to the threaded rods, and metal plates were attached to provide lifting points for the forklift.

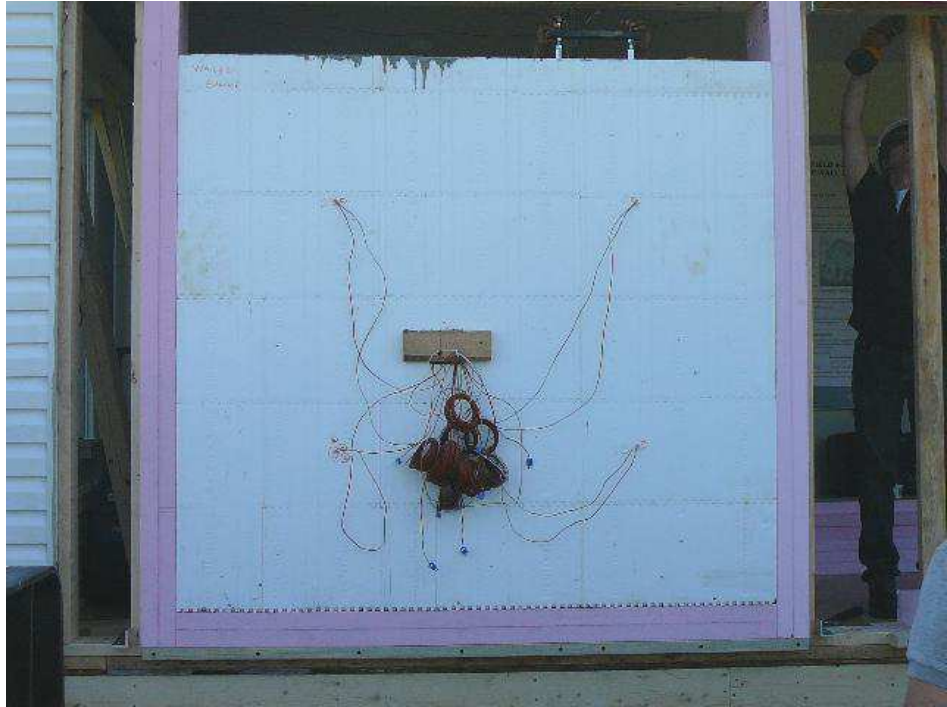
Figure A-22. The ICF is separated from the framing by 4 inches of EPS foam on the sides, bottom and top (not shown).

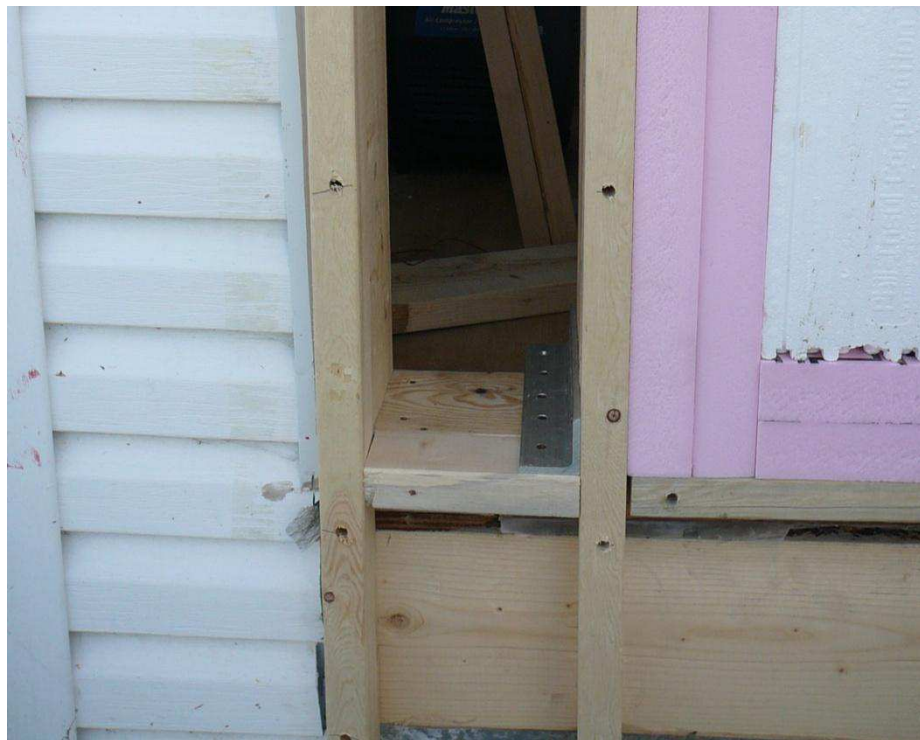
Figure A-29. Metal L brackets hold the framing in place on either side of the ICF.

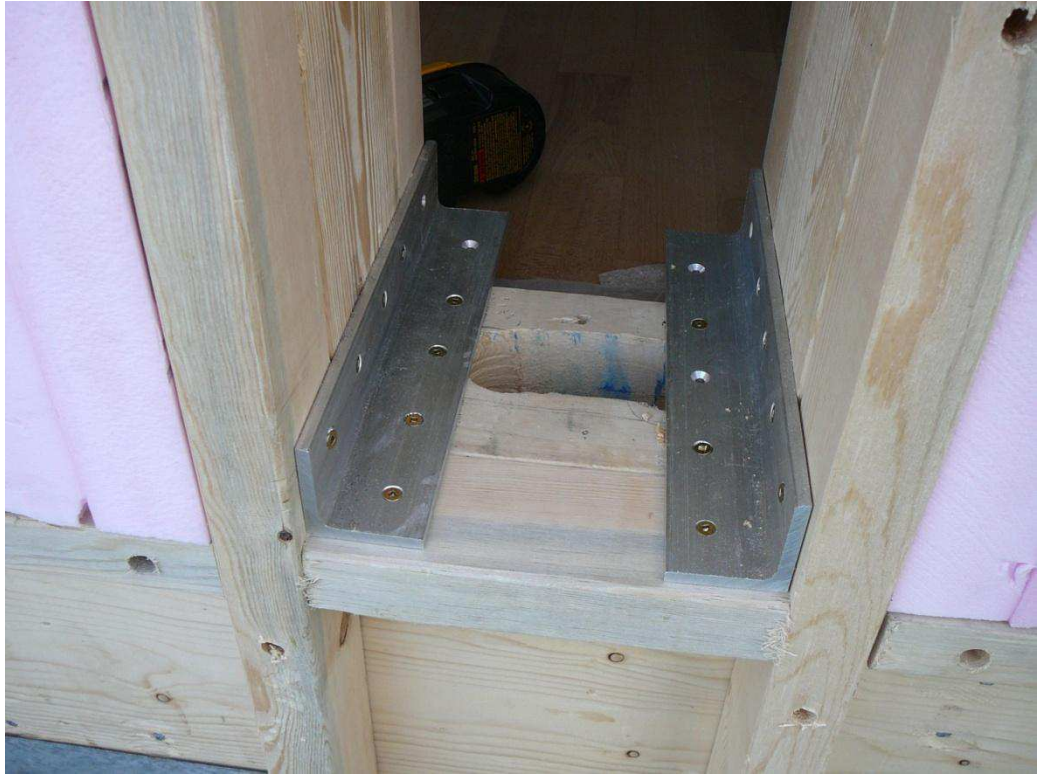
Figure A-30. Metal L brackets hold the framing in place on either side of the ICF.

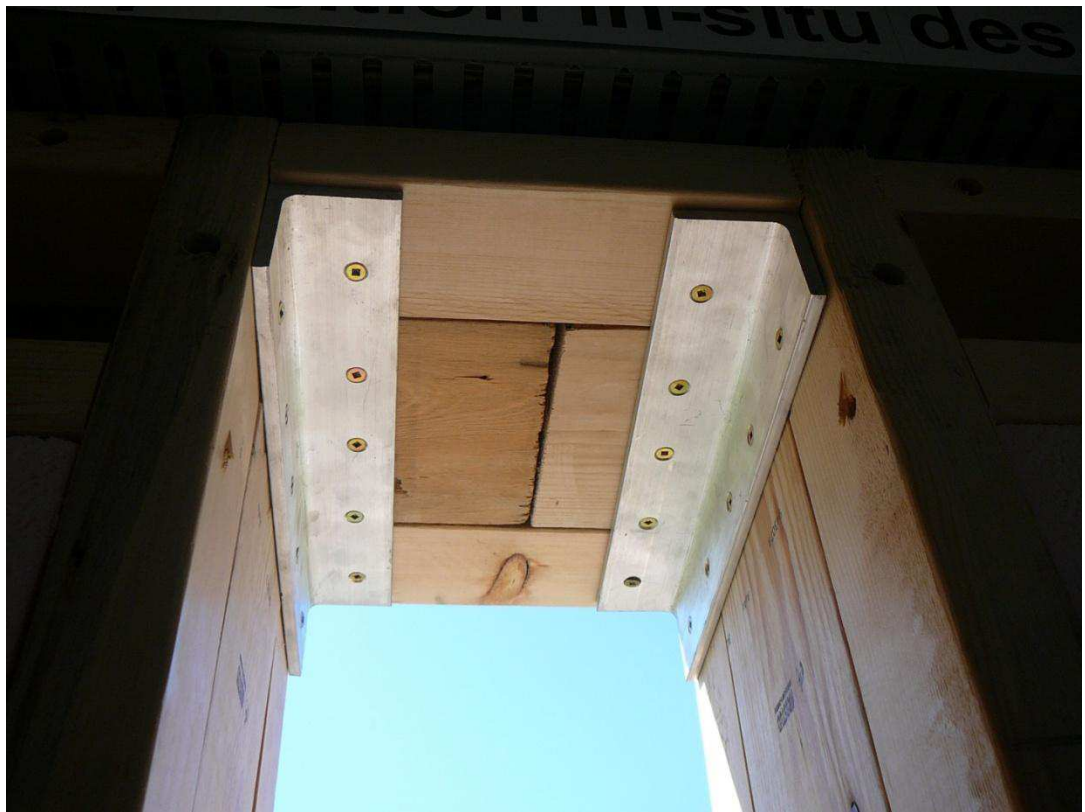
Figure A-31. Metal L brackets hold the framing in place on either side of the ICF.

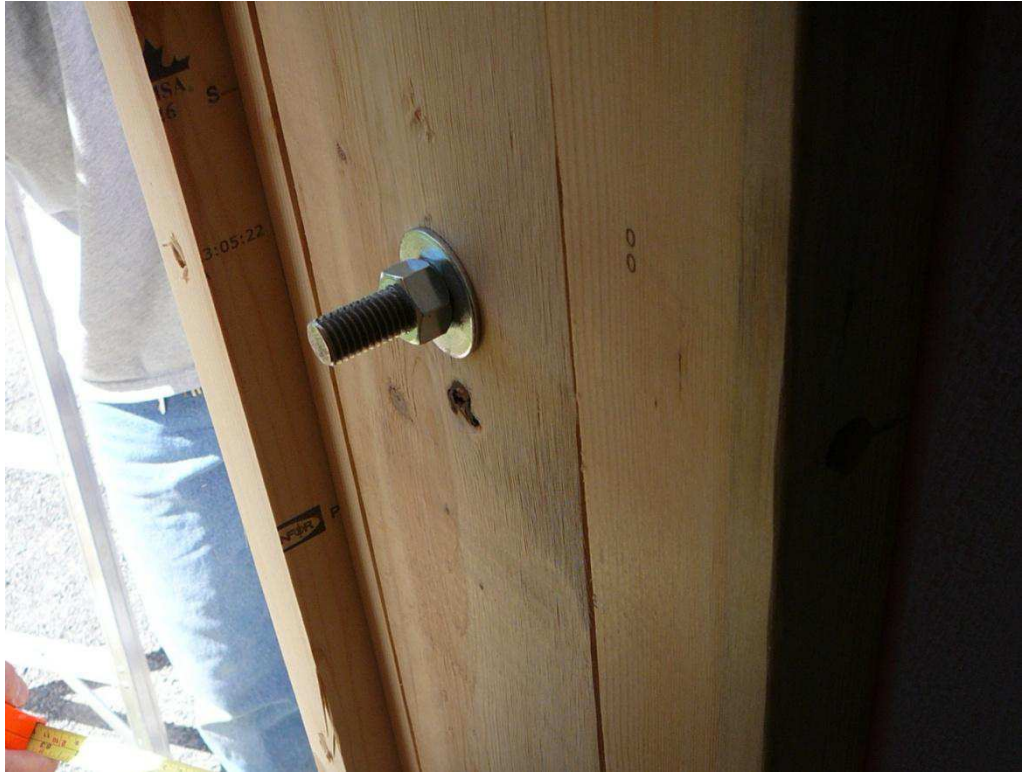
Figure A-32. Bolts secure the ICF wall specimen to the wood framing (2 bolts on each side).

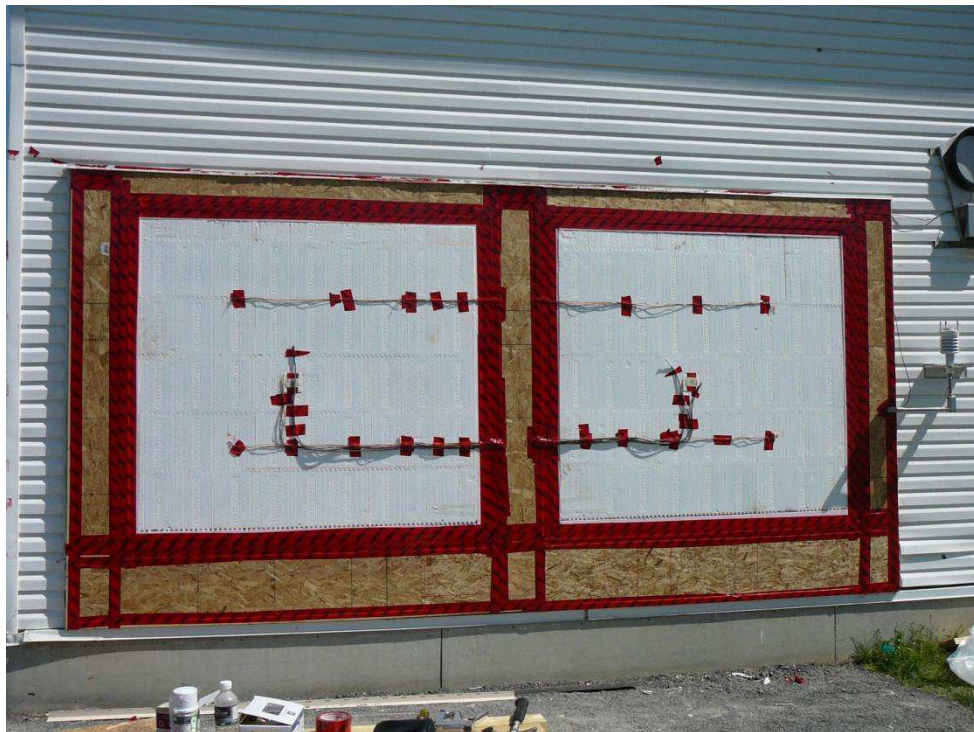
Figure A-34. OSB sheathing board installed around the specimens, joints sealed with sheathing tape.

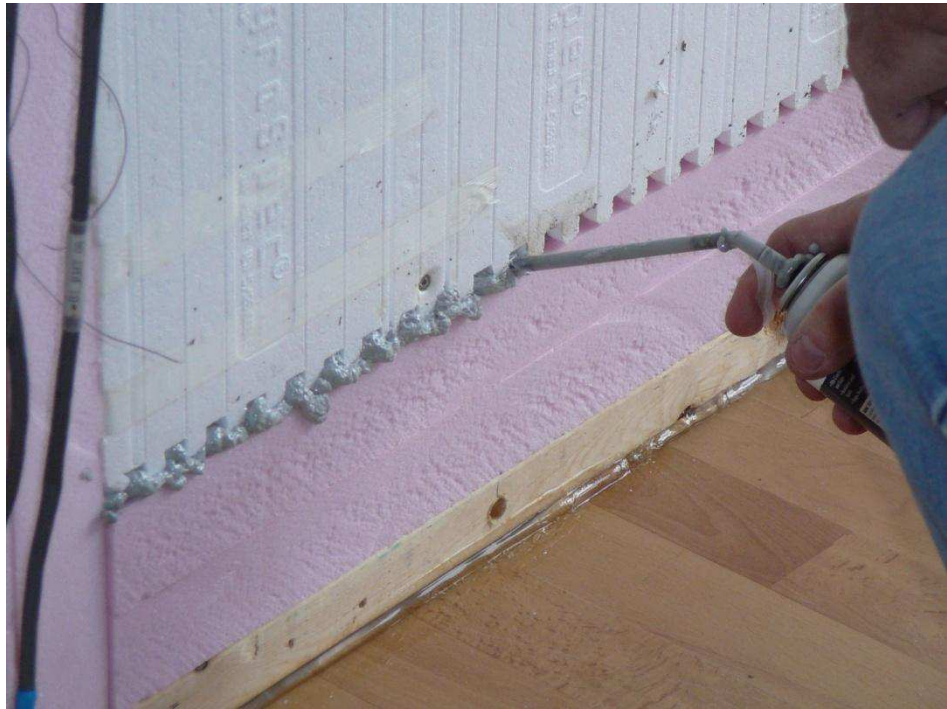
Figure A-41. Gaps in the ICF foam filled with low expansion polyurethane foam. Once cured, excess foam was trimmed from the interior face of the ICF.

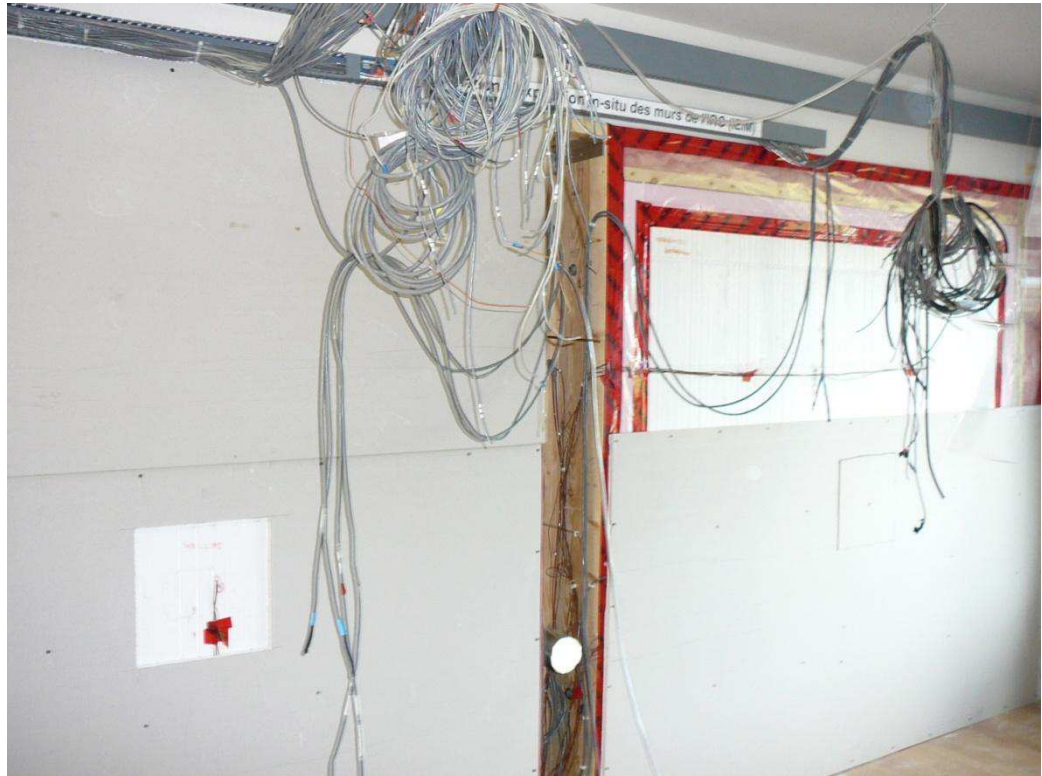
Figure A-43. Drywall being installed on the interior of the ICF wall specimens. A square access panel was cut in the centre of the drywall to allow access to the instrumentation (including heat flux transducers) on the surface of the ICF.

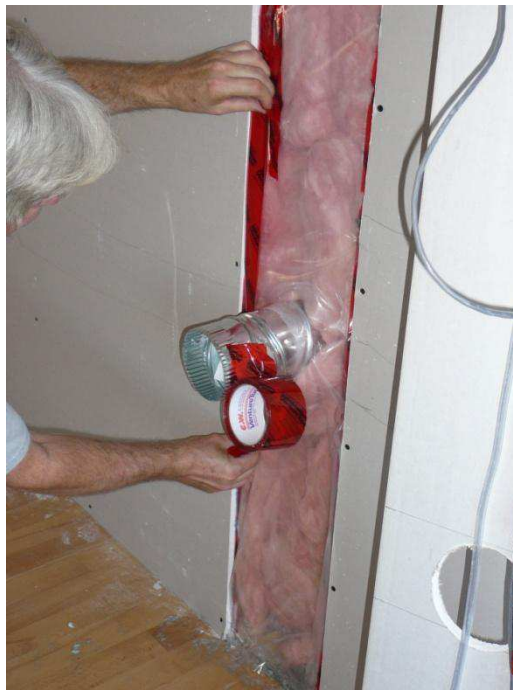
Figure A-46. Tape seals the air/vapour barrier to the surrounding wall assembly. A ventilation duct passes through the wiring chase, to permit air conditioning of the test chamber during the cooling season.

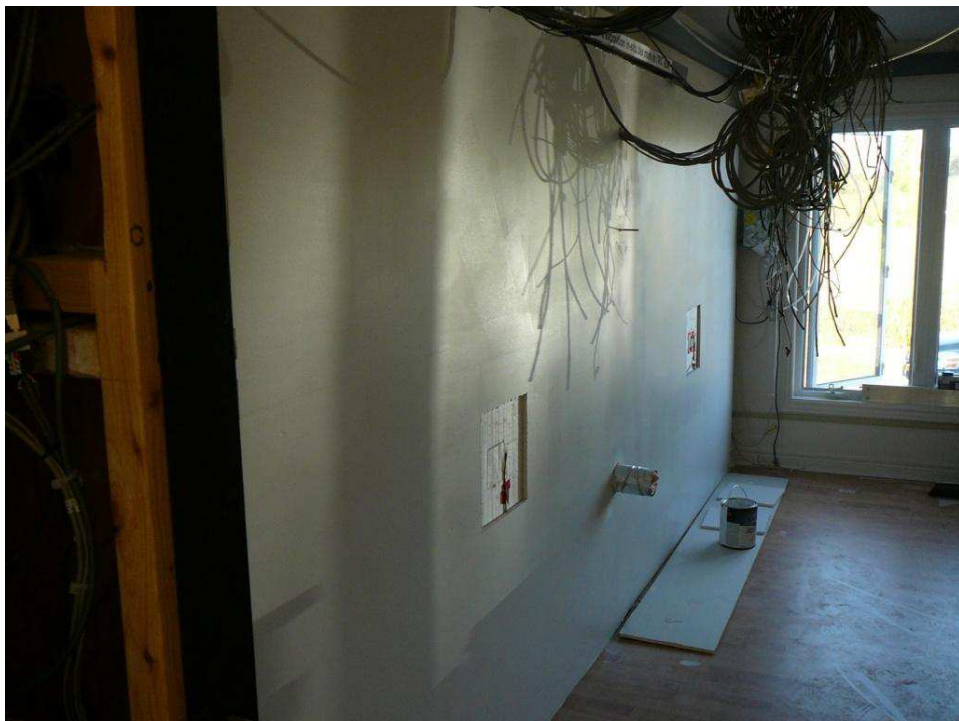
Figure A-50. ICF walls painted with acrylic paint – with access panels open (the removed sections of drywall were set back into place and taped before the start of the experiment)

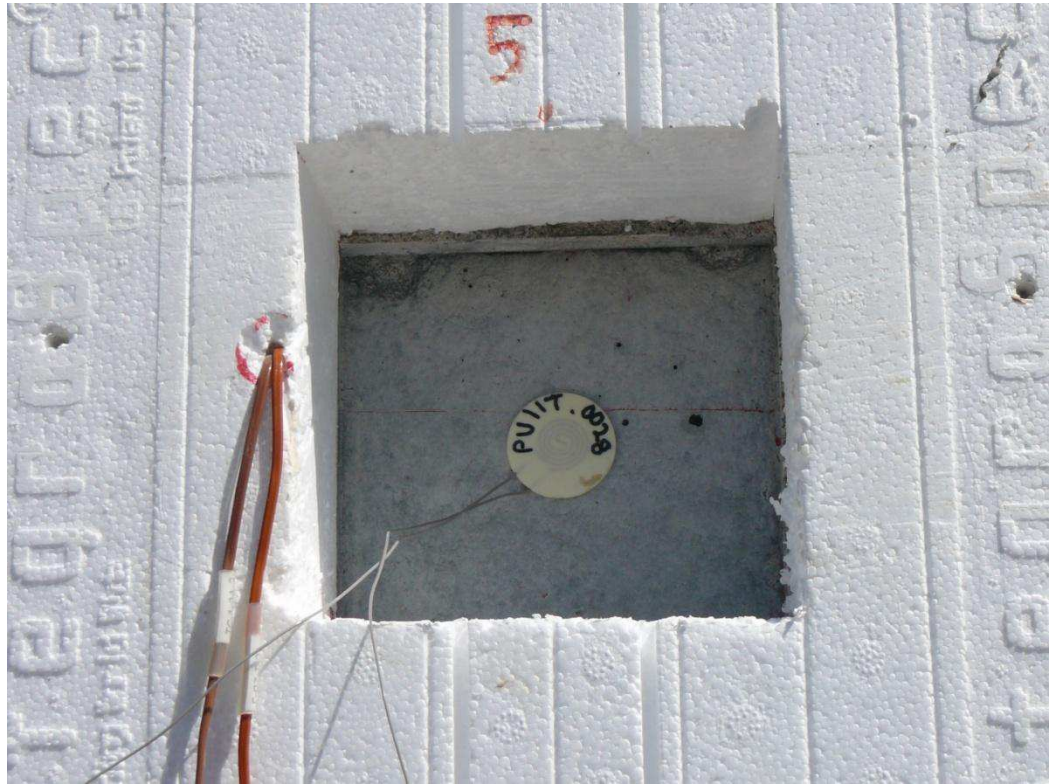
Figure A-62. Positioning of a heat flux transducer on the surface of the concrete.

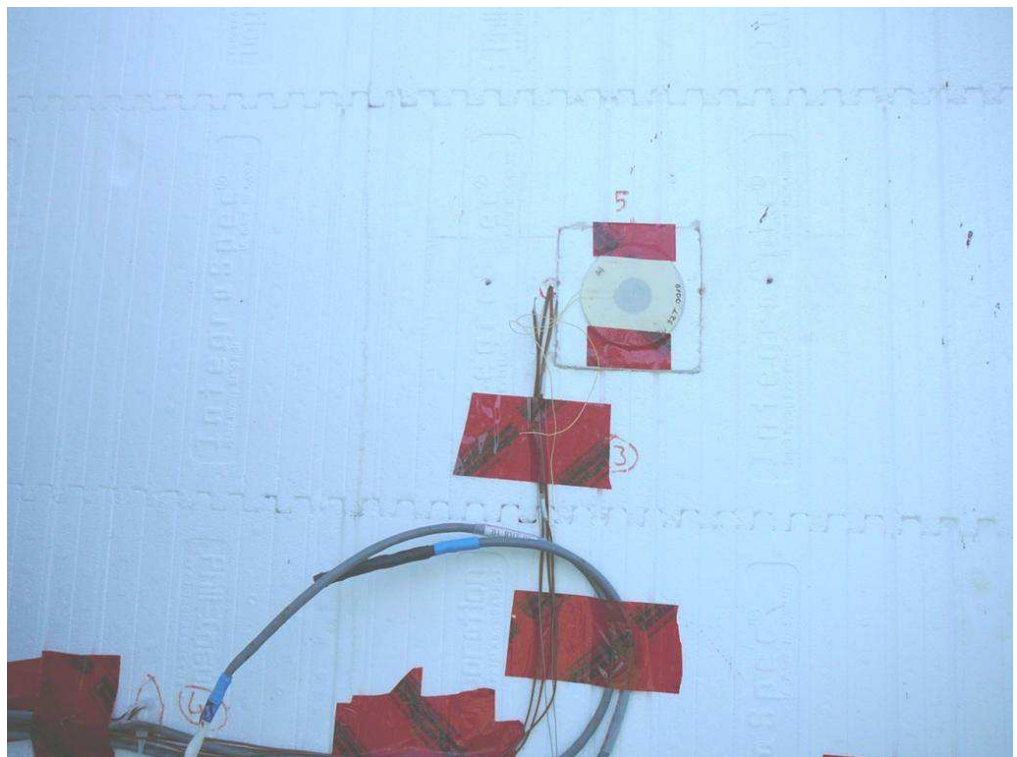
Figure A-63. Re-installation of the foam block, with a second heat flux transducer installed on the outer surface of the EPS.

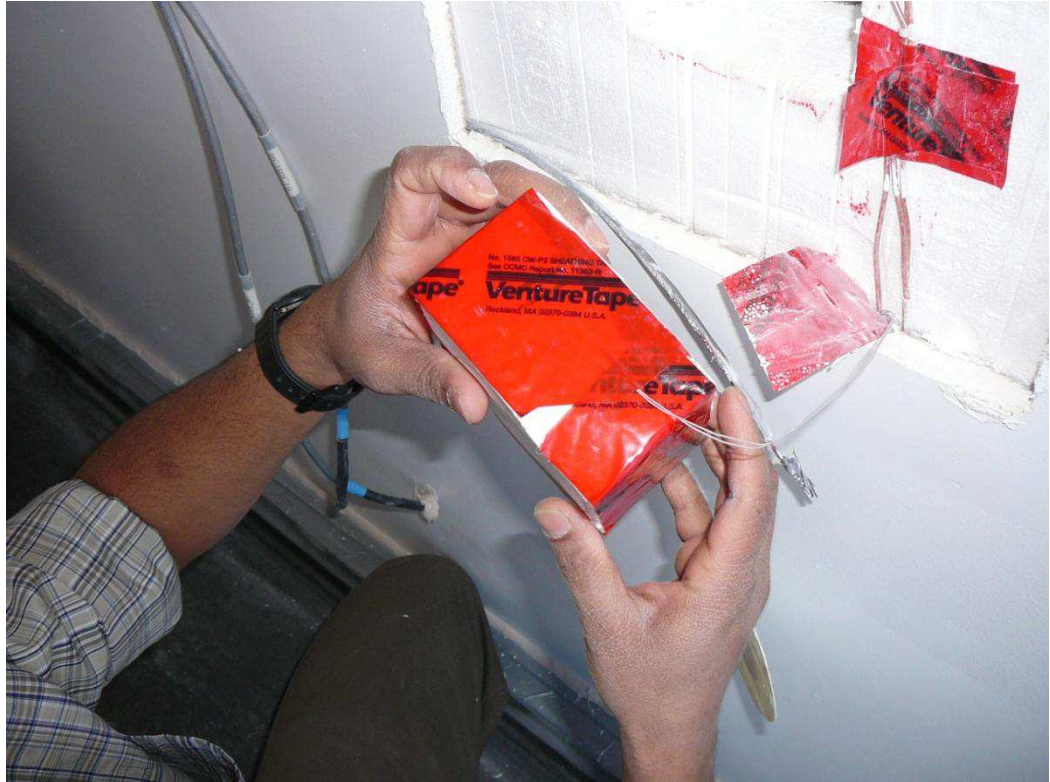
Figure A-66. Repositioning of the heat flux centre between the two sections of the foam block.

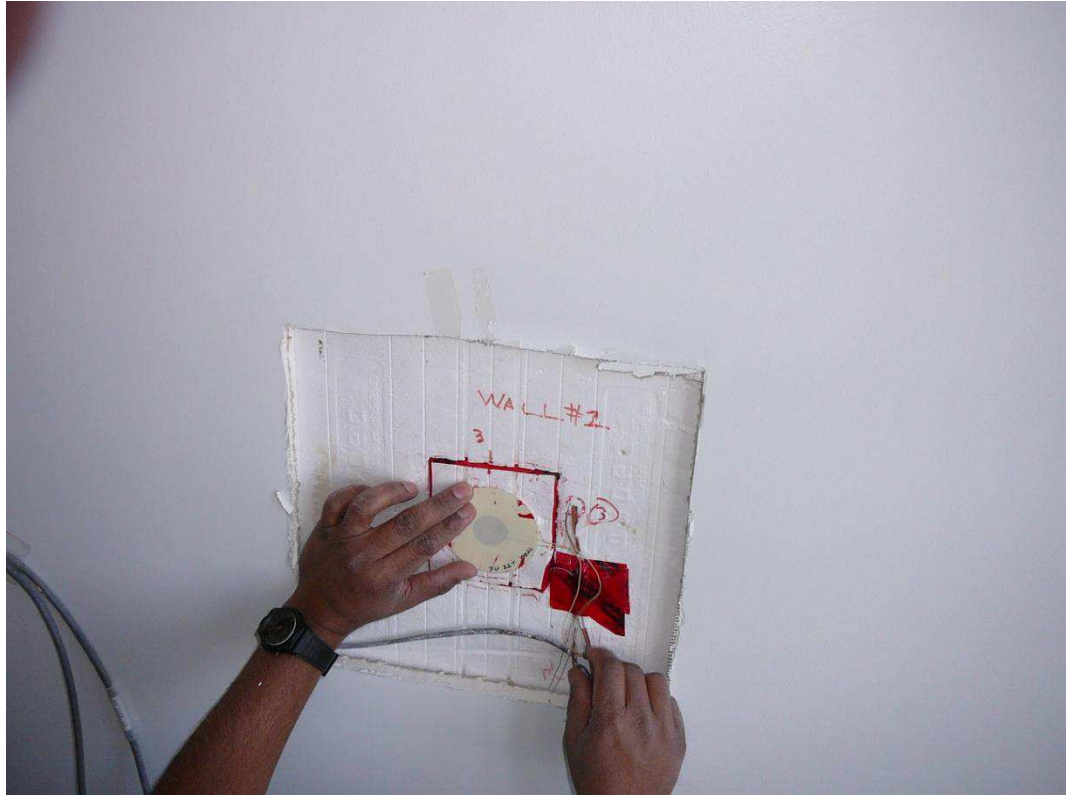
Figure A-68. Installing a second heat flux transducer on the interior surface of the ICF.

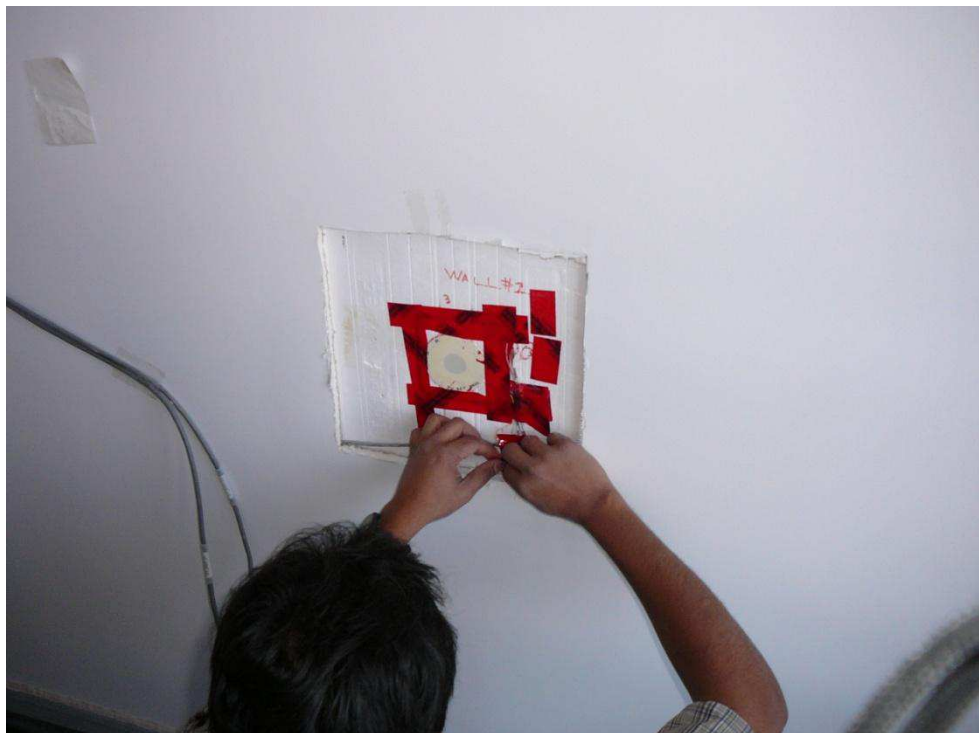
Figure A-69. Sealing the edges of the foam block to the ICF with tape.

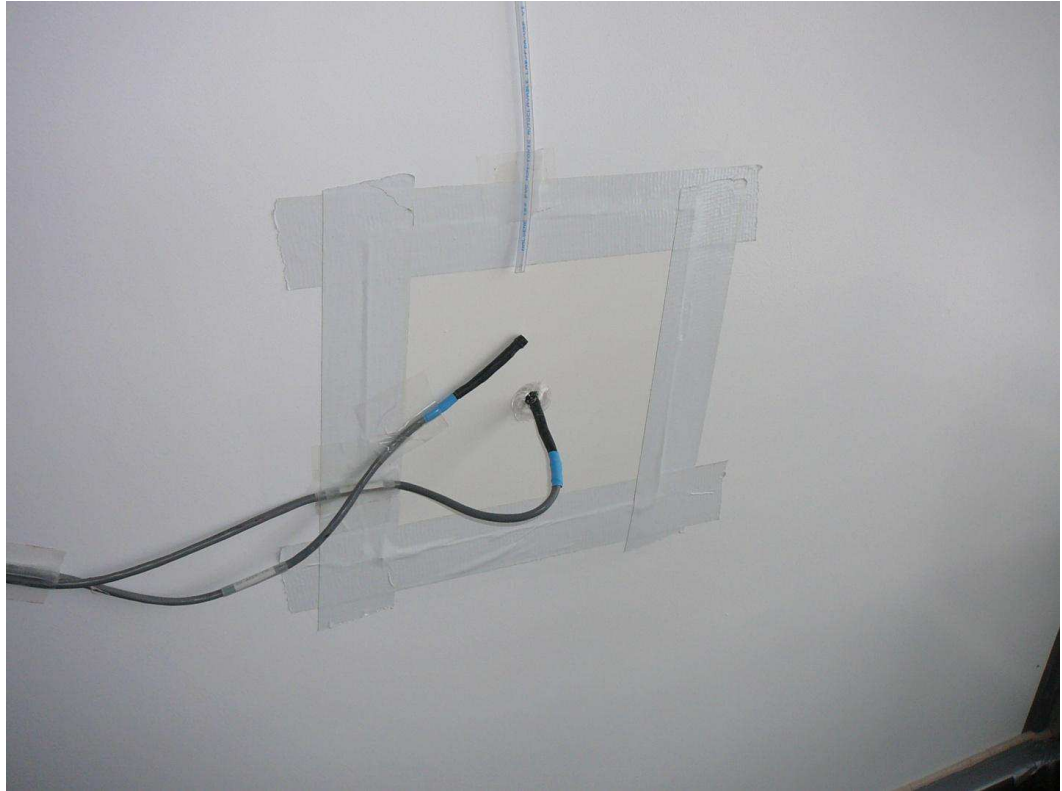
Figure A-70. Installation of the drywall access panel on top of the heat flux transducer, and repositioning of instrumentation (2 RH&T sensors and one pressure tap are shown).
