Evaluation of thermal and moisture response of highly insulated wood-frame wall assemblies: Part I: experimental trials in the field exposure of walls test facility – phase 1 and phase 2

Evaluation of Thermal and Moisture Response of Highly Insulated Wood-Frame Wall Assemblies – Part I:

Experimental trials in the Field Exposure of Walls test Facility – Phase 1 and Phase 2

Report A1-000444.5

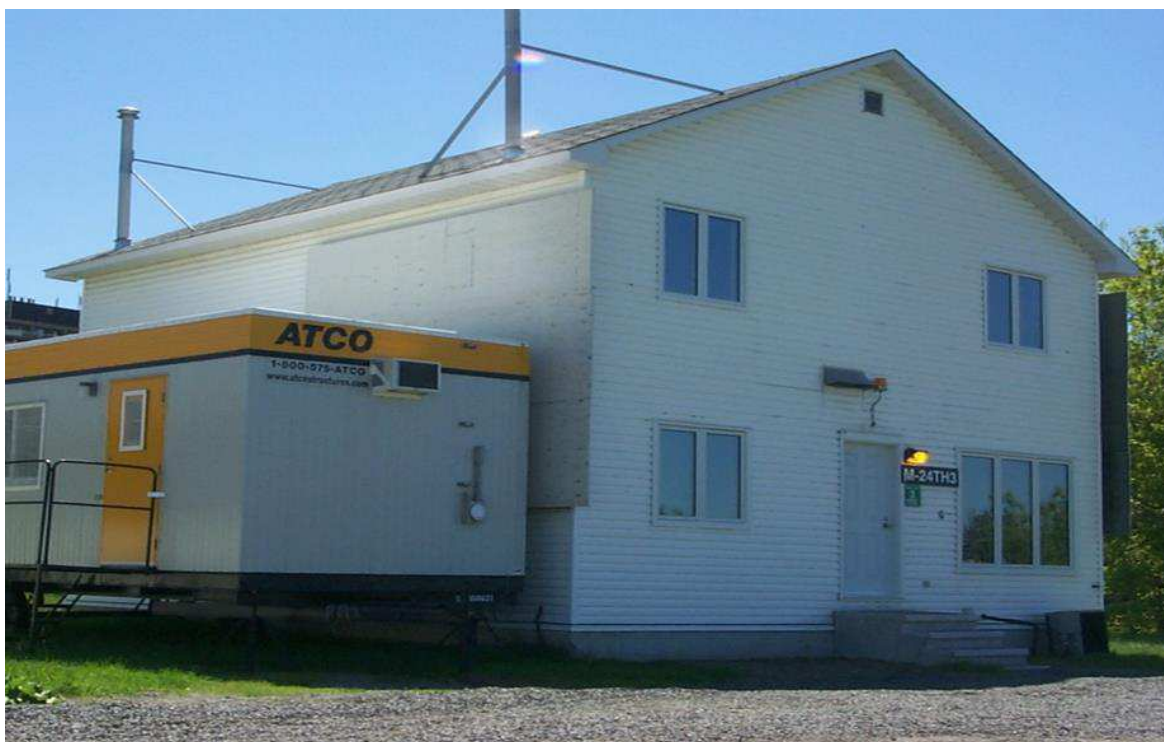
Figure 1. NRC-Construction's Field Exposure of Walls (FEWF) test facility, located at the NRC Montreal Road campus in Ottawa.

performing houses between baseline code to R-2000 levels. The wall assemblies were tested 3 at a time in NRC-Construction's Field Exposure of Walls (FEWF) test facility, shown in FIGURE 1, over a period of 9-months in a yearly cycle where the walls were exposed to outdoor conditions.

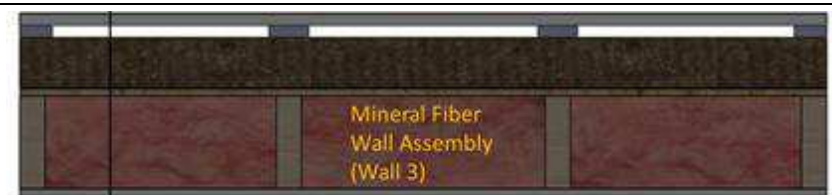
- Vinyl siding
- 1.5-in. x 7/16" thick vertical furring strips
- 76 mm (3-in.) semi-rigid mineral fibre insulation (exterior insulation)
- Sheathing membrane
- 11 mm OSB wood-sheathing
- 2x6-in. nominal stud cavity with R24 glass fiber insulation batts
- 6 mil poly air/vapour barrier
- ½ in. painted drywall

Figure 5. Wall 3 (W3: MF) - Horizontal cross-section through

wall assembly showing locations of Heat Flux Transducers (HFT)

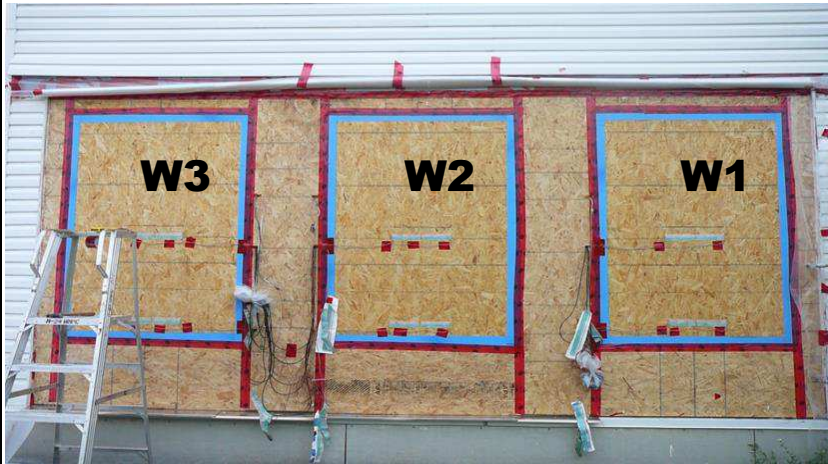
Figure 6. Installation of W1, W2, and W3 in FEWF showing exterior sheathing panel (OSB)

The sequence of installation of the primary wall components forming the exterior portion of the respective test specimens of Phase 1, and outboard of the 38 mm x 140 mm (2 x 6 in.) wood framing, is illustrated in Figure 6 to Figure 9. In Figure 6 is shown a state of fabrication where the exterior sheathing panel (OSB) has been installed for the different test specimens (W, W2, and W3); thereafter, as evident in Figure 7, the sheathing membrane overlaid the OSB panel. Following this sequence, and as is given in Figure 8, each of the different insulation products (25 mm EPS, 51 mm XPS, 76 mm MF) was installed atop the protective membrane. This was followed by the installation of wood furring strips to which was affixed the exterior cladding; this final installation sequence is provided in Figure 9, and in which is shown the vinyl siding.

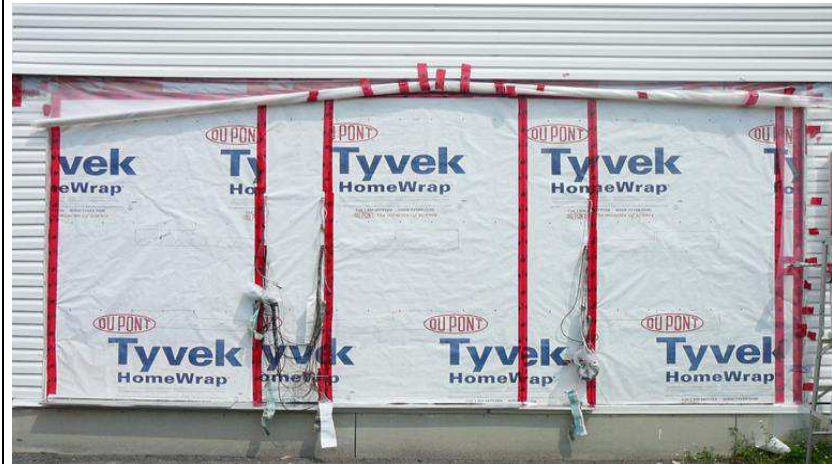
Figure 7. Installation of W1, W2, and W3 in FEWF showing sheathing membrane

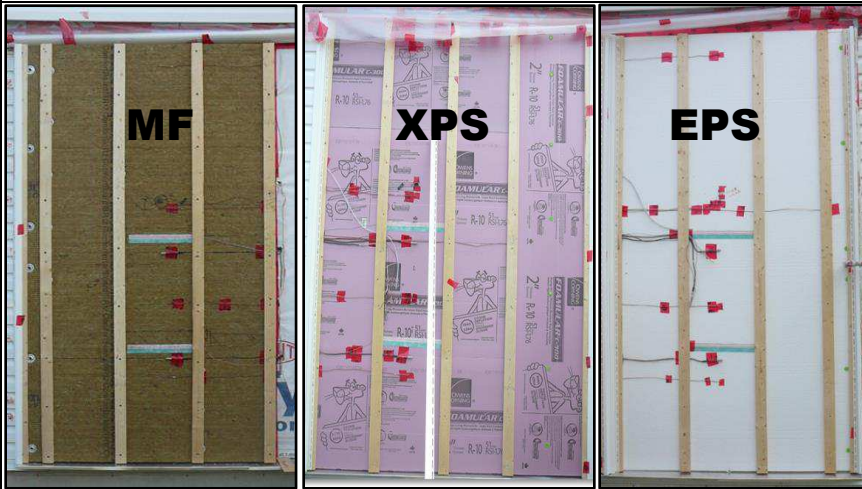
Figure 8. Installation of W1, W2, & W3 in FEWF showing respective insulation panels including EPS (W1), XPS (W2) and MF (W3)

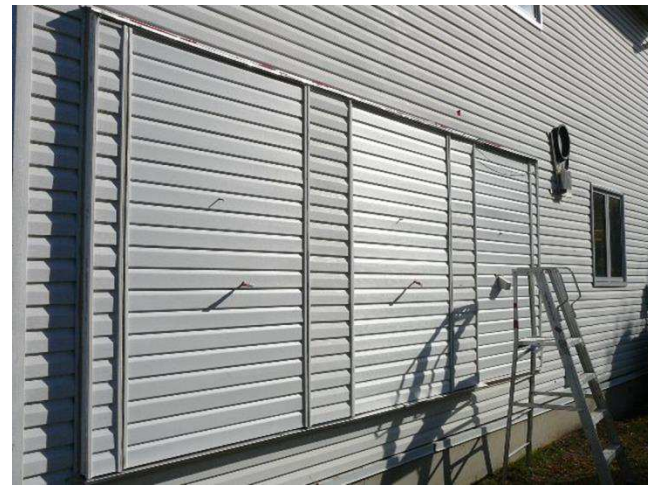
Figure 9. Installation of W1, W2, & W3 in FEWF showing exterior cladding (vinyl siding)

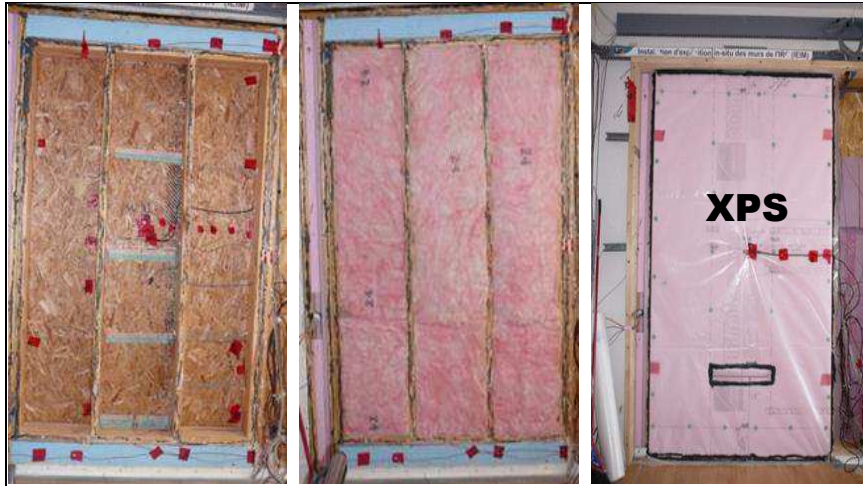
Figure 14. Wall 4 (XPS) – Interior wood frame prior to (i) & following installation GF batt insulation in stud cavities (ii), & placement of 51 mm of XPS insulation & PE vapour barrier (iii)

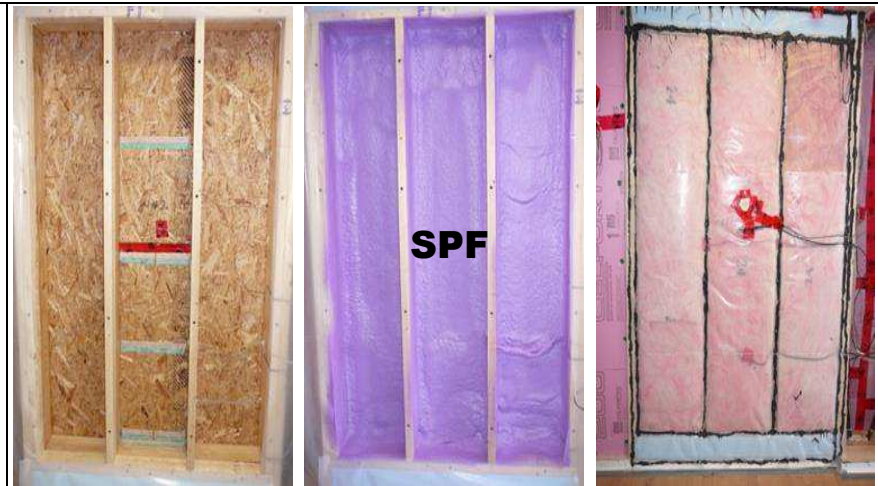
Figure 15. Wall 5 (SPF) - Interior wood frame prior to (i) & following installation SPF insulation in stud cavities (ii), & placement of 178 mm of GF insulation & PE vapour barrier (iii)

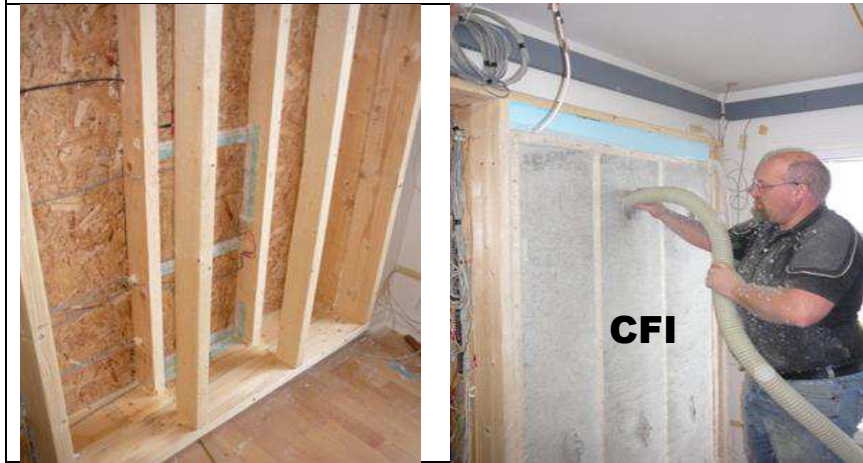
Figure 16. Wall 6 (CFI) Interior wood frame prior to (i) & following installation of cellulose fibre insulation in stud cavities (ii), & PE

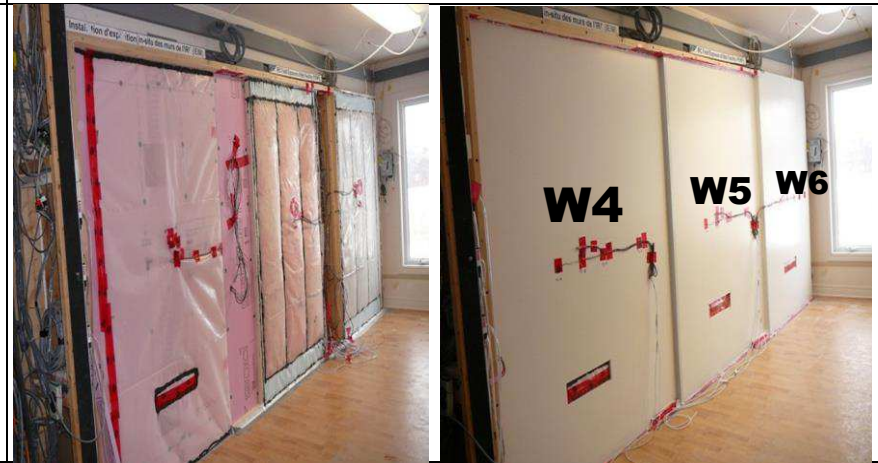
Figure 17. Interior of FEWF showing W4 (XPS), W5 (SPF), and W6 (CFI) prior to (i) & following (ii) installation of interior drywall

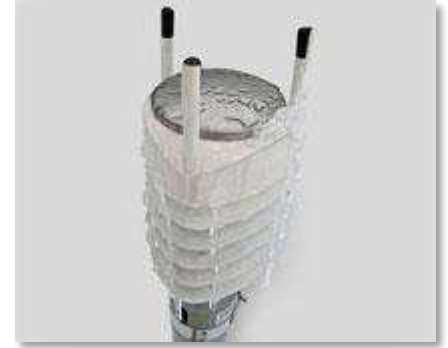
Vaisala Model WXT

A local weather monitoring device (Vaisala Model WXT 510), that included a rain gauge, sensors for air temperature, relative humidity, air pressure, wind speed and wind direction, was installed in close proximity to the wall specimens and provided information on hourly ambient exterior conditions. The combined package permitted determining the response of the respective wall assemblies to changing weather conditions over hourly, daily and seasonal periods.

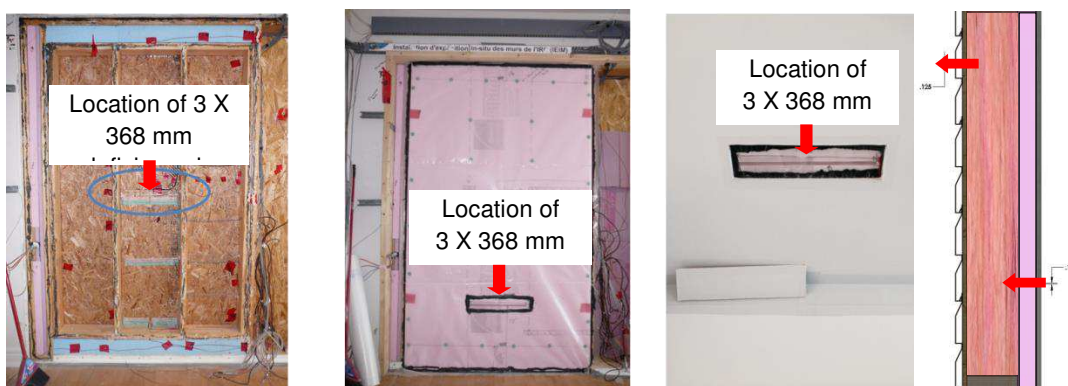
**Figure 18 – Deficiencies in wall test specimens showing location & size of deficiency in W4 (XPS)****Table 5 – Air leakage (ξ) characterization of test specimens**

Deficiencies in the wall assembly — Each test specimen included a deficiency through which air from the interior was meant to exfiltrate through the test specimens. The size and location of the respective deficiencies are shown in Figure 18. Pressure differences across the assemblies, occurring either naturally or through forced air flow to the interior enclosure, induced the flow of air through the deficiencies as suggested in the schematic on the right of the photos in Figure 18. The location of the deficiencies at the interior of the test specimens and at the exterior sheathing panel, in principal, permitted a path for air to flow. The air leakage rate at several different enclosure pressures for each of these deficiencies was determined the results of which are given in Table 5. These are given as the leakage rate (L/min.) as a function of pressure difference (Pa) in the exfiltration mode. The coefficients for the best fit equation are given for each test wall as is the degree of fit (R^2). Of importance are the values of air leakage at the exfiltration mode when the deficiencies were present in the walls (Period B-“Deficiency state”).

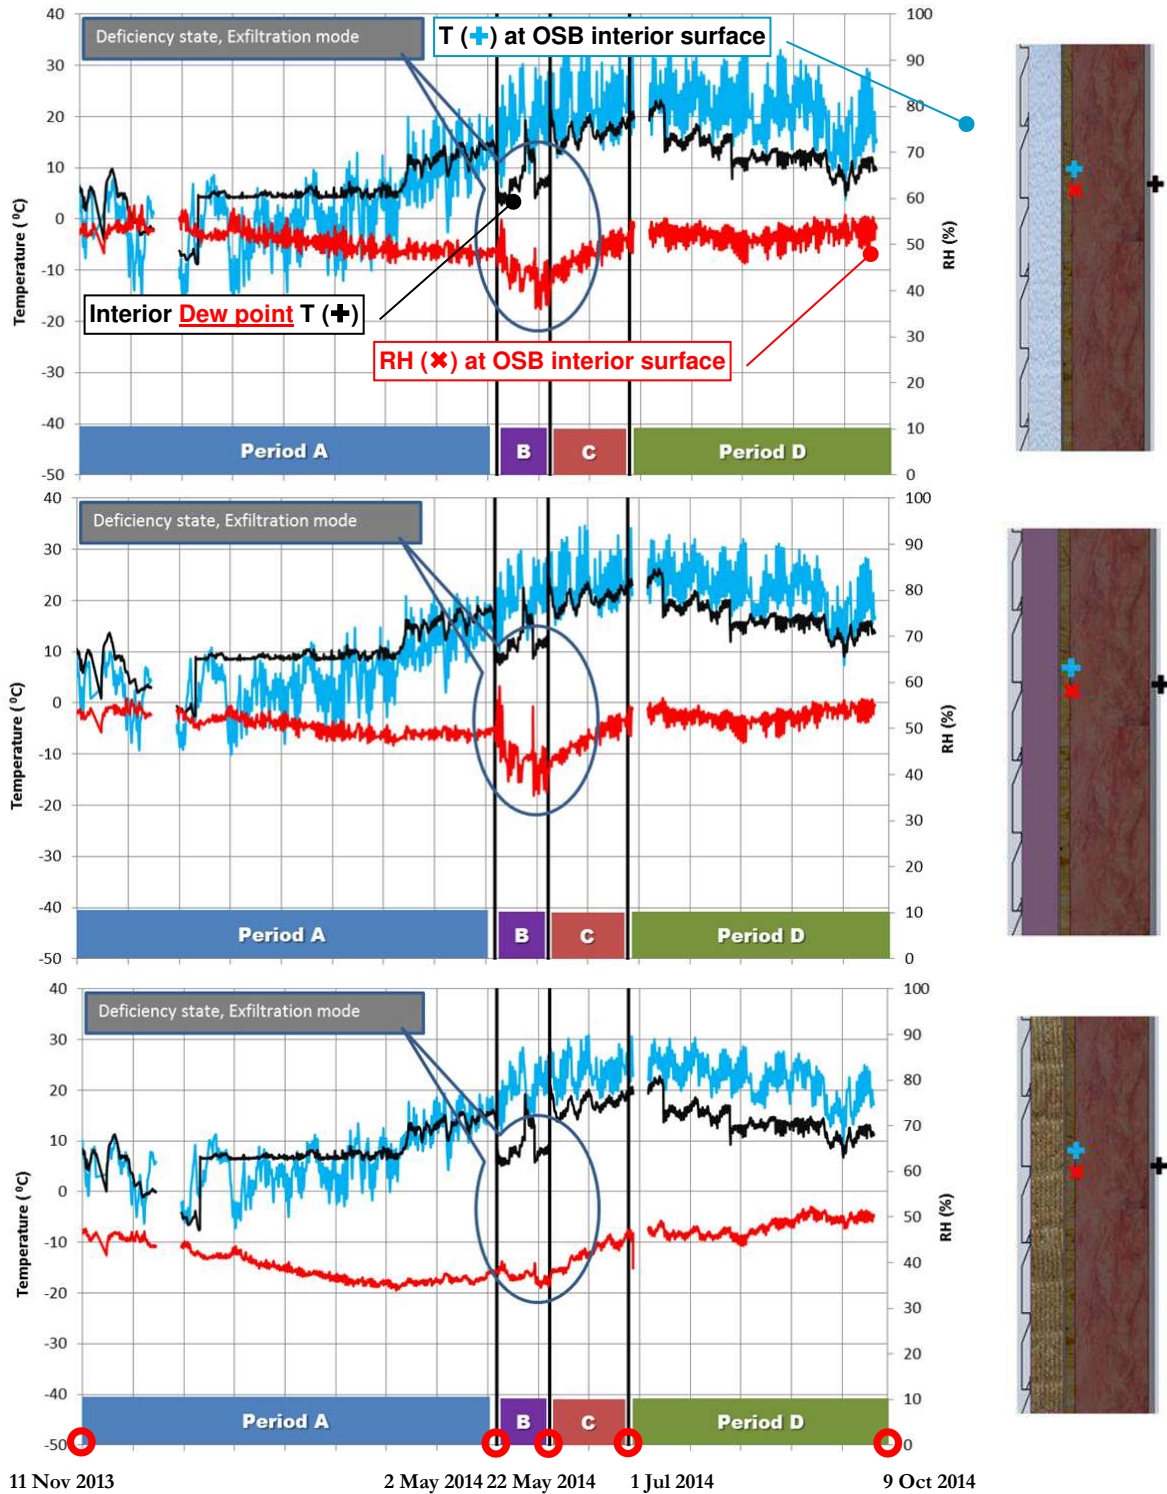
Figure 19 – Response of respective wall assemblies (Temperature [T]; RH at interior OSB surface and dew point T) over monitoring period (2013/14); (i) W1 (EPS); (ii) W2 (XPS); (iii) W3 (Mineral fibre)

The hygrothermal response of those test specimens evaluated in Phase 1 over the monitoring period of ca. 11 months is shown in Figure 19 for the respective test specimens: (i) W1-EPS; (ii) W2-XPS, and; (iii) W3-MF. The location of the temperature and relative humidity sensors for which values are provided in the figure are shown in the diagram adjacent to the plots. In the plot of Figure 19 the values recorded for the interior surface temperature and relative humidity of the OSB sheathing panel at mid-height of the wall are shown over the 4 periods of the test protocol (i.e. A, B, C, and D). The daily fluctuations in temperature of both the interior surface of the OSB and well as the interior dew point temperature are superimposed on the seasonal variations; the OSB interior surface gradually rise from below zero °C to upwards of 25°C with maximum values attaining > 30°C in Period C (May -July) and the beginning of period D (July-August). The relative humidity at the interior surface of the OSB panel varies over the monitoring period between ca. 55% and 35%, the lowest values being recorded during period B of the monitoring program.

Period B of the monitoring program was intended to bring about occurrences of condensation within the wall assembly. As noted in Figure 19, this was the “deficiency state” when warm moist air from the interior was to exfiltrate to the exterior of the test specimens under forced flow conditions. Period B was completed over a three week period at the beginning of May (2 May to 22 May 2014). This being the case, and given that the surface temperature of the interior of the OSB sheathing panel had already attained a minimum temperature of ca. 7°C, it was unlikely that any surface condensation would occur given as well that this surface temperature was well

above the interior dew point temperature. Consequently, no condensation was induced in this period for any of the walls tested. Then again, neither was any condensation evident for any of the walls over all other periods monitored in Phase 1; this was also visually verified when the walls were taken down following the end of Phase 1.

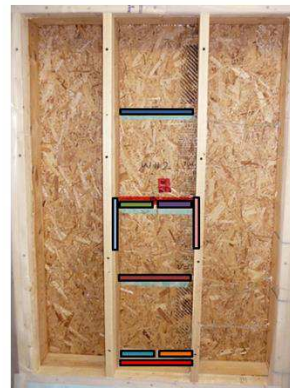
Figure 24– W5: Response of moisture detection strip to the presence of moisture in the wall

The information provided in Figure 24 shows the response of electrical resistance to the presence of moisture at locations provided in the figure. The increase in values for conductivity during period B denote the presence of condensation whereas the dissipation of moisture from the same locations in Period C is evident from decreases in values over time; no moisture detected in Period D as was the case for W4. This implies that all moisture that was deposited in the wall over this period could readily dissipate; this is the same response as was found for W4.

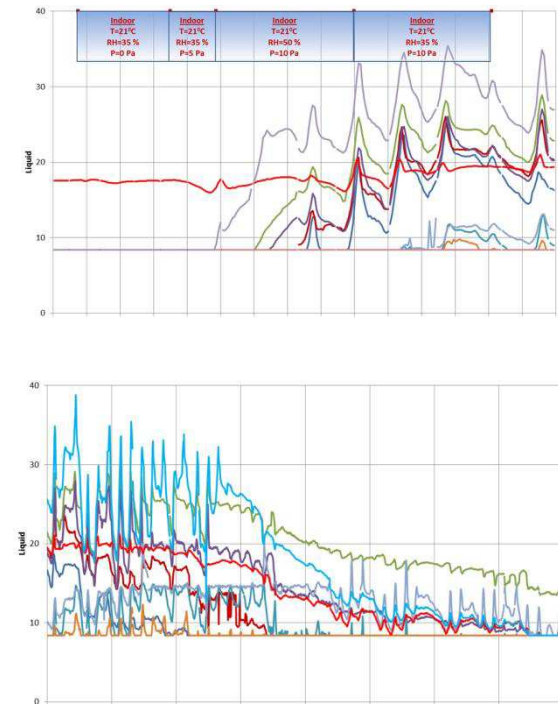
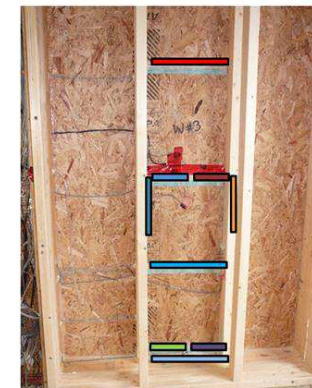
Figure 25– W6: Response of moisture detection strip to the presence of moisture in the wall

The information provided in Figure 25 shows the response of electrical resistance to the presence of moisture at locations provided in the figure. During period B the increases in values for conductivity denote the presence of condensation; this is a similar response as that determined for W4 and W5. The dissipation of moisture from the same locations in Period C is evident from decreases in values over time; no moisture detected in Period D as was the case for W4 and W5. Again, all moisture deposited in the wall over this period could readily dissipate indicative of the same response as was found for W4 and W5.
