APT Bulletin, 30, 2-3, pp. 67-73, 1999

Designing a Test Blasting Program for an Underground Building on Parliament Hill

MARÍA INÉS SUBERCASEAUX, GERRY PERNICA, and MARCUS V. VAN BERS

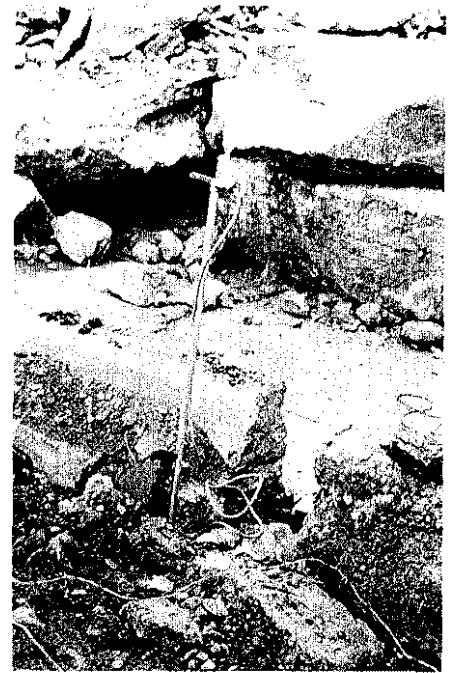
Fig. 4. Sensors installed on the sidewalk near the Centre Block building assessed the effects of blasting on the ground. Photograph by Maria Inés Subercaseaux.

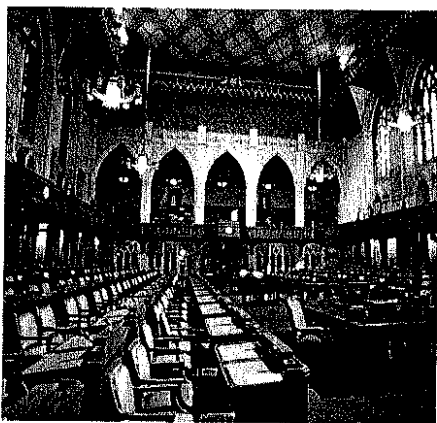
Fig. 5. The interior of the House of Commons, Centre Block, Parliament Hill, 1998. During the test blasting, stained-glass windows and decorative elements had to be monitored by NRC and Golder VMC for blast impact. Photograph by Jean-Pierre Jerome.

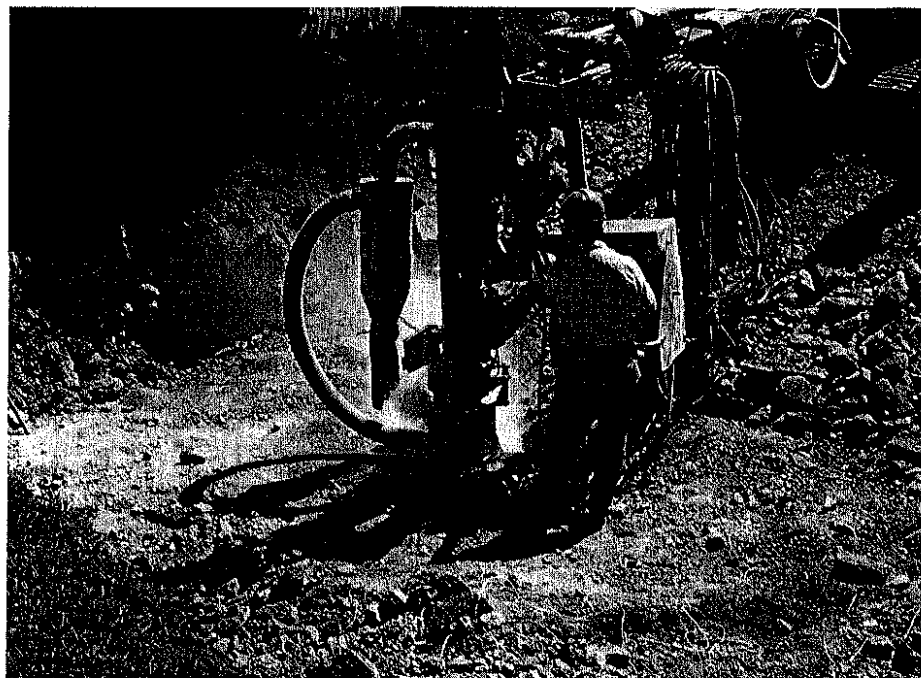
Fig. 6. Blasting areas outlined in Fig. 3 had to be marked on the ground. Grass was removed, boundaries delineated, and the sites were prepared for the installation of cartridge explosives. Photograph by Maria Inés Subercaseaux.

Ten controlled blasts were detonated at each blast site between August 12 and 23, 1996. Each blast involved detonating between 10 and 15 50-mm diameter holes in lifts (depth of blast) of 1.0 to 2.0m. Each blast consisted of a series of smaller blasts, produced by the action of delay detonators attached to each of the holes. Non-electric millisecond detonators were used because of the presence of radio towers, wireless radios, and cellular phones and to minimize charge weights (amount of explosive material) per delay. Various timing delays were tried to determine the influence of delay time on the vibrational response of adjacent structures. Cartridge explosive products were also used to avoid inaccuracies in the accounting of explosive material within each blast delay (Fig. 6).

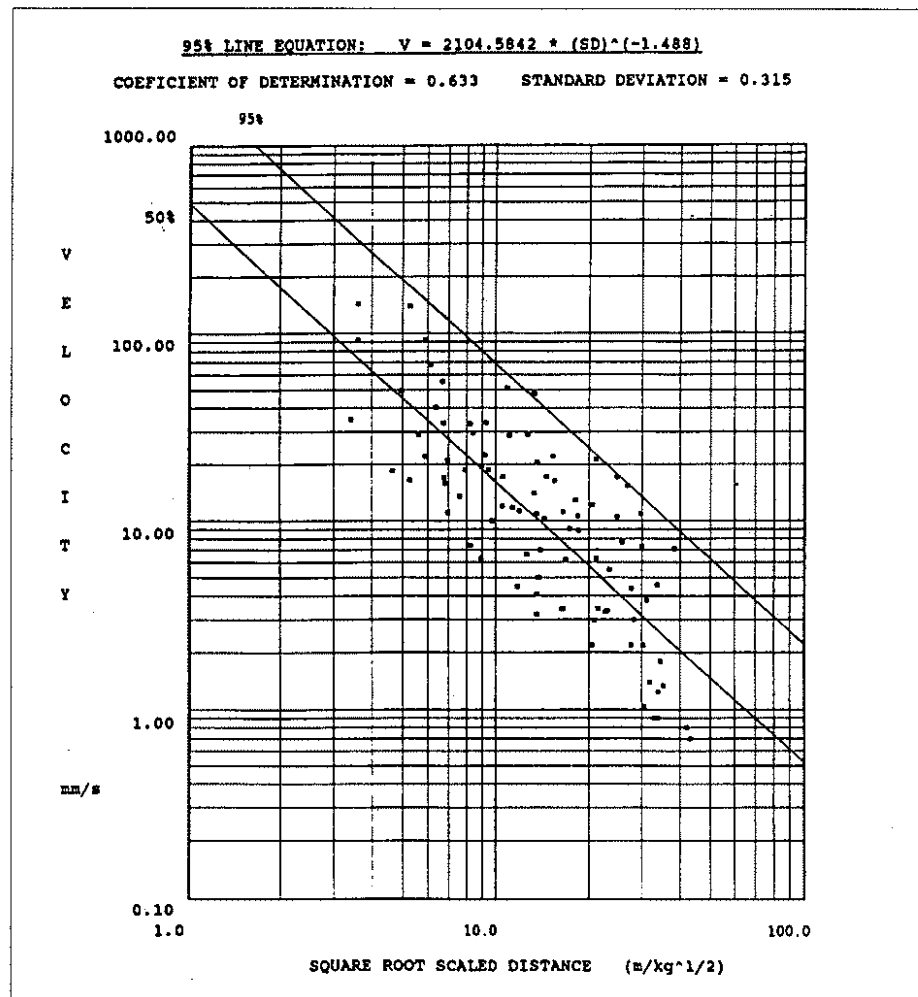
Fig. 7. Ground vibration attenuation characteristics. Courtesy of VME Limited.

Ground attenuation. A scaled-distance relationship, which describes the rate at which ground vibration levels at the CBUS site decay with increasing distance from a blast, was established from the monitored subsurface responses (Fig. 7). The regression line, which was obtained from the set of bedrock responses, was expressed as $PPV = 2104(SD)^{-1.488}$, where PPV = peak particle velocity (mm/s), SD = scaled distance ($d/W^{0.5}$), d = distance in meters from blast, W = charge weight (weight in kg of explosive material per delay).
