Vulnerability assessment of reinforced concrete structures for fire and earthquake risk Mostafaei, H.

Handbook of Seismic Risk Analysis and Management of Civil Infrastructure Systems, pp. 366-386, 2013

17 Vulnerability assessment of RC structures in fire and earthquake

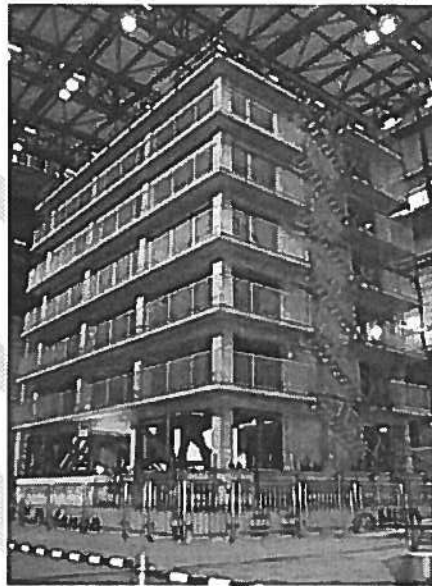
Figure 2. The reinforced concrete wall-frame building specimen.

This section explores a case study to provide a better understanding of how structures would perform in such a full burning scenario, following an earthquake. The case study investigates the vulnerability of a six-storey building to a fire following an earthquake using a numerical analysis tool. The building was in fact tested in January 2006 under a seismic load representing the 1995 Kobe Earthquake ground motion, using the large scale shaking table facility in Miki (or Hyogo), Japan. Since detailed information and experimental results of the test were available, this is a suitable example to be investigated for the scenario of fire after an earthquake. For this purpose, it was assumed that the building structure has undergone a fire following the tested earthquake. Performance of the building in the hypothetical fire was simulated by carrying out a numerical analysis. The six-storey building was made of reinforced concrete. Figure 2 shows the building on the shaking table after the earthquake test.

The six-storey nearly full-scale reinforced concrete building has a total height of 15 meters, (Kabeyasawa et al. 2005). The building was previously tested on a shaking table under the 1995 Kobe ground motion at the E-Defense Miki (or Hyogo), Japan. Details of the structural system, dimensions, and material properties can be found in Kabeyasawa et al. (2005). Figure 2 shows a picture from the building specimen on the shaking table.

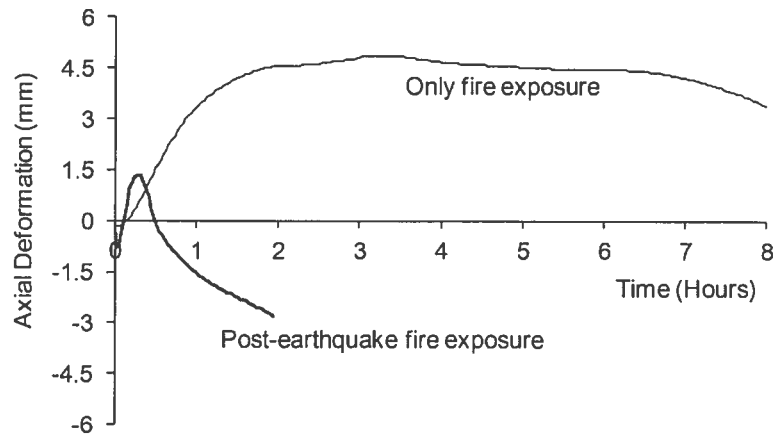
Figure 6. Axial deformation capacity response of a short column in the ground floor

Figures 6 and 7 show the results of the fire resistance response for the short corner columns in the first floor, Axis X1, of the building before and after they were damaged by the earthquake. Based on the results of this case study, following remarks can be made:

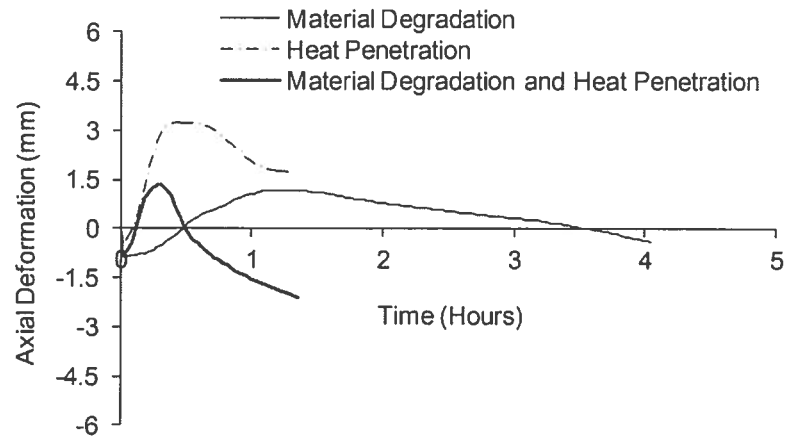
Figure 7. Axial load capacity response of a short column in the ground floor subjected to post-earthquake fire showing effects of material degradation/heat penetration on the response

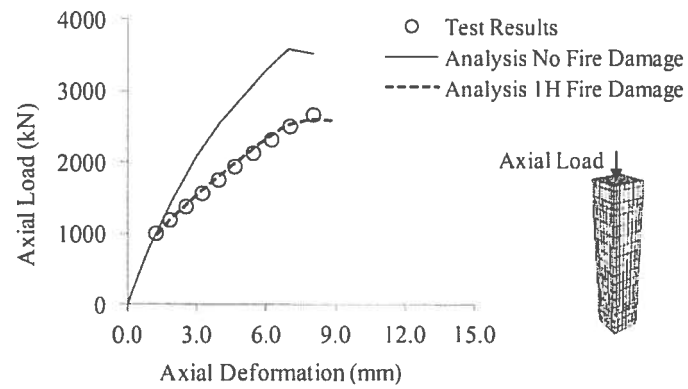
(a) Column A

(b) Column B

Figure 10. Axial load and deformation ratio relations: numerical and test results.
