*Proceedings 18th International Symposium on Ice, IAHR'06, 1, pp. 231-238, 2006-08-26*

## **RESPONSE OF TWO PIERS ON CONFEDERATION BRIDGE TO ICE LOADING EVENT OF APRIL 4, 2003**

**R. Frederking<sup>1</sup>, I. Kubat<sup>1</sup> and S. Prinsenberg<sup>2</sup>**

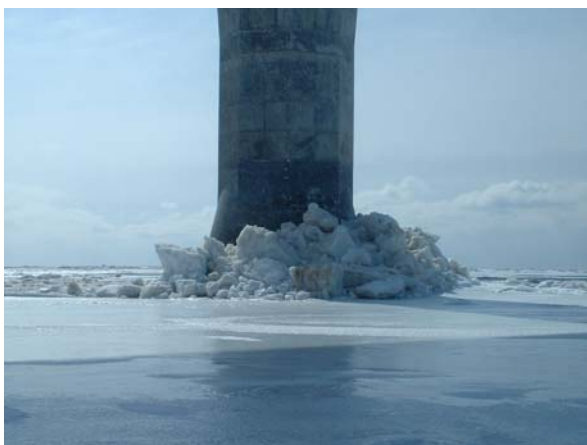
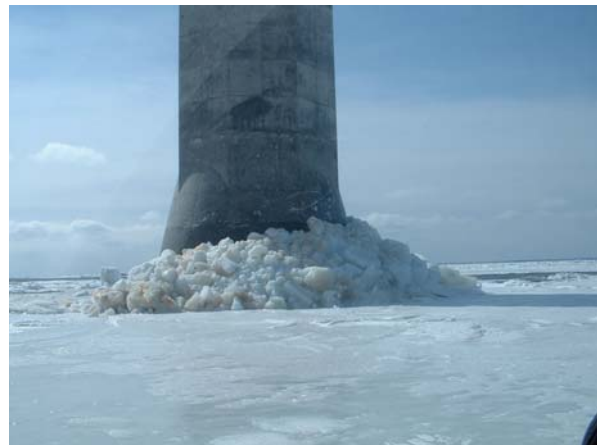
**Figure 11 Contrast of ice failing to produce large ice pieces (a) or small ice fragments (b)**

To illustrate that there were different failure modes against the piers, Figure 10 (a) shows a flexural type of behaviour with relatively large ice pieces, while Figure 10 (b) shows crushing behaviour with small ice pieces.
