### **Monitoring performance of corrosion inhibitors in a reinforced concrete bridge**

## MONITORING PERFORMANCE OF CORROSION INHIBITORS IN A REINFORCED CONCRETE BRIDGE

### Abstract

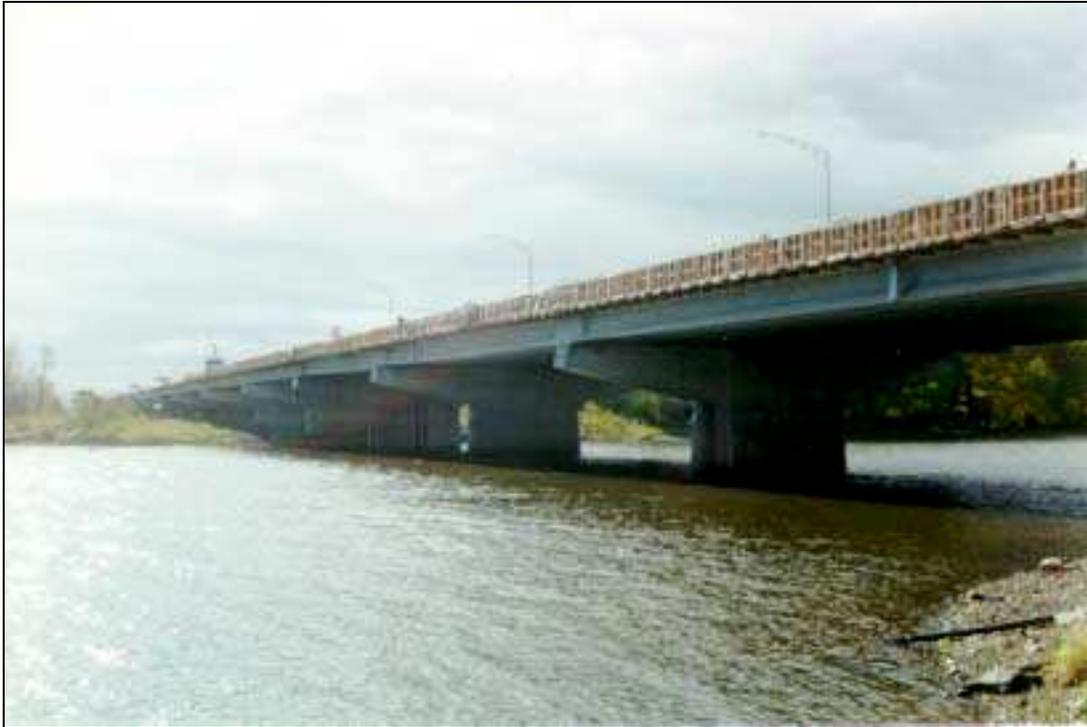
**Figure 1: Vachon bridge during rehabilitation in the summer 1996**

The structure selected is the Vachon bridge located north of Montreal (Quebec) on Highway 13 across Mille-Îles River (Figure 1). This 6-lane wide, 714-m long bridge includes twenty-one 34-m long single spans of prestressed concrete girders supporting a reinforced concrete slab. In 1996, the Ministry of Transportation of Quebec (MTQ) proceeded with the replacement of the deteriorated parapets, the patching of the concrete slab, and the replacement of its membrane and asphalt layer.

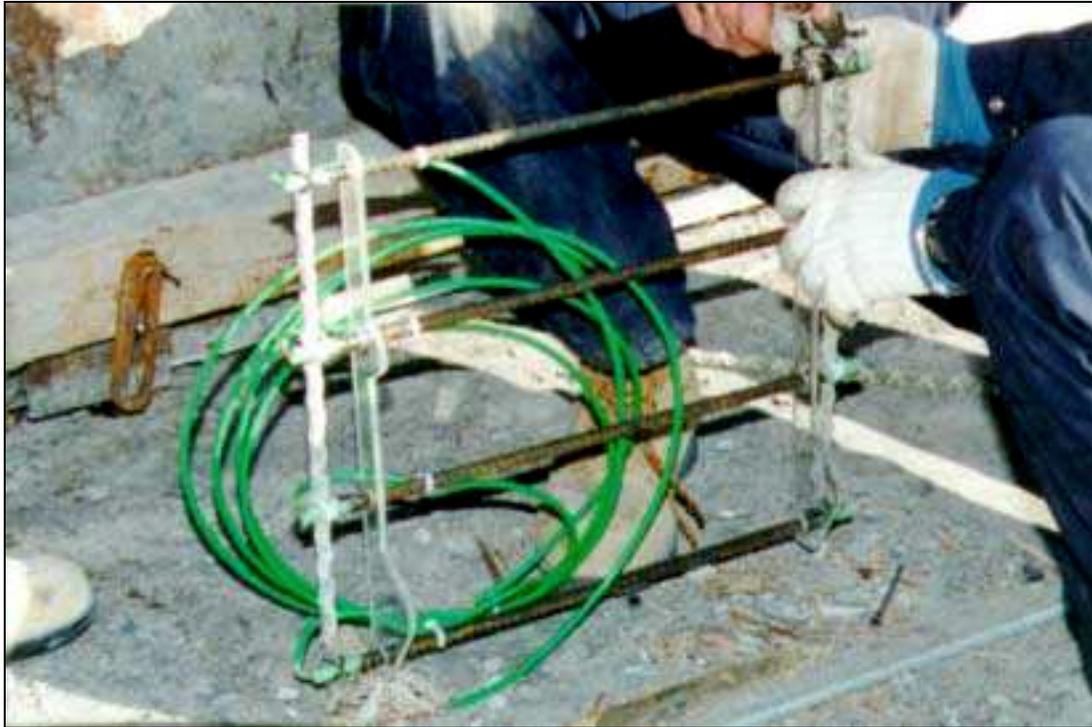
**Figure 4: Special rebar ladder before installation in the parapet form**

Since the concrete cover to the standard rebars in the parapets is 75-mm thick, it may take time before salt and moisture penetrate and initiate corrosion. To permit the earliest possible corrosion detection, rebar ladders with four steel rebars (rungs) and two plastic rails (verticals) were designed and built at NRC and embedded in the parapet (Figure 4). Two sets were placed near the traffic-exposed surface of each test span of parapet. Each set consists of four parallel 10-mm rebars measuring 470 mm in length and spaced at intervals of 125 mm; the top rebar being 125 mm below the top of the parapet. These rebars, with extremities epoxy-coated, were mounted on the rigid plastic rails supported on the inner surface of the front form of the parapet. The rails were designed to hold the bars in a horizontal position, parallel to the surface of the parapet, with only 13 mm of concrete cover for the upper bar, and 25, 38 and 50 mm, respectively, for the others. A copper wire was welded to each rebar as well, running to the rear of the parapet to permit the measurement of corrosion potential and corrosion rate during the annual on-site tests. These rebar ladders received the same anticorrosion treatments as those used on the corresponding test span. For the control spans, epoxy-coated bars were used in span 12, and uncoated bars in span 21.

The electrochemical potential of the steel rebars in the parapet is measured against a  $\text{Cu}/\text{CuSO}_4$  reference electrode. Readings are taken vertically at 110, 345, 550 and 780 mm from the top of the parapet and horizontally at 300-mm intervals over the central 15-m section of each parapet span. Locations of transverse cracks located in the grid area are noted. Half-cell potential readings are also taken at the center point of each bar of the two special rebar ladders installed in every test span of parapet (Figure 4).

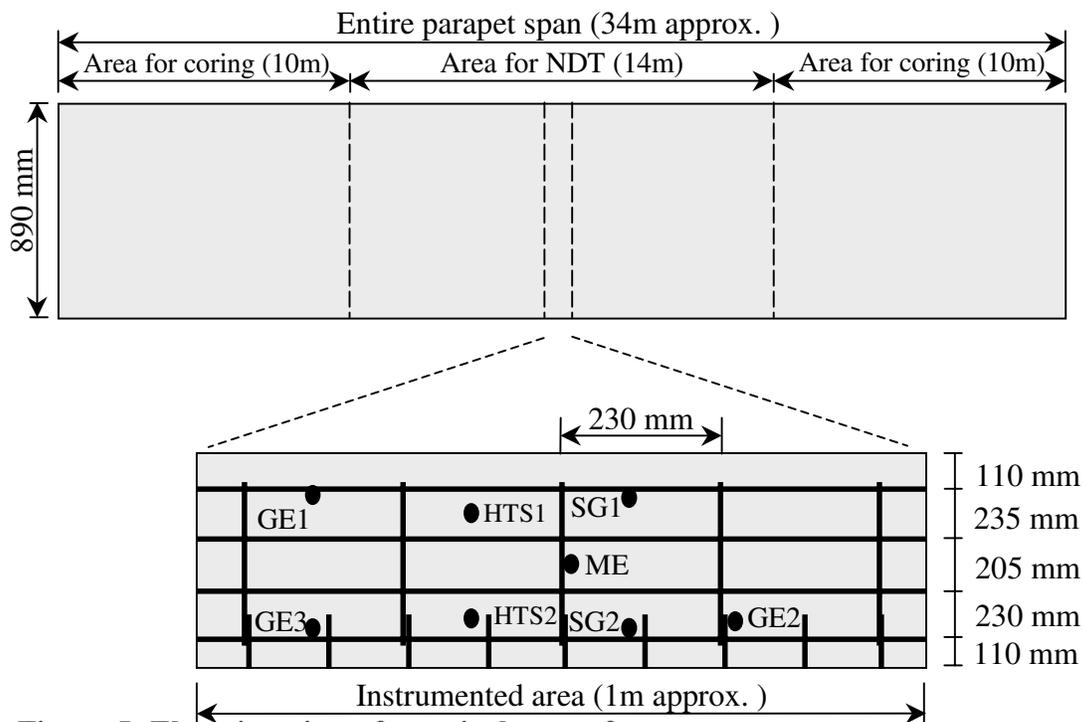
**Figure 5: Elevation view of a typical span of parapet**

The sensors were distributed along a 1-meter long section at the center of each of the 10 test spans (Figure 5). The manganese dioxide electrode is identified as ME, the graphite electrodes as GE1 to GE3, the RH and temperature sensors as HTS1 and HTS2, and the strain gauges as SG1 and SG2. Plastic rods/ties were used to secure sensors in place before casting so that no sensors are in contact with the rebars.

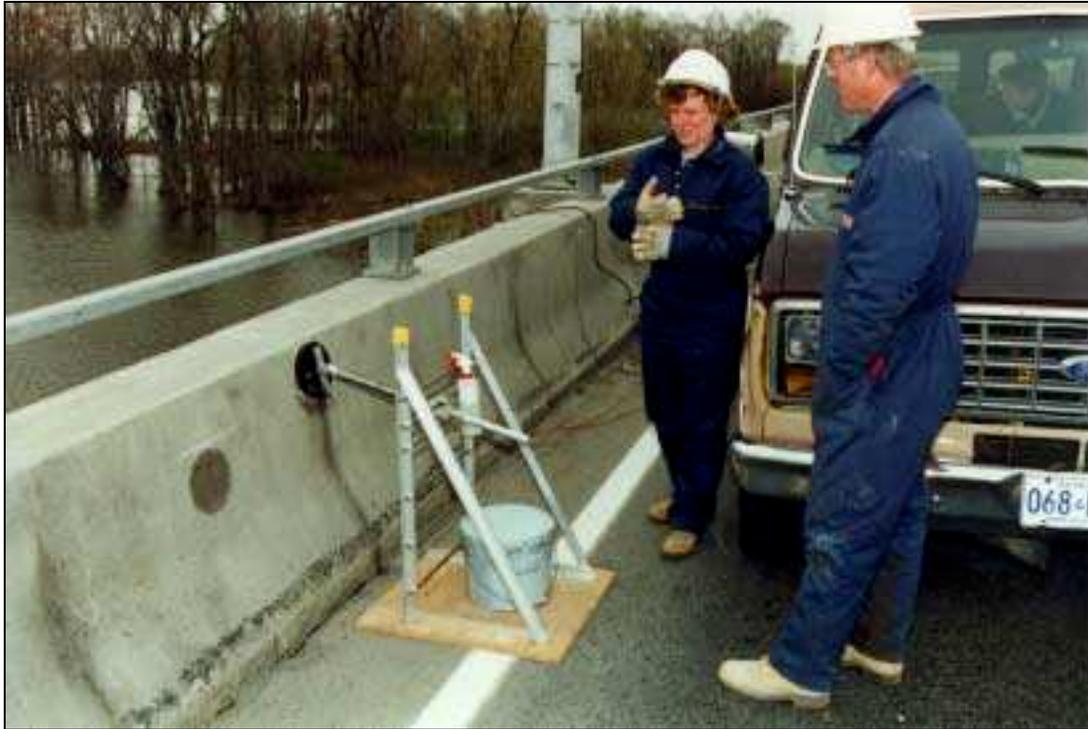
**Figure 6: Annual corrosion survey of the parapet front face**

Corrosion currents are measured using the linear polarization technique and the Gecor 6 equipment with a guard ring (Figure 6). As the guard ring confines the current to a known area, accurate measurements of the current density can be made.

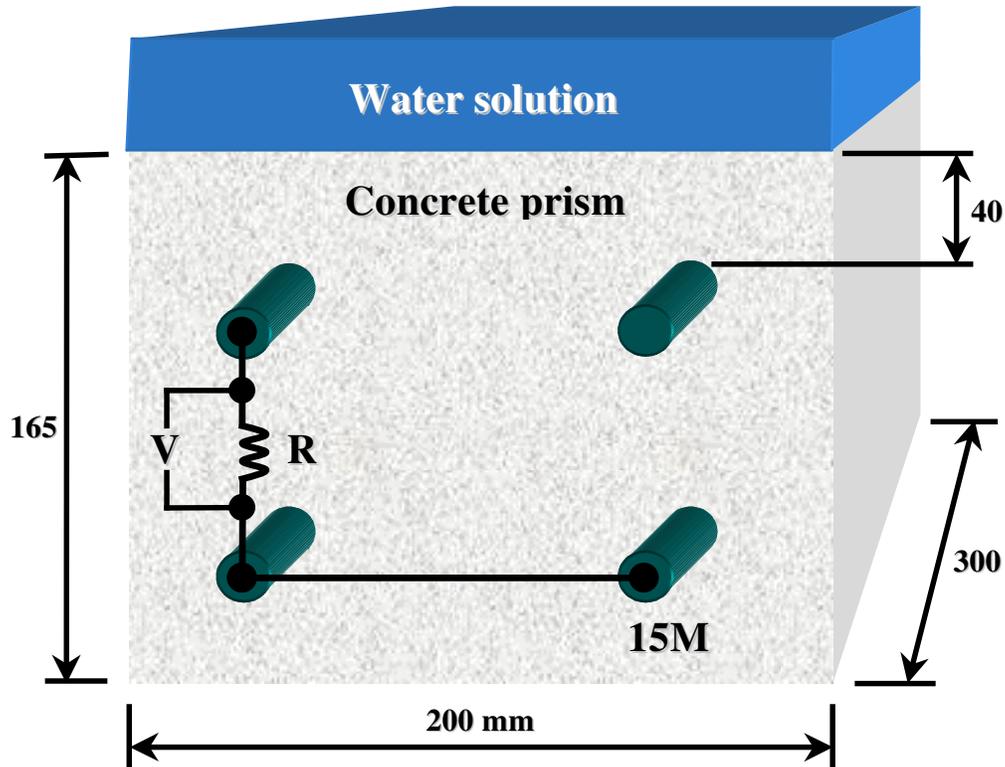
Figure 7: Typical reinforced concrete prism for accelerated corrosion lab study

As a complement to the on-site testing, NRC is also conducting accelerated laboratory experiments on the corrosion-inhibiting systems under study. At least 80 reinforced concrete prisms (a minimum of 8 per test span) were cast on site and returned to NRC laboratories (Figure 7). The top and bottom rebars on the left were connected with a wire of a known resistance to permit the current measurement while the two bottom rebars were electrically connected with a copper wire to induce a corrosion cell. The concrete prisms are kept in a controlled environment (50% RH, 22°C) and submitted to wet/dry cycles for periods of 28 days. Measurements of the electrochemical potential and the linear polarization resistance are taken monthly to monitor the corrosion progression with time.
