Thermal evaluation of a highly insulated steel stud wall with vacuum insulation panels using a guarded hot box apparatus

Moore, Travis V.; Cruickshank, Cynthia A.; Beausoleil-Morrison, Ian;
Lacasse, Michael

Journal of Building Physics, pp. 1-20, 2020-12-27

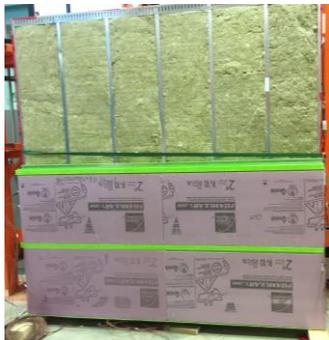
214 **Figure 1: Schematic of wall assembly layers. (a) shows the gypsum layer being installed over the steel**
 215 **studs and the vapour barrier; (b) shows a representative XPS-VIP-XPS sandwich panel; (c) shows a**
 216 **representative fiberglass clip (dimension in inches on tape measure); (d) photo showing mineral fibre**
 217 **insulation and sandwich panel install; (e) shows the complete wall assembly with 8 distinct XPS-VIP-**
 218 **XPS sandwich panels installed; and, (f) shows the wall assembly layers, wherein numbers are from**
 219 **Table 6.**

201 consisted of #8 self-tapping flat head screws spaced at 203 mm (8 in.) on centre around the
202 perimeter, and spaced 305 mm (12 in.) on centre along the height of interior studs. The materials
203 and dimensions used in the wall assembly are listed in Table 2 and a sketch of the layers of the
204 wall assembly is shown in Figure 1.

221 In Figure 1, layer 5 represents the XPS-VIP-XPS sandwich layer, which were made by adhering XPS

to the interior and exterior side of 600mm x 1200mm x 25mm VIP panels. The XPS layers were

223 added to the VIP panel to protect the VIP surface from coming in to contact with sharp or abrasive
224 surfaces in the wall assembly, including the surface and edges of the steel studs, the fiberglass
225 clips holding the panels in place, and the fasteners from the exterior strapping. There were eight
226 (8) sandwich panels installed in the wall assembly.

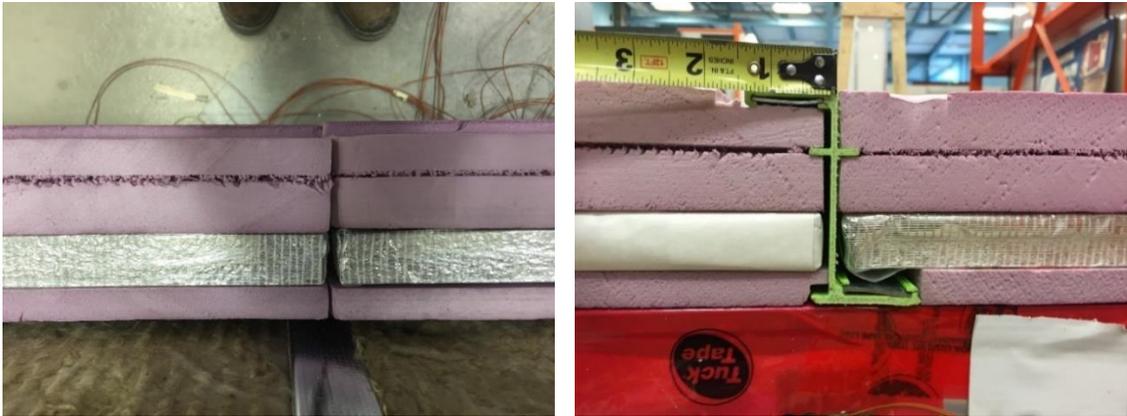
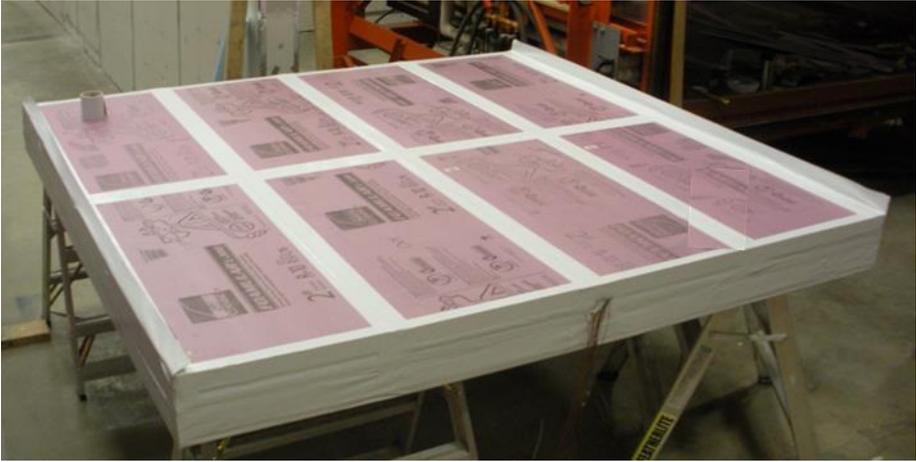
245 **Figure 3: Photos depicting the assembly air gaps that existed between XPS-VIP-XPS at the air joint**
246 **between VIP panels (a); the air joint at the fiberglass clips (b) (the tape measure is in inches); and the**
247 **taped exterior surface to eliminate air exchange with the cold exterior (c).**
248

232
233 Due to construction tolerances and the oversized XPS portions of the sandwich assembly, the butt
234 jointed panels resulted in slight air gaps. To eliminate the effect of the vertical air gap between
235 XPS panels, caulking was added to the vertical joints. Air gaps at the vertical VIP panel joint in the
236 centre of the wall assembly and between the VIP and the fiberglass clips were not filled. All seams
237 were sealed on the exterior surface with tape to ensure that air exchange did not occur between
238 these air joints and the exterior environment during testing. In addition, the air leakage of the
239 wall assembly was tested in a separate apparatus previous to the GHB test, which resulted in an
240 air leakage of the wall assembly of 0.033 L/s-m² at a pressure difference of 75Pa. The air leakage

241 tests were completed following the procedures in ASTM E2178 (ASTM E2178-13, 2013) adapted
242 for a full scale wall.
243 Representative photos of the butt joint, air gaps present in the assembly and the final taped
244 exterior surface are shown in Figure 3.

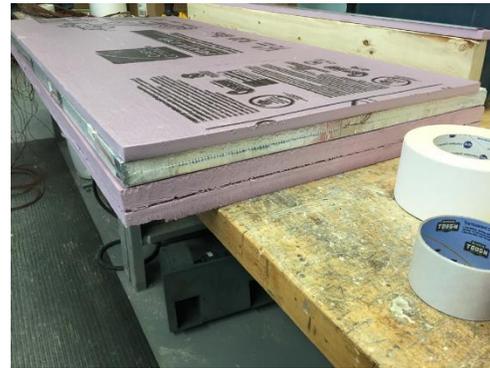
303 **Figure 6: The top left photo depicts the thermocouples instrumented on the VIP on the exterior (cold) surface**
304 **of the VIP (a). The top right photo depicts the sandwich panel assembly and shows the edge thermocouples (b).**
305 **The bottom photo is a graphical representation of the location of all thermocouples installed on the interior**
306 **(warm, ‘W’) surface, exterior (cold, ‘C’) surface, and edge (‘E’) of the VIP (c); the dashed grey lines represent**
307 **where the steel studs are located in proximity to the temperature sensors.**

300 The interior and exterior surfaces of a single VIP were instrumented to determine the difference in
301 temperature between the centre of the panel and edge of panel during the test. The thermocouple
302 locations for the VIP panel are shown in Figure 6.

376 A representative VIP panel was instrumented on the interior and exterior surfaces to determine the
377 temperature variation from centre of the panel to the edges. The results for each exterior temperature
378 location from Figure 6 is shown in Table 6.

Table 6: Interior and exterior VIP surface temperature for exterior temperatures of -35°C. The thermocouples are labelled for interior side (W), exterior side (C) and edge (E), numbers as per Figure 6.
