Test Report

TR-1993-06

NORTHUMBERLAND STRAIT ICE PROPERTIES MEASUREMENTS

F.M. Williams, G. Crocker and S. Butt

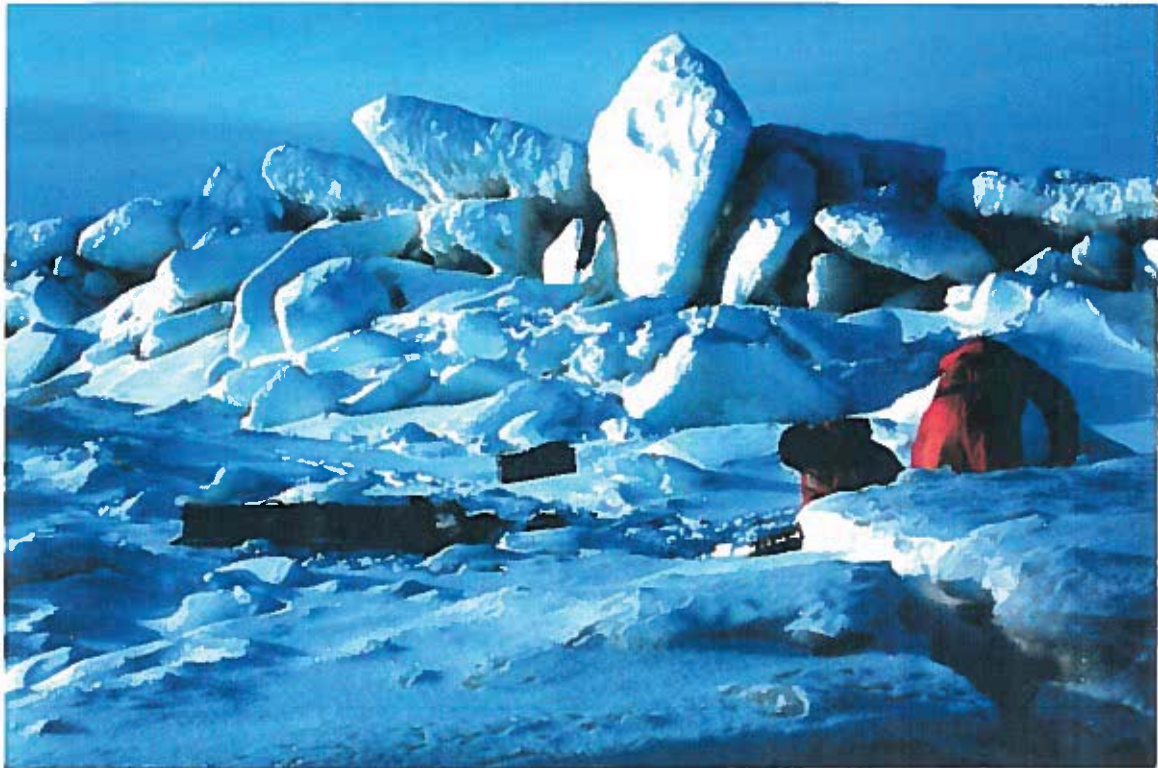
Rubble #4 sail with N-S axis viewed from SW near core site

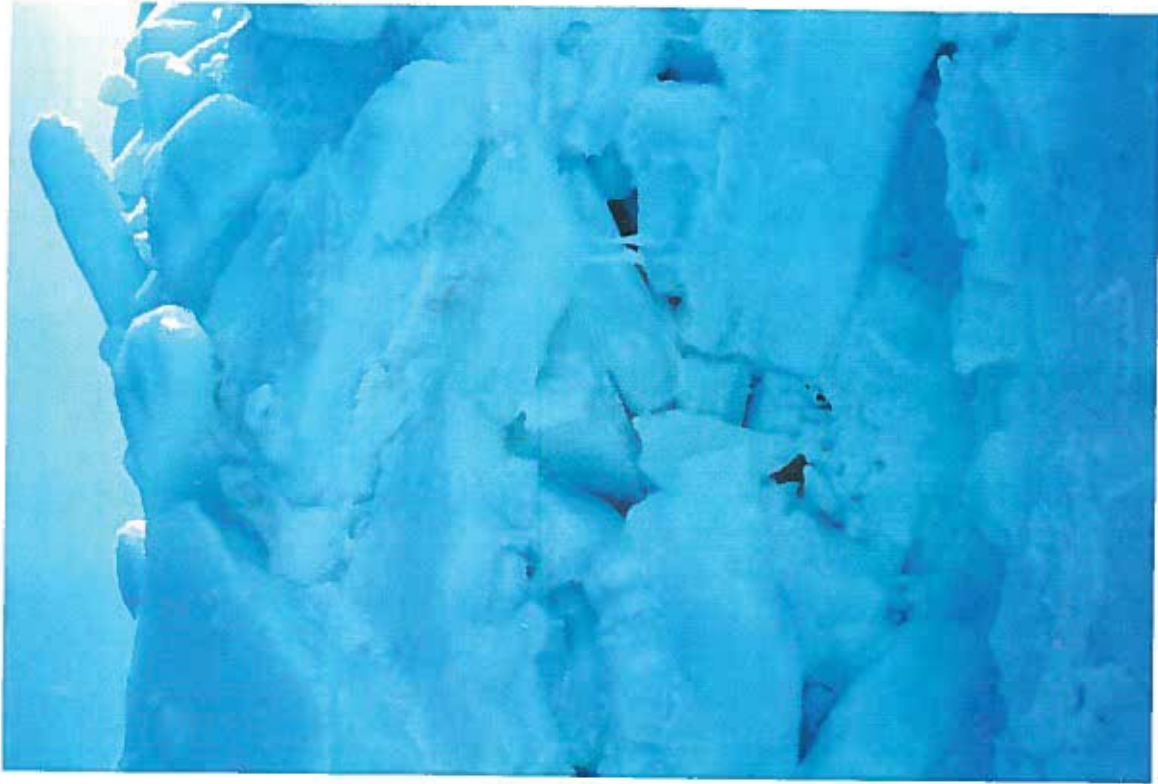
Rubble #5 sail, offshore face, showing ground ice packed between blocks

Although rubble pile growth is due principally to compression, shear activity in the ice produces distinctive rubble formations. As drifting ice pushes past a grounded rubble feature, it grinds away the offshore flange, leaving an almost vertical face on the sail-

keel beam (Photos 3, 4). On this face, the ice porosity is almost zero, because ground up ice has been forced between the larger blocks like mortar. If low temperatures follow a shear event, this compacted, drained face will consolidate quickly.

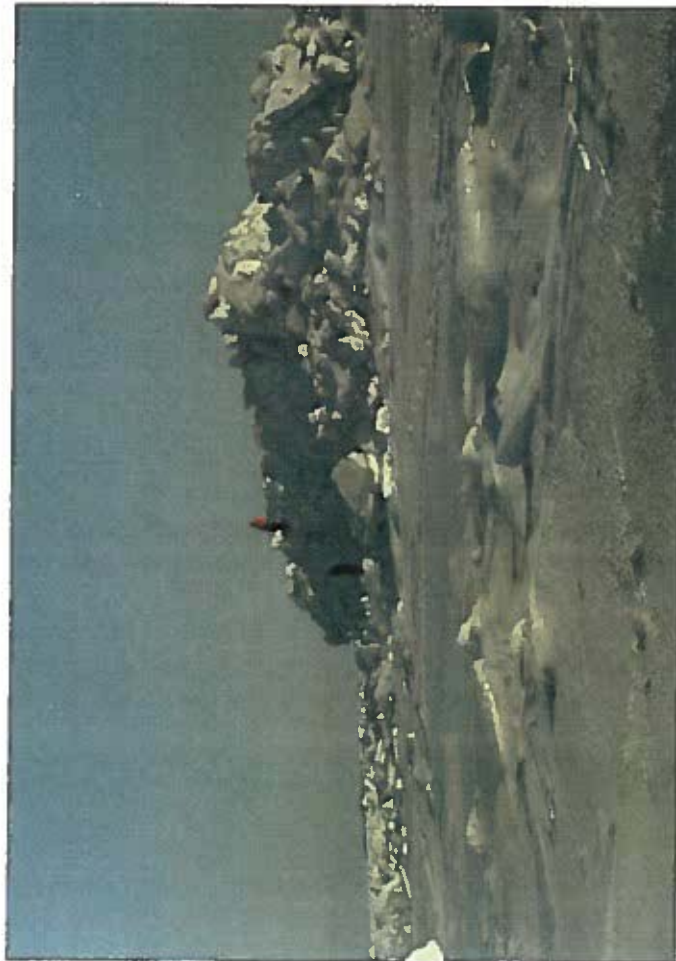
Rubble #5 offshore face of sail with N-S axis viewed from NE

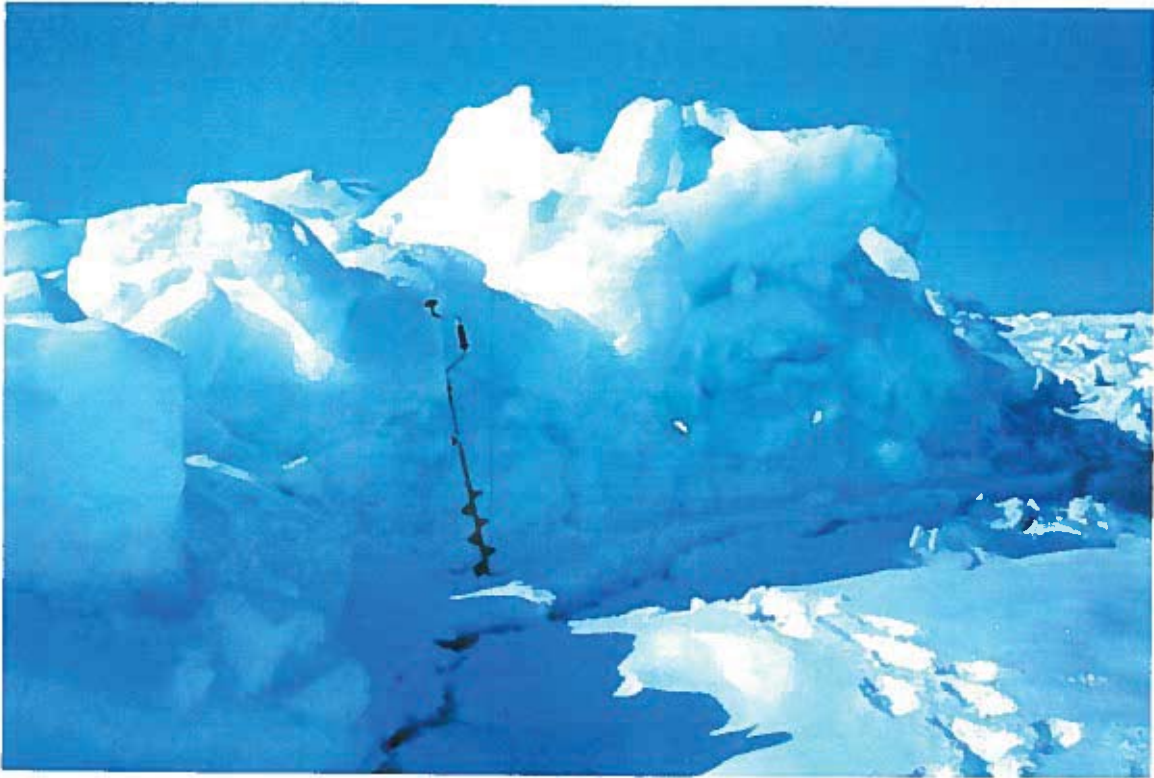
Rubble #3 offshore face of sail and adjacent level ice with tide crack

Once the rubble pile is established, landfast ice may extend to enclose it. Because of tides, cracks separate the grounded rubble from the adjacent floating ice, on both the inshore and offshore side. Occasionally, cracks appear in the rubble perpendicular to the long axis. These may also be due to tides, moving floating portions of the rubble relative to the grounded portions. If the area is still active, the ice on the offshore side may be buckled, submerged, or absent. (Photos 5, 6)

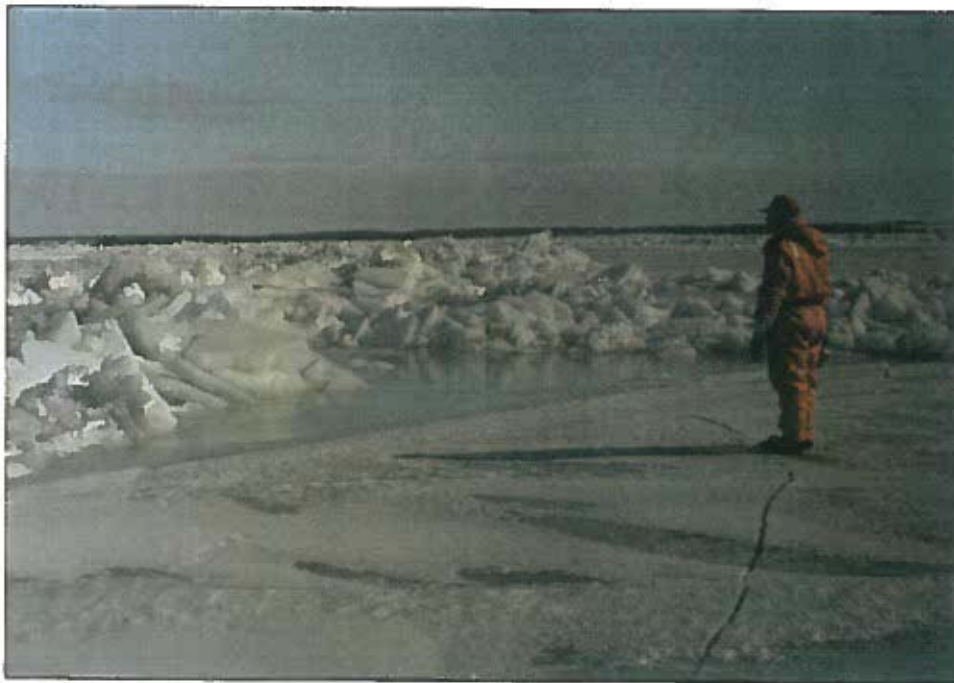
Rubble #4, submergence, flooding, and flexure crack in adjacent ice sheet

The ice sheet adjacent to the rubble pile is thickened by rafting and by spreading of the keel. The main body of the rubble pile is separated from the adjacent sheet by tide cracks, both inshore and offshore. These tide cracks are also activity sites, showing flooding, buckling, and shearing.

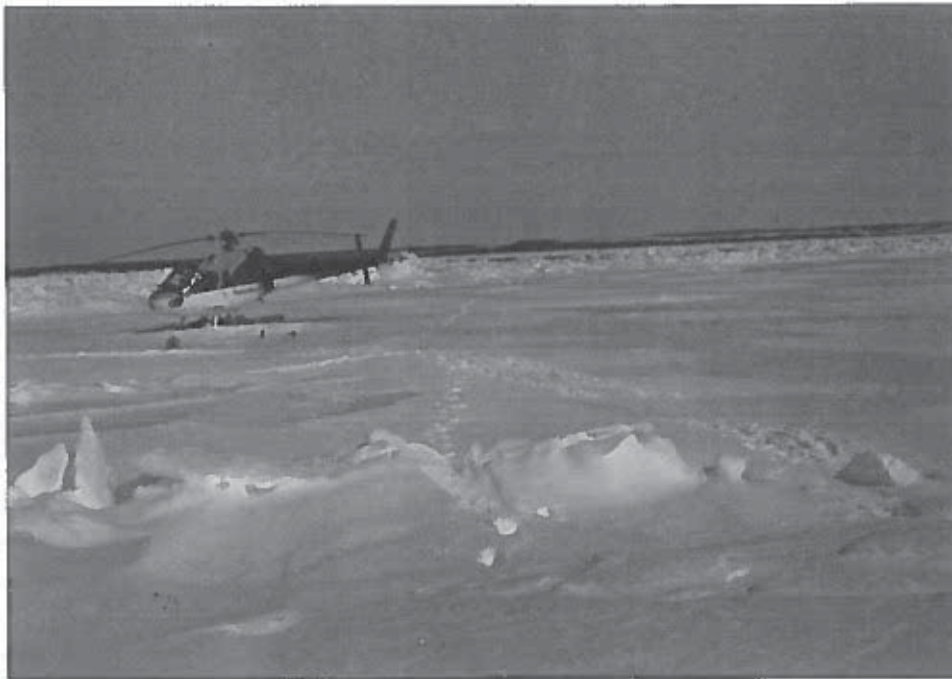
Floe #4. Foreground ice is rafted, 0.89 m thick; under helicopter is 0.47 m

A large percentage of the level ice is formed by the rafting and bonding of two or more simple ice sheets (Photo 7). Surface variations show that larger floes may also be formed by lateral adhesion of adjacent floes of similar thickness. This is probably more common earlier in the season, as the seams in these composites were usually packed with old snow (Photo 8).

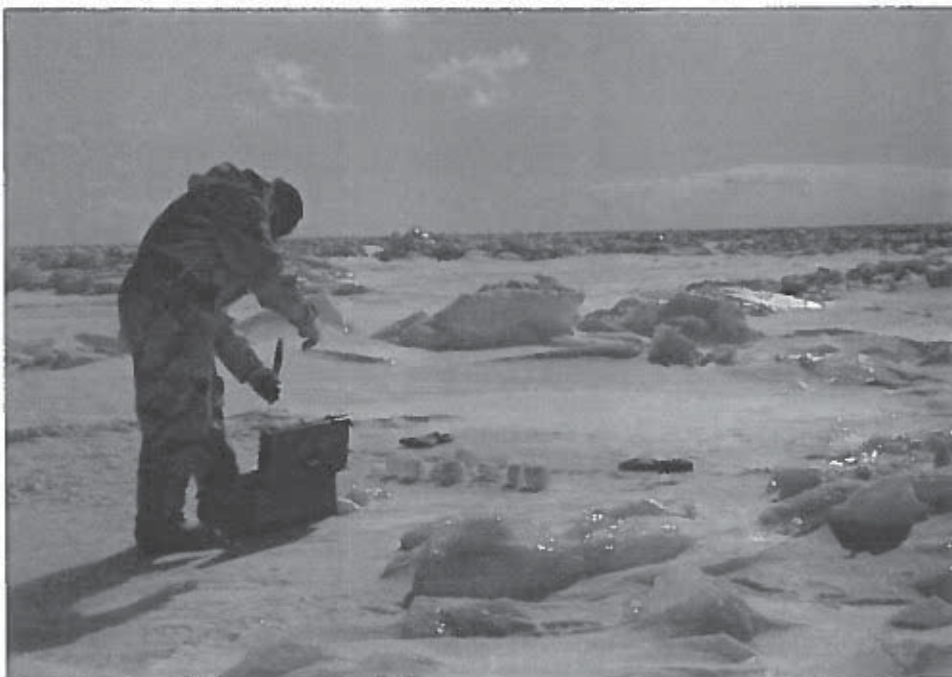
Floe #4 at core site, showing level sections and seams joining them

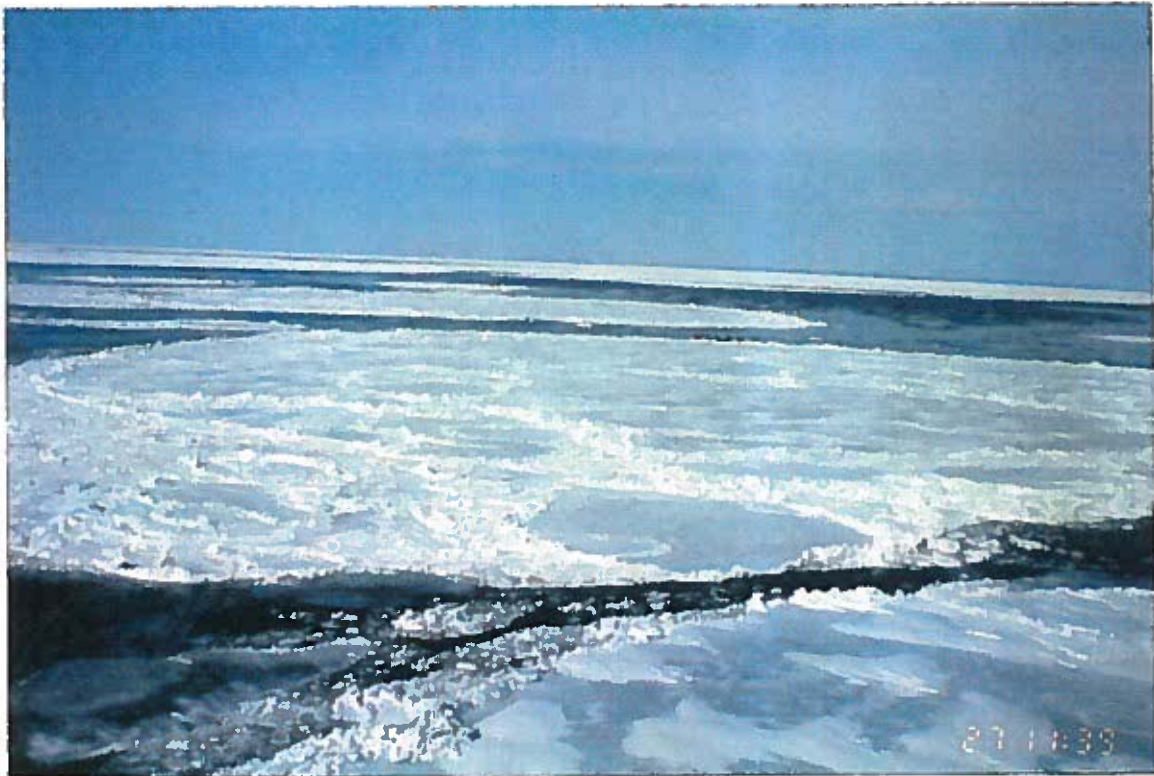
Summerside to Tormentine transect, large floes with open water and nilas

Since there is frequently open water in the Northumberland Strait, new ice is forming throughout the growth season. However, when the floe movements bring this new ice in contact with older, thicker ice, the new ice is broken up, forming a fresh ridge on the margin of the older floes. Hence, except for nilas, most of the ice in the strait was large floes such as those sampled, bordered and surrounded by fresh ridges and rubble (Photo 9).

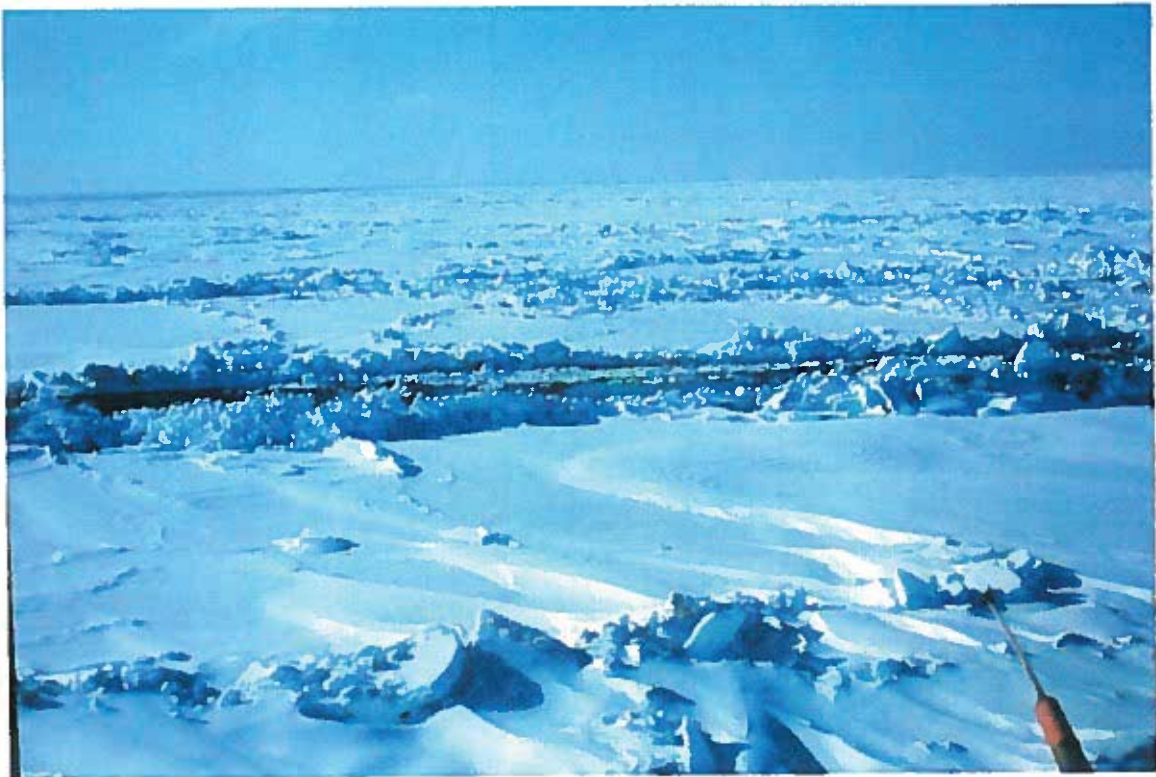
Helicopter view westward during ridge count flight

parent ice sheet, and hence the ridges formed earlier in the season tend to be smaller. Because of the activity of the ice in the strait, ridging is extensive (Photo 10). Older ridges appear as surface features within large floes. Newer ridges surround the margin of floes, and isolated fragments of ridges float freely in open water.
