Test Report

Evaluation of Tire Pressure Monitoring Systems (TPMS) – Phase 2

National Research Council of Canada
Automotive and Surface Transportation Research Centre

Project: A1-019321
Report number: AST-2020-0026

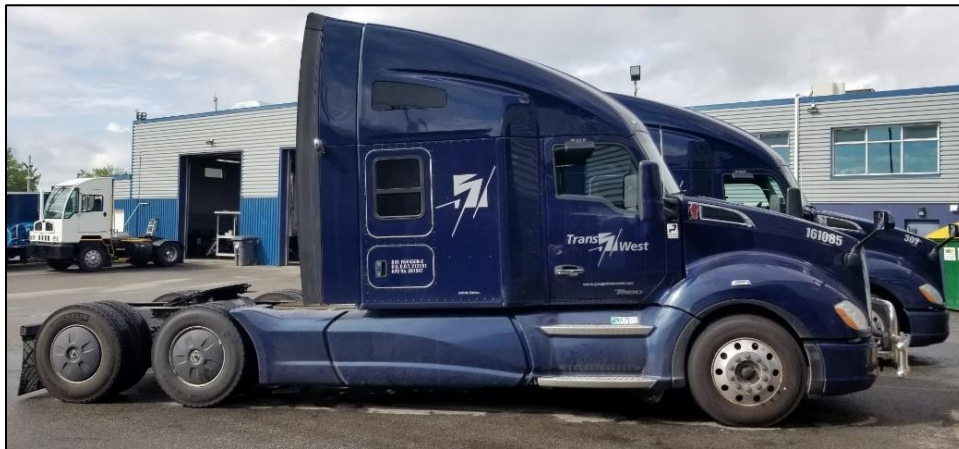
Figure 1: Kenworth T680 test vehicle

Ten 2019 Kenworth T680 Class 8 trucks, shown in Figure 1, with Cummins X15 engines, Eaton Fuller Advantage series automated 10-speed transmissions and complete aerodynamic packages, were selected for the test campaign. At the time the new tires were installed (as detailed in Section 3.1), the mileage of the trucks ranged from 616,905 to 716,659 km (average mileage 666,431 km).

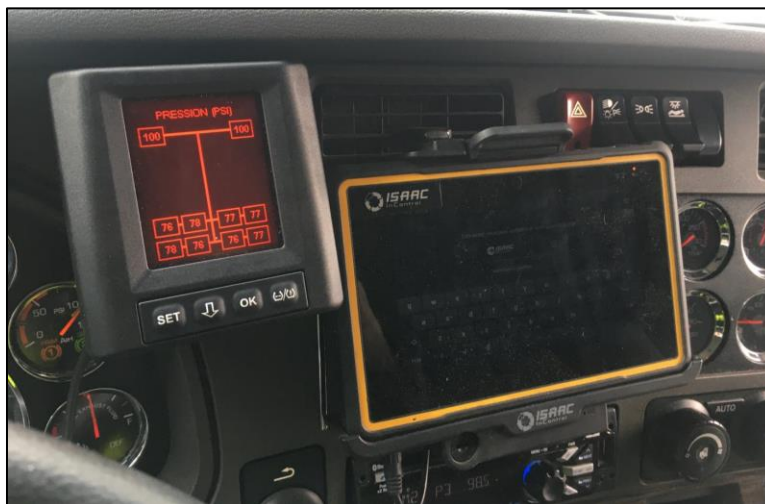
Figure 4: Continental in-cab display unit and Isaac Instruments telematics system tablet installed in truck

A display unit was installed in the cab of the truck and it enabled the driver to view live inflation pressure and temperature data, and receive real-time sensor warnings. As detailed in Section 3.2, the trucks were previously outfitted with a telematics system manufactured by Isaac Instruments, and the TPMS was integrated into that system. The TPMS display unit as well as the Isaac telematics system tablet installed in a test truck is shown in Figure 4. The display unit technical specifications are presented in Table 5.

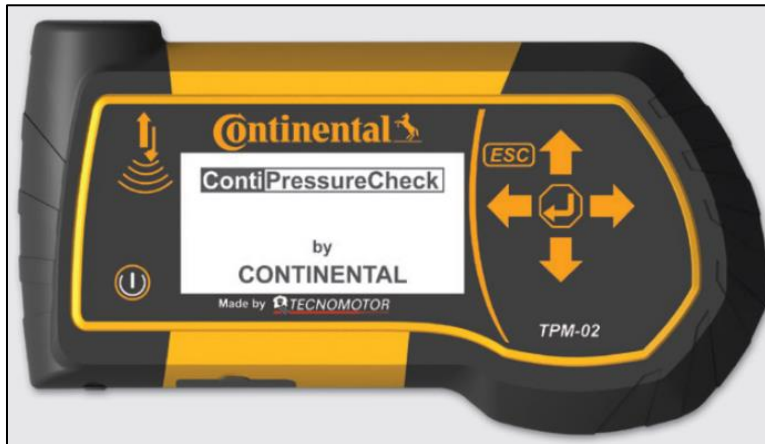
Figure 5: Continental TPMS hand-held tool

The TPMS were programmed using a Continental TPM-02 hand-held configuration and diagnostic tool, shown in Figure 5. The hand-held tool was used for the following:

- setting up and configuring the TPMS;
- activating the tire sensors;
- verifying the operation of the tire sensors;
- measuring tire pressures and temperatures;
- performing any necessary changes to the initial configuration;
- verifying system performance (test drive);
- reading error codes; and
- logging vehicle and configuration data.

The handheld tool can also be used to confirm sensor battery state where a “low battery” status is displayed.

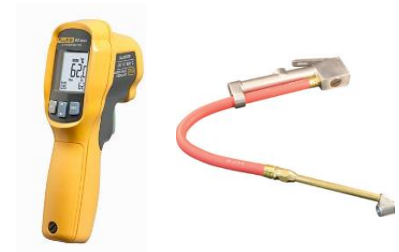
Milton Model S-506 pressure gauge

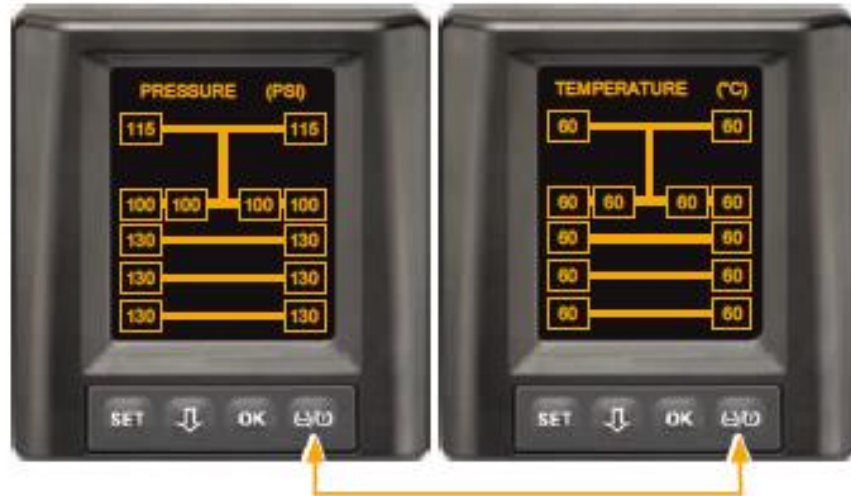
TPMS Display Operation Keys and Warning Symbol Description

Switching between pressure and temperature display

FAST PRESS. LOSS	Continuous, fast pressure loss. Tire damage and tire destruction will occur.

VERY LOW PRESSURE	The tire pressure falls below the recommended alarm threshold value. Tire damage or even tire destruction is possible.

LOW PRESSURE	The tire pressure falls below the recommended warning threshold value. Tire damage or even tire destruction is possible.

SENSOR DEFECT	Tire Sensor is defective

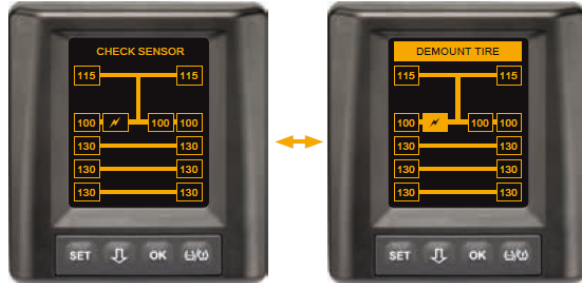
Both displays appear alternately at intervals of 1.5 seconds.

Warning type: High-level warning

Warning message: Check Sensor

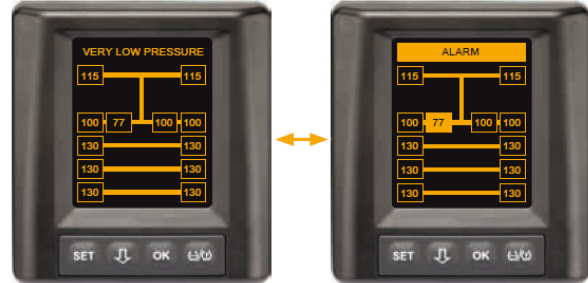
Both displays appear alternately at intervals of 1.5 seconds.

Warning type: High-level warning

Warning message: Very low pressure

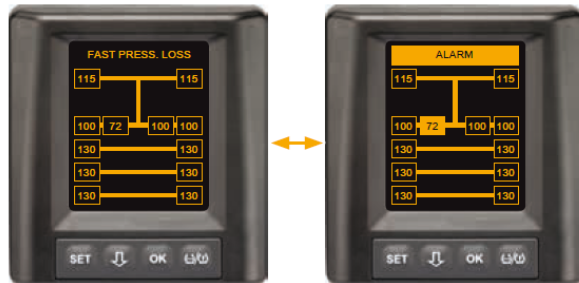
Fast pressure loss

Both displays appear alternately at intervals of 1.5 seconds.

Warning type: High-level warning

Warning message: Fast press. loss
