**FAILURE MECHANISM AND DAMAGE CHARACTERIZATION IN  
AXIALLY CRUSHED AlMg3.5Mn ALUMINIUM TUBES**

H. R. Shakeri and A. Rahem  
*Aluminium Technology Centre, NRC  
501 Université Boulevard East  
Chicoutimi, Quebec, Canada G7H 8C3  
[hamid.shakeri@cnrc-nrc.gc.ca](mailto:hamid.shakeri@cnrc-nrc.gc.ca)*

M.J. Worswick  
*Department of Mechanical Engineering  
University of Waterloo  
Waterloo, Ontario, Canada N2L 3G1*

R. Mayer  
*Vehicle Development Research Lab, GM R&D Center.  
30500 Mount Road, P.O. Box 9055  
Warren, MI, U.S.A. 48090-9055*

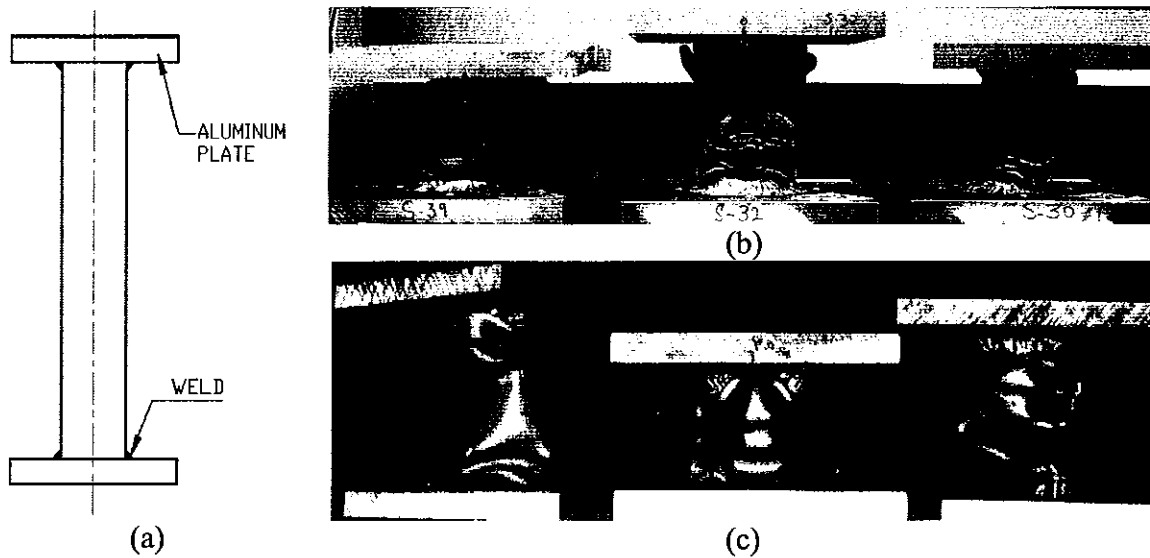
Figure 3 (a) schematic of the original tubes with aluminium plates welded at the two ends, (b) and (c) sets of axially crushed 2 and 3.5 mm thick tubes, respectively.

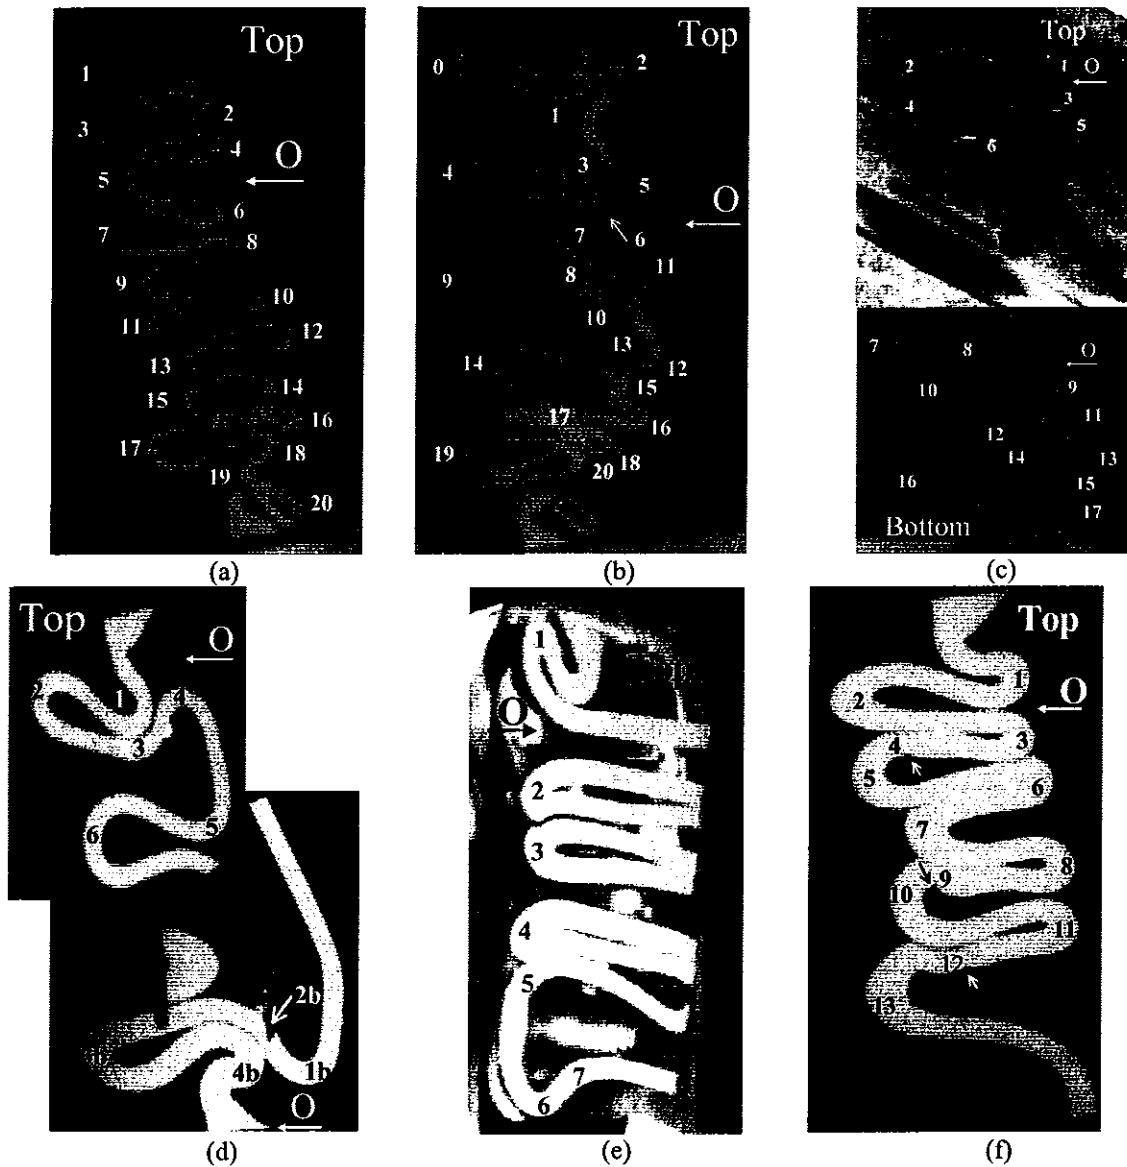
Figure 6 – Some of the mounted sections the specimens are shown here, (a), (b) and (c) are from 2 mm thick tubes and (d), (e) and (f) are from 3.5 mm tubes. The letter “O” indicates the outside of the tubes and also the topside is also marked; (a) specimen S-30 section C, (b) specimen S-30 section D, (c) specimen S-32 section A, (d) specimen S-28 section A, (e) specimen S-43 section D, and (f) specimen S-45 section B.

It seems that whenever several folded segments align under each other they might act like a cutting tool shearing the next neighbouring folding segment. In addition during the folding sequence the contact between different folding segments might produce a

“locking effect” for a neighbouring segment limiting the flow of the material in that segment leading to fracture. Adding to the complexity of the situation, it is also possible that two ends of the tube do not remain parallel, during the crash test, and add shearing, tearing component or a combination of the two into the equation.
