Monitoring the hygrothermal performance of a masonry wall with and without thermal insulation

MONITORING THE HYGROTHERMAL PERFORMANCE OF A MASONRY WALL WITH AND WITHOUT THERMAL INSULATION

A H P Maurenbrecher¹, C J Shirtliffe², M Z Rousseau¹ & M N A Saïd¹

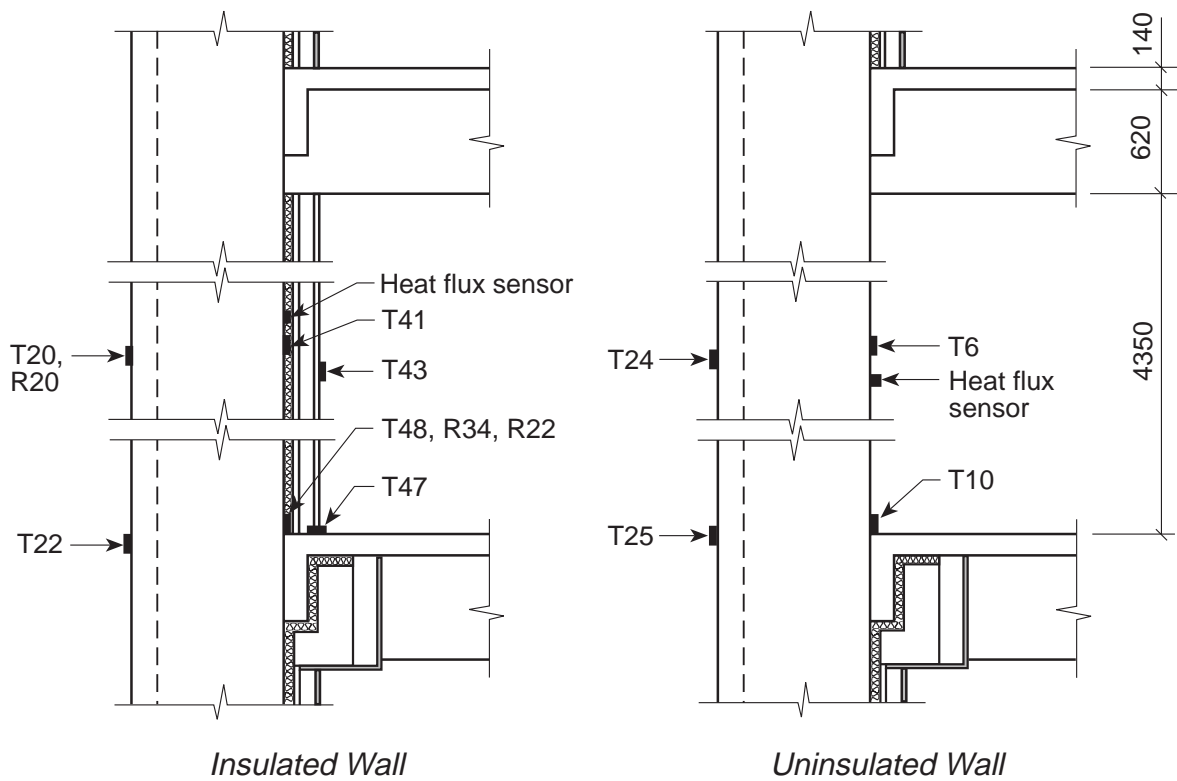
Figure 4 Location of thermocouples (T) and moisture sensors (R) at the bottom and mid-height of the wall

Preliminary investigations of the building indicated that steel beams and columns embedded in the masonry could act as thermal bridges where they connect with concrete encased steel beams in the heated space. The concrete floor slab is also in direct contact with the exterior masonry wall thus producing a low resistance path for heat to flow around the insulation. The potential thermal bridge at the floor slab-wall intersection was selected for further investigation. Modelling of the temperature profile was used at the design stage to support the selection of a retrofit technique while monitoring was used in the operational stage to follow-up on actual performance. For the monitoring, thermocouples were located in both the insulated and uninsulated wall sections on the surface of the floor (Fig 4, T10, T47, and T48).

At the wall/floor interface, the temperature (T10) ranges from 7°C to 12°C. This large difference (up to 9°C) from the mid-height location (T6) would not be expected in a completely uninsulated wall system but in this building, only one wall section has been left uninsulated for research purposes. The wall on the second floor as well as a small section of its ceiling have been insulated (Fig. 4). Minimal heat flow from adjacent materials was available to raise the temperature of the masonry at the floor level of the monitored uninsulated wall section. If the wall underneath the uninsulated test section had not been insulated, the difference between the wall/floor junction and mid-height would have been much less. Based on the measured temperature, condensation would occur at the wall/floor interface when humidity level indoors exceeds 35% RH.
