NRC PERD 079 Project - Task 1 - Findings from the Inuvit NT survey

NRC PERD 079 Project- Task 1

**Findings from the Inuvik NT Survey
prepared by
Madeleine Rousseau, Marianne Manning,
Nady Said, Mike Swinton and Steve Cornick
Feb. 2007**

Inuvik Survey

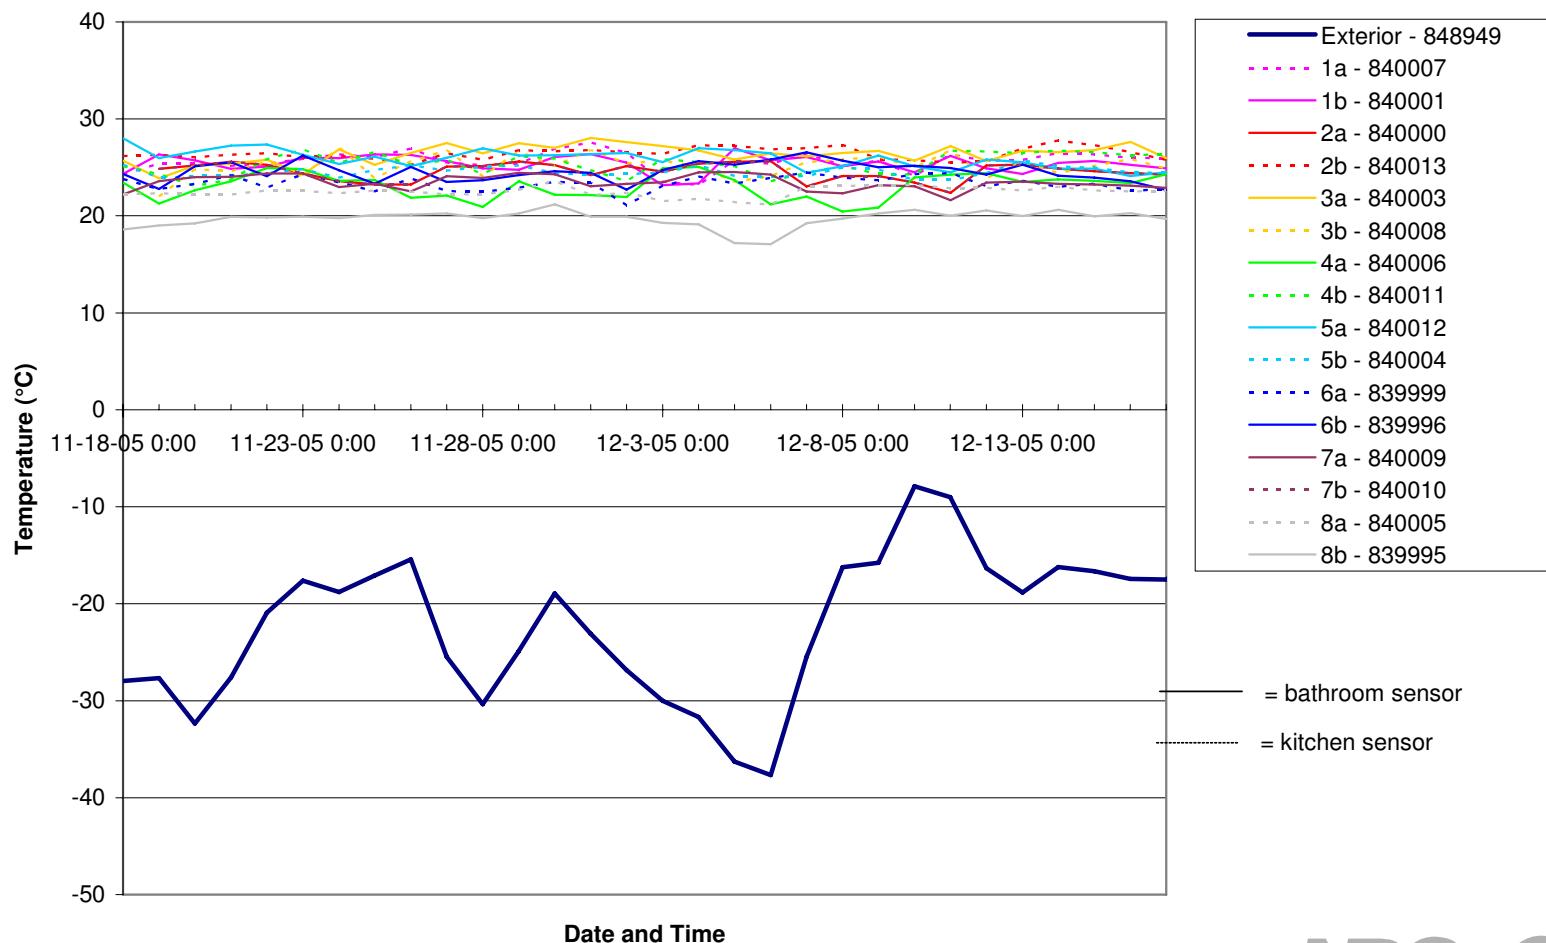
Average Daily Temperature

- Daily averages of indoor T not much influenced by outdoor T

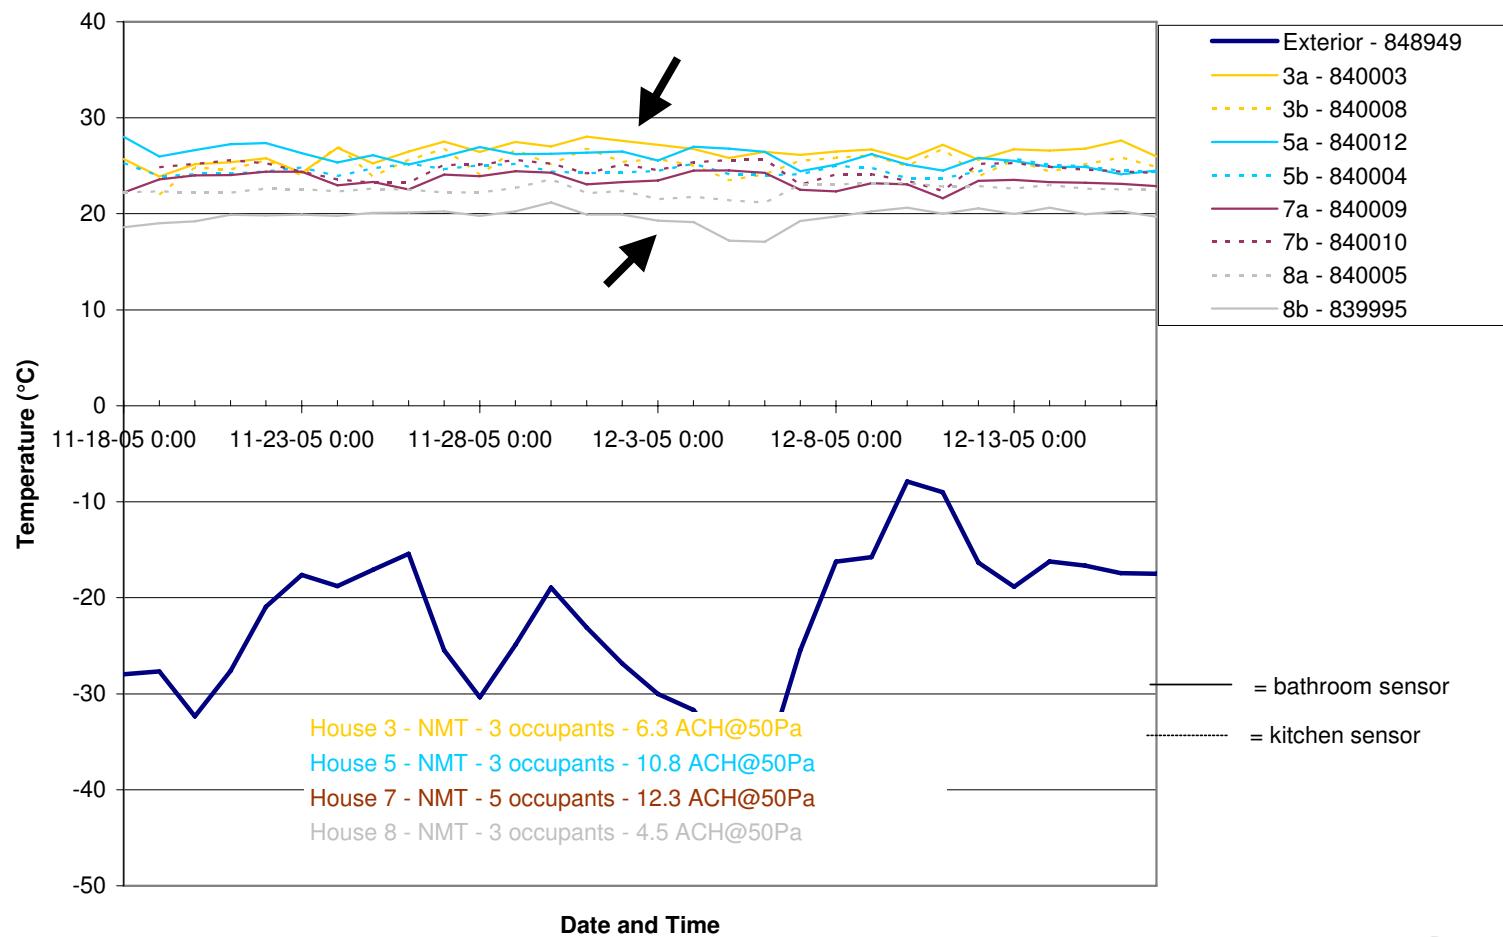
Average Daily Temperature - Non Moisture-Troubled Houses

- House 8 (bathroom) was cooler
- House 3 (bathroom) ran warmer

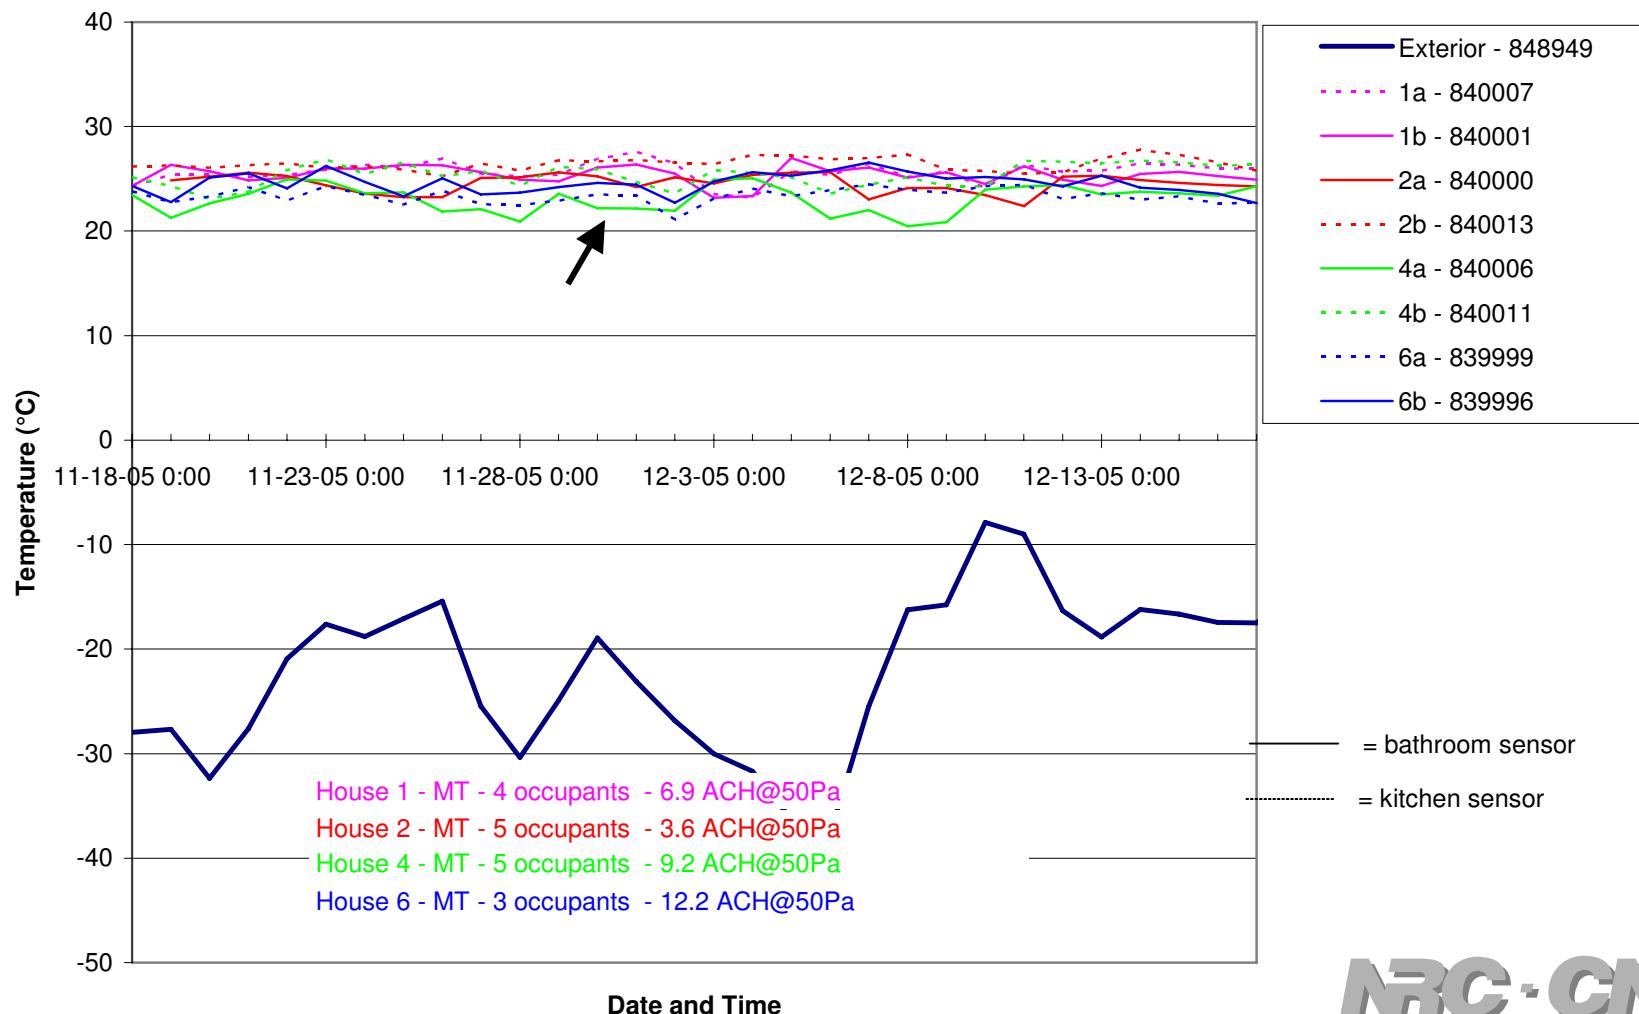
Average Daily Temperature - Moisture-Troubled Houses

- Narrow band of average daily T
- House 4 (bathroom) was slightly cooler

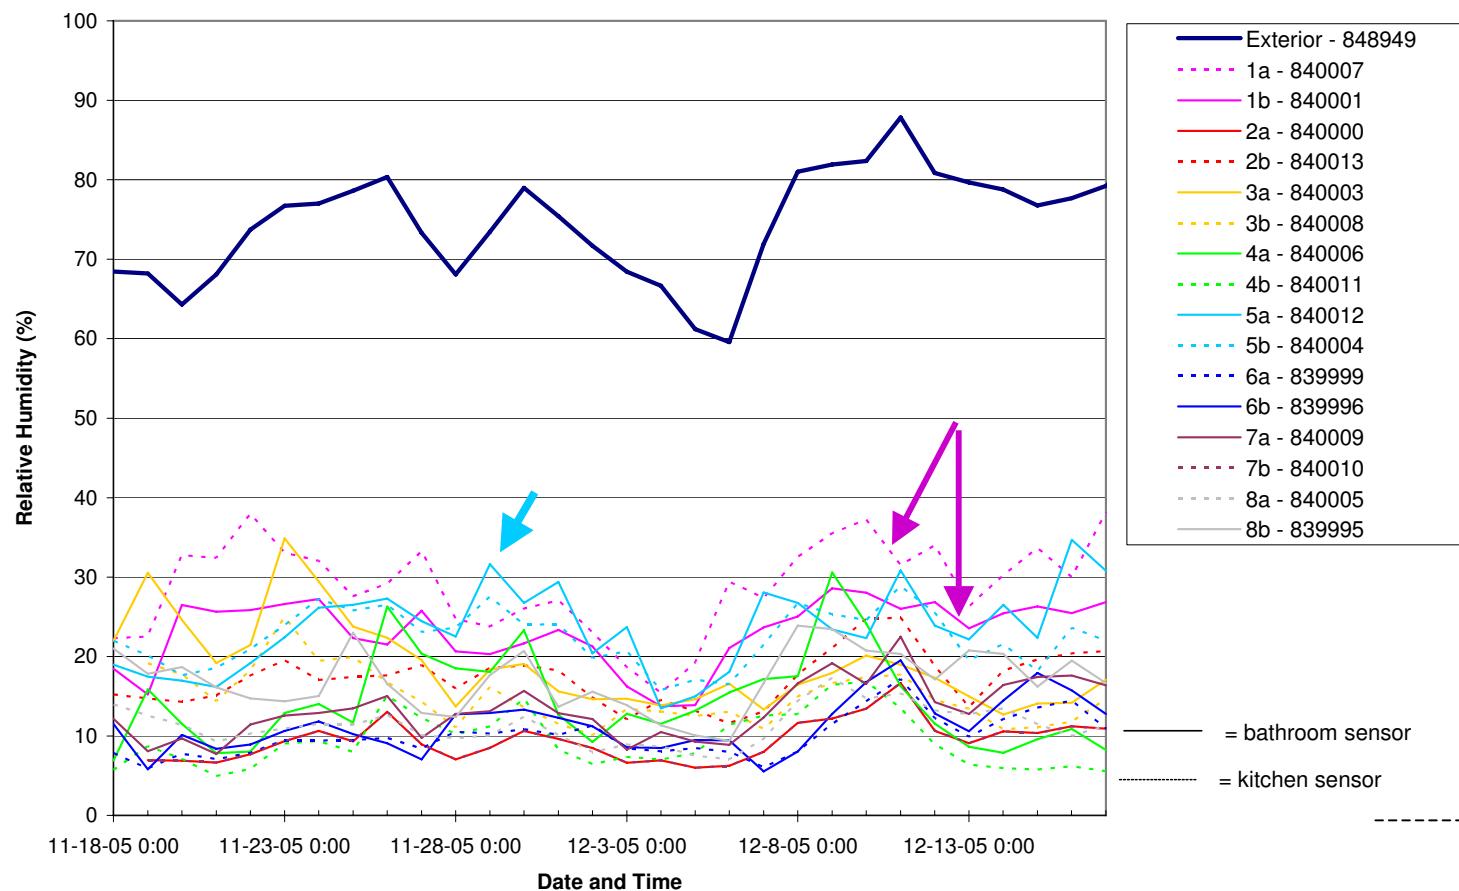
Average Daily Relative Humidity

- Houses #1 and # 5 have indoor RH with some resemblance to outdoor RH
- Daily averages of indoor RH is low (below 40%)

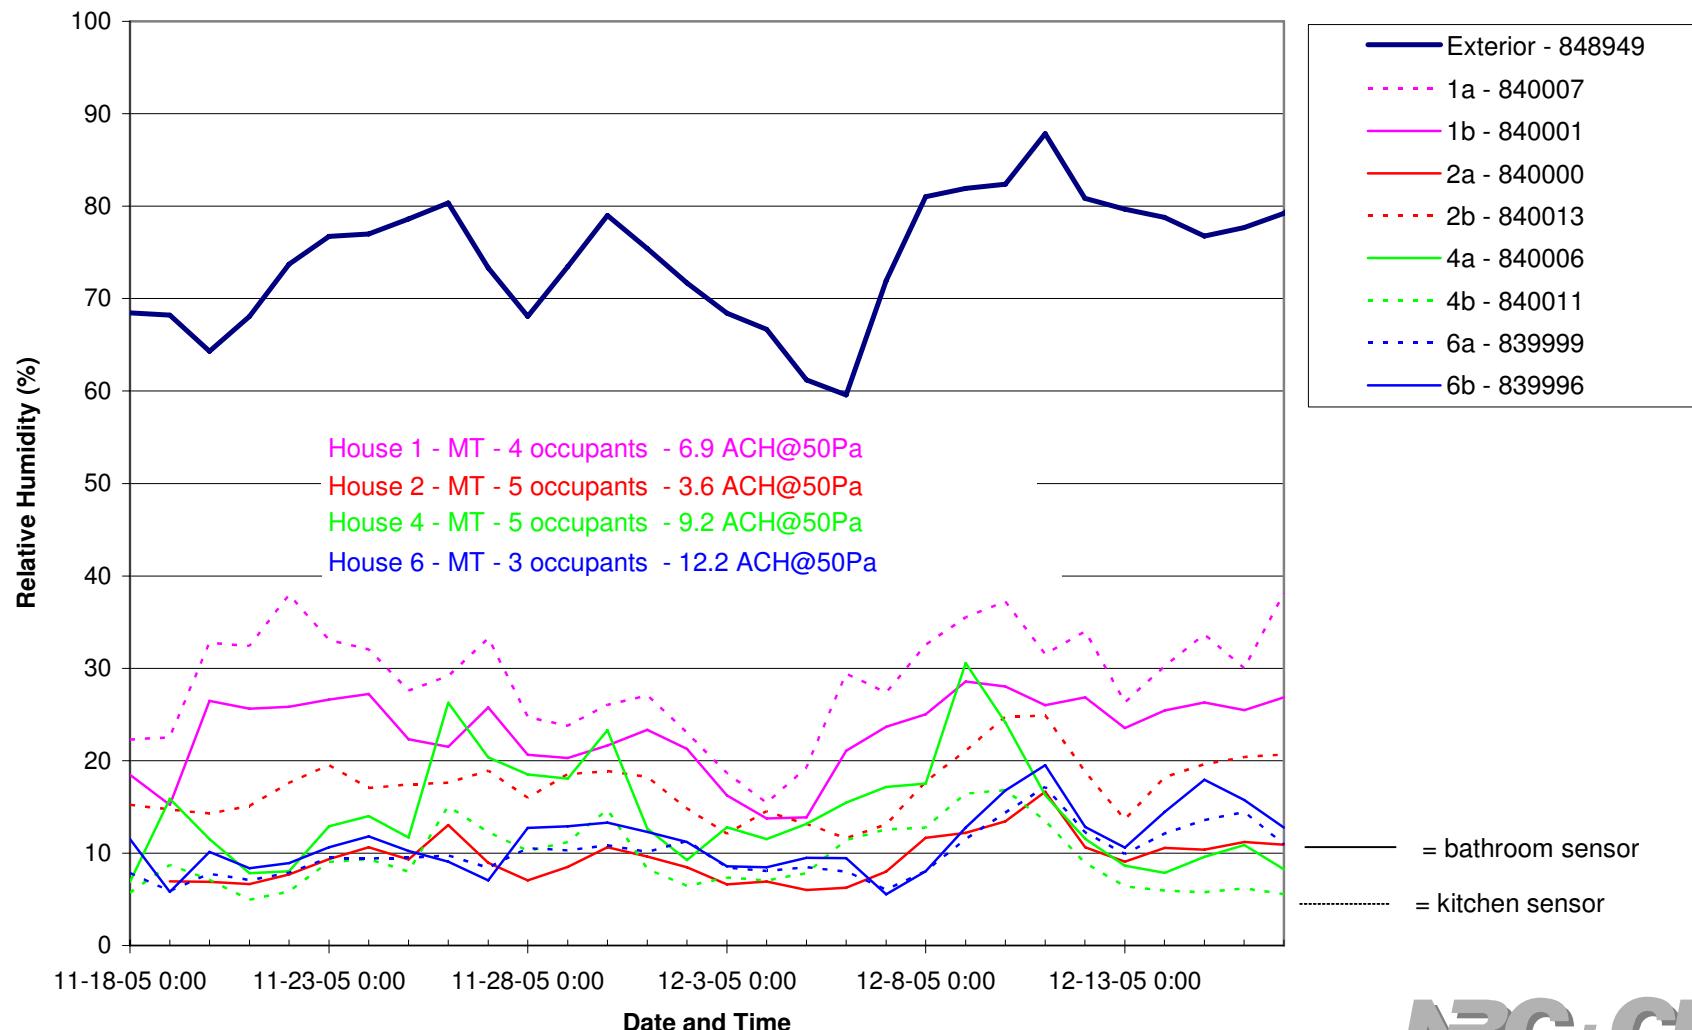
Average Daily Relative Humidity - Moisture-Troubled Houses

Daily averages of indoor RH is low (below 40%)

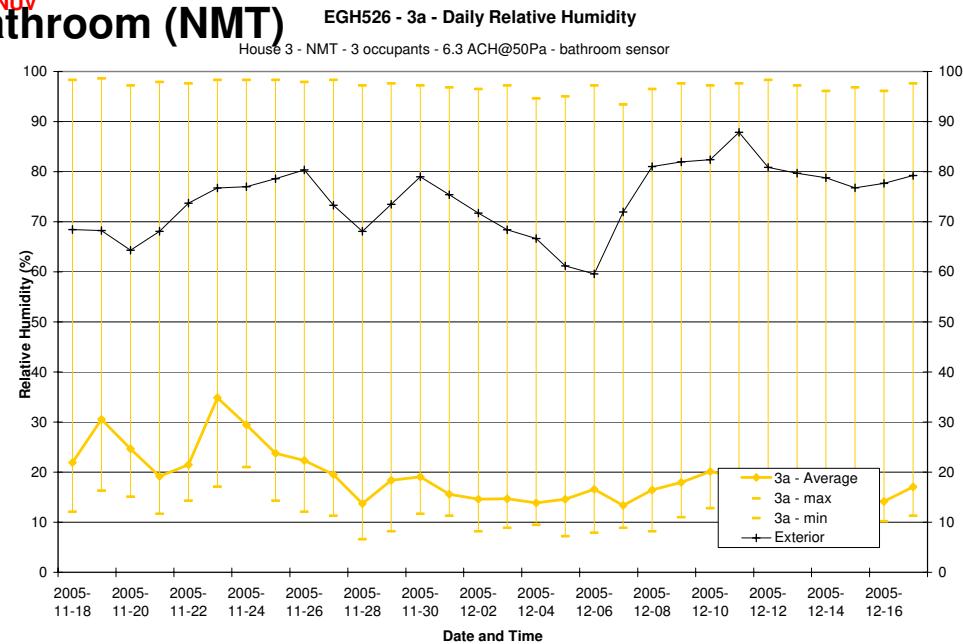
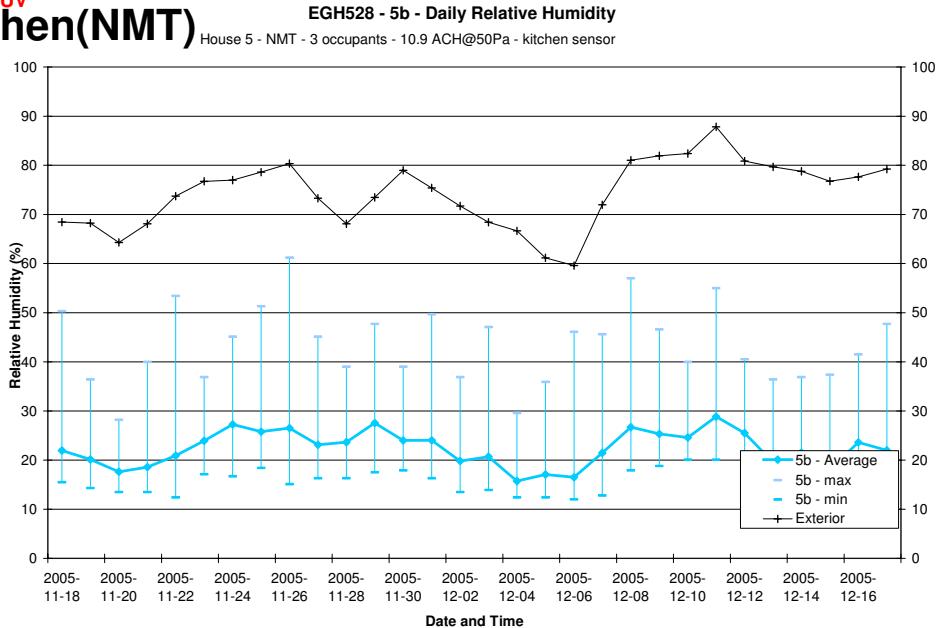
Bathroom Effect- RH extremes

**Daily RH peak near
100% in bathrooms**

**Peaks in kitchens
present daily but
lower RH**

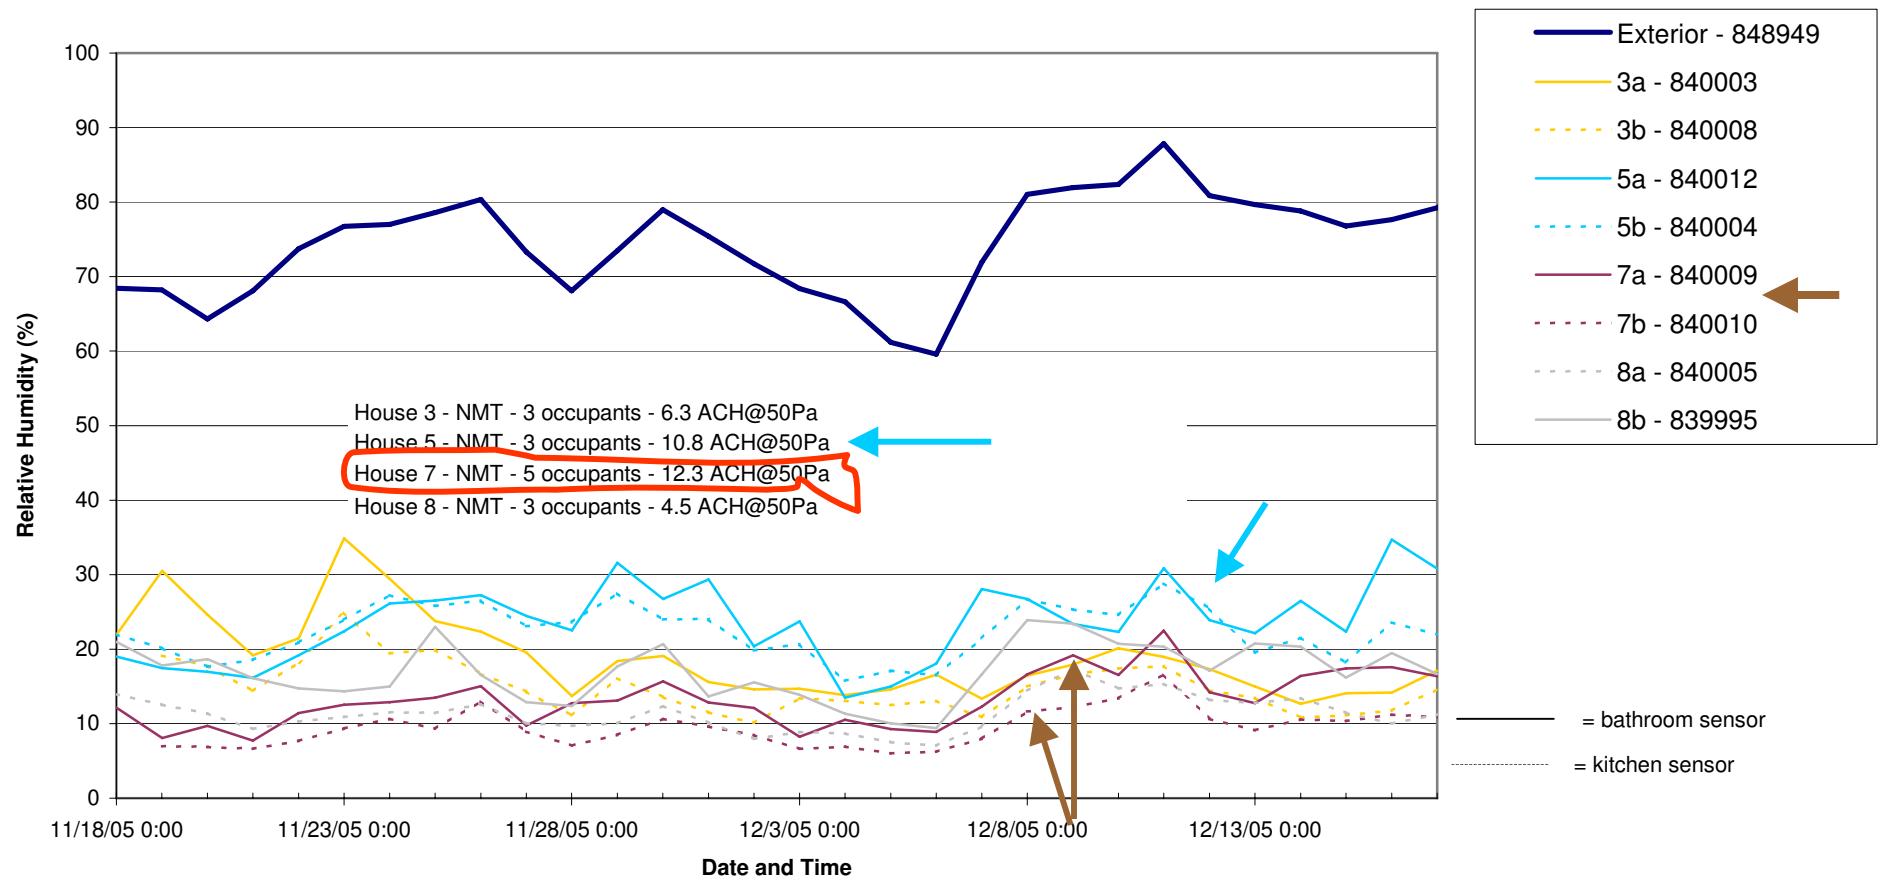
Average Daily Relative Humidity - Non Moisture-Troubled Houses

Higher occupancy loads did not translate in higher indoor RH (air exchange –natural and mechanical- is another factor)

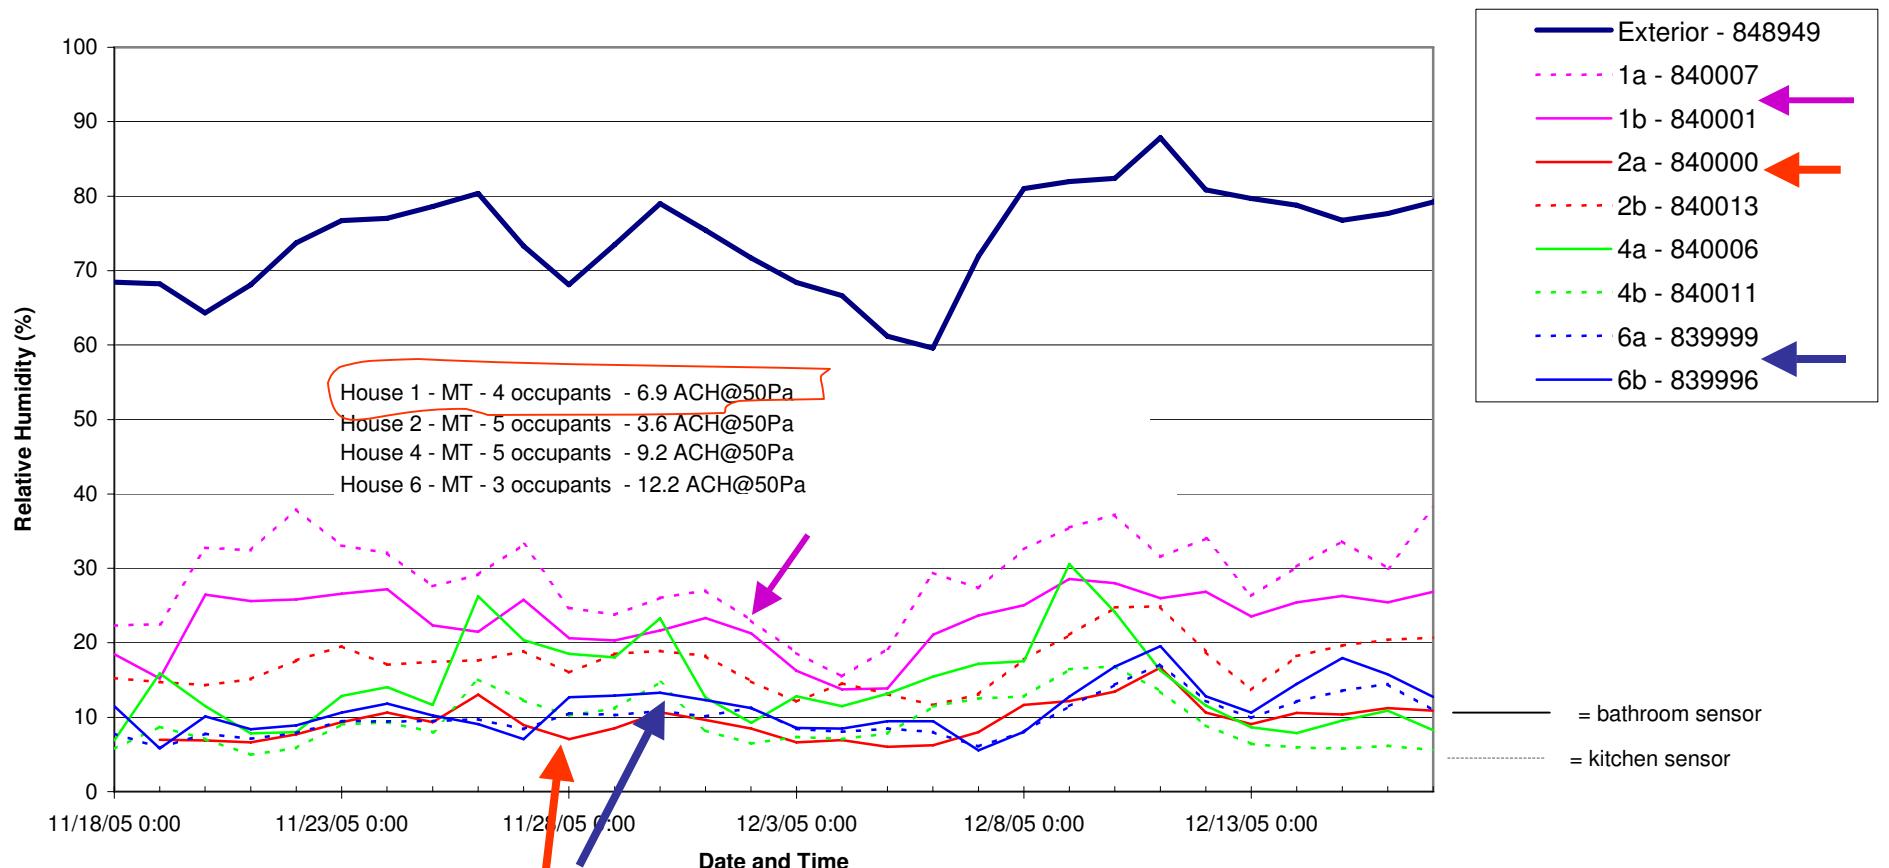
Average Daily Relative Humidity - Moisture-Troubled Houses

House #1 has highest daily average RH

Houses 2 and 6 have lowest average daily RH
with different occupancy and very different air leakage characteristics

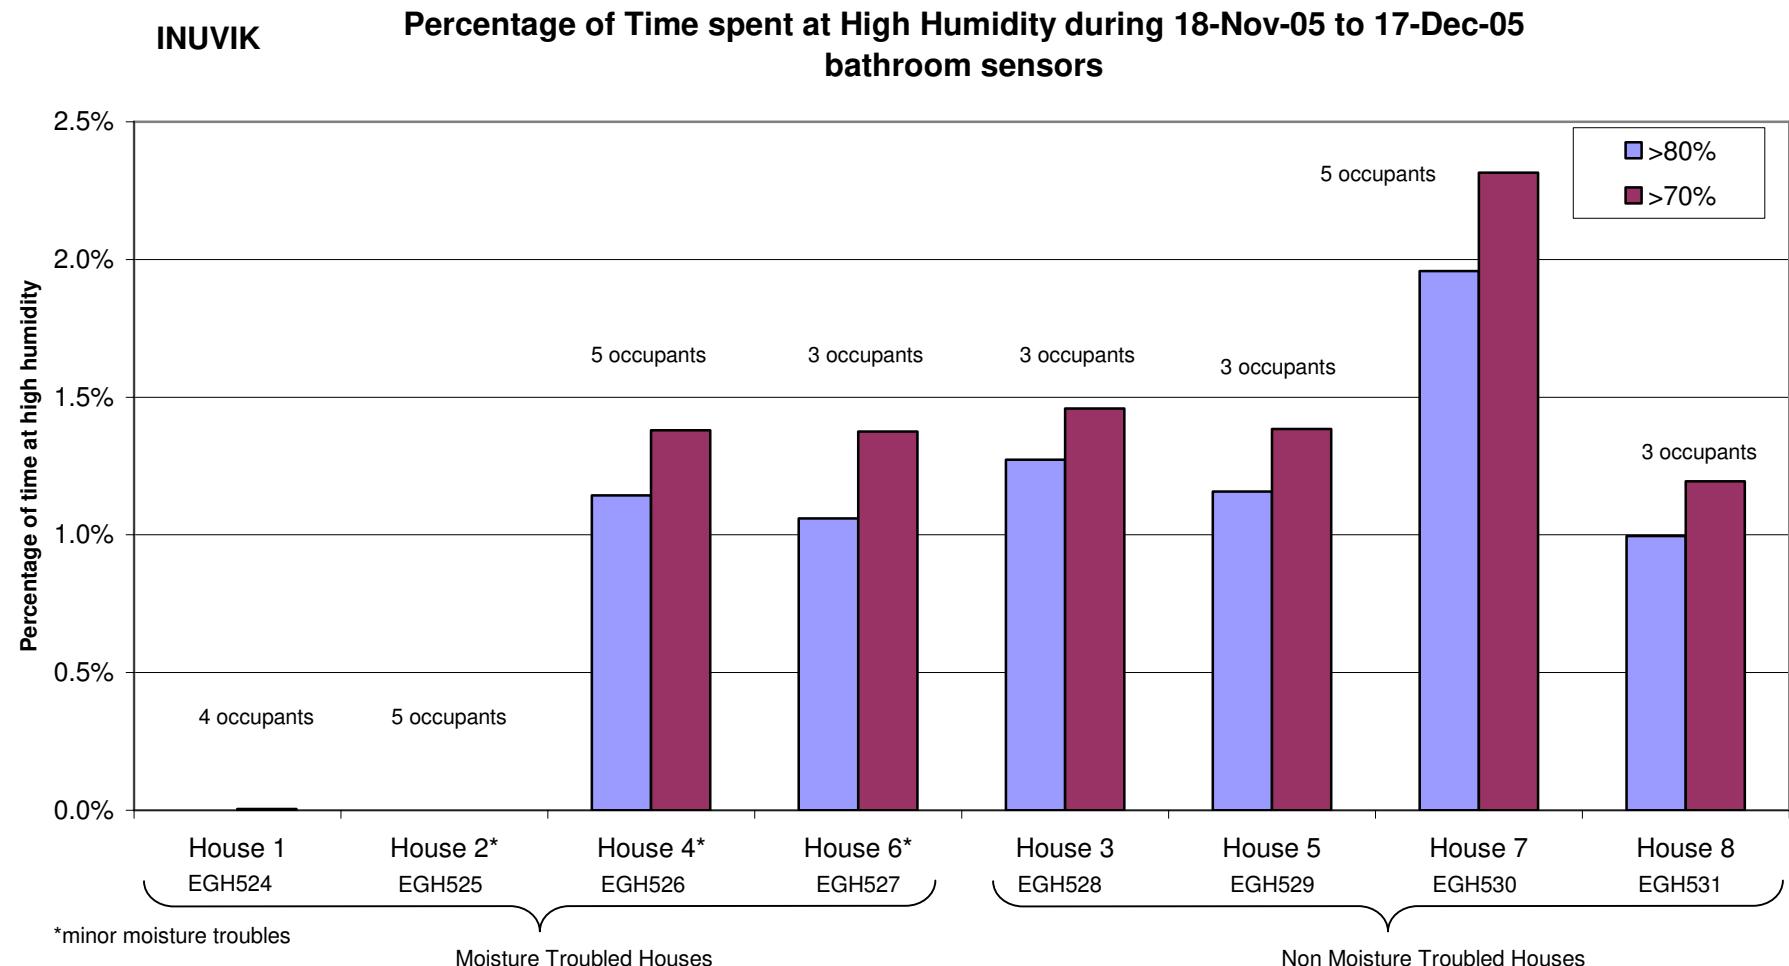
Time spent at High Humidity- Bathrooms

Bathrooms: NMT sample experienced more higher RH events

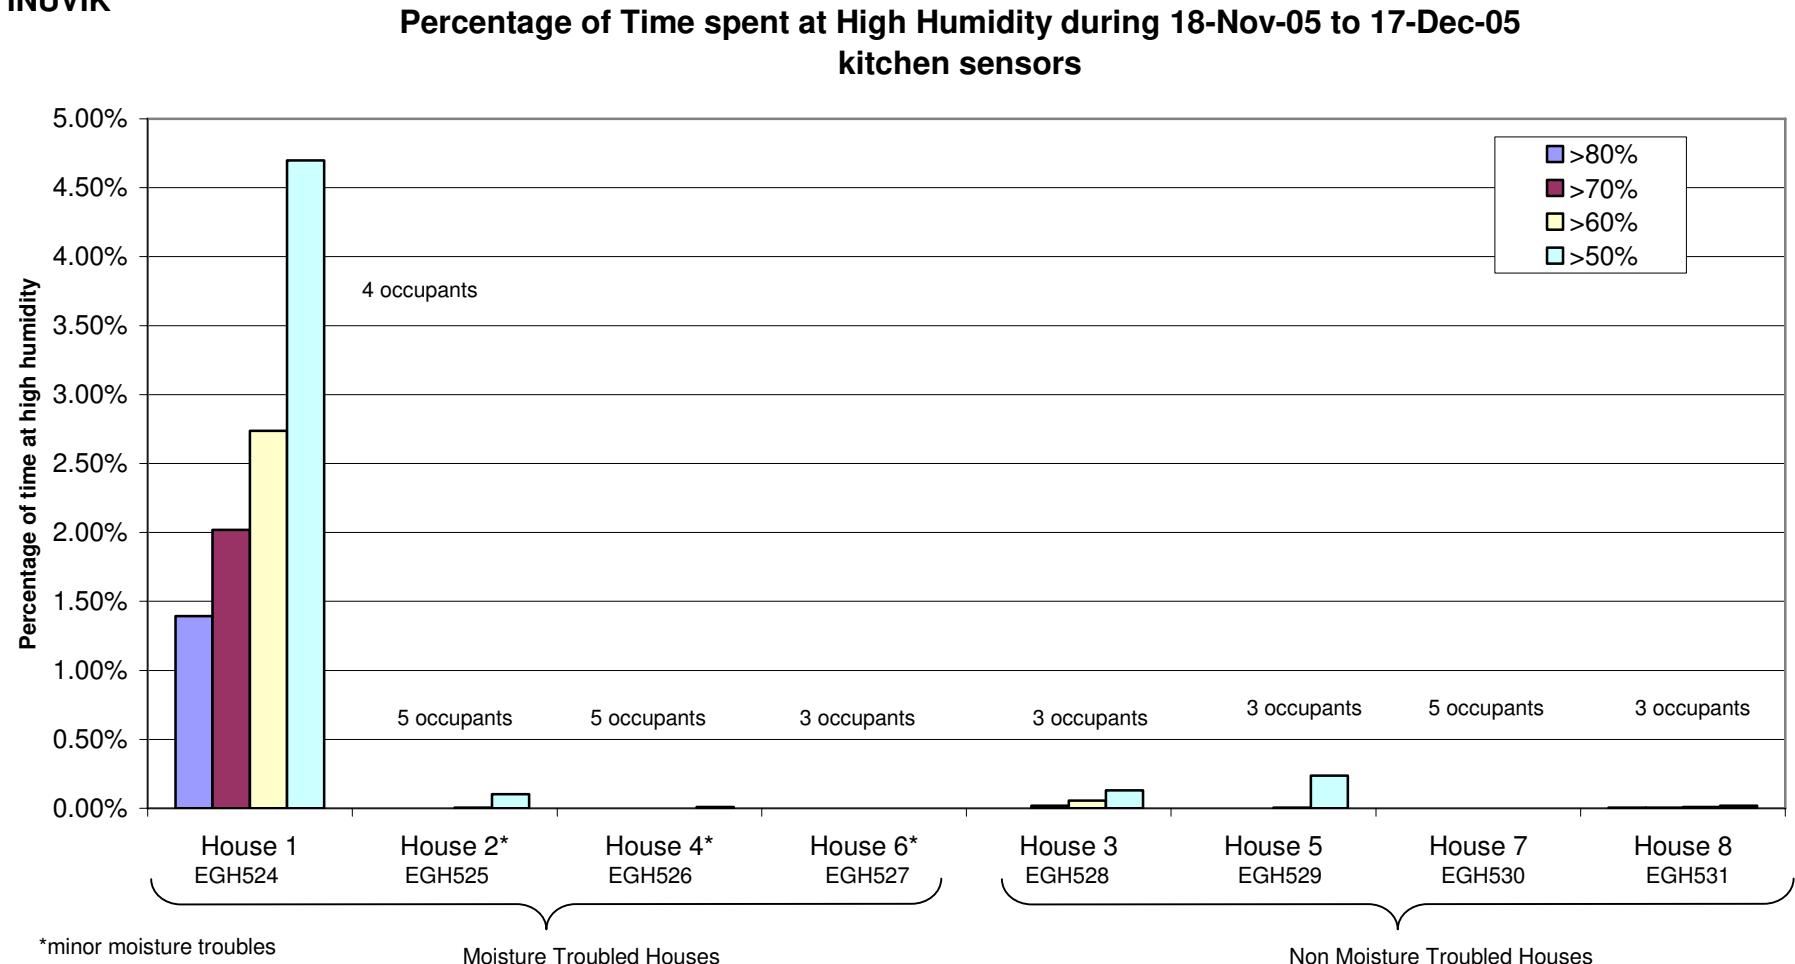
*****House 1 may have had its 2 Hobo sensors mixed...**

- Range of indoor moisture loads : from 4g/kg_{da} to 17 g_w/kg_{da}
- NMT sample experienced higher moisture loading than MT

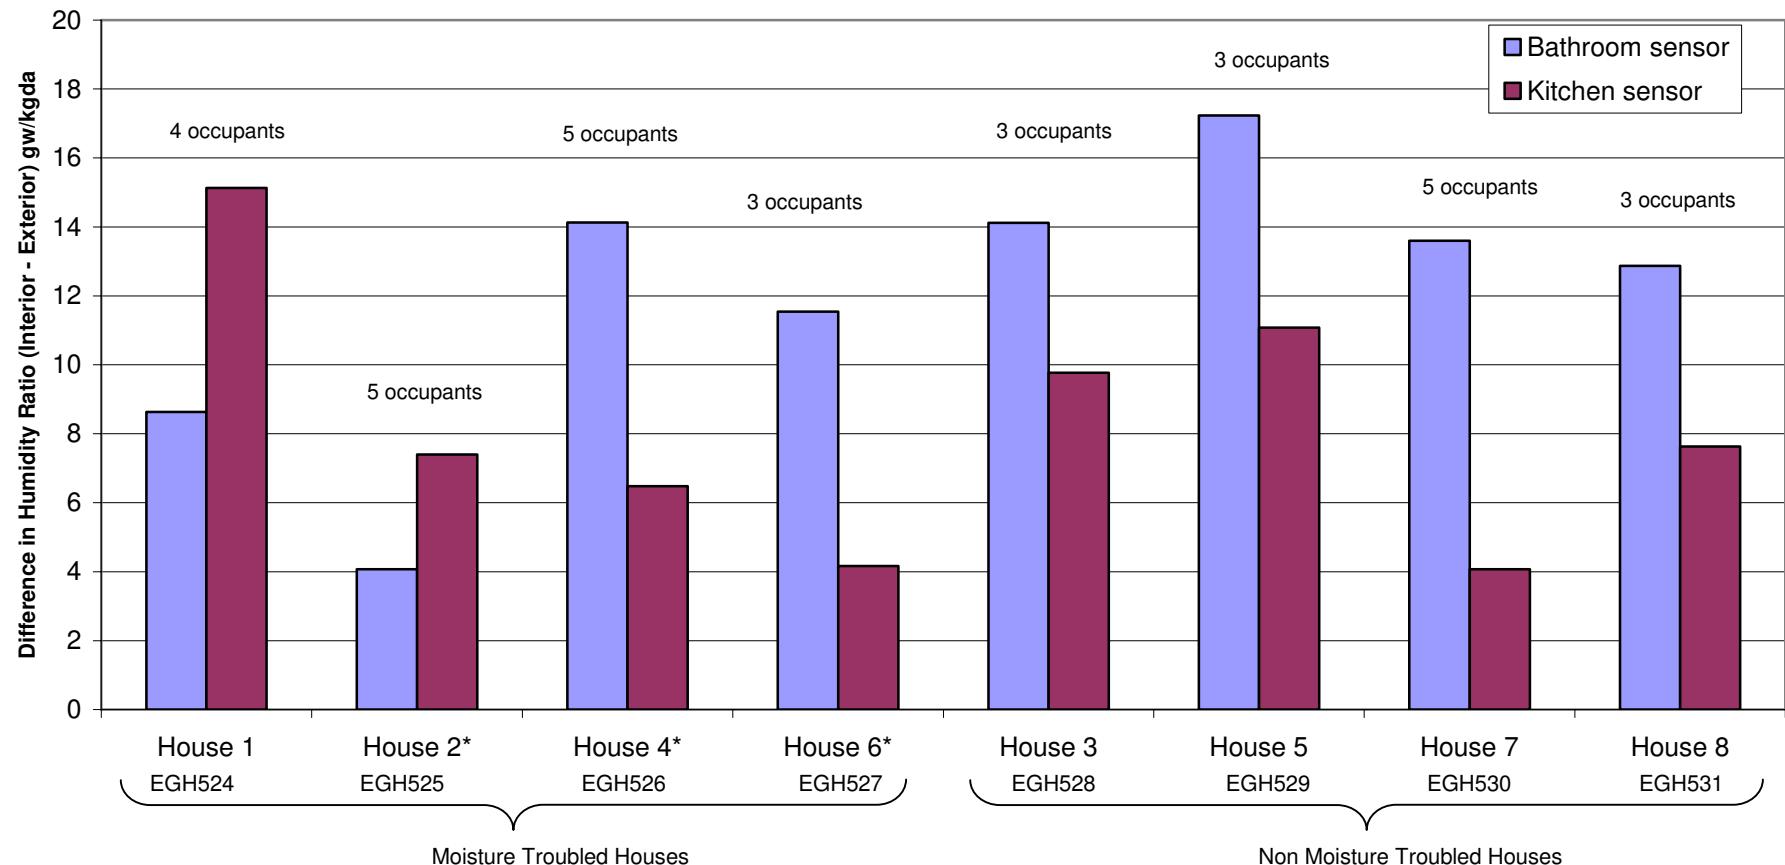
Maximum Difference in Humidity Ratio (Exterior - Interior)
18-Nov-05 to 17-Dec-05

Difference in Humidity Ratio (Exterior – Interior)
