B707 lap joint specimen No. 349 - NDI inspections Taremi, F.; Bellinger, N.; Brothers, M.; Gould, R.

Report No.: **LTR-SMPL-2003-0271**

**B707 LAP JOINT SPECIMEN No. 349
NDI INSPECTIONS**

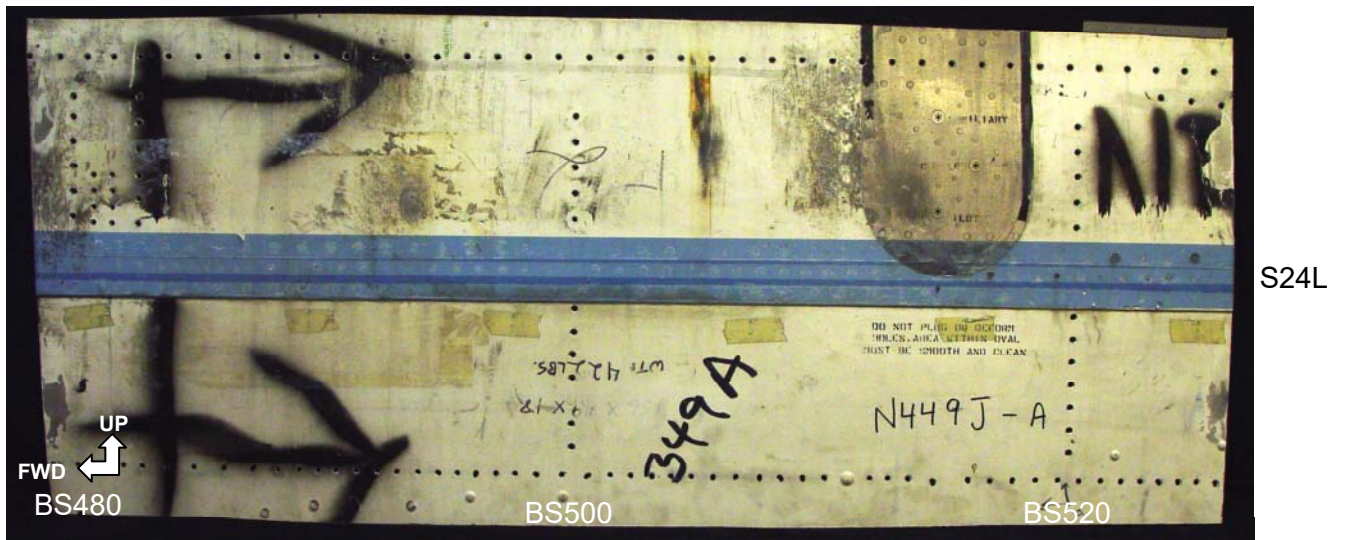
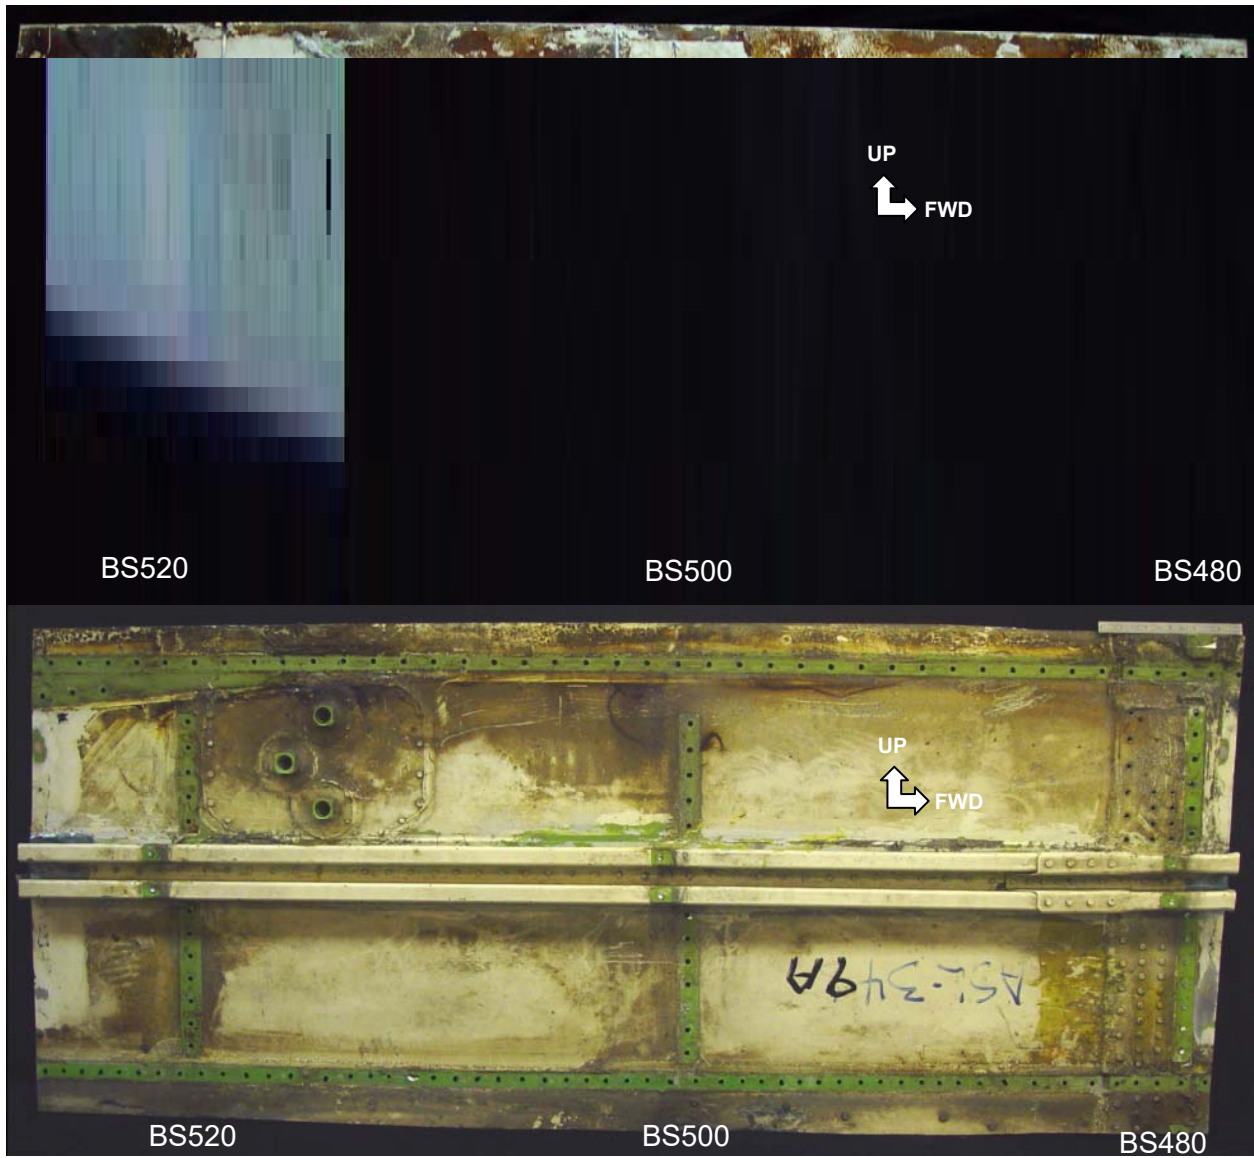
Figure 4. Front and rear surface views of Specimen 349A

This 48.25 inch long lap joint specimen was located between BS480 and BS520 on STR24L. There is an internal skin doubler at the BS480 fuselage frame. The pilot's and co-pilot's data probe mounted above the lap joint between BS510-520 incorporates both a skin doubler and a tripler. Front and rear surface images of this specimen are shown in Figure 4.

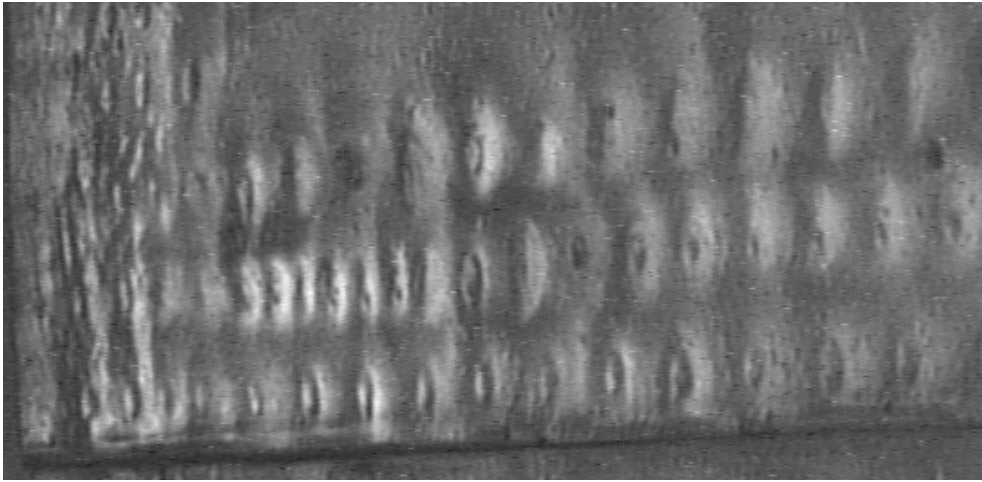
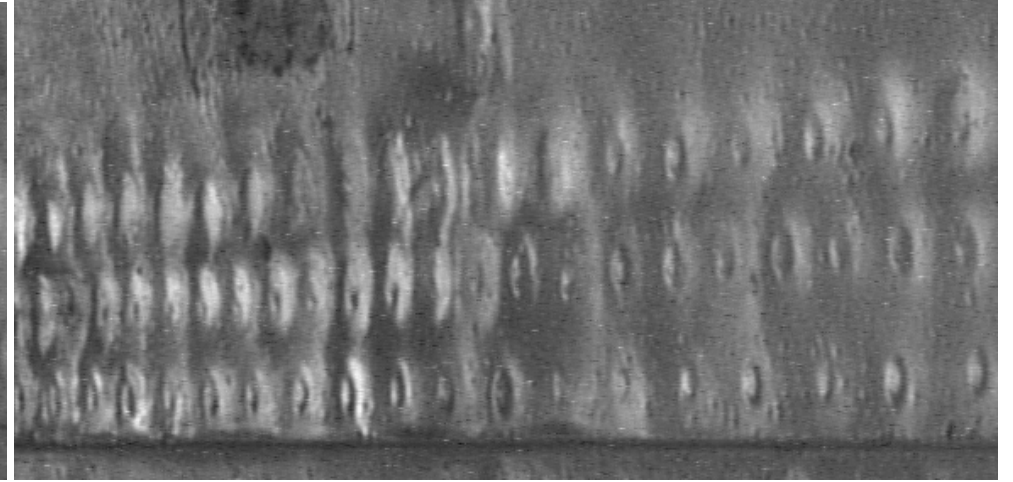
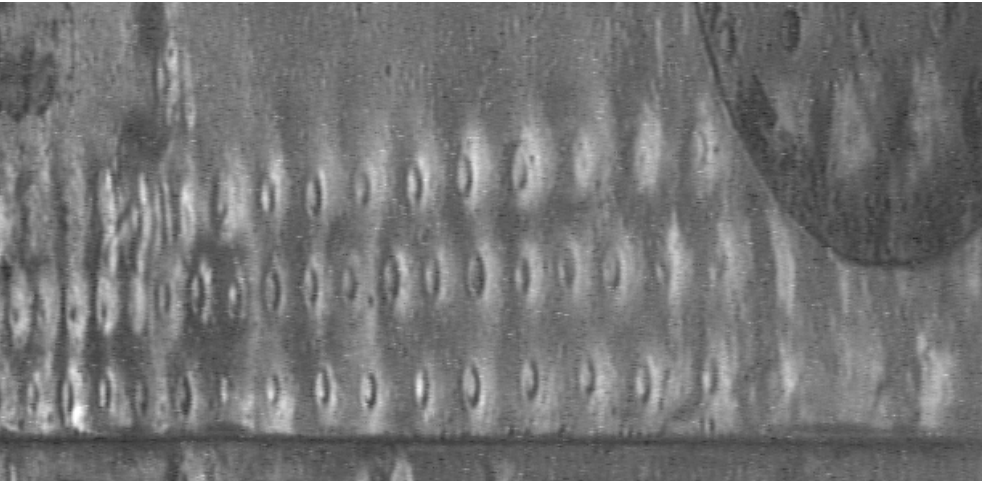
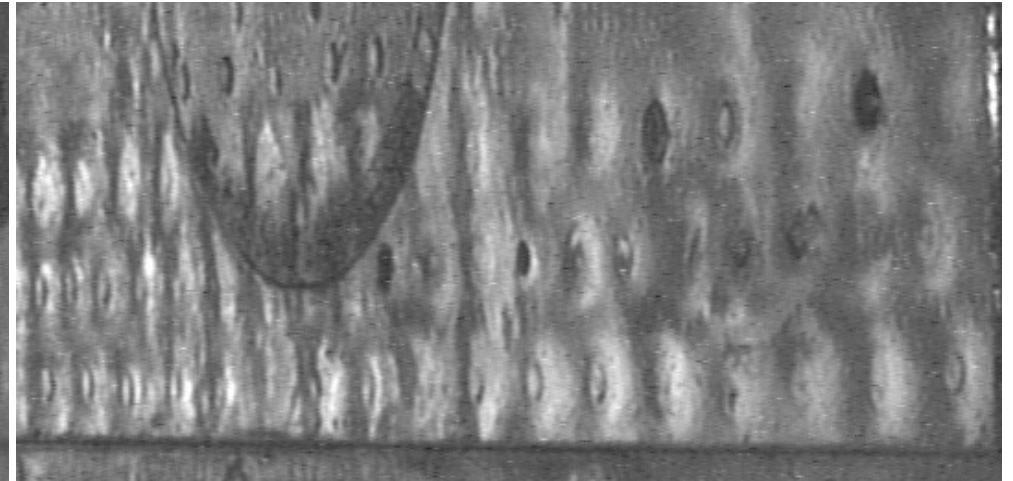
Figure 7a). D Sight inspection results for 349A - Painted.

Significant amounts of corrosion pillowing as well as failed and deformed rivets were observed. An advantage of using D Sight over other automated NDI methods was that the ends of the specimen could be inspected. The surface roughness can significantly affect the D Sight images because this technique uses reflected light to highlight the out of plane deformation caused by corrosion pillowing. To obtain better D Sight signatures of the joint surface the paint was removed. The surface was inspected with the aid of SolidHi™ as negative pressure was applied to conform a 10 mil black vinyl sheet. The use of the SolidHi technique provided uniform reflectivity over the inspection area. These inspection images are shown in Figure 7b).

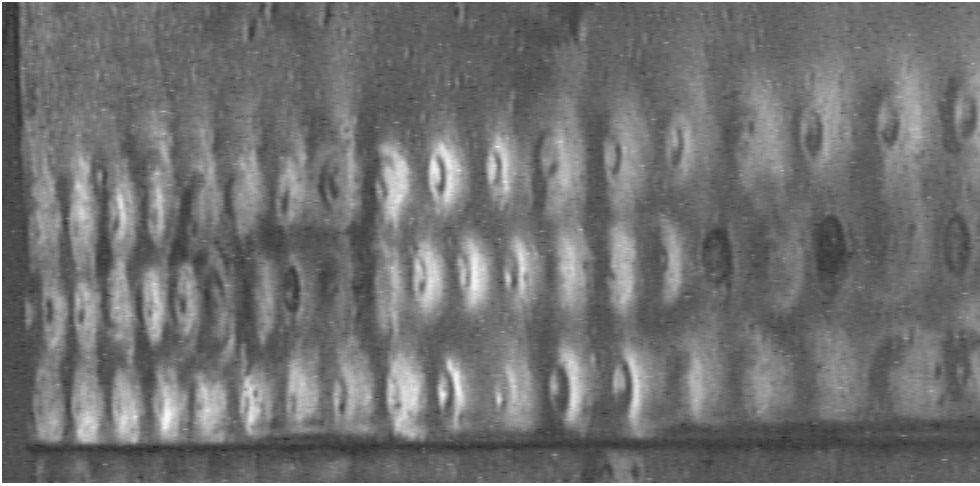
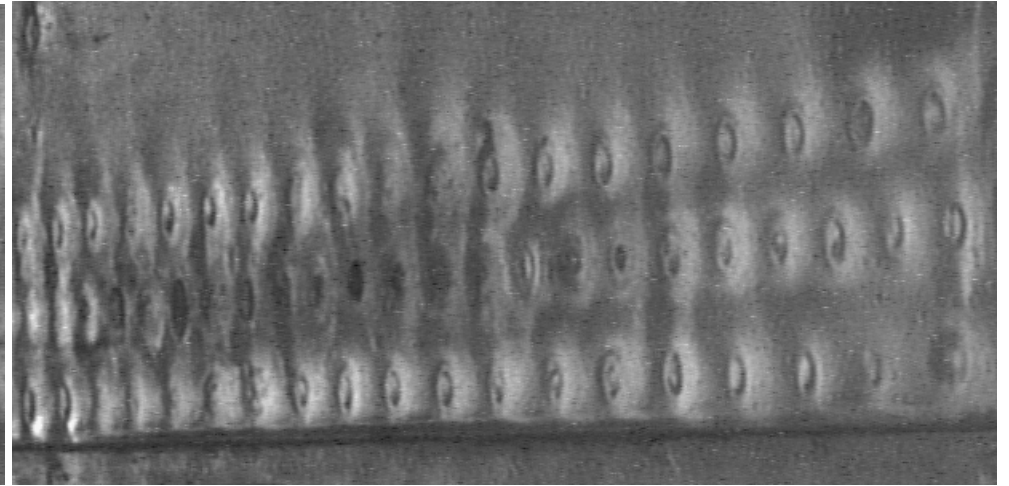
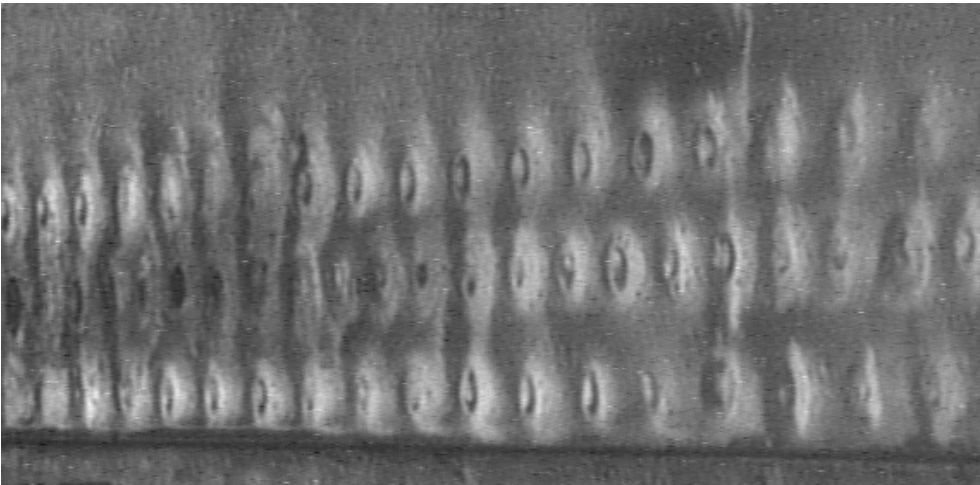
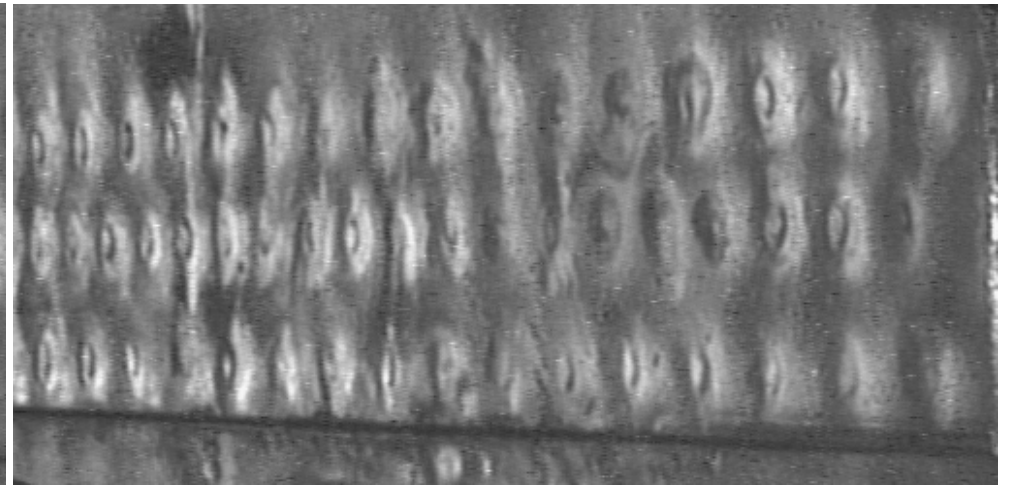
Figure 15a). D Sight inspection results for 349B, Painted.

A schematic of lap joint 349B showing the location of the DAIS 250C inspections is shown in Figure 14. Four D Sight images were taken with 50% overlap to cover the total length of the joint and the results are shown in Figure 15a. To obtain better D Sight signatures of the joint surface the paint was removed. The surface was inspected with the aid of SolidHi and negative pressure to conform a 10 mil black vinyl sheet. These inspection images are shown in Figure 15b). Figure 14 is also used to mark the areas containing pillowing cracks as detected by X-ray inspection of the joint.

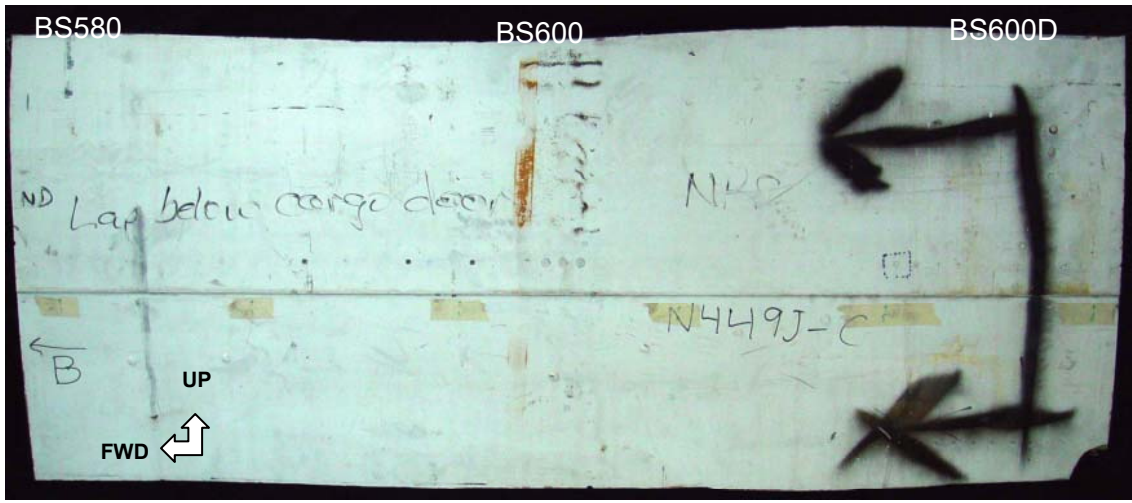
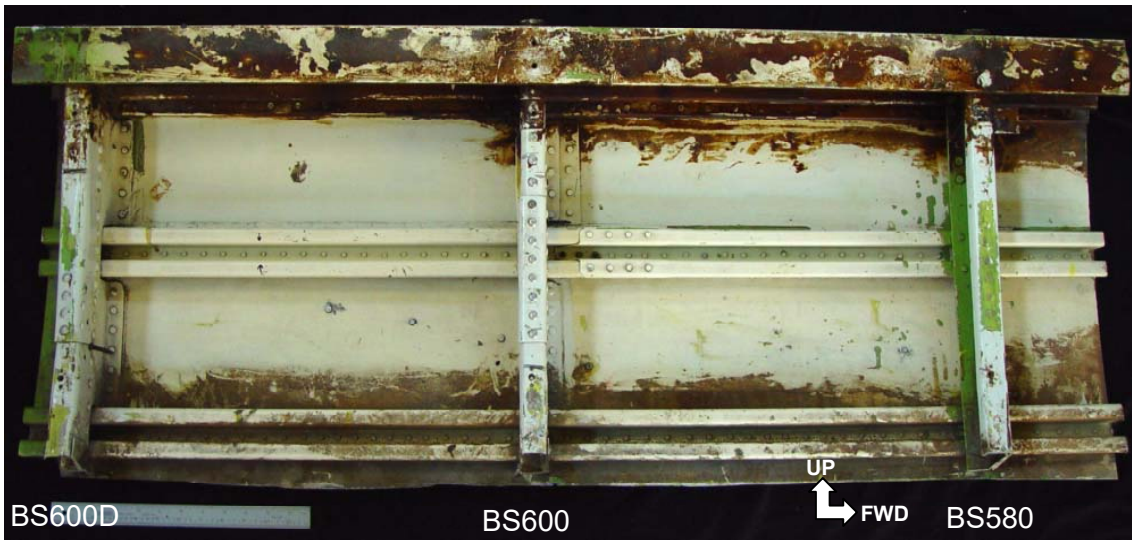
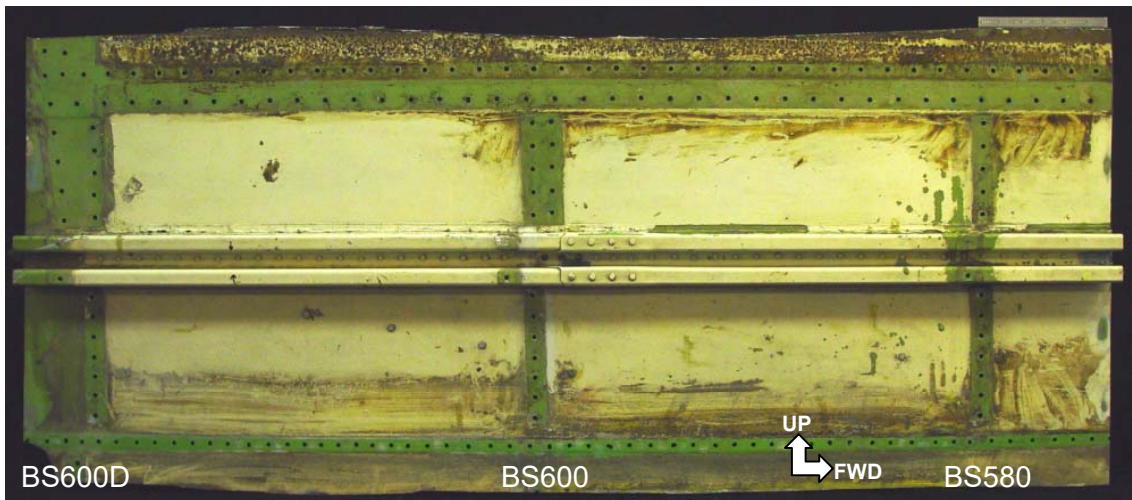
Figure 21. Front and Rear surface views of lap joint Specimen 349C.

This 49 inch long lap joint specimen was located between BS580 and BS600D on STR24L. The specimen suffered from pillowing due to corrosion as well as corrosion on the inboard skin and stringer. Some of the original rivets replaced with steel fasteners, while others were sheared off due to the pillowing stress. Some of the rivets were cracked or had pitting corrosion and some were on the verge of popping out. Photographs of both front and rear surfaces of the specimen are shown in Figure 21 **Error! Reference source not found.**. The results from the visual inspections indicating the problem areas such as replaced or popped out rivets are presented in Table 4 and images of these areas are shown in Figure 22 **Error! Reference source not found.**.

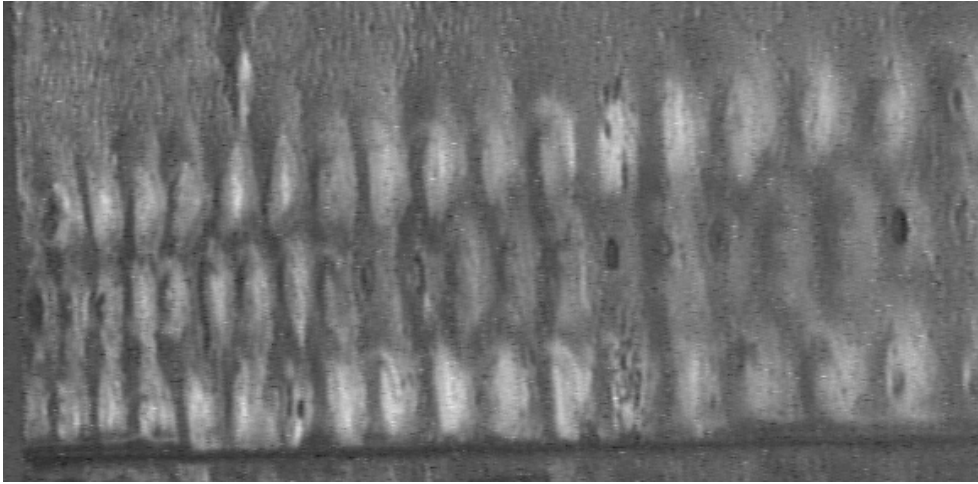
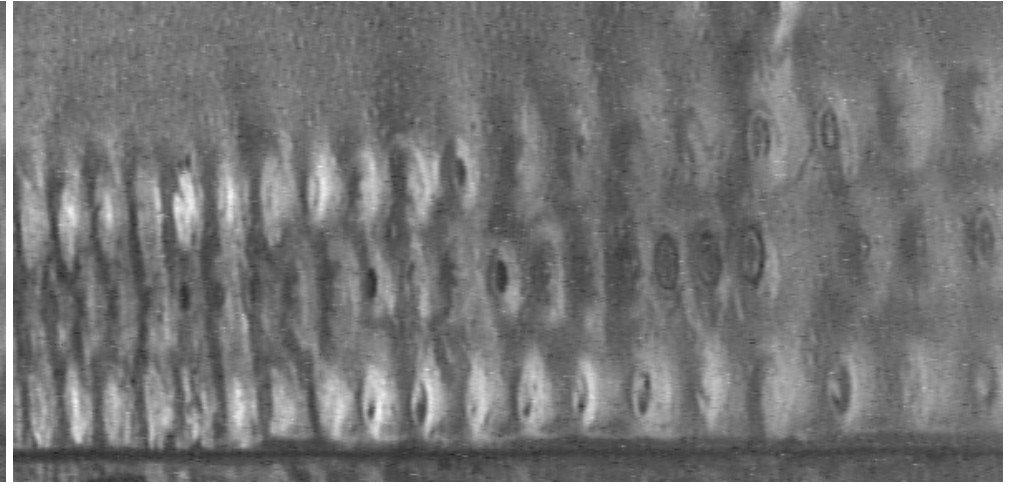
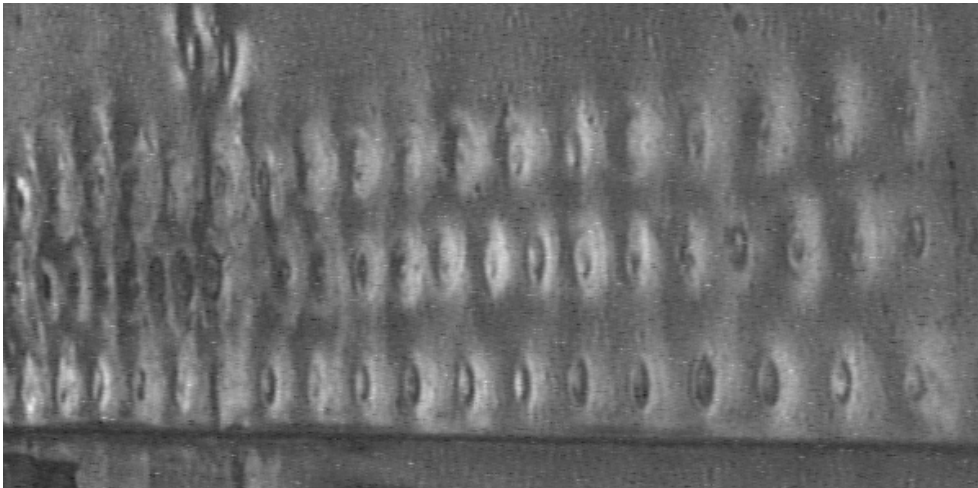
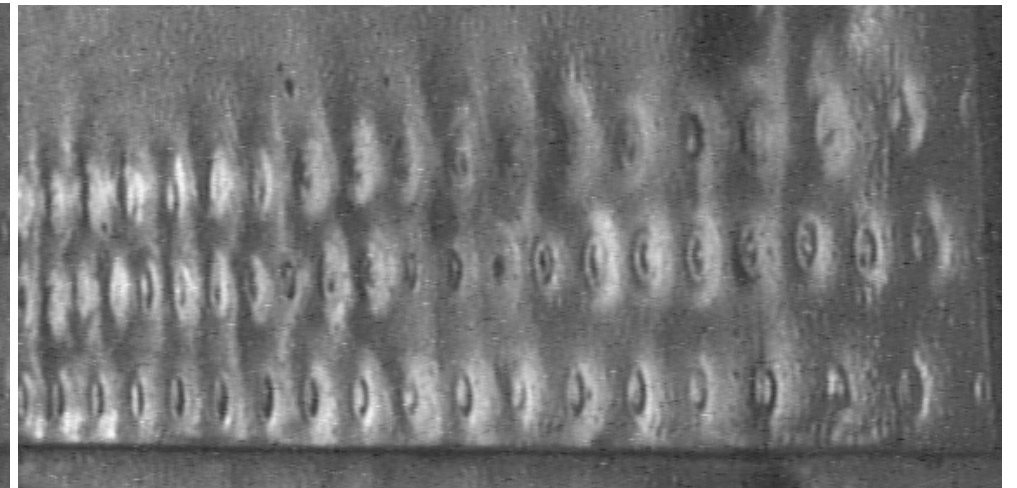
Figure 24a). D Sight inspection results for lap joint 349C. Painted.

A schematic of lap joint 349C showing the location of the DAIS 250C inspections is shown in Figure 23. Four D Sight images were taken with 50% overlap to cover the total length of the joint and the results are shown in Figure 24a. To obtain better D Sight signatures of the joint surface the paint was removed. The surface was inspected with the aid of SolidHi and negative pressure to conform a 10 mil black vinyl sheet. These inspection images are shown in Figure 24b). Figure 23 is also used to mark the areas containing pillowing cracks as detected by X-ray inspection of the joint.
