A Report on the Alexis Nihon Office Complex Fire

G.C. Gosselin and J.R. Mawhinney

Internal Report No. 531

Date of issue: April 1987

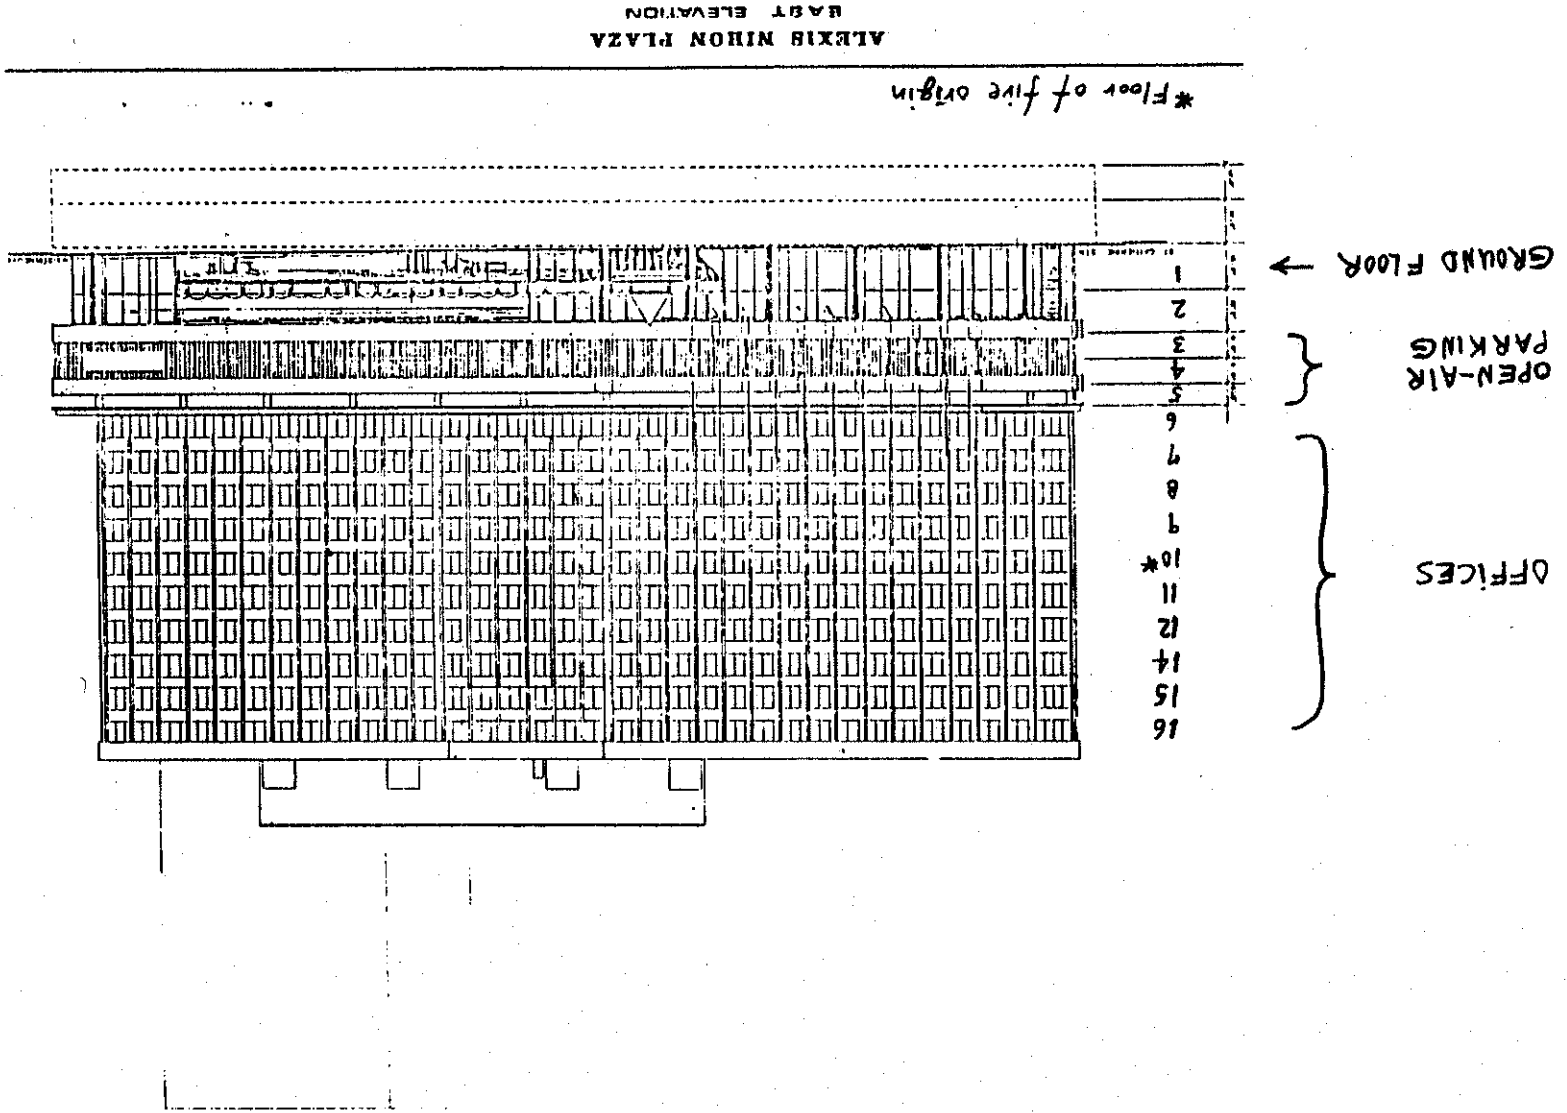
Fig. 2 Office Building Elevation

The building consists of a 15 storey tower, attached to a larger 5 storey complex housing assembly, mercantile and low hazard industrial operations (see Figure 2). The first two levels of the tower contain assembly and mercantile occupancies. Above them, a 3 storey open-air parking garage is located. The top ten floors of the tower (numbered 6 to 16, there being no designated 13th floor) consist of multi-tenanted office occupancies.

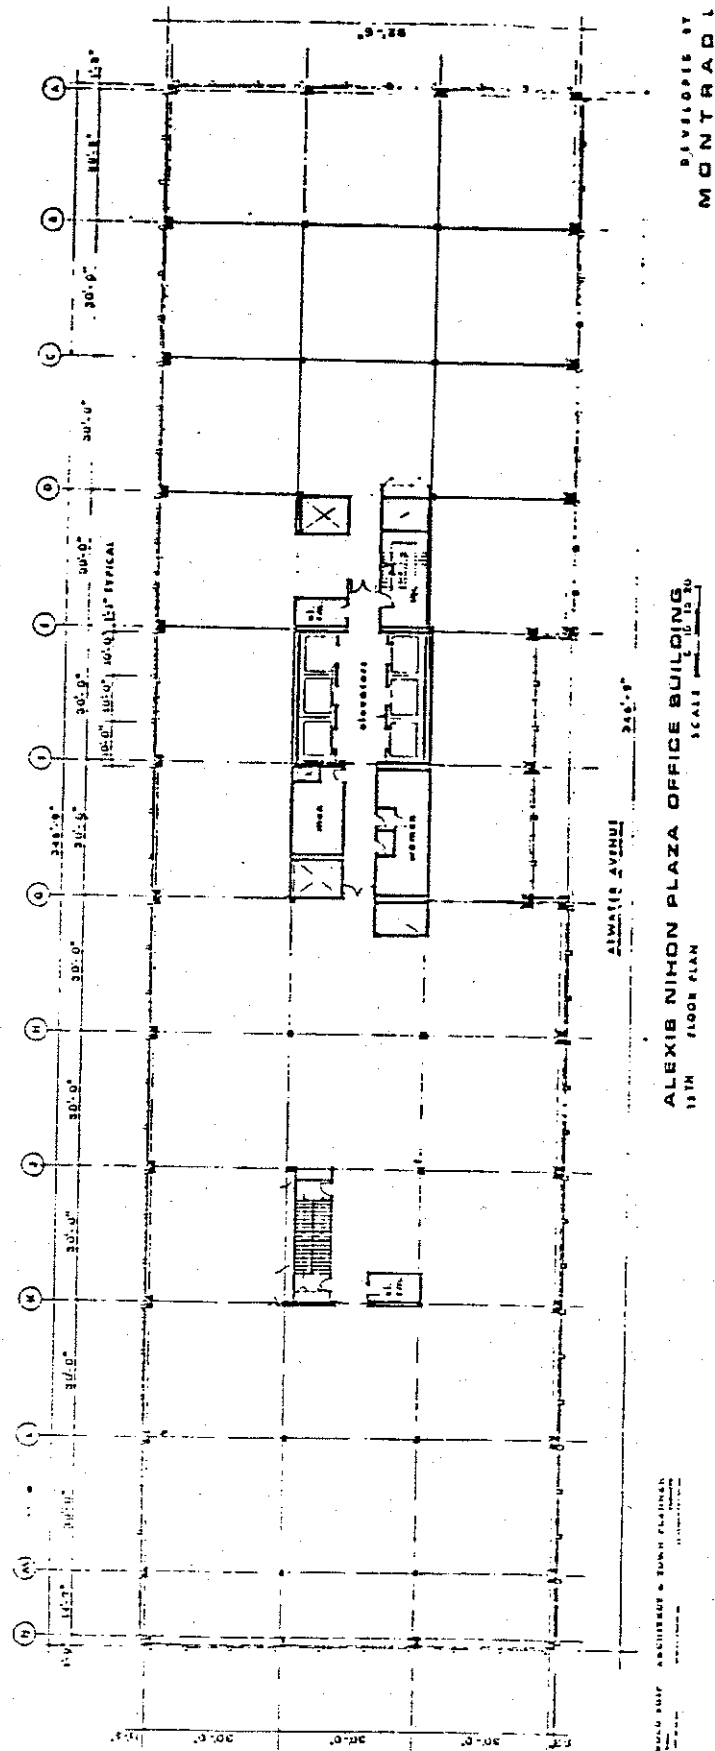
Fig. 3 Typical Floor Plan (suite separations not shown)

A typical office floor plan is shown in Figure 3. The floor area, approximately 27 m x 105 m (90 ft x 345 ft), is served by two stairshafts (hereafter labelled North and South) containing three separate exits (the South shaft contains two separate "scissors" stairs). A service core,

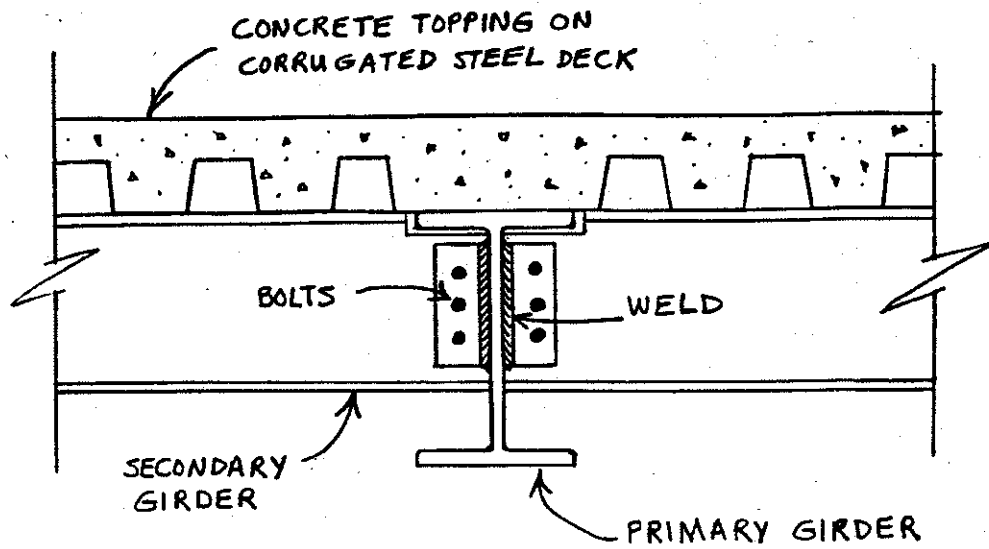
(a) Primary to secondary girder connection

All floor assemblies consist of concrete slabs on corrugated steel decks, supported by secondary structural steel I-beams, which are themselves attached to primary steel girders. The floor assemblies are attached to structural steel columns spaced 9 m (30 ft) on centre along both axes. The secondary to primary girder connections and girder to column connections all consist of double angle connectors bolted to the supported element, and welded to the supporting element (see sketch in Figure 4). The structural fire protection (2 h fire resistance-rating is specified in the 1960 edition of the NBC) is provided by a sprayed-on cementitious or mineral-fibre material. In his oral report, Michael Isner indicated that the thickness of protection, as observed on floors unaffected by the fire, is more substantial for the columns than the floor beams and girders. He reported having measured thicknesses of 32 mm on columns and 19 mm on beams and girders.
