FIRE TEST OF A "TRI-SEAL" FLOOR AND CEILING ASSEMBLY

FIRE STUDY NO. 5

This report describes a fire test conducted on a "Tri-Seal" floor and ceiling assembly of the Gypsum, Lime and Alabastine Limited, on November 11, 1959. The test was requested by the Toronto Office of the Gypsum, Lime and Alabastine Limited.

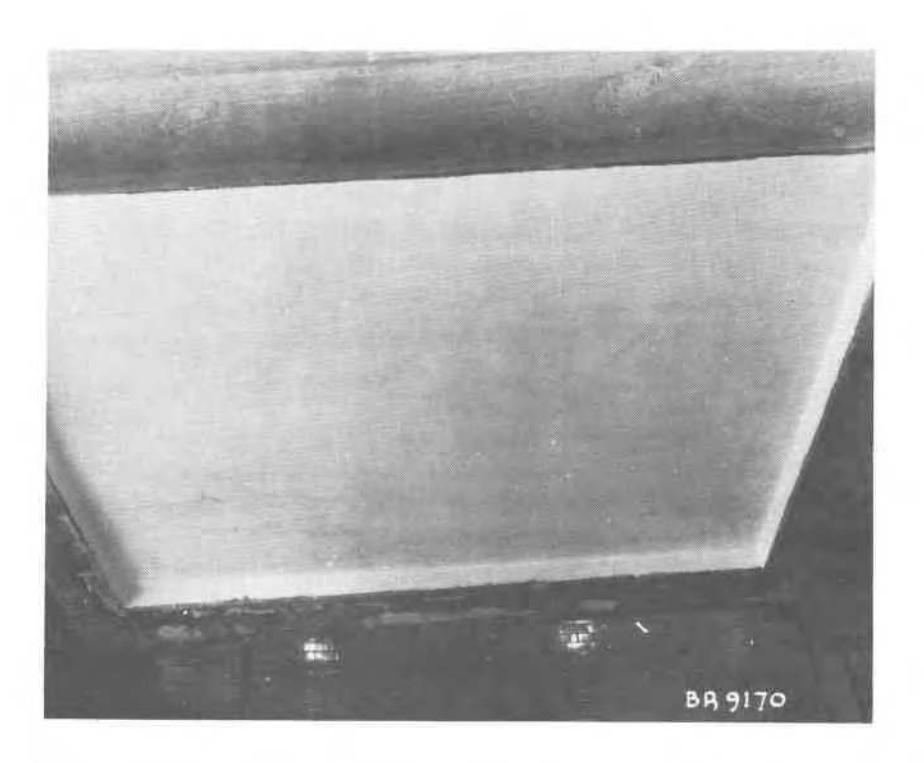
Figure 10 Plastered surface of the ceiling before the fire test

The plastered surface of the ceiling immediately before the test is shown in Fig. 10.
