THE WHITEHORSE ESCARPMENT

(Prepared for the Advisory Committee on Northern
Development, Department of Northern Affairs and
National Resources)

R.F. Legget and G.H. Johnston

Report No. 136
of the
Division of Building Research

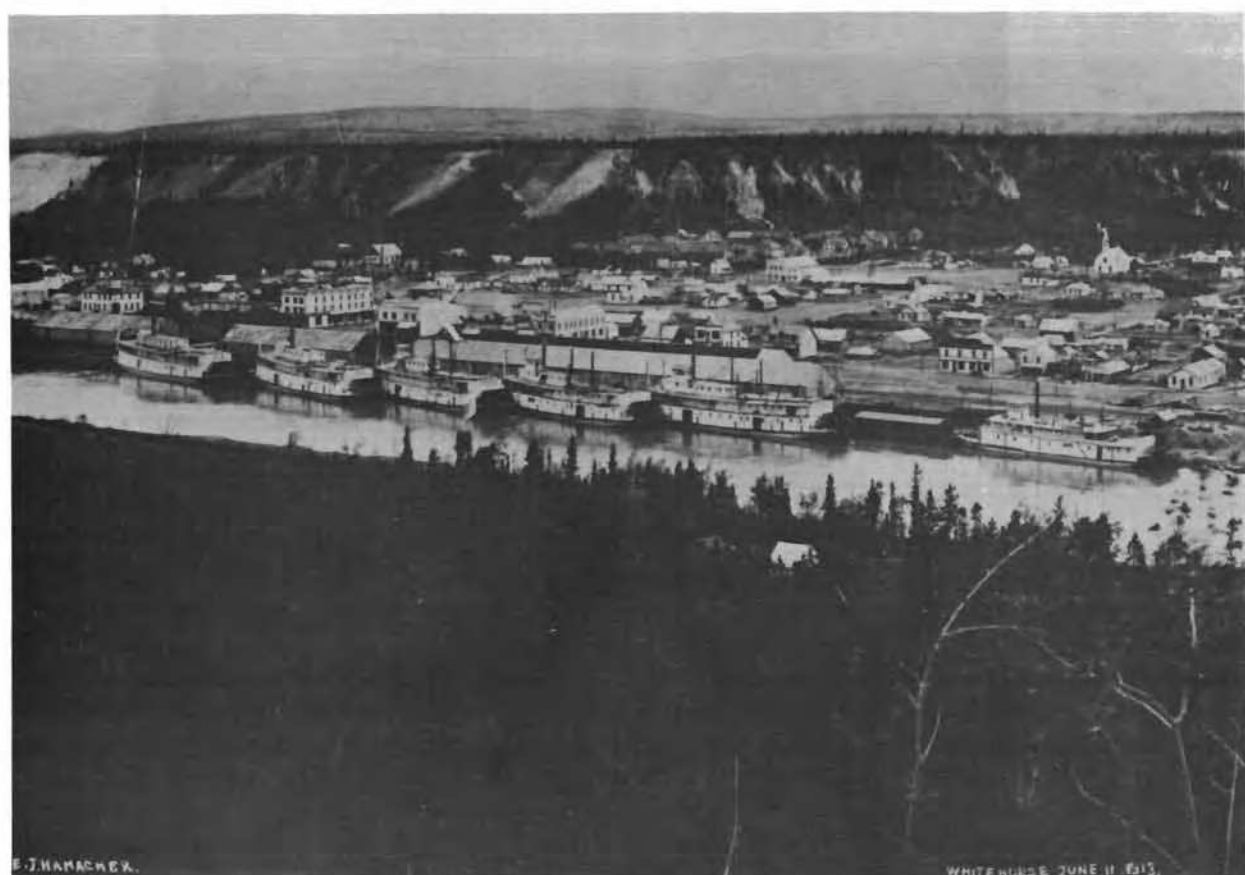
It can be seen from Fig. 1 (June 13, 1913) that those parts of the slope which then had no trees or standing vegetation had a surface cover of grass, which no doubt, is the same as the grass cover existing on similar slopes in the vicinity today. It will also be noted that what appear to be mud flows were even then taking place on the face of the escarpment but were minor and much less extensive compared to those occurring at the present time.

Figure 1. Whitehorse - June 11, 1913. Note "bridle path" on face of escarpment. (Photo taken by E.J. Hamacher; original print loaned by W.D. McBride, Whitehorse.)

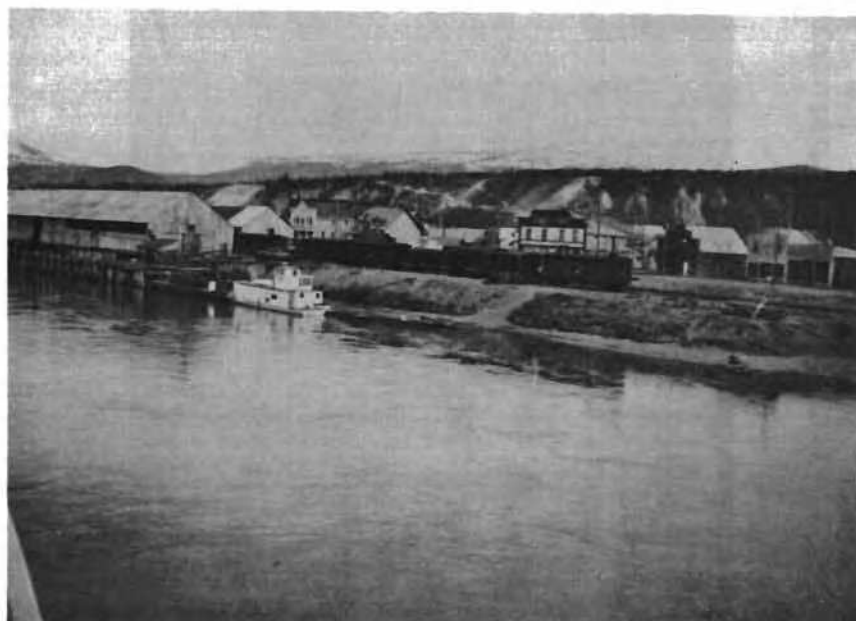
In contrast with what is shown on old photos (Figs. 1 and 4), which show the face of the escarpment in a relatively well-wooded condition, the vegetation today (Fig. 5) has been totally destroyed or at least badly disrupted on that portion from the southern extremity of the building area on the top of the escarpment to approximately a point in line with the cross runway or about 1,000 feet north of the northern limit of the building area. The total length of escarpment involved is about 4,000 feet.

Figure 4. Town of Whitehorse and escarpment, 1938. (Note "bridle path" and Whitepass and Yukon route access road to airfield.) (Geol. Survey of Canada photo No. 84601)

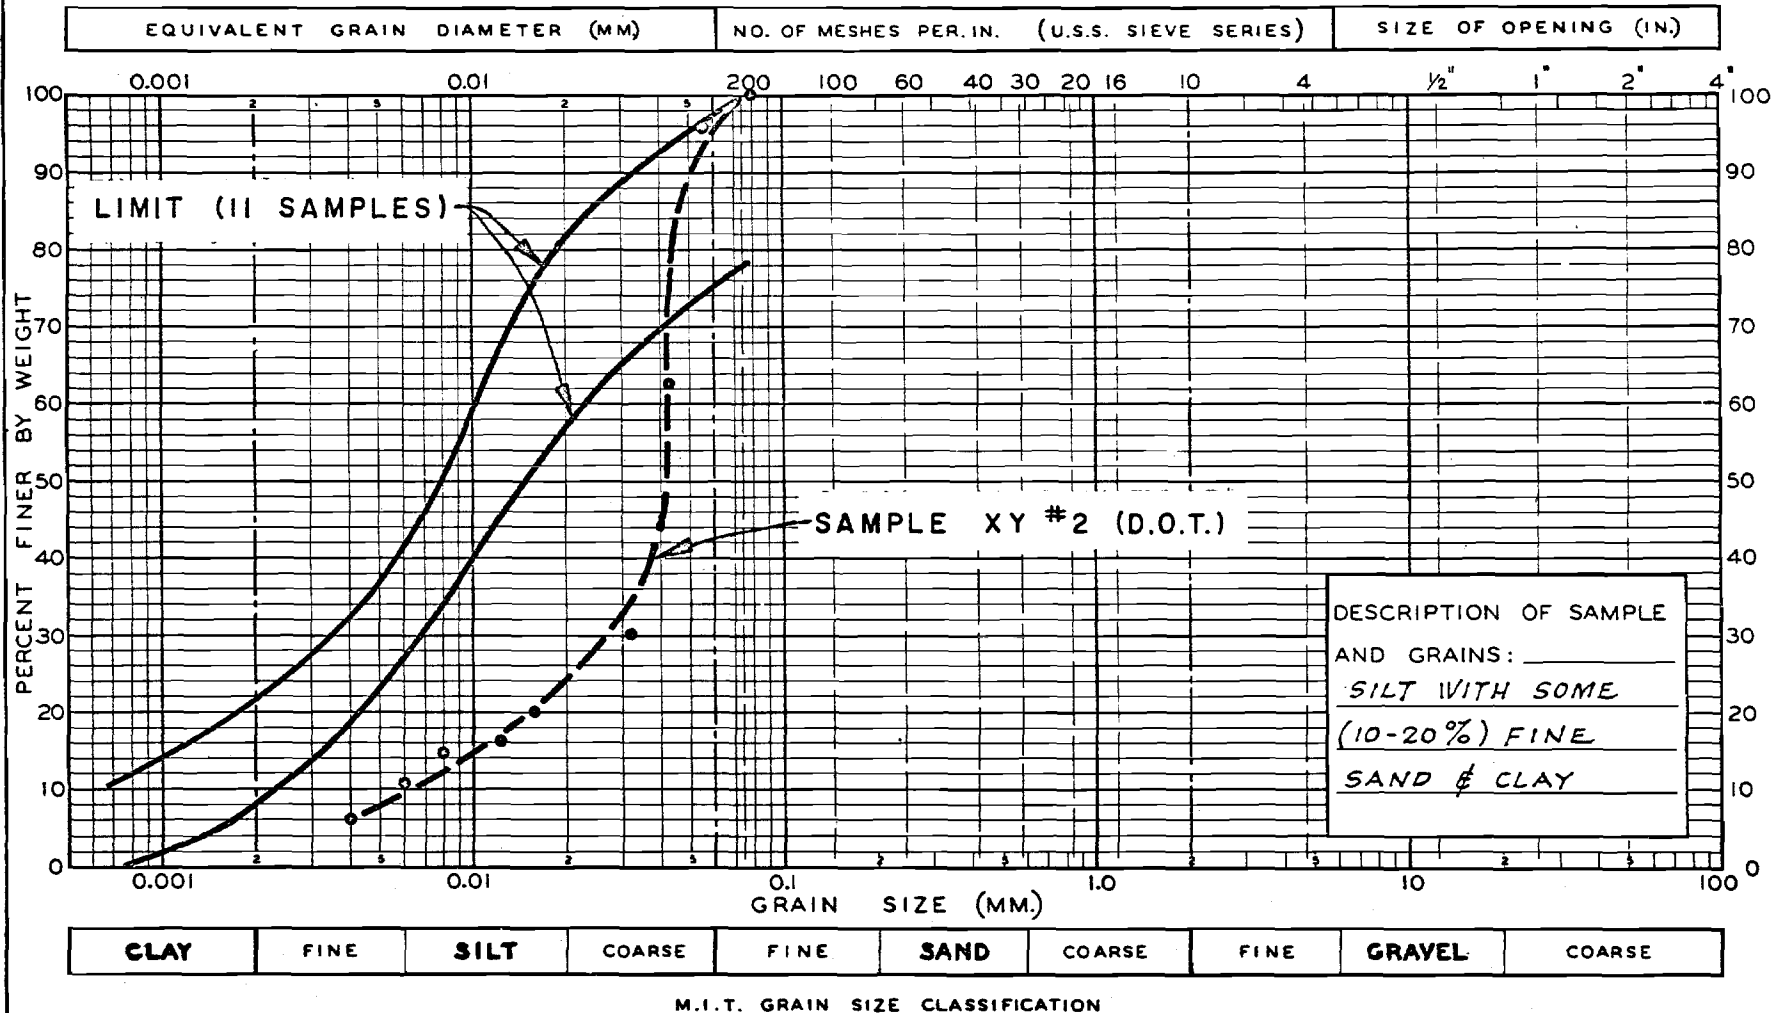
FIGURE E-2

WHITEHORSE SILT - GRAIN SIZE DISTRIBUTION LIMITS.
