Canadian & Cold Regions Rail Research Conference 2021, pp. 56-63, 2021-11-09

Rail failure root cause analysis on North American railway

Daniel Szablewski and Robert Caldwell
*National Research Council Canada Automotive and Surface Transportation,
Ottawa, ON, Canada*

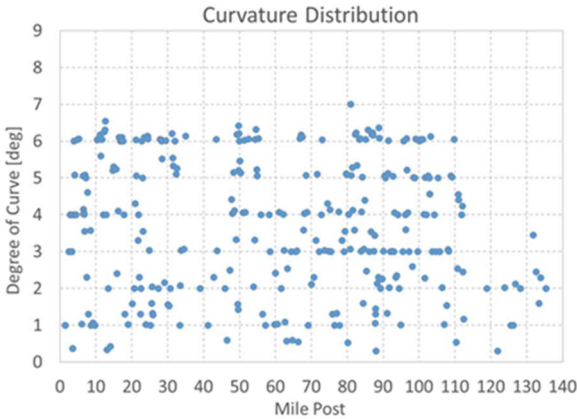
During this portion of the work the main focus was to understand the distribution of curves on the subdivision and to develop a better knowledge of the potential problem size. The degree of track curvature and respective length vs. mile post (MP) for the entire subdivision were mapped out. This showed that all curves were in the 1-7 degree range (Figure 3), and that they were mostly below 1,200 feet in length (Figure 4).

Figure 3. The degree of track curvature vs. mile post on the subdivision.

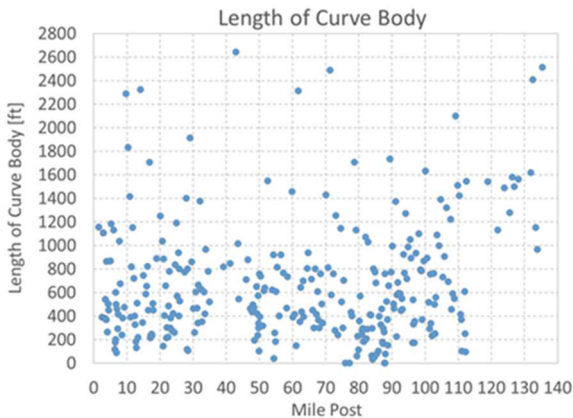
Figure 4. The length of each curve body vs. mile post on the subdivision.

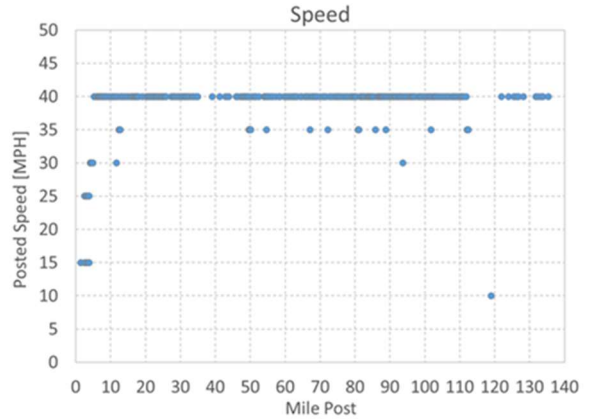
NRC also mapped the posted train speed for all the curve locations (see Figure 5). Based on that data the maximum permissible train speed was 40 mph. However, this speed was the timetable speed of the train. Rail profile measurements would indicate whether trains operated predominantly above or below the balanced speed. The differences between these two conditions are addressed in a later section of this work.

Figure 5. The posted train speed for curves vs. mile post for the subdivision.

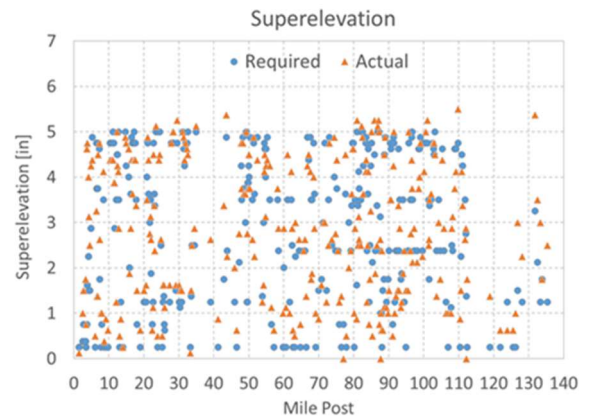
To understand the track geometry condition on the line, NRC plotted the 'required' (based on speed shown in Figure 5) and 'actual' track superelevations vs. MP (see Figure 6).

Figure 6. The 'required' and 'actual' track superelevation as a function of MP on the subdivision.

Both of these plots of superelevations vs. MP were essentially point clouds. However, mapping superelevation as a function of track curvature provided a much clearer understanding of its distribution in the subdivision (see Figure 7).

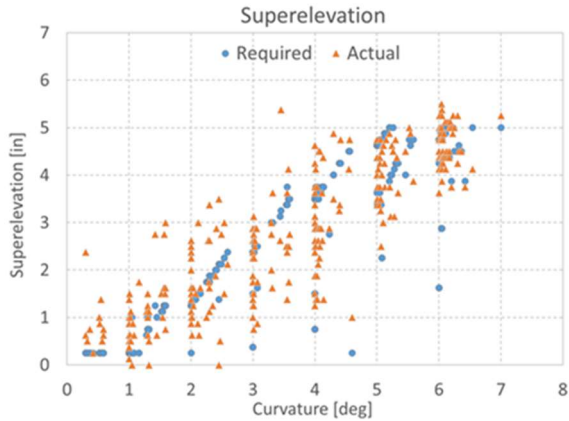
Figure 7. The 'required' and 'actual' track superelevation as a function of track curvature on the subdivision.

Seeing increasing superelevation with increasing curvature was a positive sign that superelevation was being matched to curvature to ensure balanced loading on the high and low rails at all times of train operation on the subdivision. However, as Figure 7 indicates, there was an observable difference between the designed (i.e. 'required') track superelevation and that present in track (i.e. 'actual'). This was an indication that the trend shown in Figure 7 was encouraging, but there were still many curves with incorrect elevation for the typical train speed.

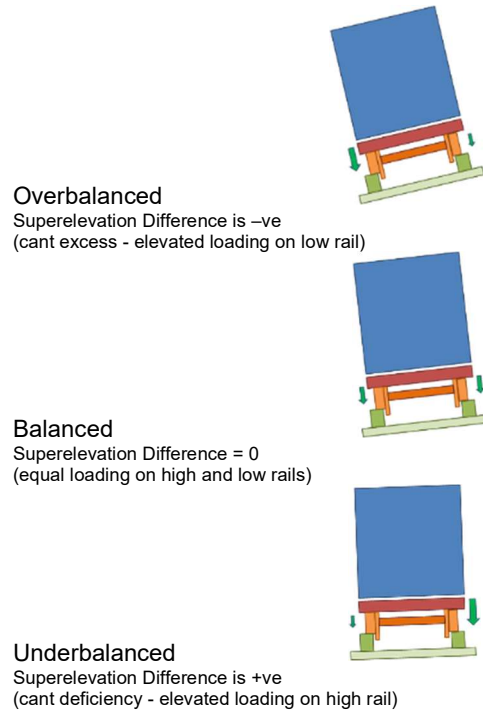
At constant train speed in a constant-radius curve the overbalanced condition occurs when the loading on the low rail is elevated (or excessive). This results in excessive wear and plastic flow on the low rail. On the other hand, an underbalanced condition occurs when the loading on the high rail is elevated (or excessive). This results in excessive wear and plastic flow on the high rail. Neither of these conditions is desirable, as it shortens the overall life cycle of the track, as well as increases track maintenance costs.

The ideal condition is to have equal loading on both rails, as this distributes the wear and plastic flow evenly on both rails, thereby maximizing track longevity and reducing overall maintenance costs.

Figure 9. Schematic representation of the overbalanced, balanced, and underbalanced rail loading conditions due to superelevation differences in a curve. High rail is the right hand rail in each diagram.

Therefore a cant deficiency increases loading on the high rail, and this loading increases as the positive difference increases. Curves in the 3-5 degree range are the ones that had the greatest cant deficiency, and therefore suffered the greatest elevated loading on their high rails (see Figure 8).
