Lifting fans for VTOL aircraft: Investigation into a quill-shaft failure in a 12 in. dia. gear-driven fan
Levy, G.G.; Rimmer, R.J.

SUBJECT Lifting Fans for VTOL Aircraft: Investigation into a Quill-Shaft Failure in a 12 in. dia. Gear-Driven Fan

TEST REPORT PM-68-22

FAILURE OF MODEL FAN DRIVE

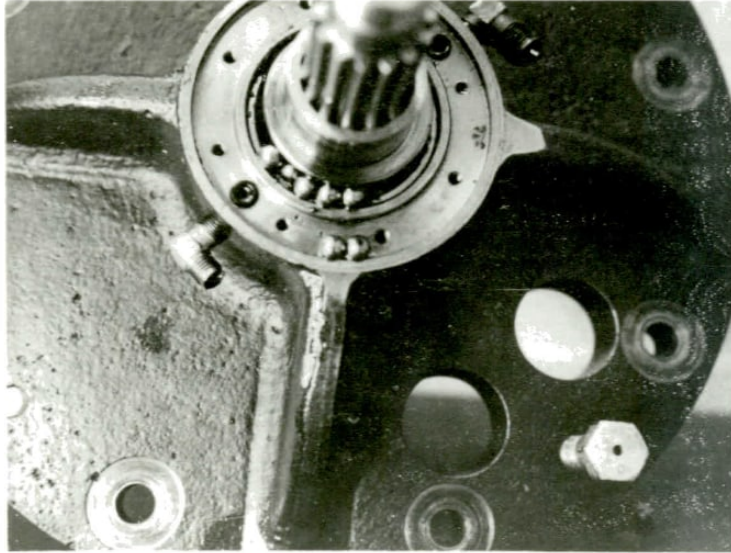
FIG. 4

The tips of 3 pinion teeth were chipped (Fig. 3) and there were damage marks on the housing adjacent to the pinion (Fig. 4).

DAMAGE MARKS ON HOUSING
