Drone Impact Damage Assessment on a Legacy Transport Aircraft Structure: Empennage Testing

Report No: LTR-GTL-2021-0002

Prepared for: Defence Research and Development Canada

Aerospace Research Centre, Gas Turbine Laboratory
January 18, 2021

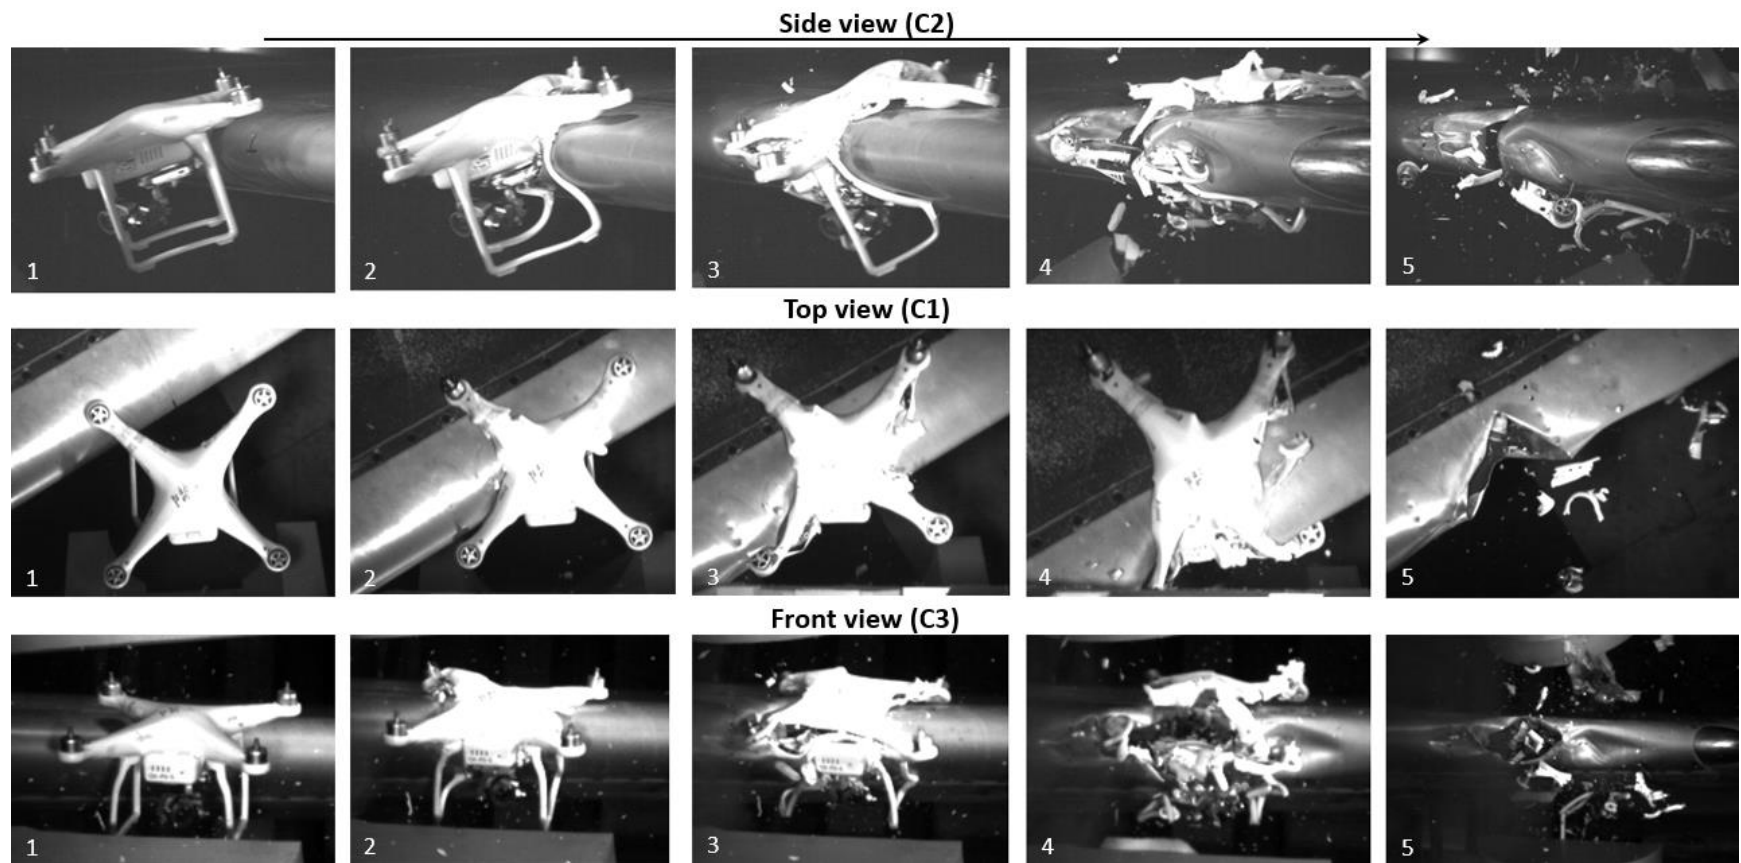
Figure 13: Drone/HS impact sequence (Test #1: HS-T1)

Figure 13 shows the sequence of images from Test #1 (HS-T1) of the drone impact with the horizontal stabilizer at a recorded speed of 128.2 m/s (249.2 kt). During this first test, the drone experienced an upward pitch angle of 18°. However, the yaw and roll angles were insignificant with approximate values of 5.5° and 2° respectively. The relatively high pitch angle caused the motors M1 and M2 to miss the HS leading edge. However, the shot was on target. The main body and legs of the drone impacted the HS first followed by the motors M3 and M4 respectively. While the main body and battery pack penetrated through the leading edge, M3 and M4 each caused damage and fell on to the ground as a result of the breakage of their arms. The drone camera module did not contribute to the impact as it snapped off its mount before the impact and passed under the HS.

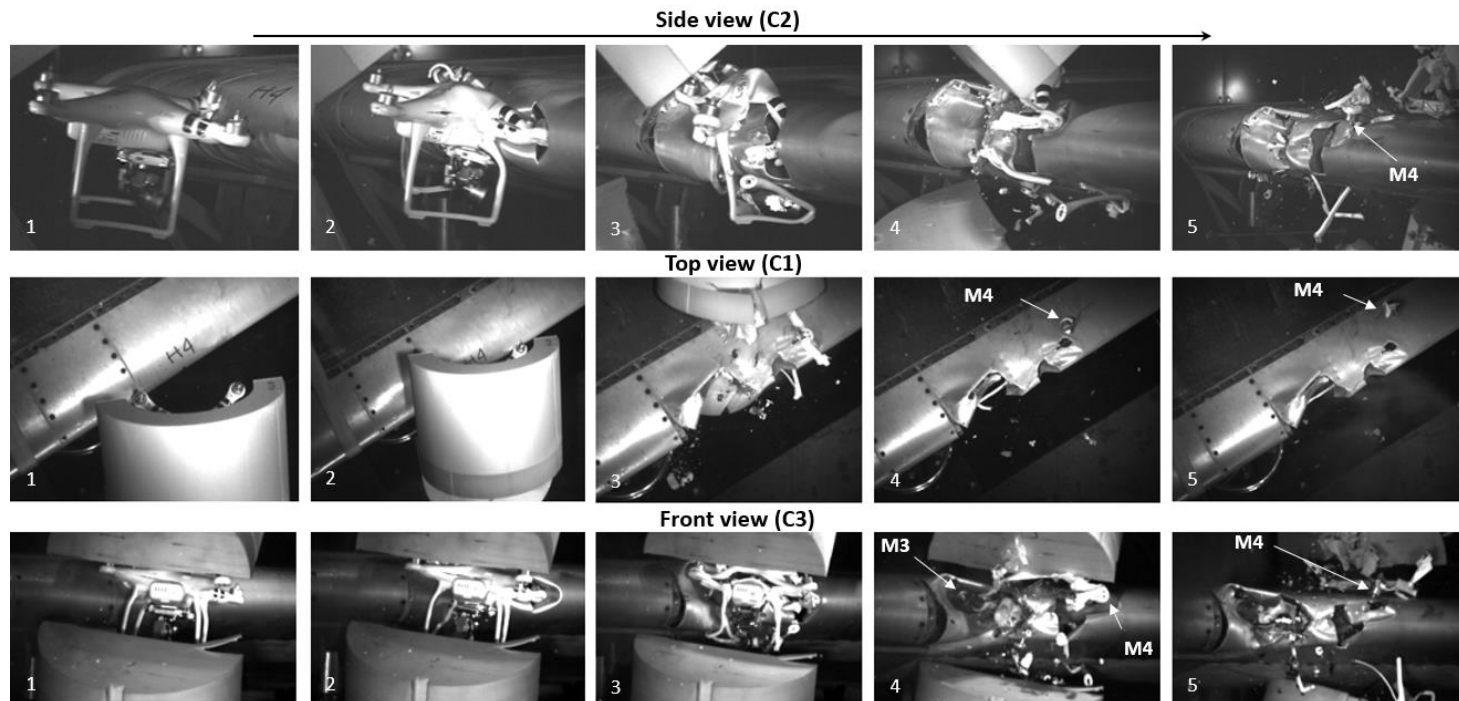
Figure 17: Drone-HS impact sequence (Test #2: HS-T2)

The shot was on target with a recorded impact speed of 126.4 m/s (245.7 kt) and resulted in a drone penetration into the leading edge. **Figure 17** shows frames extracted from the high speed camera videos. As opposed to the first test, the drone headed towards the target with a downward pitch angle of 9.5°. This resulted in a full impact by motors M1 and M2 with the leading edge. The yaw and roll angles were very limited with rotations of 5.5° and 5° respectively. Because of the HS sweep angle, the drone first hit the leading edge with motor M2, followed by M1 and then the main body. Motors M3 and M4 were the last to impact the leading edge as is clearly shown by the side view pictures. While motors M1, M2 and M3 penetrated the HS along with the battery pack, motor M4 punctured the leading edge and then deflected away as noted in the pictures extracted from the various high speed camera videos. The drone-mounted camera module missed the impact and continued its trajectory under the HS. Frames #2 and #3 of the C2 side view video show the drone camera as it passes under the HS.

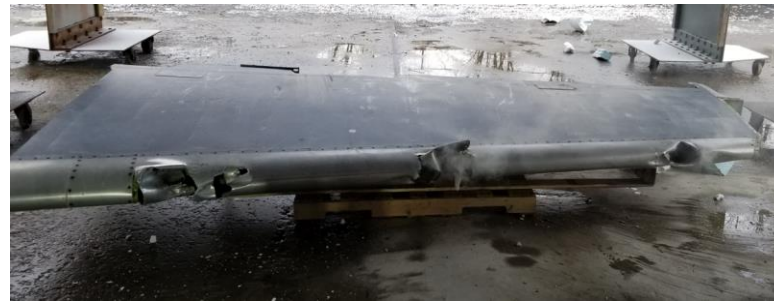
Figure 24: Test segment after impact

Figure 23 depicts pictures of the HS segment right after the test. The shot was on target at a speed of 126.4 m/s (245.7 kt). The drone penetrated the leading edge and the impact resulted in severe damage to its structure. The impact has also caused smoke to come out through the various openings of the HS. The smoke was dense and the fan was immediately employed to clear the test room. The HS segment was quickly dismantled and moved outside of the testing facility to prevent exposure to the smoke (**Figure 24**). Based on thermal images of the HS upper skin surface of the structure adjacent to the rear spar, the temperature was 104°C (219°F) suggesting ignition of the battery cells near this location. The outdoor ambient was near freezing with a wind both of which were contributing towards cooling the structure.

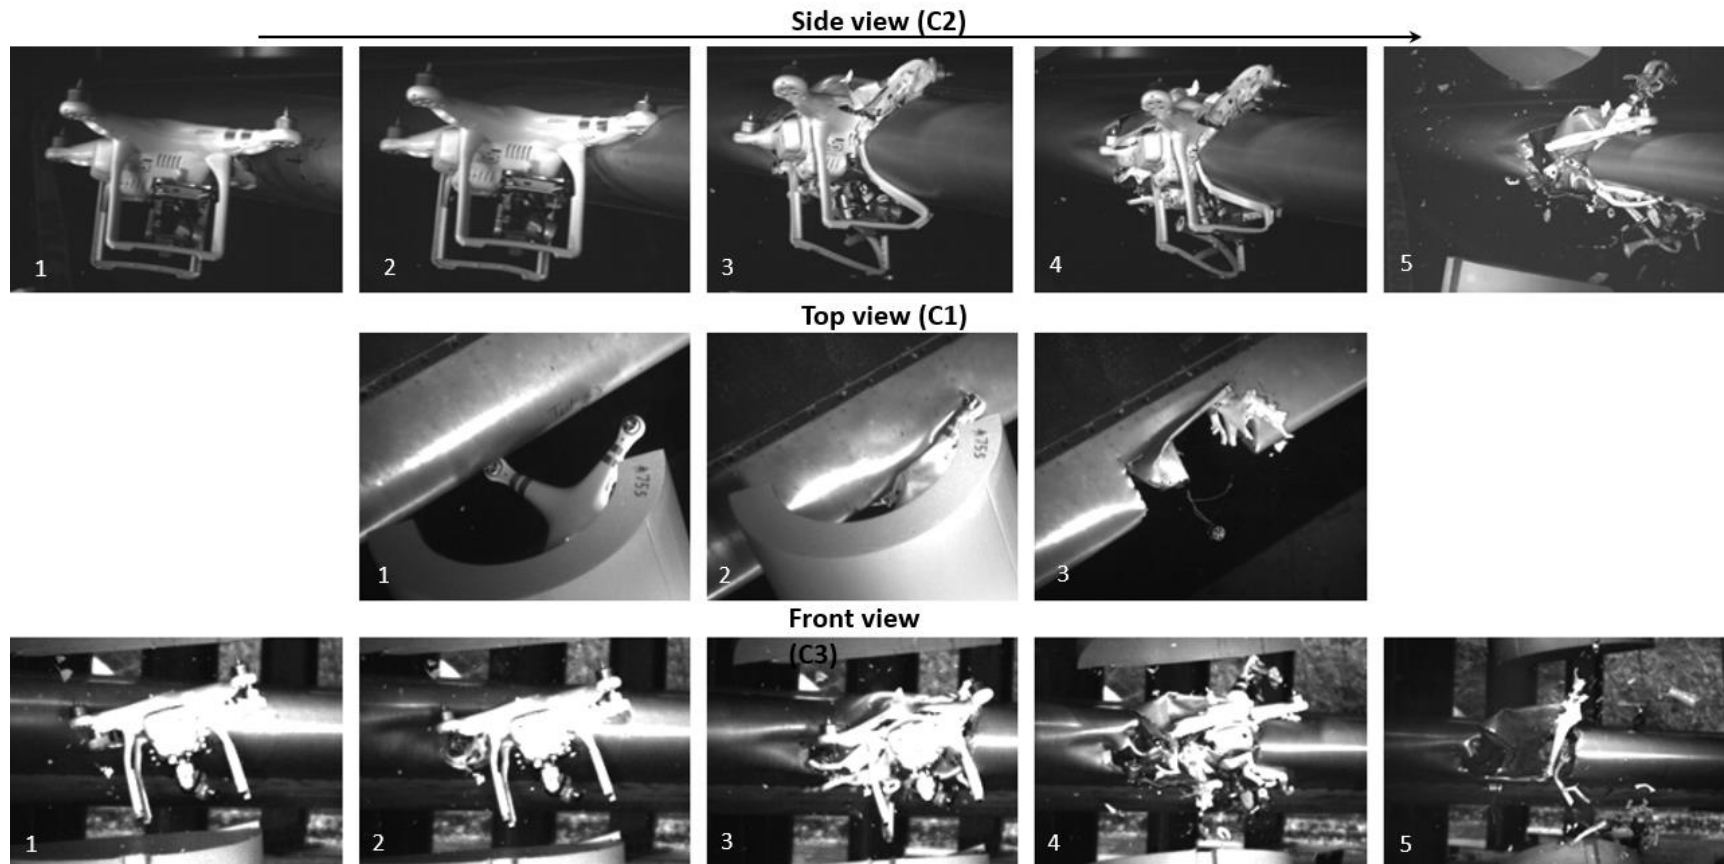
Figure 25: Drone-HS impact sequence (Test #3: HS-T3)

Figure 25 shows the impact sequence for this third test from the three camera positions. The sabot separation was slightly delayed which led to the sabot upper part obscuring the view of the impact sequence from the top camera (C1). However, the side and front cameras (C2 and C3) captured the main impact scene. As opposed to the first two tests, the drone exhibited higher yaw and roll rotation angles: 15° for the yaw and 13.5° for the roll. This could have been due to the slight weight differences between the test drones (~ 60.9 g) and mass distribution. The pitch angle was very close to that recorded for HS-T2 with a value of 7° (downward).

a leading edge rib (LER 21). As the rib locations represent the stiffest points of the leading edge structure, the motors caused dents but did not penetrate: M2 featured a free fall after the impact whereas, M1 was deflected away towards the trailing edge of the horizontal stabilizer. The drone legs and M3 were the last to hit the leading edge. The drone arm containing M4 broke completely and caused the motor to divert from the leading edge. The camera module was still attached to the drone during the impact and passed under the leading edge.

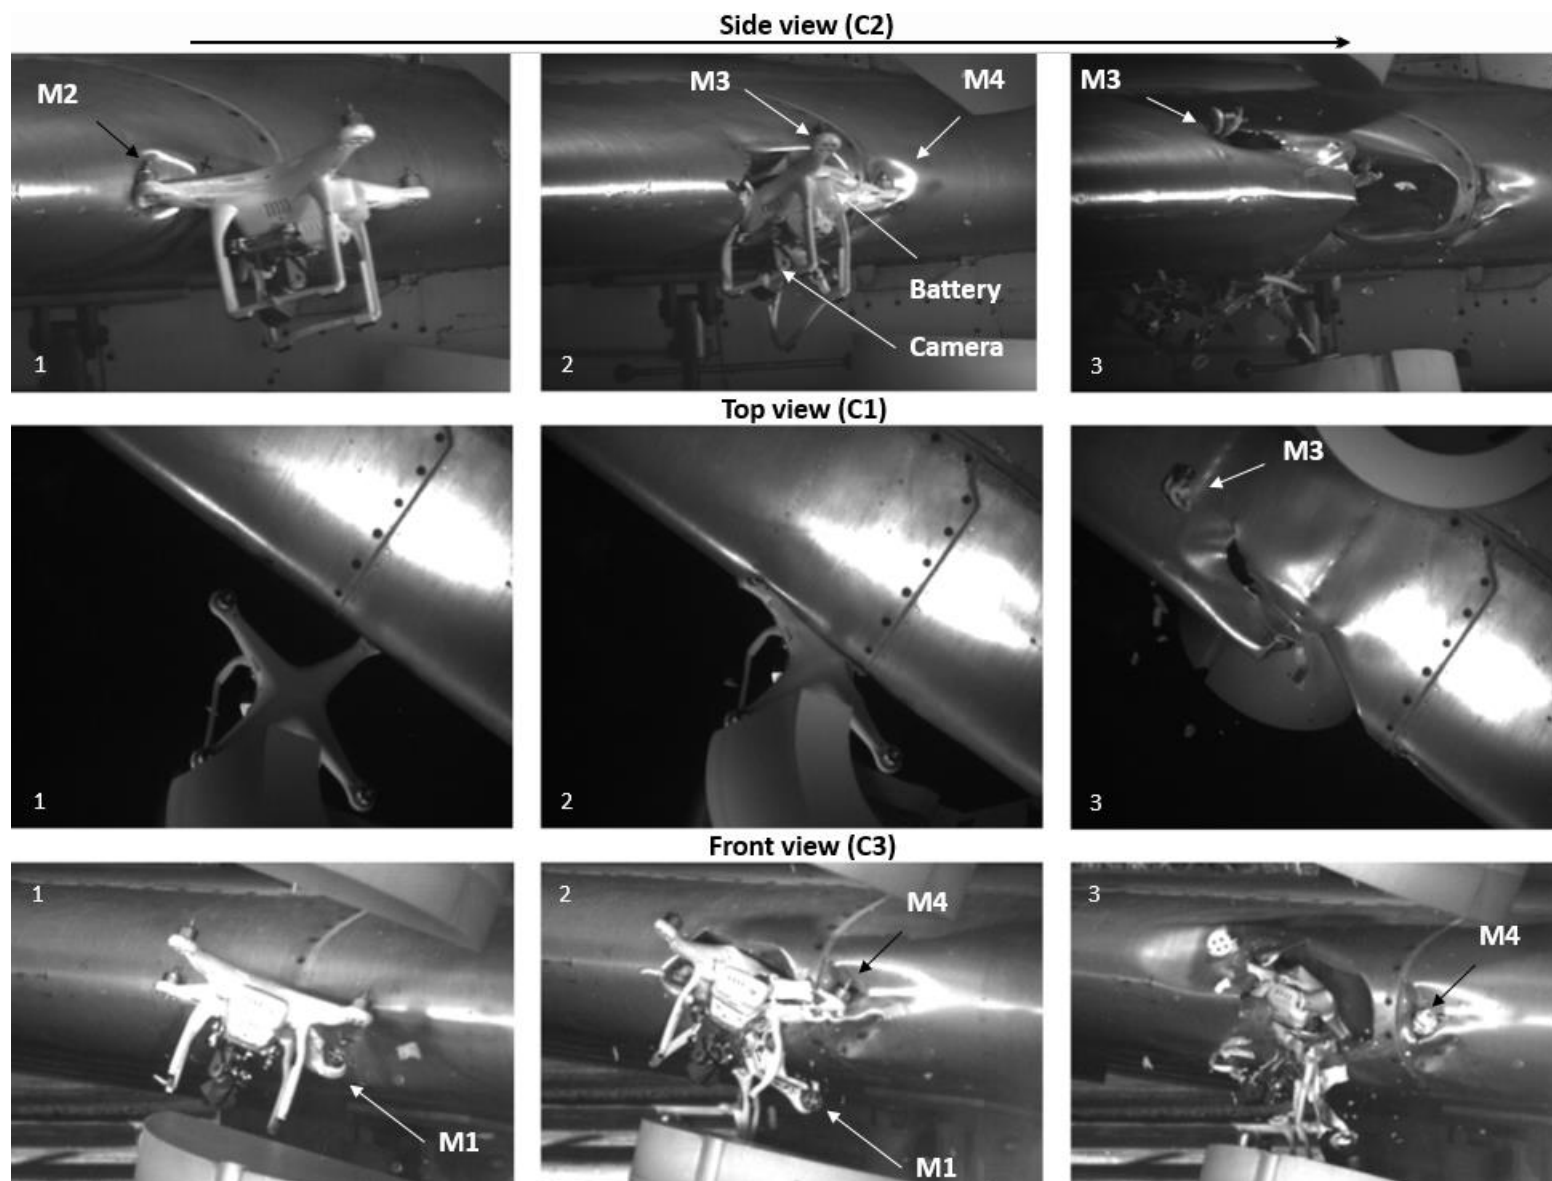
Figure 30: Impact sequence (HS-T4)

The central segment of the empennage was properly aligned with the centerline of the cannon allowing the HS segments to be at their correct sweep angle of 40°. The drone was launched with a discharged battery. The impact was on target at a speed of 126.4 m/s (254.6 kt). This test featured a drone rotation of about 14° in all directions (pitch: 13.5°, yaw: 14° and roll: 15°). The drone hit the leading edge in the following order: M1, M2/main body, legs, M4 and finally M3 as depicted in the frames extracted from the high speed camera videos (**Figure 30**). The drone's downward pitch and clockwise roll rotations caused M1 to hit the leading edge under the apex. The motor did not penetrate the leading edge but caused a deep dent on its skin. The drone arm holding M1 broke upon collision with LER3. M2, the drone main body with battery and M4 impacted the apex of the leading edge and penetrated the HS. The arm containing M3 impacted LER3 and broke. This caused M3 to roll over, tear the leading edge skin and then deflect away from the HS. The camera module passed under the HS and did not contribute to the impact.

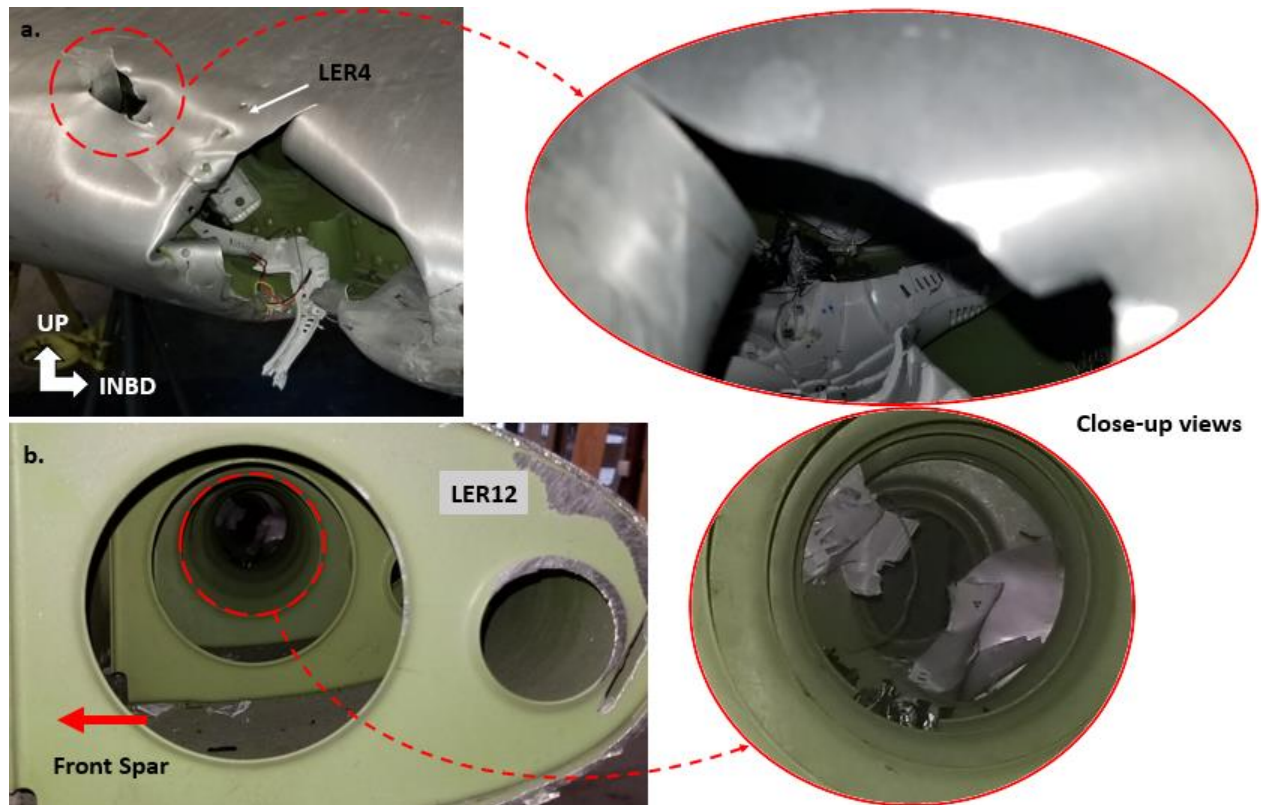
Figure 34 : Drone structural debris (HS-T4)

Figure 33 shows pictures of the damage incurred to the HS interior structure. LER3 was deformed and LER4 suffered severe damage and fractured at two locations. LER 5 was also deformed and disjointed from the lower skin surface. The front spar was also deformed in the vicinity of a lightening hole. Similarly to the previous tests, the battery pack passed through the lightening holes of the front spar, caused damage to the internal structure and landed near the rear spar of the HS. **Figure 34** shows damage to the leading edge as viewed from above (a) and debris of the drone body found inside the damaged section of the leading edge (b) as viewed from the side through the lightening holes of the LE ribs (looking inboard).

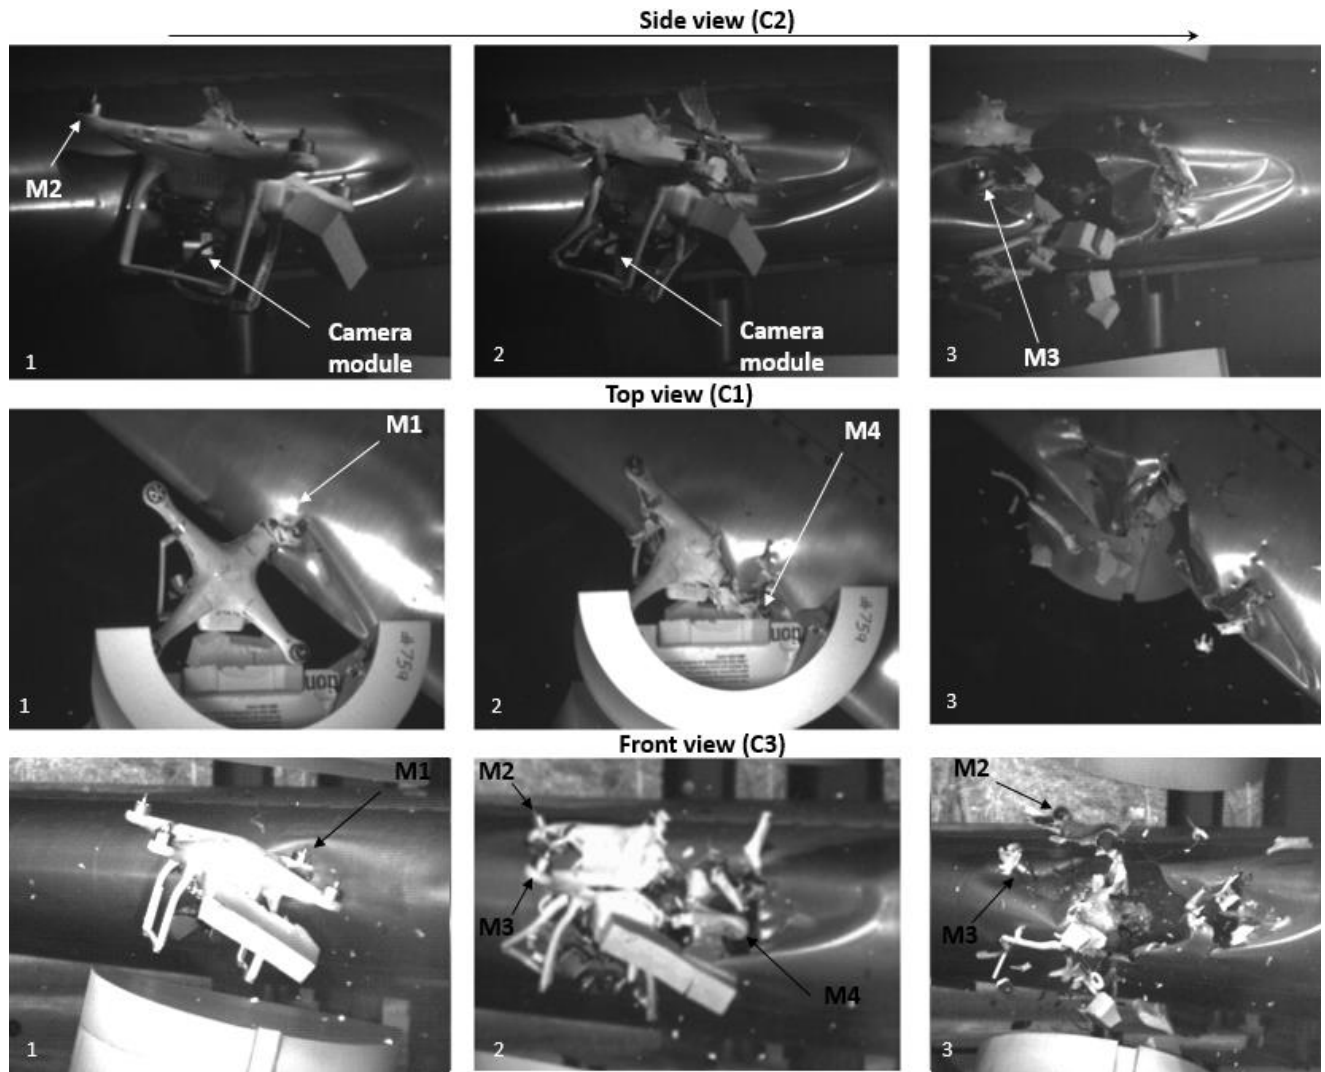
Figure 36: Impact sequence (HS-T5)

The drone impacted the leading edge on target at a speed of 132.3 m/s (257.2 kt) and penetrated the HS. **Figure 36** shows frames of the impact sequence extracted from the high speed camera videos. Compared to the fourth test, the drone exhibited an upward pitch rotation of 9° and only a slight yaw rotation angle (2°). However, the roll angle was similar in direction (clockwise) and amplitude (16°). Motor M1 was the first to impact the leading edge close to LER7, followed by the main body/battery, legs, M2 arm, camera module, M4 and finally M3. M1 deformed the leading edge section between LER6 and LER7, pierced the skin and lodged inside the HS. Its arm broke off upon contact with LER7. The roll angle caused M2 and its arm to graze the upper surface of the leading edge skin and then deflect above the HS. The main body/battery, camera module and M4 tore and penetrated the leading edge. M3 was the last component to impact the HS. Its arm broke on contact with LER8. The motor hit the leading edge past LER8, rolled over, ripped the LE upper skin surface and then deflected away from the leading edge.

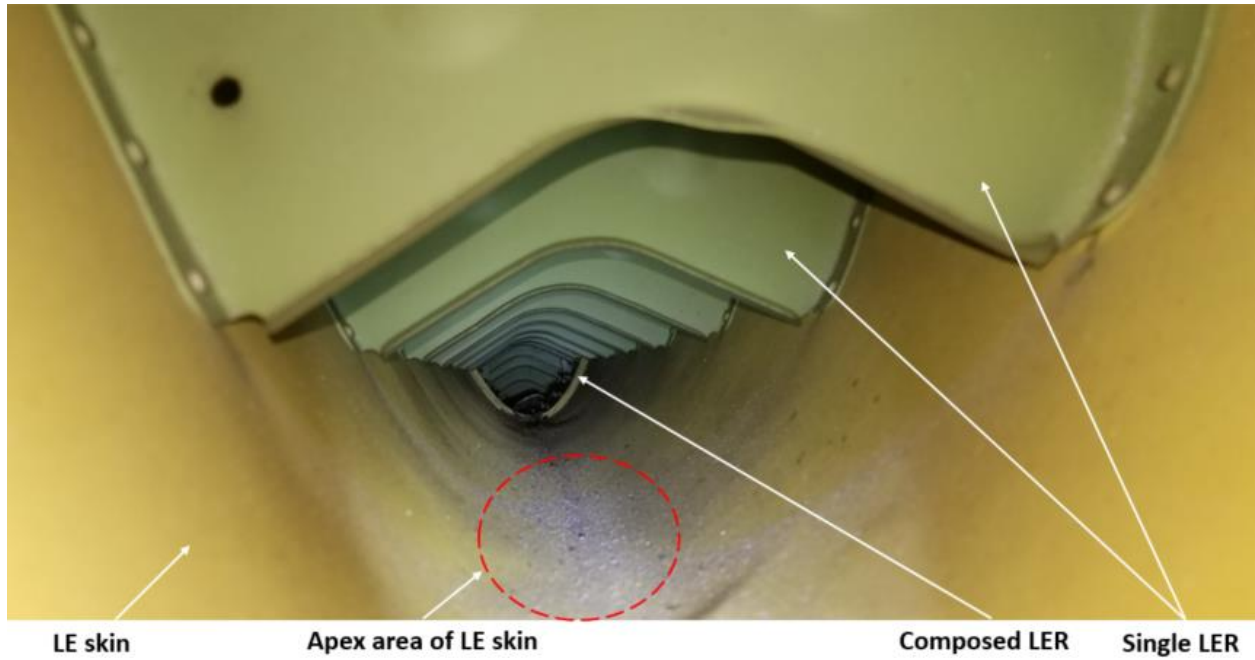
Figure 42: Leading edge inner structure

It is important to note that the structure and size of the ribs vary depending on their location and structural functionality. **Figure 42** shows an inner picture of the leading edge viewed from its exposed side of the lower panel (**Figure 41**). The LERs can be categorised as either single or composed. The single ribs are mounted to the leading skin with a single row of rivets on each side of the rib as depicted in **Figure 43**. The apex area of the leading edge is not supported by the rib. However, the composed ribs provide full support to the leading edge internal surface. **Figure 44** depicts a composed LER mounted to the leading edge with a single-row of rivets. On the other hand, **Figure 45** shows partial pictures of composed ribs assembled to the leading edge with a double-row of rivets. The structure of the latter ribs may also differ as the figure shows.

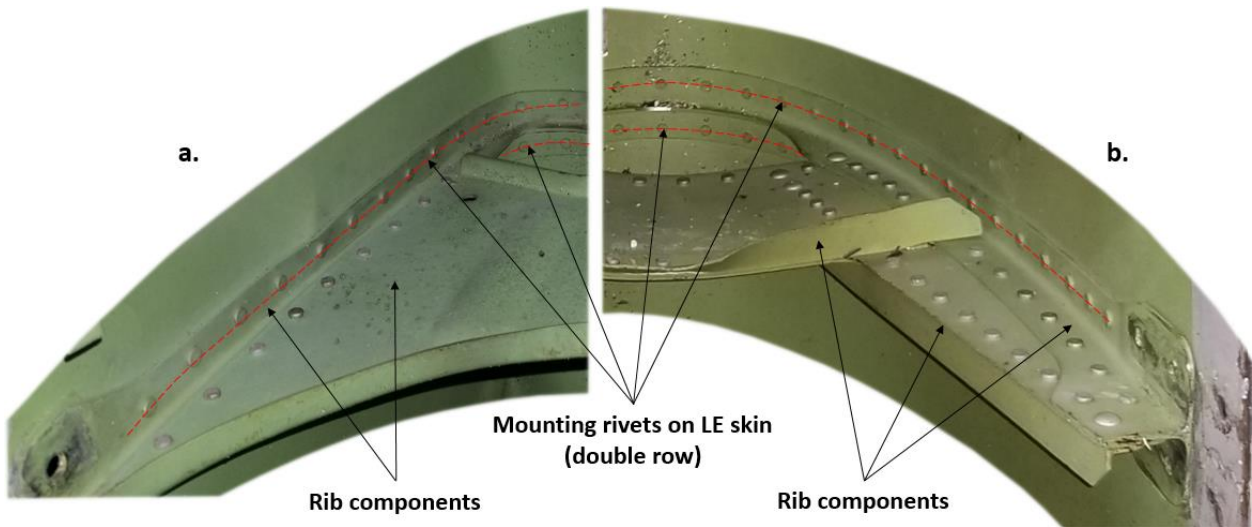
Figure 45: Composed leading edge rib (double-row rivets)

The target for the vertical stabilizer test (VS-T1) was located between LER2 and LER3. The former is a single rib whereas, the latter is a composed rib mounted to the LE with a double row of rivets (**Figure 45a**). **Figure 46** shows the test setup for VS-T1.

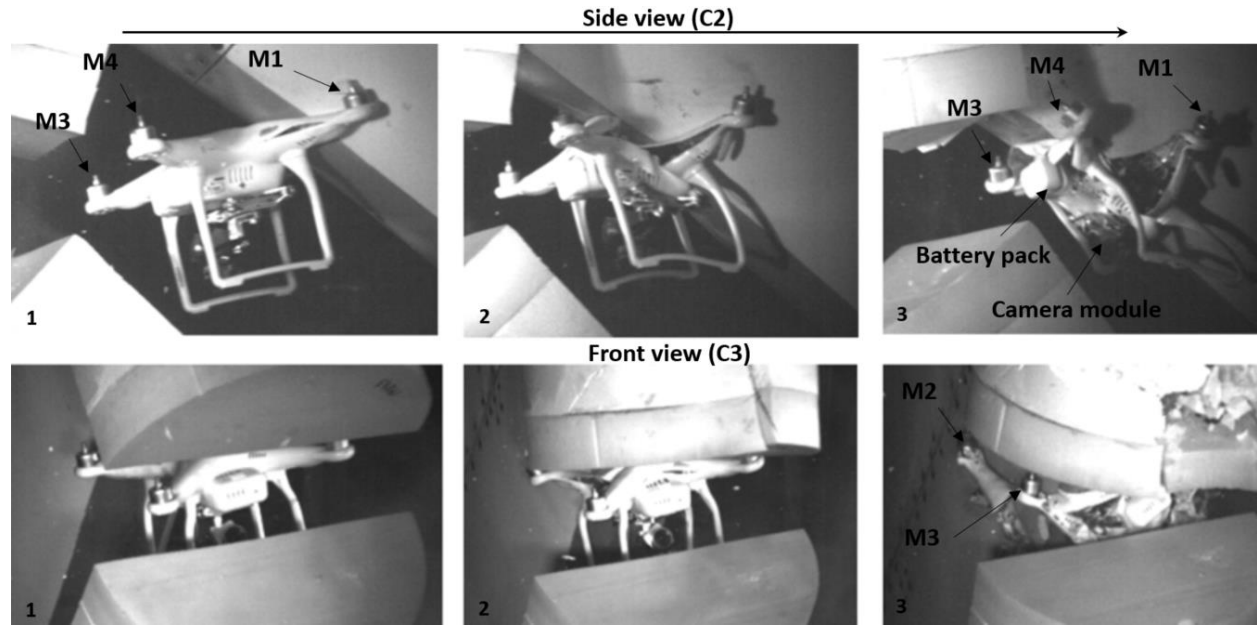
Figure 47: Impact sequence (VS-T1)

The drone hit the leading edge on target, closer to LER2, at a speed of 130.7 m/s (254.1 kt). The impact caused a tear in the leading edge skin without penetration by any of the drone components. **Figure 47** shows frames of the impact sequence extracted from the high speed camera videos located at the side (C2) and front (C3) of the test segment. The orientation of the test segment with the layback angle of 59° obscured the view of the impact sequence from the top camera (C1). As the images show, the main body of the drone impacted the leading edge of the VS with an upward pitch angle of 9.5° and a counter clockwise roll angle of 9° . The motors of the drone missed the leading edge due to its parabolic curvature and the orientation of the VS. The arms of the motors broke off upon impact with the LE and were deflected to the sides of the VS. As a result, the motors impacted the inboard segments of the horizontal stabilizers and caused collateral damage as depicted in **Figure 48** and **Figure 49**. The collateral damage on the HS segments was not very significant as one can notice. The trajectory of the motors could also be different in a real case due to the air flow, which was not considered for this test.

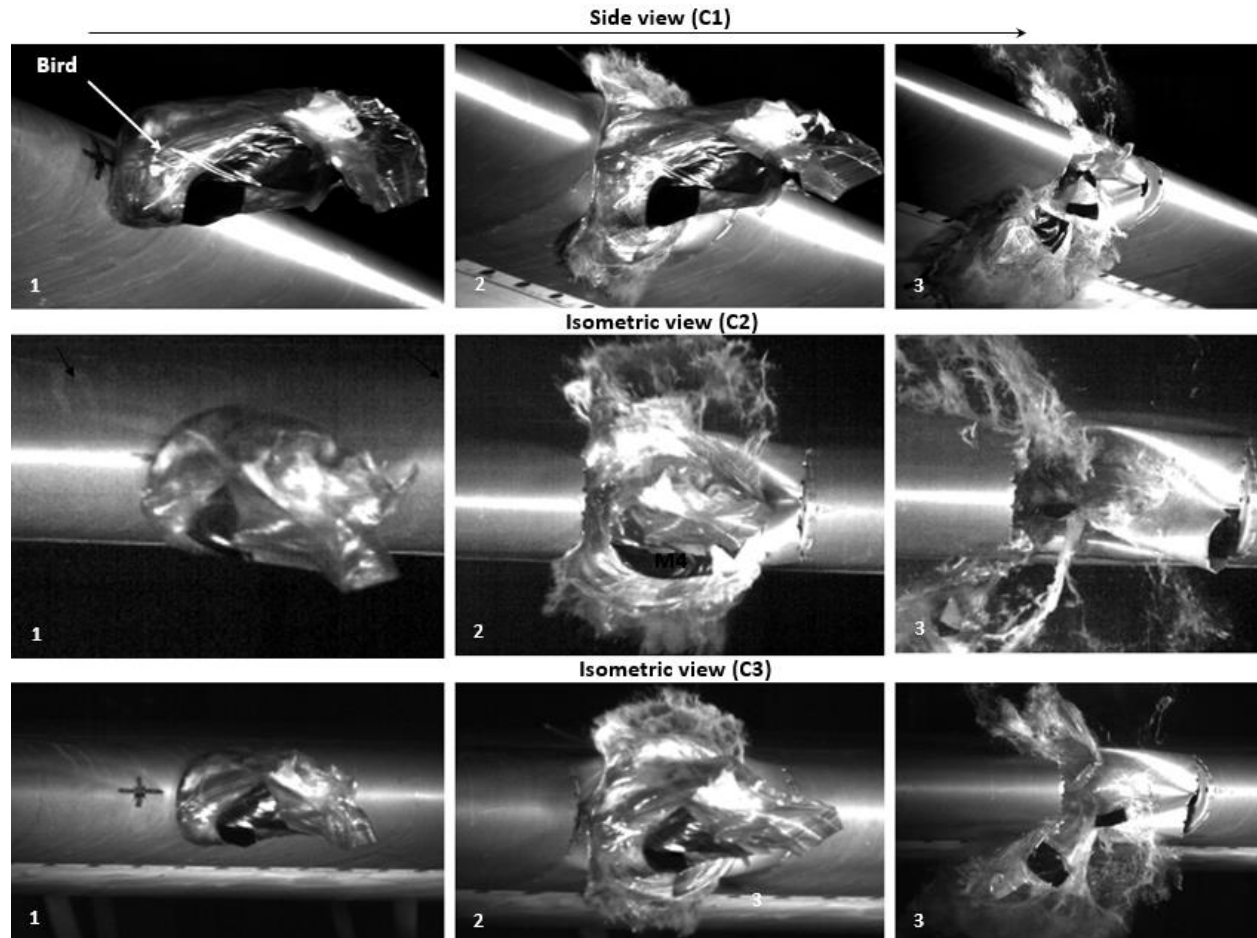
Figure 54: Selected high speed camera frames of bird impact (HS-T6)

The bird impact was on target at a speed of 128.4 m/s (249.5 kt). The bird penetrated the leading edge of the HS and caused permanent damage as shown in the impact sequence images extracted from the high speed cameras C1, C2 and C3 (**Figure 54**). The damage extended over a distance of 24.5 cm (9.6 in) between the leading edge ribs as shown in **Figure 55**.

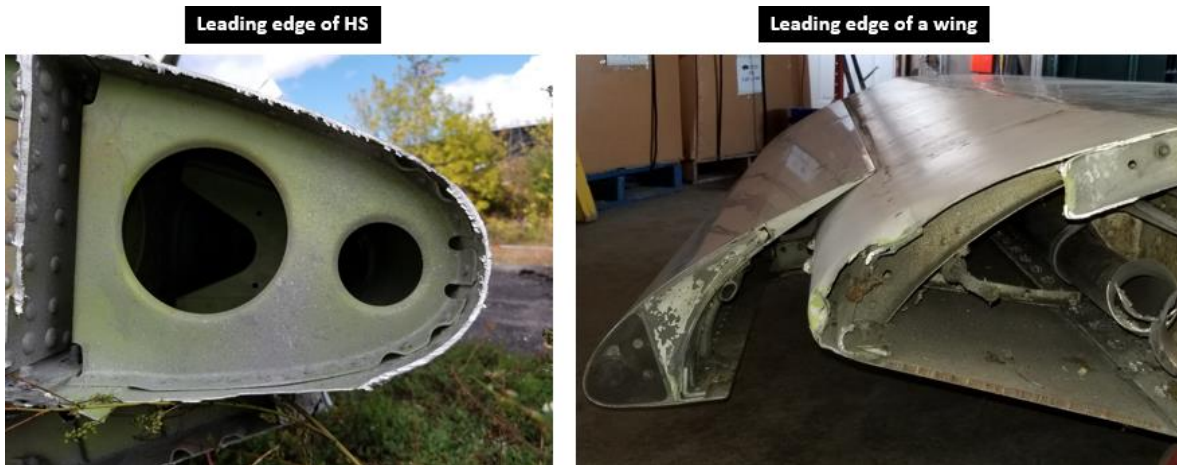
Figure 57: Leading edge of HS vs. wing

It is also worth noting that the damage incurred to a wing leading edge, reported in a previous study [2], was less significant compared to that on the horizontal stabilizer at the same impact speed. The difference in structure of both segments is shown in **Figure 57** and explains the difference in damage severity as a result of drone impact.
