De-icing flight tests of a Boeing-Vertol 107-II helicopter: part 2: 1962/63 tests

AERONAUTICAL REPORT
LR - 382

DE-ICING FLIGHT TESTS
OF A BOEING-VERTOL 107-II HELICOPTER
PART 2-1962/63 TESTS

BY
G. A. GIBBARD AND R. D. PRICE
DIVISION OF MECHANICAL ENGINEERING

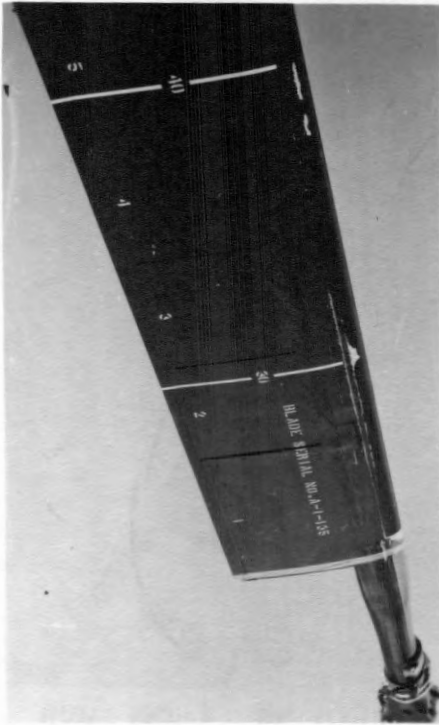
RUN 181-1 FRONT ICEGUARD BLADE

EXAMPLES OF SHEDDING FROM ROTOR BLADES

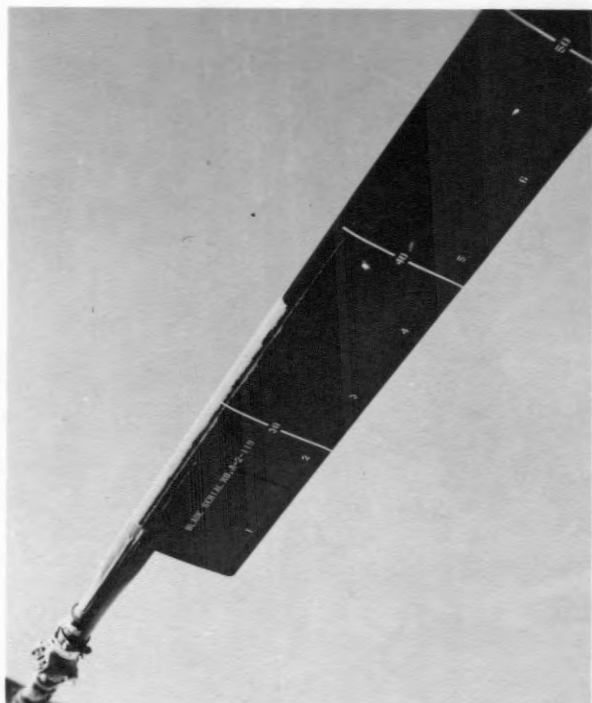
RUN 190-4 DE-ICING OF AFT
SPRAYMAT BLADE A-2-119

COMPARISONS BETWEEN THE
SHEDDING OF ICE FROM SPRAYMAT AND ICEGUARD HEATER ELEMENTS
