### Survey of basements in Aklavik

A SURVEY OF BASEMENTS IN AKLAVIK

Report No. 114  
of the Division of Building Research

February, 1957

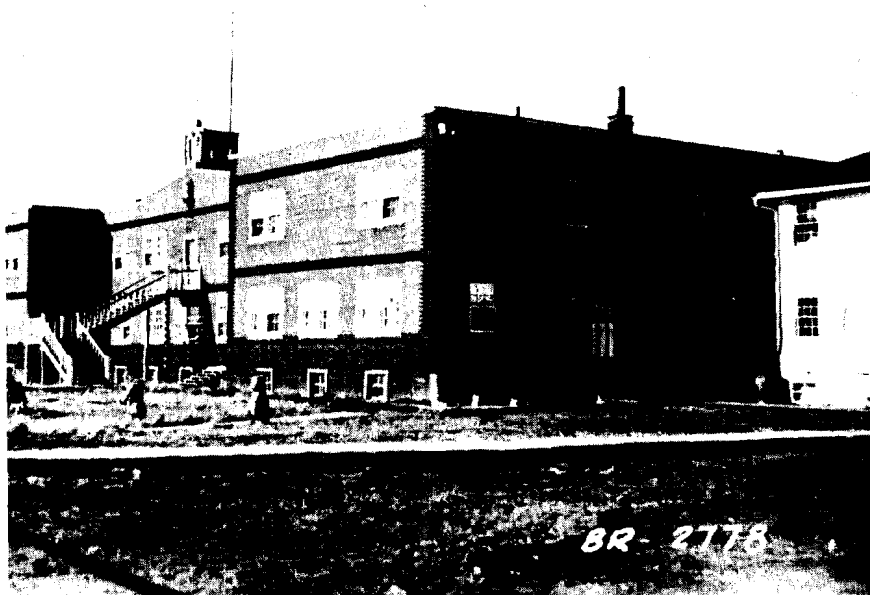
Figure 4 R.C. Mission School

Remarks: Father Biname reported that for several years after the building was constructed there was considerable seepage of water into the excavated space beneath the building. Initial seepage into the excavated area was removed by a siphon; later the incoming water was controlled by pumps.

Father Biname also stated that this seepage was accompanied by general settlement of the soil in the area beneath the building which led to considerable movement of the log surface foundations and a cave-in of the logs lining the walls of the excavated space. The building had to be re-levelled at frequent intervals during this period.

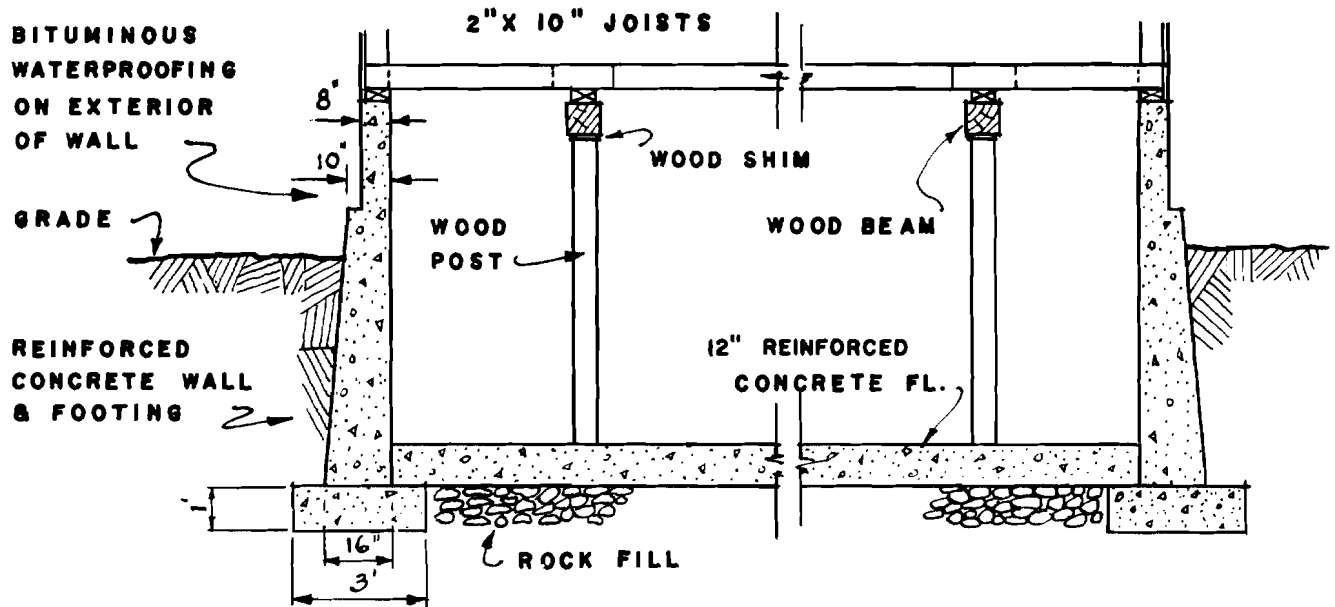
FIGURE 5   BASEMENT SECTION

Basement Details: (Fig. 5). The floor of the basement is 12 inches of unreinforced concrete placed over a rock fill. The concrete walls, 8 inches at the top and 16 inches at the base, are reinforced and are supported on a continuous concrete footing. The floor above is carried on 2- by 10-inch joists, 8- by 8-inch and 10- by 10-inch wood beams, and posts at 12-foot centres.

Condition: The basement of this building is generally in good condition. The concrete floor is rough in a number of spots apparently due to the application of a new concrete topping which was too thin and has been breaking up and scaling off.

There are a few cracks in the floor but none are serious. One crack, along the middle third of the building about 3 feet from the south wall, suggests that this wall has undergone some settlement and caused the floor near it to tilt and crack. Movement of this south wall is reflected in the shimming which has been necessary under the floor joists at their point of support on the wall. Minor shimming was also necessary under beams at the top of posts. The basement was dry, although water stood in the sumps to within a few inches of the floor level.

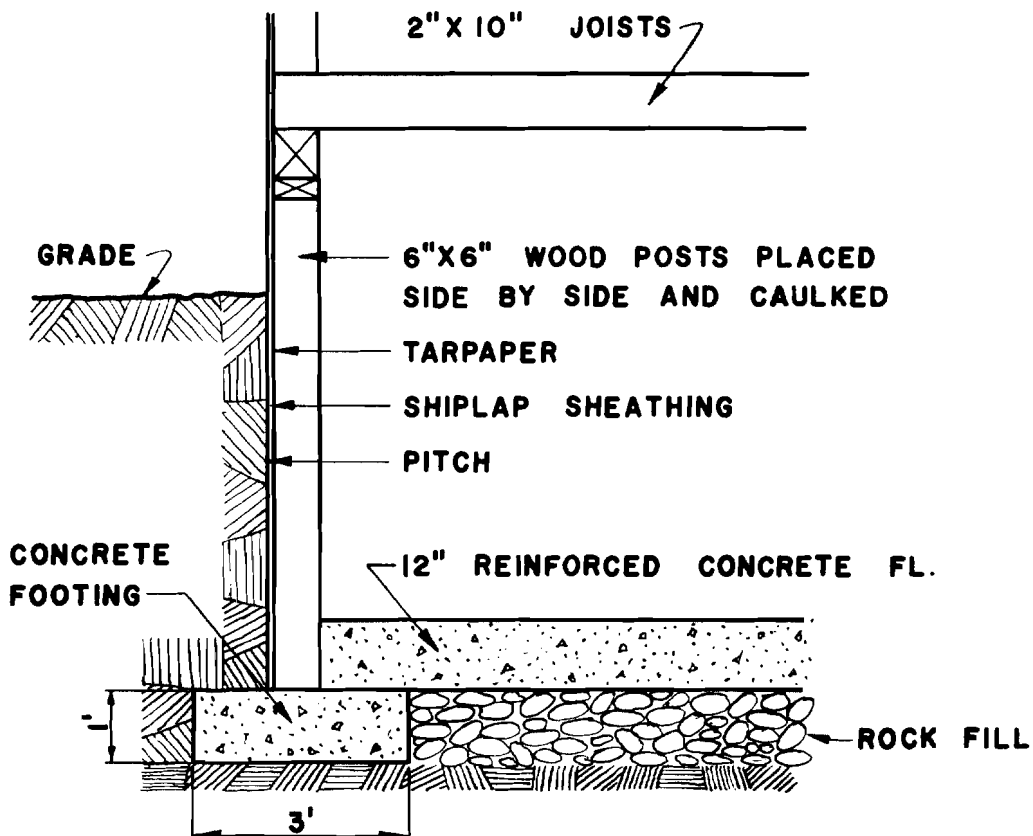
FIGURE 8      BASEMENT SECTION

Condition: The general condition of this basement is the same as that of the school. It was reasonably dry when examined. Father Biname reported that water was no longer a problem and the subsurface drainage is being handled satisfactorily by the sump pump.

Remarks: When construction of the present basement was started in 1950 it was found that the permafrost under the building had receded to a considerable depth. Observations taken at that time and reported in the field notes of D.B.R. staff members indicate that the permafrost had receded to a depth of more than 8 feet beneath the furnace.

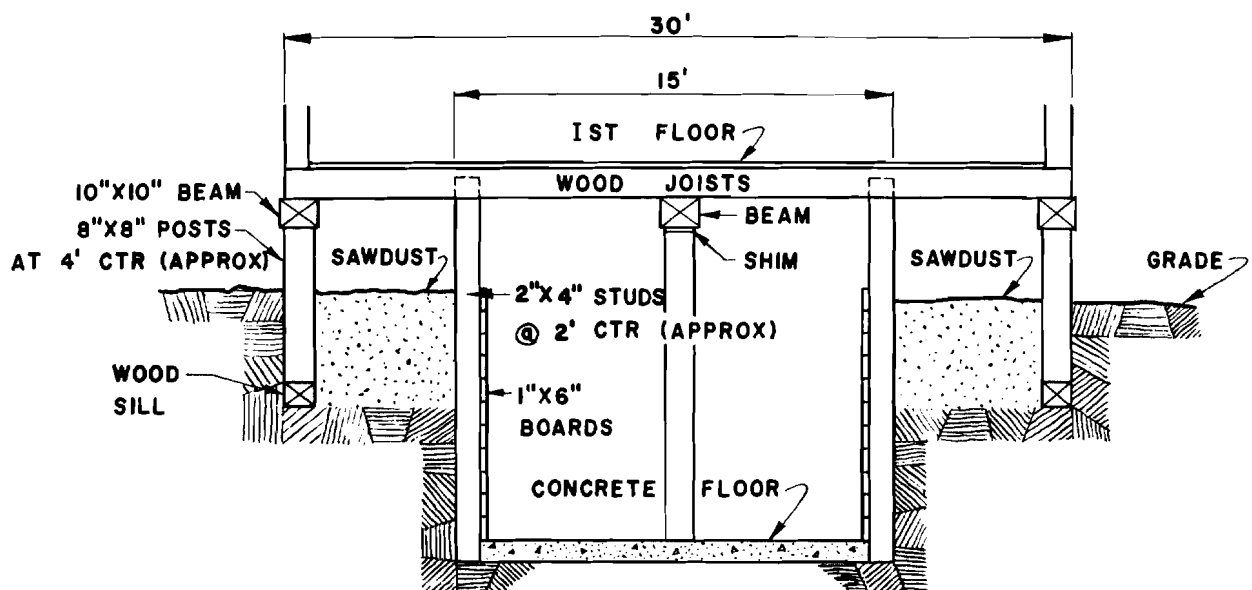
FIGURE 12 BASEMENT SECTION

Basement Details: (Fig. 12). The floor of the basement is reported to be of 4-inch thick concrete. Under the furnace a thicker concrete pad has been used. The walls are 2- by 4-inch studs lined with 1- by 6-inch boards on the inside to a height of 4 1/2 feet. Sawdust has been placed between the exterior foundation and the basement wall. The centre 10- by 10-inch beam is supported in the basement area by one post. A sump pit in the floor is pumped out at intervals with a hand pump.

Condition: The concrete floor was covered with a thin layer of dirt and sawdust and its condition was not easily determined. Parts of the floor that were examined were roughly finished and damp, indicating leakage or overflow from the sump, which was full and needed pumping.

Remarks: Notes from an earlier survey of this basement indicate that in 1950 the post which supported the beam over the basement area, had settled 10 inches and cracked the concrete around it. To compensate for this movement, the building had been jacked up in 1950 and a 10-inch shim placed on top of the post. The area of cracked concrete had evidently been replaced.

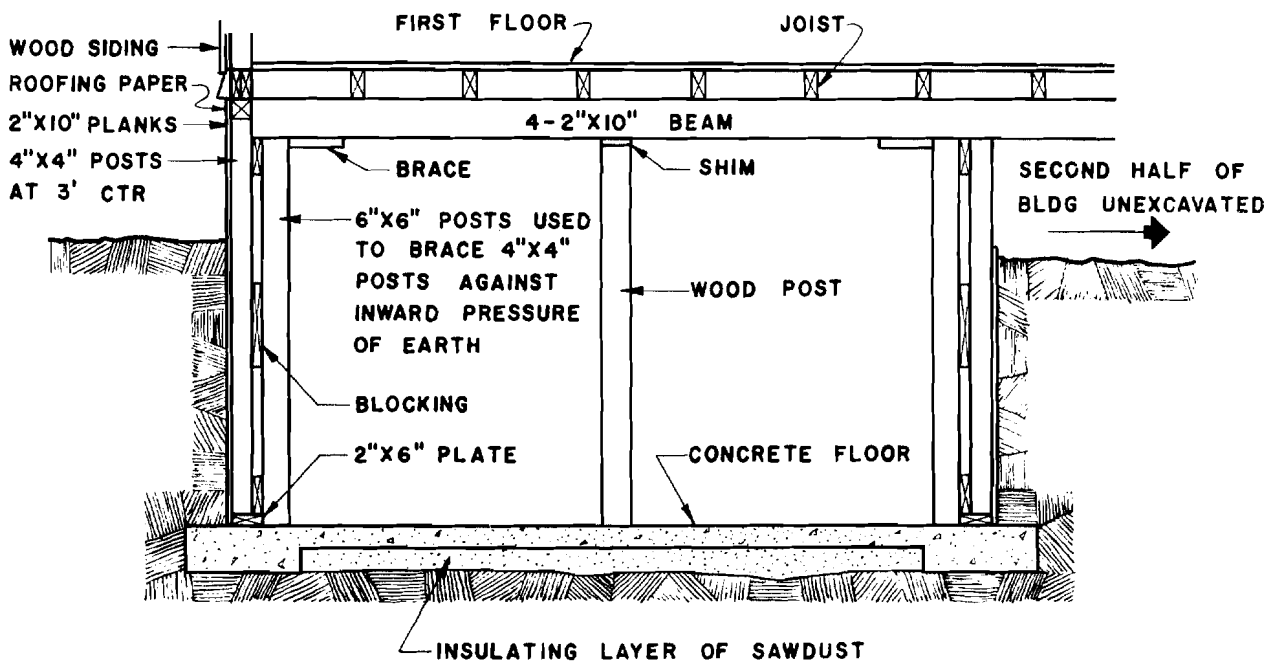
FIGURE 14      BASEMENT SECTION

Basement Details: (Fig. 14). The basement walls are constructed of 4- by 4-inch posts at 3-foot centres finished on the outside with 2- by 10-inch planks covered with roofing paper. They are reported to be carried on a concrete footing 2 feet wide and 10 inches deep. The floor, said to be 4-inch thick concrete, is laid on a 4-inch insulating layer of sawdust. The basement is equipped with an oil-fired warm air furnace and a sump with automatic pump.

Condition: The floor of this basement showed a few minor cracks but its general condition was good. There was some evidence of dampness (Fig. 16); it was reported, that enough leakage had occurred on a number of occasions to necessitate care in the storage of food supplies in the basement. A groove, several feet in length, had been cut into the concrete floor presumably to obtain better drainage to the sump.

The wood walls of the basement had pushed-in several inches due to earth pressure and it had been necessary to erect 6- by 6-inch posts behind the 4- by 4-inch posts to brace them against movement.

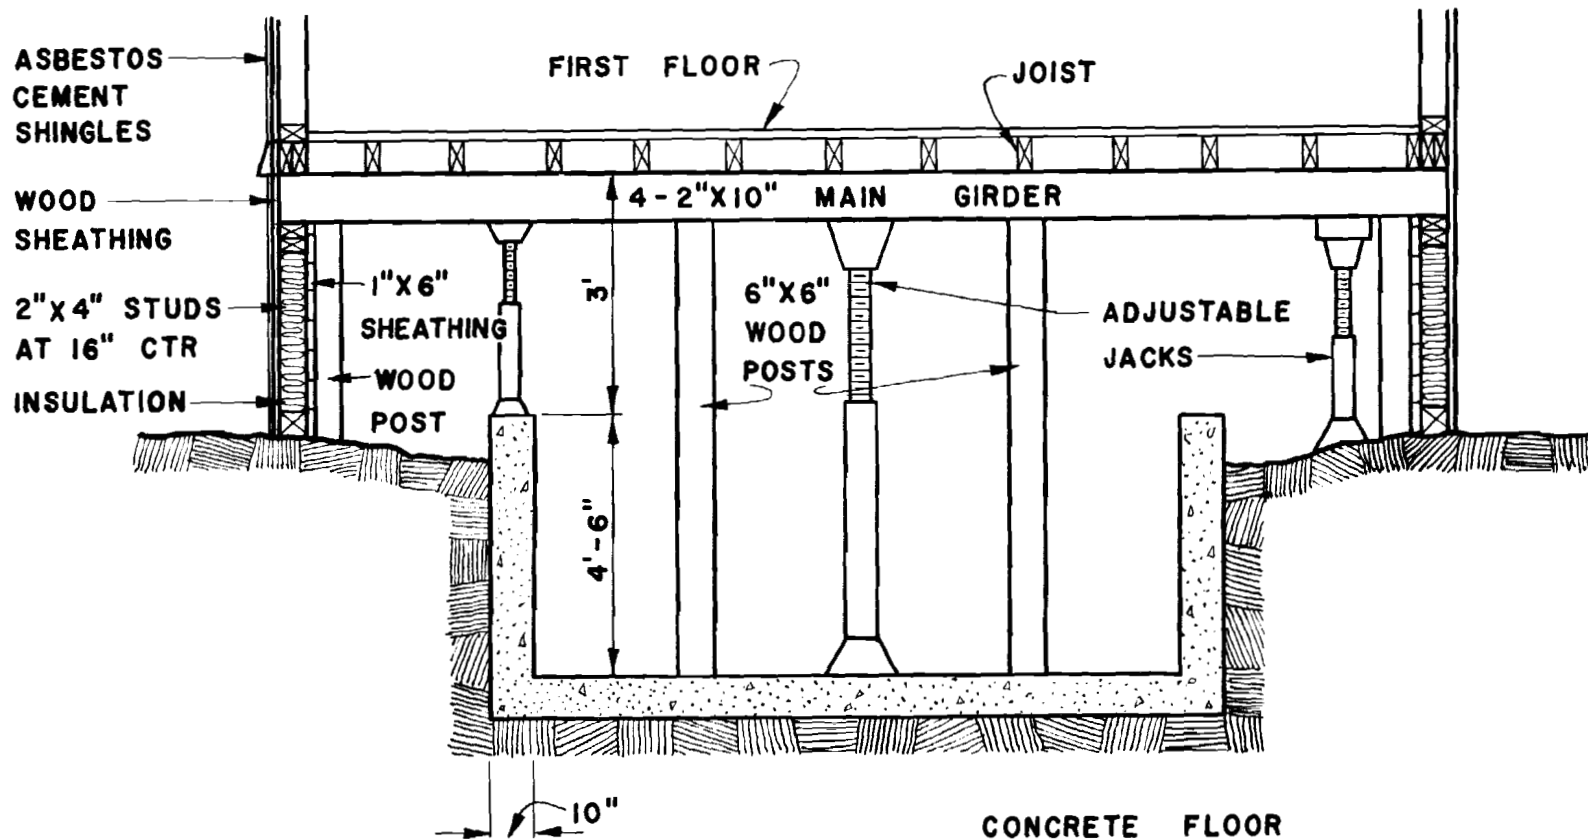
**FIGURE 18**      **BASEMENT SECTION**

Basement Details: (Fig. 18). The basement is of concrete with stub walls 10 inches thick and 4 1/2 feet high, and a floor reported to be 10 inches thick.

Remarks: It was reported that the installation of a long jack between the two posts in the basement had been necessary during the first winter of operation. During that period, the posts separated from the main girder due to frost heaving under the mud sills or settlement of the basement structure. Differential movement of the building and the basement reportedly became more severe each year until in the autumn of 1953, it was necessary to provide two additional jacks (Fig. 18) to raise the building back to its original level. In March 1954, serious leakage developed through the concrete floor around one of the wood posts; the water entered the basement in spurts as though under pressure.

To remedy this condition, the floor was rebuilt with drain tile under the floor, leading to a sump.

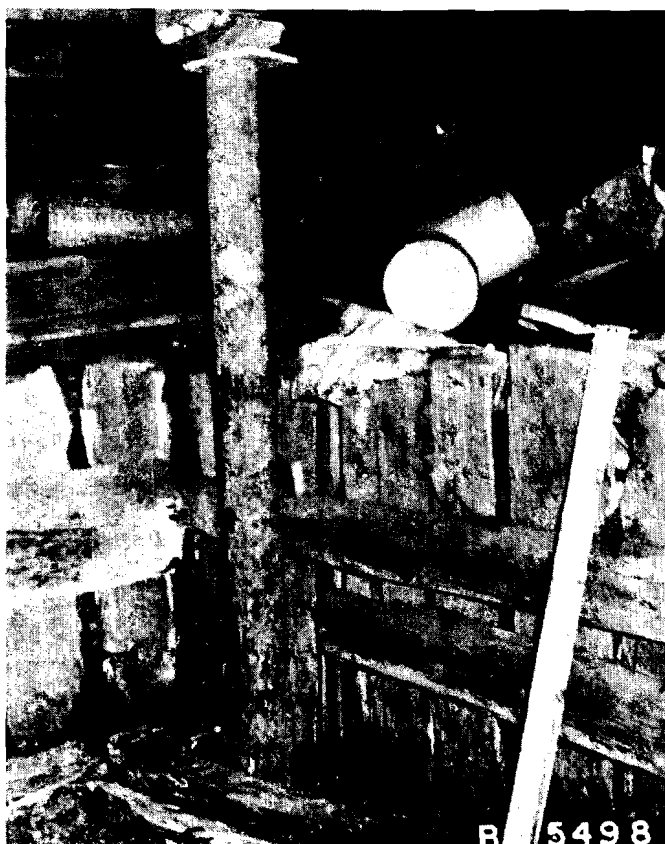
Many of these partial basements consist of little more than an excavation in the ground beneath the building large enough to provide space for a heating unit or food storage. The sides of these basements are usually lined with boards, some only to mid-height; the floors are covered by wood planking or a roughly finished concrete slab. The types of construction range from the primitive details of the Anglican school basement (Figs. 34, 35, and 36) and the Anglican Cathedral basement (Fig. 40), to the more carefully finished basement under the R.C.C.S. station (Fig. 41).

In general, these partial basements have not performed well. There is much evidence of leakage resulting in conditions that seriously limit their usefulness as basement areas. In nearly every case, settlement of the building has also occurred, and some adjustment of the exterior walls of the building has been necessary (Figs. 33 and 35). In some of the basements, such as those under the Anglican hospital, the Anglican school principal's residence,

Figure 40 Partial Basement  
of Anglican Cathedral  
showing Walls lined to  
mid-height with rough  
wood slabs

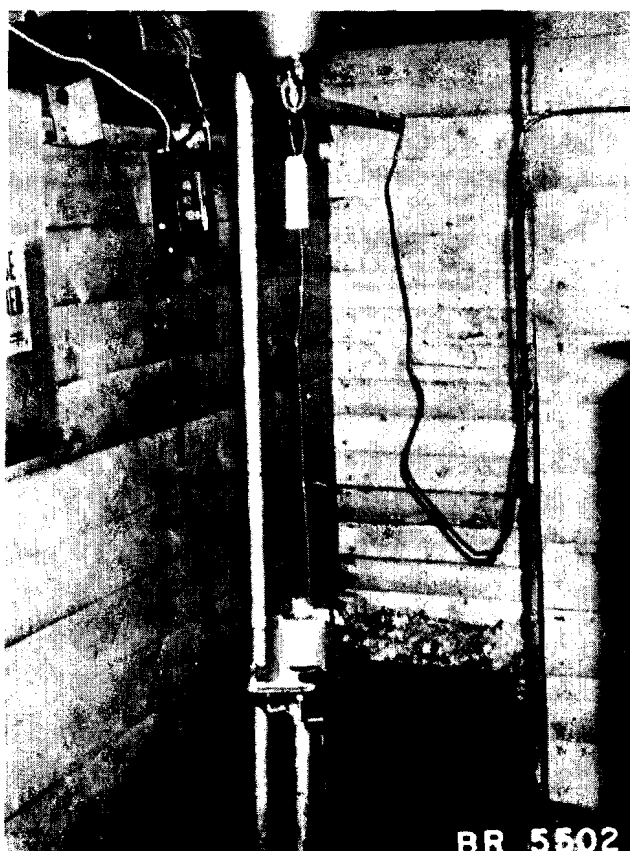
Figure 41 Partial Base-  
ment of R.C.C.S.  
Station showing Walls  
lined to full height  
with wood sheathing
