Appendix C

MEDOF PANEL PERFORMANCE ASSESSMENT BY NRC-CHC

R. Frederking and D. Sudom

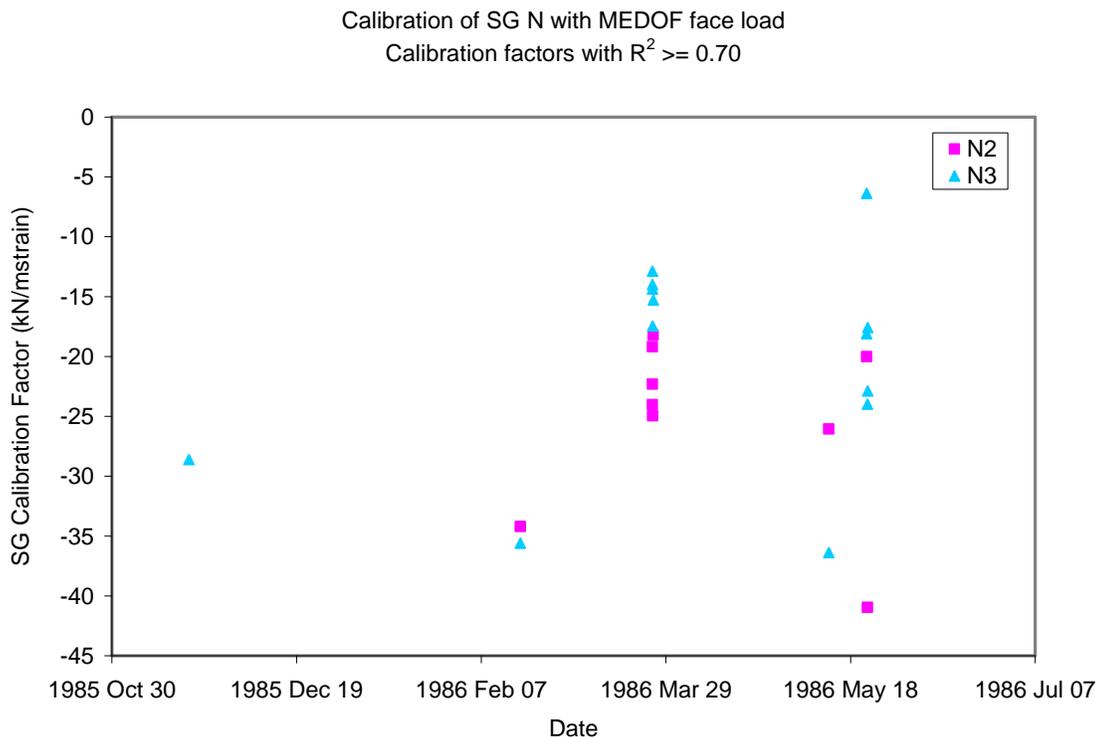
Figure 8 Strain gauge SG09 calibration factors for North face as a function of time

Calibrations of Medof Panel groups on the north and east faces versus SG09 strains were examined to see if any trends could be determined. If there was softening or hardening of the panels over the winter, a change might be detected. In doing this it is assumed that the strain gauges themselves were relatively stable. Time based plots for the north face results, N2 and N3, and east face results, E2, were examined for the whole 1985-86 season to see if any trends could be determined. Figures 8 and 9 do not show any discernable trends with time over the 1985-86 winter season. Softening by a factor of two would appear as a change of the calibration factor, from -30 kN/us to -60 kN/us.
