Corrosion of electronic components by hydrogen fluoride

Kim, A. K.; Crampton, G. P.

Journal of Fire Protection Engineering, 18, February 1, pp. 55-73, 2008-02-01

Corrosion of Electronic Components by Hydrogen Fluoride (HF)

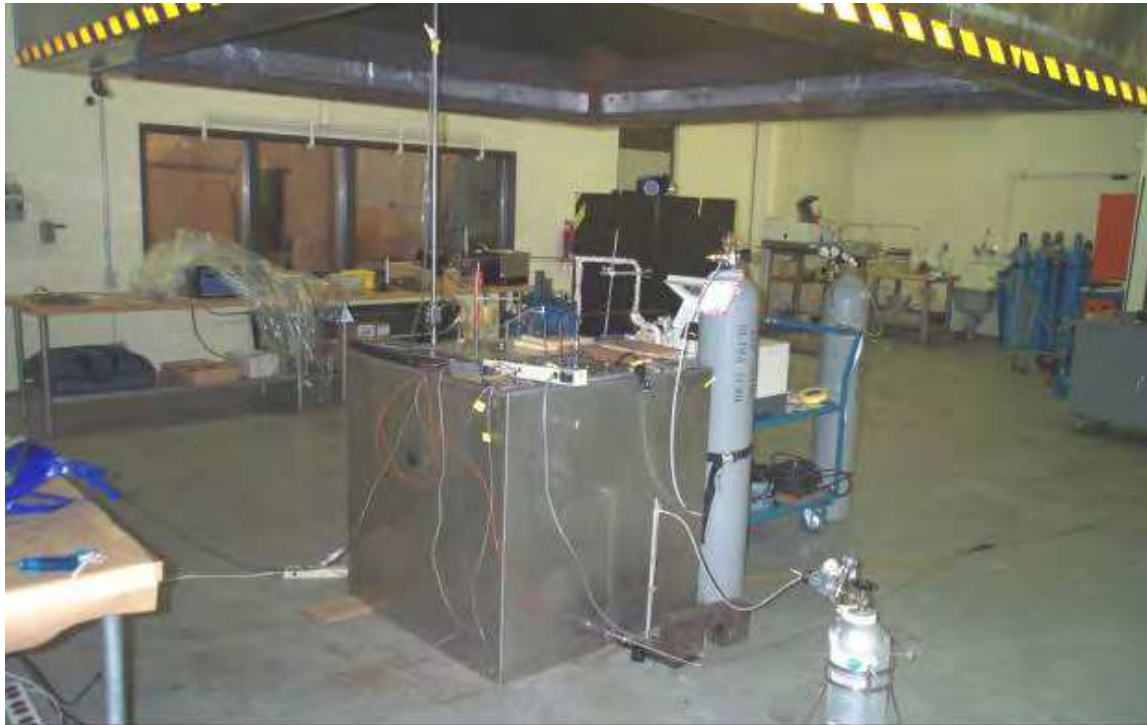
Figure 1 Picture of Test Set-up

The 1 cubic meter square box was constructed using 20 gauge 316 stainless steel. All joints and wall penetrations of the compartment were sealed to reduce air leakage. The top of the box had a 300 mm x 300 mm opening to allow access to the box. This opening was normally covered with a lexan window sealed with a polyethylene gasket. There were 2 holes plugged with rubber corks at mid-height of one side through which a torch flame and hot air were introduced into the test box during some tests. A picture of the test box with instrumentation is shown in Figure 1.

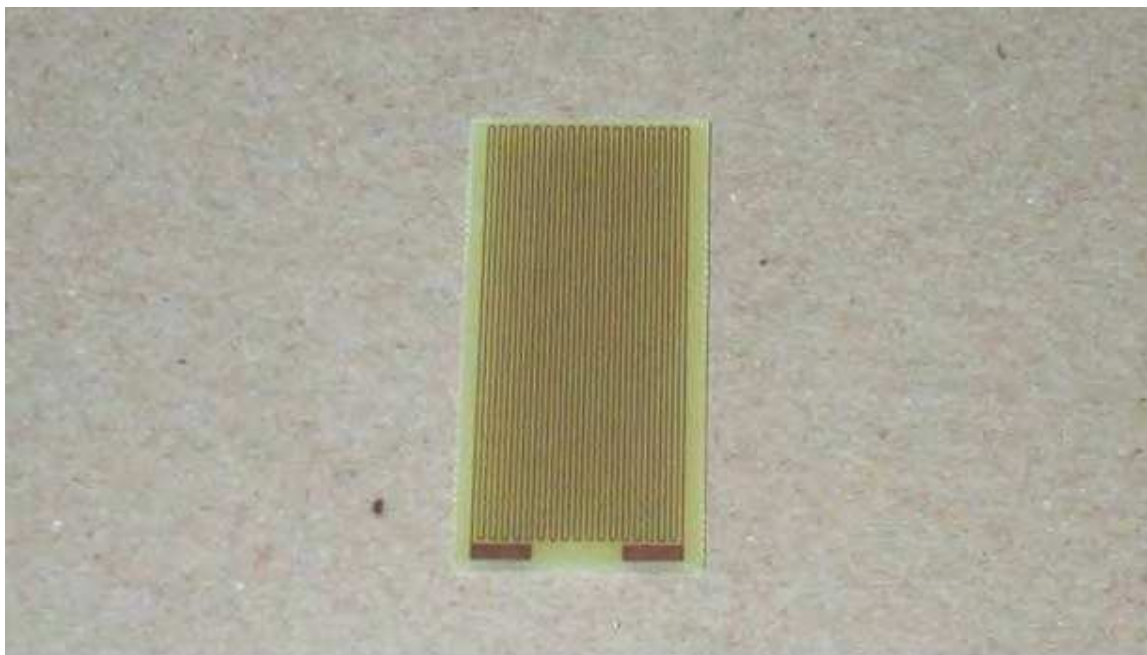
Figure 2 Picture of Corrosion Detector Board, Type 1.

One of the custom-made corrosion detector boards (Type 1) had a continuous copper wire loop, which detects the loss of current due to corrosion of the copper loop. The Type 1 board was made from 3.175 mm thick board material with 0.036 mm thick copper clad on one side. It was 25.4 mm wide by 55.88 mm long. A continuous trace of 0.305 mm wide copper circuit ran back and forth along the board with 0.305 mm spacing between the rows. Solder tabs were located at either end of the trace for mounting electrical connections to the board. The electrical resistance of a new Type 1 board before any exposure to HF was 4.1 ohms plus or minus 0.1 ohms. During the test, the electrical resistance of the board was continuously measured to detect any onset of corrosion on the board. The copper trace on the board was clean and unprotected prior to testing. Figure 2 shows a picture of the Type 1 corrosion detector board.

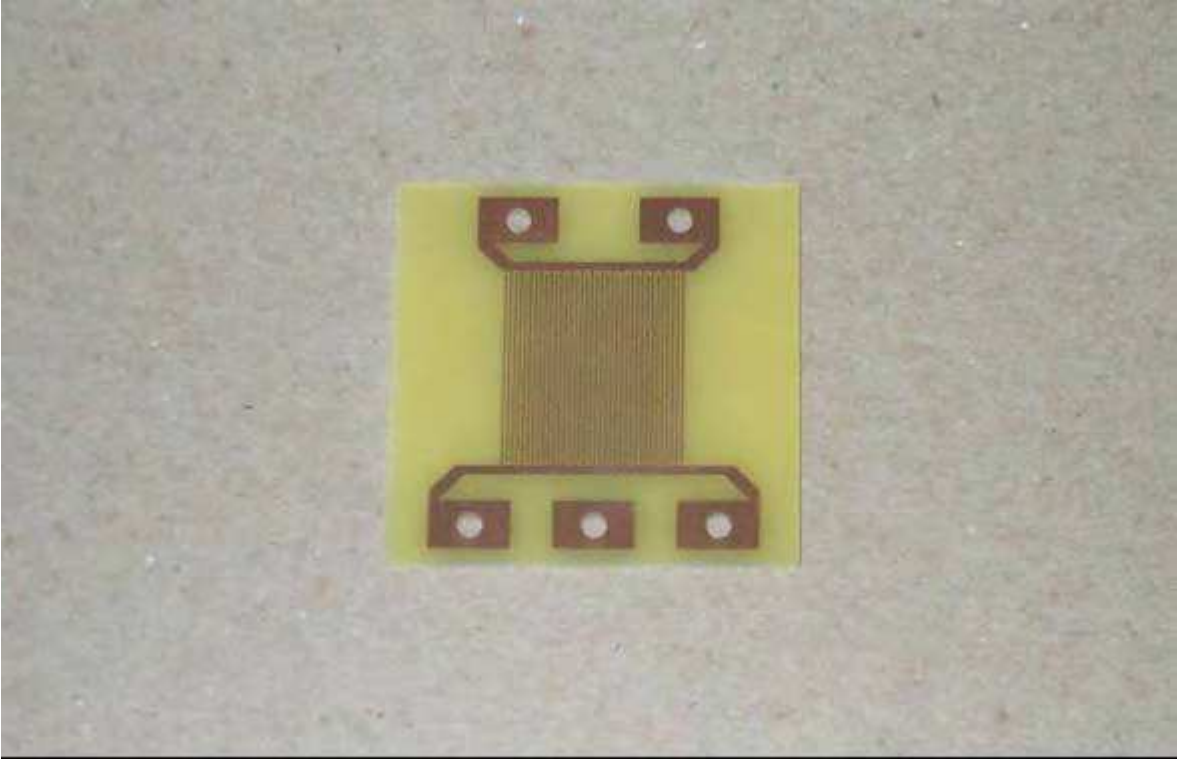
Figure 3 Picture of Deposition Detector Board, Type 2.

The Type 2 board was made from 3.175 mm thick board material with 0.036 mm thick copper layer on one side. It measured 50.8 mm wide by 50.8 mm long. Parallel traces of 0.318 mm wide copper circuit was put on the board; one copper loop runs along the board from one side and an identical loop runs from the other side such that no electrical connection exists between the two loops. These traces were separated by 0.318 mm spacing between the loops. Solder tabs were located at either end of the board for mounting the electrical connections. The electrical resistance of a new Type 2 board before any exposure to HF showed an open circuit. During the test, the electrical resistance of the board was continuously monitored to detect any resistance between the two loops, which indicates the onset of corrosion on the board. The copper traces on the board were clean and unprotected prior to testing. Figure 3 shows the picture of the deposition board Type 2.

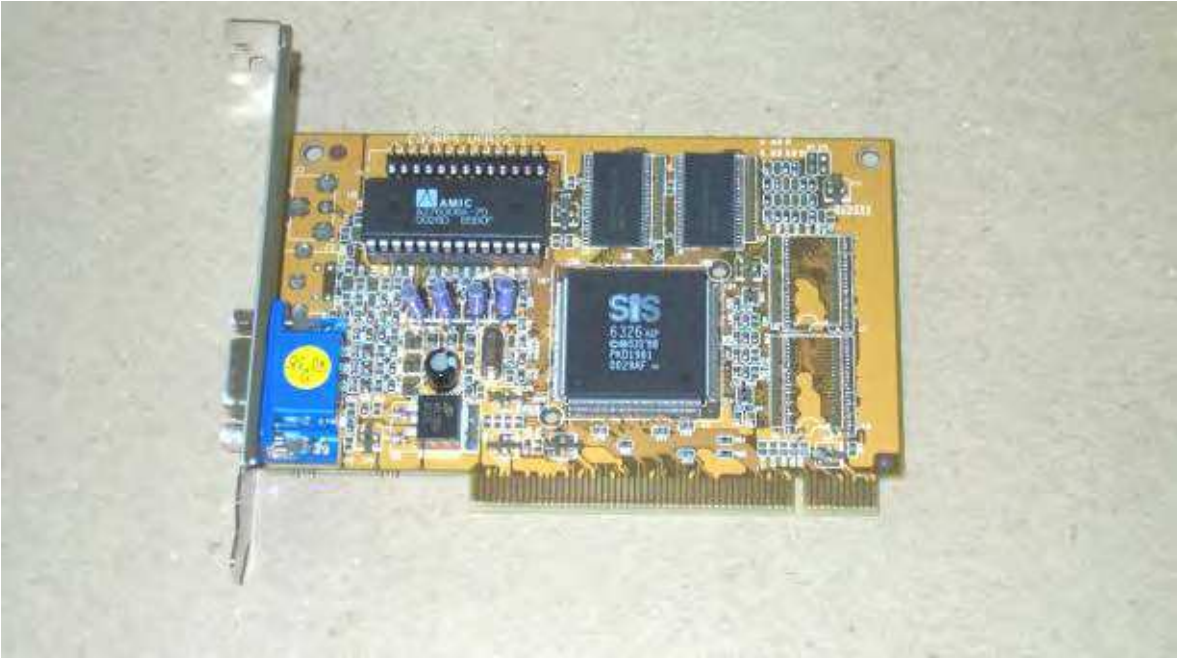
Figure 4 Picture of video card

The computer video card used in the tests was a commercial grade, 5 volt PCI video card, SIS brand, model C6326. The video card contained many small components mounted on the surface of the board. This was a newer type of board, which is less rugged than older boards. Older boards had discreet components mounted on the board with pin connections and were very rugged. Newer video cards are more fragile and sensitive to corrosion effects. Surface mounted components were hot air soldered and they were protected by very thin casings rather than the more rugged casing found on older style boards. The corrosion would attack the thin protective layer of the small surface mounted components rather easily and would affect the functionality of those components. A picture of the video card is shown in Figure 4.

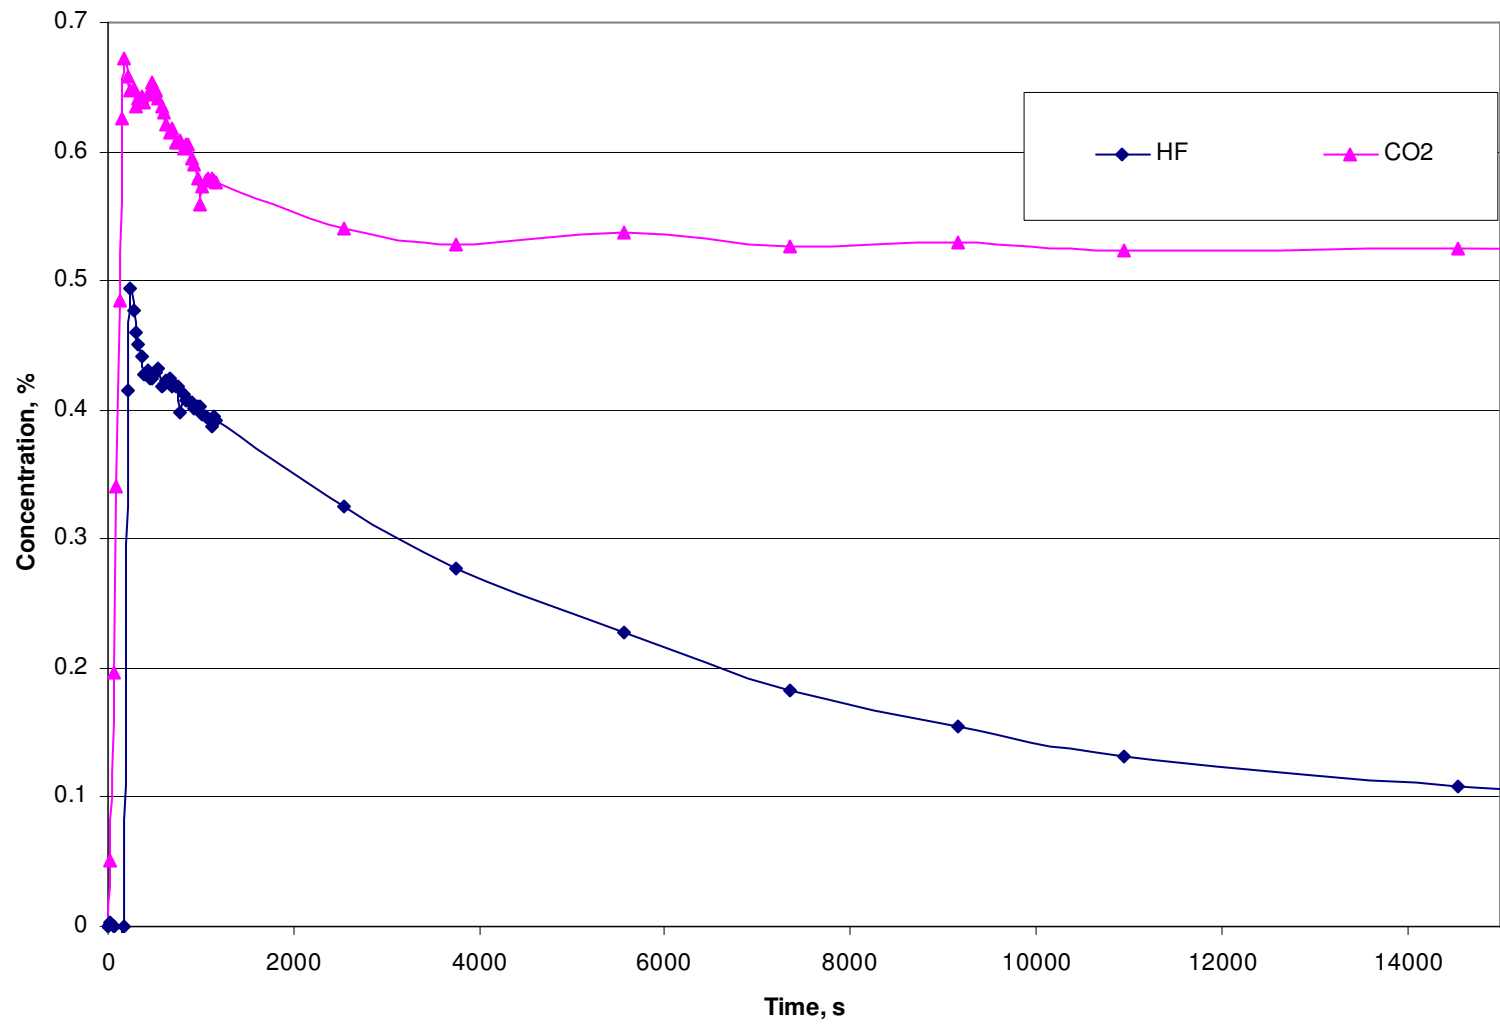
Figure 5 Graph of HF and CO2 concentrations in the test box

Figure 5 shows the HF and CO₂ concentration changes with time. The figure shows that the CO₂ concentration remains steady while the HF concentration drops sharply, confirming that the test box was not leaky and HF reduction was due to the HF reaction with moisture.

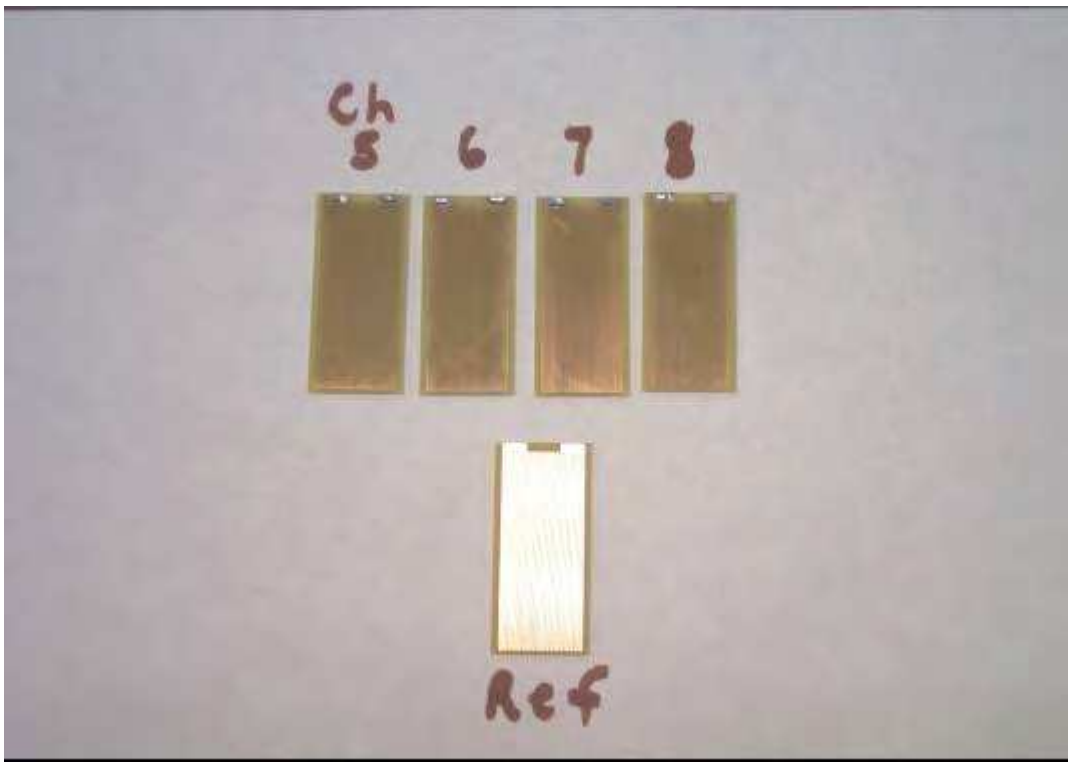
Figure 6 Picture of Type 1 board before and after exposure to HF

Test results showed that surface corrosion on the electronic boards was visible when the test specimen was exposed to HF concentrations above 1000 ppm for a 1 h exposure duration. Figures 6 and 7 show pictures of Type 1 and Type 2 corrosion detector boards before and after exposure to HF. Above 5000 ppm, heavy corrosion damage on the specimen surface was noted, and the printed circuit on the surface was also damaged, which affected the functionality of the board. When exposed to HF concentrations of less than 1000 ppm, no visible corrosion damage on the surface was noted. However, the surface corrosion damage depended not only on the concentration of HF but also depended on the humidity of the surrounding air. When the humidity was high in the test compartment, minor surface corrosion was noted at 1000 ppm HF, however, under very dry conditions, no surface corrosion was noted even at 2500 ppm HF.

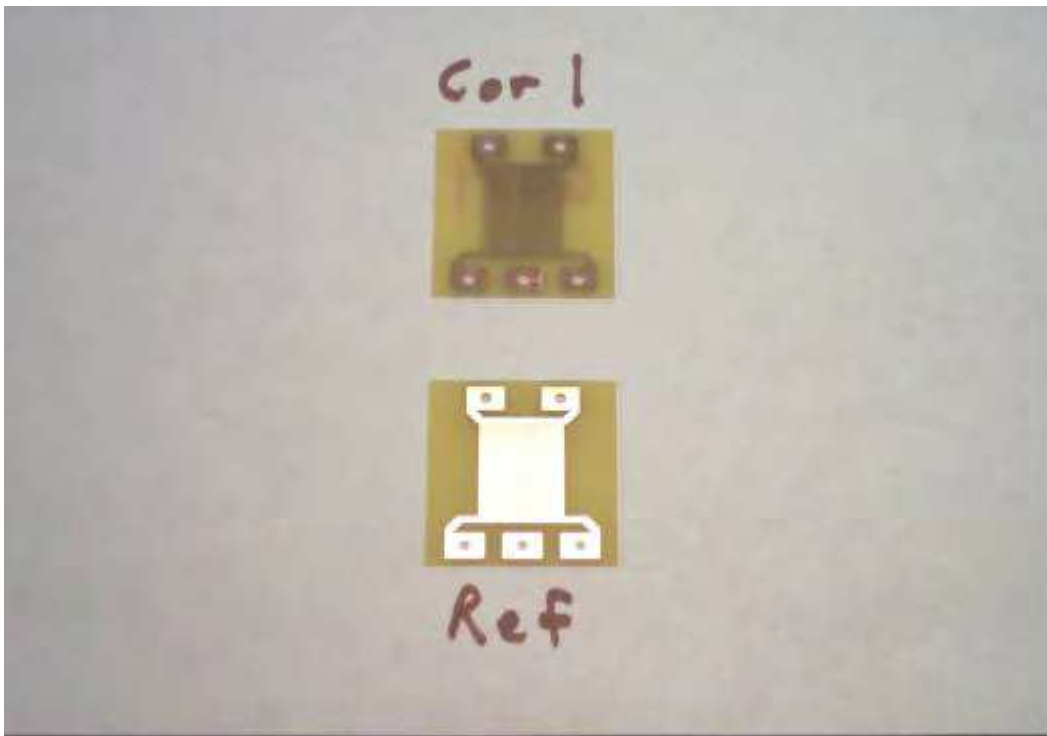
Figure 7 Picture of Type 2 boards before and after exposure to HF
